Lease Road to English #1 Well

Report on the Investigation of the Natural Gas Invasion of Aquifers in Bainbridge Township of Geauga County, Ohio

September 1, 2008
Ohio Department of Natural Resources
Division of Mineral Resources Management

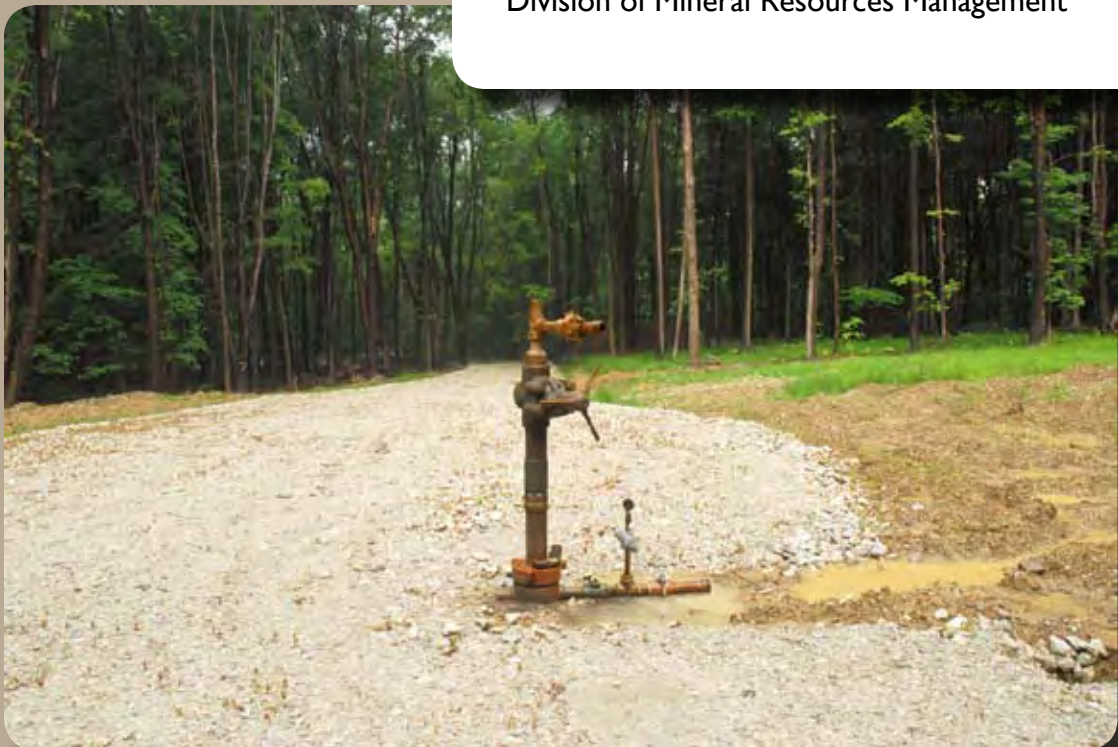
English #1 Well

The DMRM determined that accumulation and confinement of deep, high-pressure gas in the surface-production casing annulus of the English #1 well, between November 13 and December 15, 2007 resulted in over-pressurization of the annulus. This over-pressurized condition resulted in the invasion, or migration, of natural gas from the annulus of the well into natural fractures in the bedrock below the base of the cemented surface casing. This gas migrated

Three different factors in the drilling and completion of the English #1 well are believed to be the primary contributing factors that led to the gas invasion of the shallow aquifers and subsequent explosion in the house on English Drive. The first contributing factor was inadequate cementing of the production casing prior to remedial cementing on December 15 2007. The second contributing factor was the decision to proceed with stimulating, or hydro-fracturing, the well without addressing the issue of the minimal cement behind the production casing. Hydro-fracturing is the process in which fluid is pumped into the oil and gas reservoir through perforations in the production casing to enhance fractures and improve the flow of gas and/or crude oil into the production casing. Finally, the third and most critical contributing factor leading to the incident was the 31 day period after the fracturing stimulation of the “Clinton” sandstone during which the annular space between the surface and production casings was mostly shut in. This confined the deep, high-pressure gas from “Newburg” and/or “Clinton” within this restricted space. Readings taken and reported by OVESC during this shut in period were consistently 320 psi or greater.

1. Inadequate primary cementing of the production casing has been remedied by the subsequent squeeze cementing operations;
2. The deep high-pressure gas zones that were the source of over-pressurization of the aquifers have been isolated and sealed from the well bore through the squeeze cementing procedures;
3. The confinement of annular gas, which caused the build up of pressure, has been eliminated.
