Final Report

The effect of power-line explosion on the performance of E-glass/Vinyl Ester Composite Panels Manufactured by Armorcast Products Co. for the Voltek System

This report is submitted as part of cooperative agreement No. F-14-3575-1.0 between The University Corporation at California State University Northridge and The Voltek Division of Armorcast Products Company.

The effect of power-line explosion on the performance of E-Glass/Vinyl Ester Composite manufactured by Armorcast Products Co. for the Voltek System

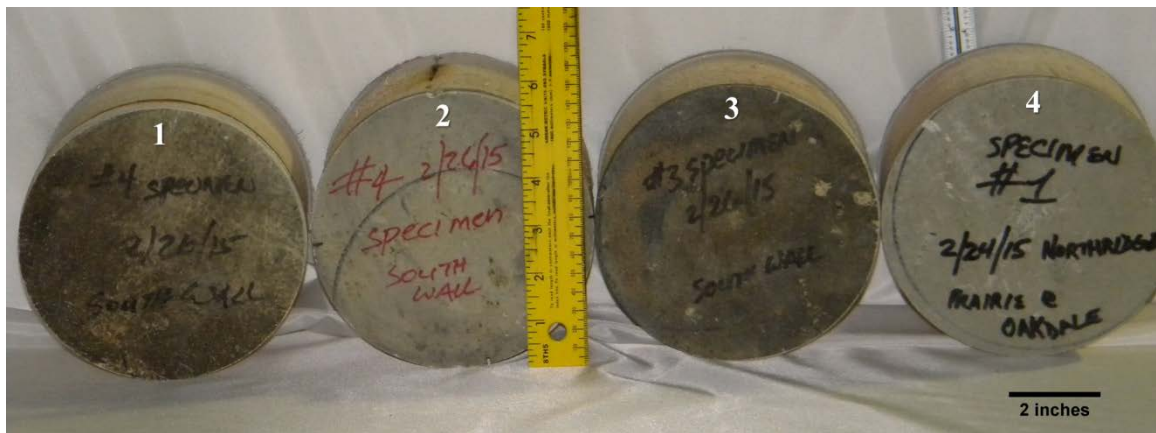
Figure 2: Front view of field harvested samples.

Five specimens with width of 12.44 \pm 0.43 mm (95%) and thickness of 6.01 \pm 0.01 mm (95%) were cut from the field-deployed sample block that was most affected by the power-line explosion, i.e.,

sample block #3 in Figure 2, which exhibited the most burn marks and in-service contaminations of the supplied sample blocks. Additionally, four specimens 12.83 ± 0.05 mm (95%) wide and 5.98 ± 0.04 mm (95%) thick were extracted from the new composite panels. The length of the all the specimens was set to 70 mm, which was fixed by the distance between the stationary clamps (Figure 4).

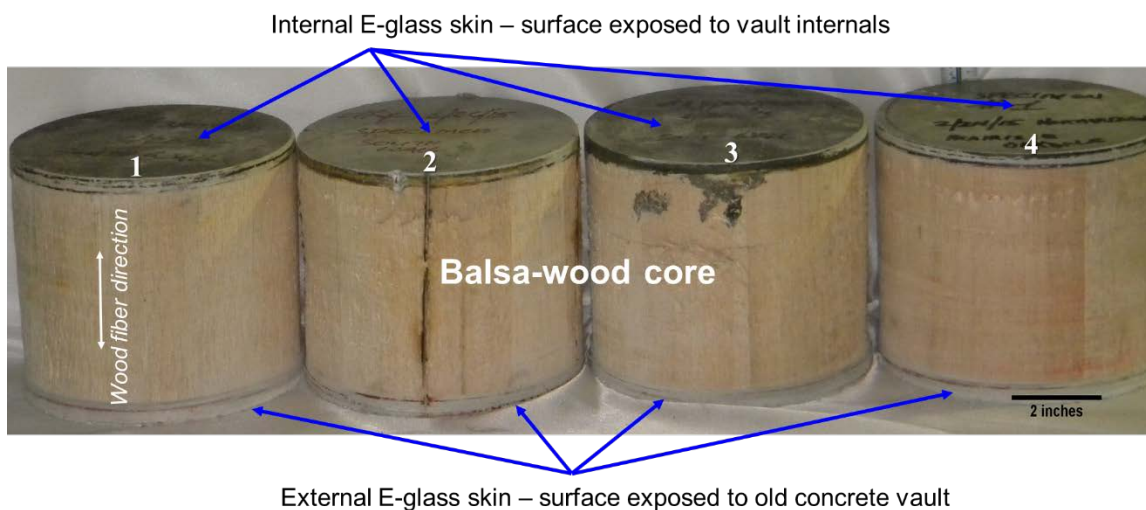
Figure 3: Side view of the field-harvested samples.

The specimens used in this study were prepared from panels that were provided by Armorcast Product Company. The construction of all the panels was ~ 6.35 mm in skin thickness and ~ 140 mm in core thickness. Generally, the panel's skin is made of E-Glass/Vinyl Ester and the core is made of balsa wood [1]. Figure 2 shows the front view of the four sample blocks, which were harvested from field-deployed vault panels after a 34.5kVA power-line explosion [Exhibit 1]. The samples were extracted using ~152 mm dia. hole-saw from a vault located in Northridge, CA, and owned and operated by the Los Angeles Department of Water and Power (LA-DWP). The samples exhibit different degrees of contaminations and burn marks depending on the surrounding environment during installation, in-service conditions, and the proximity of the panels to the power-line explosion site, respectively. Figure 3 shows the profile view of the extracted samples, which indicates that the burn marks are limited to the surface and has not penetrated beyond few micrometers of the exposed surface. It is important to note that the balsa wood core did not show any signs of water absorption, which indicates that the E-glass/Vinyl Ester skin completely concealed the core from the surrounding environmental conditions. The burn mark shown on the profile view of the second sample block (Figure 3 – 2nd sample from the left) is attributed to the

extraction process, which resulted in burn marks on the wood core as the saw blade was cutting. In addition to these samples, Armorcast Products Company provided two completely new panels from the same product line, of which testing specimens were prepared. These panels were new off the production line and have not been deployed in the field. In short, specimens used in this experimental investigation were extracted from both field-deployed and new panels to compare the effect of field deployment, specifically power-line explosion, on the mechanical performance of the composite panels.

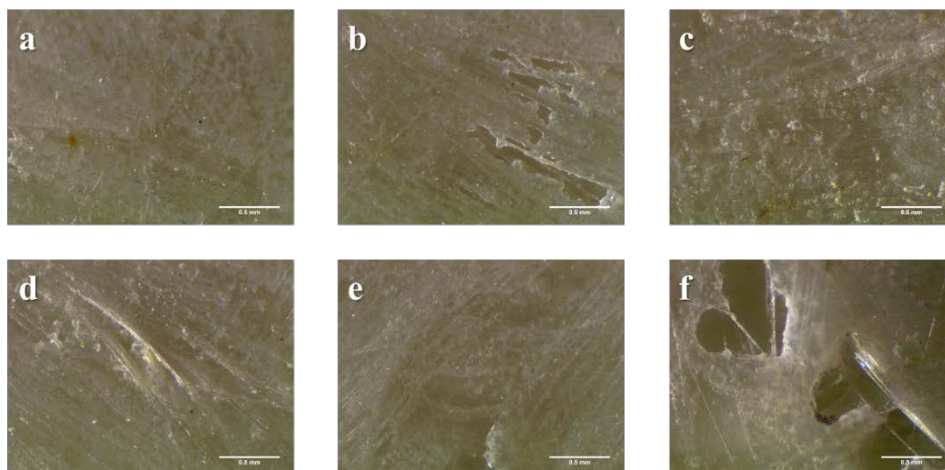
Figure 6: Optical micrographs of the surface of new (new) composite panels.

Figure 6 shows the surface micrographs of new E-glass/Vinyl Ester composite panels, which include six different digital images that were taken from different regions. All the images show consistent fiber/resin ratio and verify that the fibers are in tension regardless of the fiber orientation (Figure 6-a, 6-b, 6-d and 6-e). Figures 6-b and 6-f show small areas (note the scale on the right-lower corner of the image), where the matrix is not continuous and voids are present. The voids are attributed generally to the wet layup manufacturing process used to make the panels, where a relatively low viscosity resin is spread over the dry glass fiber and then pressed together in cold hydraulic press for curing. Finally, Figure 6-c shows entrapped bubbles on the surface, which are associated with the matrix curing process. That is, the matrix releases chemical volatiles as a byproduct of the curing process, which are inhibited from escaping due to the pressure applied by the cold-press to complete the curing.

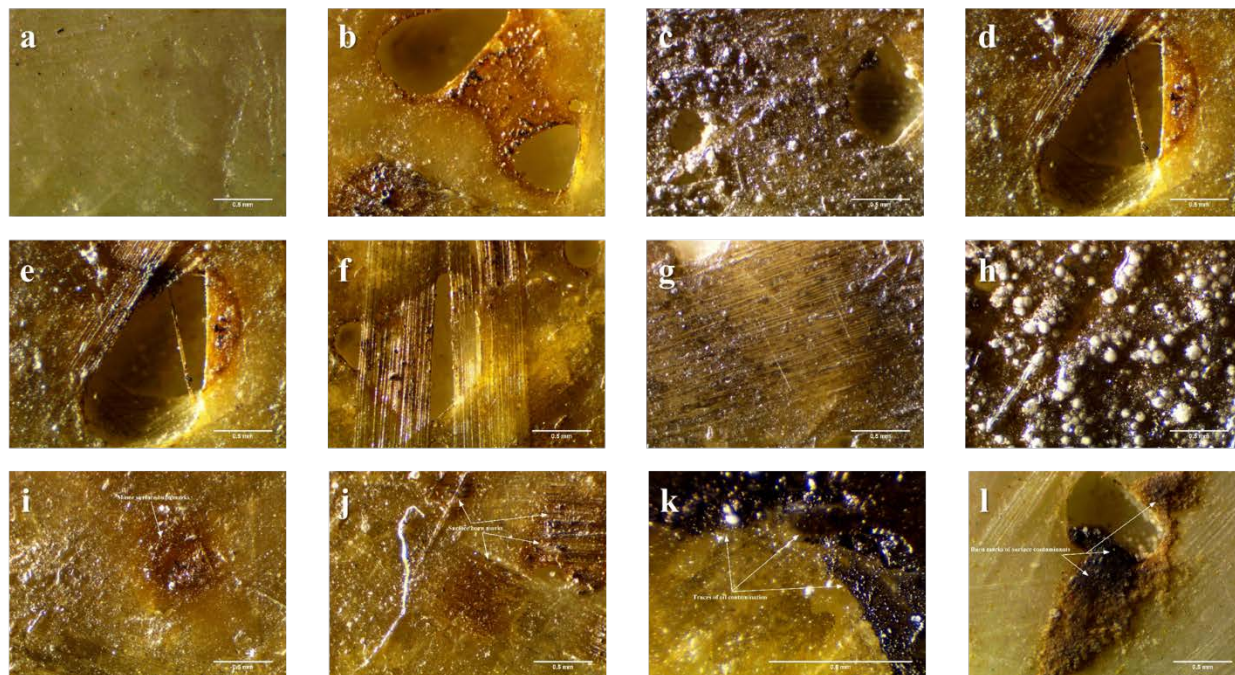
Figure 7: Optical micrographs of the surface of field-deployed samples after power-line explosion.

Figure 6 shows twelve surface micrographs of the field-deployed panels that were exposed to in-service conditions and power-line explosion, as noted earlier. Similar to the new panel, these micrographs were taken from different surface regions from the most affected sample block (Sample #3 in Figure 2). Figure 7-a shows a clean portion of the surface, which indicates that although this region was in the vicinity of the explosion, i.e., adjacent to the regions in the remaining micrographs shown in the Figure 7, there is no significant change as it compares to pictures shown in Figure 6. Moreover, all the micrographs in Figure 7 resemble the characteristics of the new composite panel specimens as discussed in the previous paragraph. Specifically, the consistent fiber/resin ratio and fiber tension are evident, which are accredited to the consistency of the manufacturing process. The tension in glass fibers are clearly shown in Figures 7-d through 7-g, which indicates that surface temperature caused by the fire that accompanied the power-liner explosion never exceed the melting temperature of the matrix. The absence of evidence of fiber draping or embrittlement of the polymer matrix show that the surface temperature mostly likely

never exceeded the polymer softening temperature. In other words, the fibers remain in tension and the matrix remains without surface cracks.

Figure 7-b through 7-f and 7-l show the presence of voids, which also attributed to the wet layup manufacturing process as discussed above. Also, the unaffected edges of the voids show that the voids existed before the power-line explosion and that the fire did not alter the materials in or surrounding the cavity of the voids. In the perspective of the entrapment of gaseous volatiles on the surface, Figures 7-c and 7-h show the existence of the bubbles on the surface covered by layers of contaminations of dusty (dull appearance) or oily (shiny and reflective appearance) natures. As discussed before, these bubbles are also a byproduct of the curing process and are not a result of in-service conditions.

The existence of surface contaminations due to installation or in-service conditions created a rich environment for the fire to affect the exposed surface of the composite panels. For example, Figure 7-k shows two adjacent regions on the same few millimeters-squared area, where the boundary of the highly-fire affected and mostly-unaffected, except for a slight color change (minor burn marks), regions is determined by the presence of surface contamination. The same effect can be observed on the remaining micrographs in Figure 7, where the existence of dust particles or surface contaminations left different level of burn marks compared to those on clean surfaces. Overall, the micrographs in Figure 7 show minor surface burn marks and an absence of excessive increase in the surface temperature, which is due to the fire-retardant properties of the composite panels. The

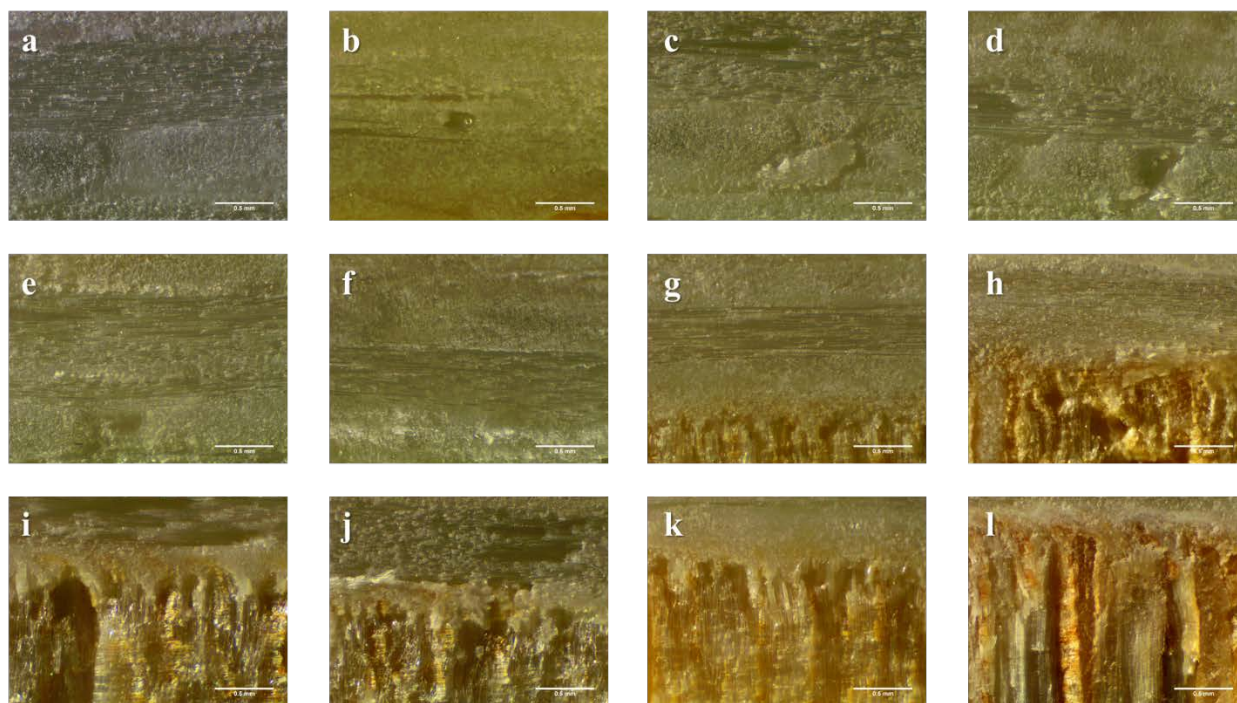
Figure 8: Cross-section images of new panels.

Figures 8 and 9 include series of digital images of the cross-section view of specimens cut from new and field-deployed panels, respectively. In analysis of these images, the focus was on explicating the nucleation of inter-laminar failure and the debonding of the skin/core interface that may have been caused by the power-line explosion or accompanied increase in temperature. When comparing Figures 8 and 9, it is evident that the composite panels remained unaffected by aforementioned harsh in-service conditions. The inter-laminar bonding strength and the skin/core bonding interface are higher than the mechanical and thermal stresses induced by the explosion and fire loading scenarios, respectively. This effect has been investigated using numerical simulation, the results of which are included at the end of this report.

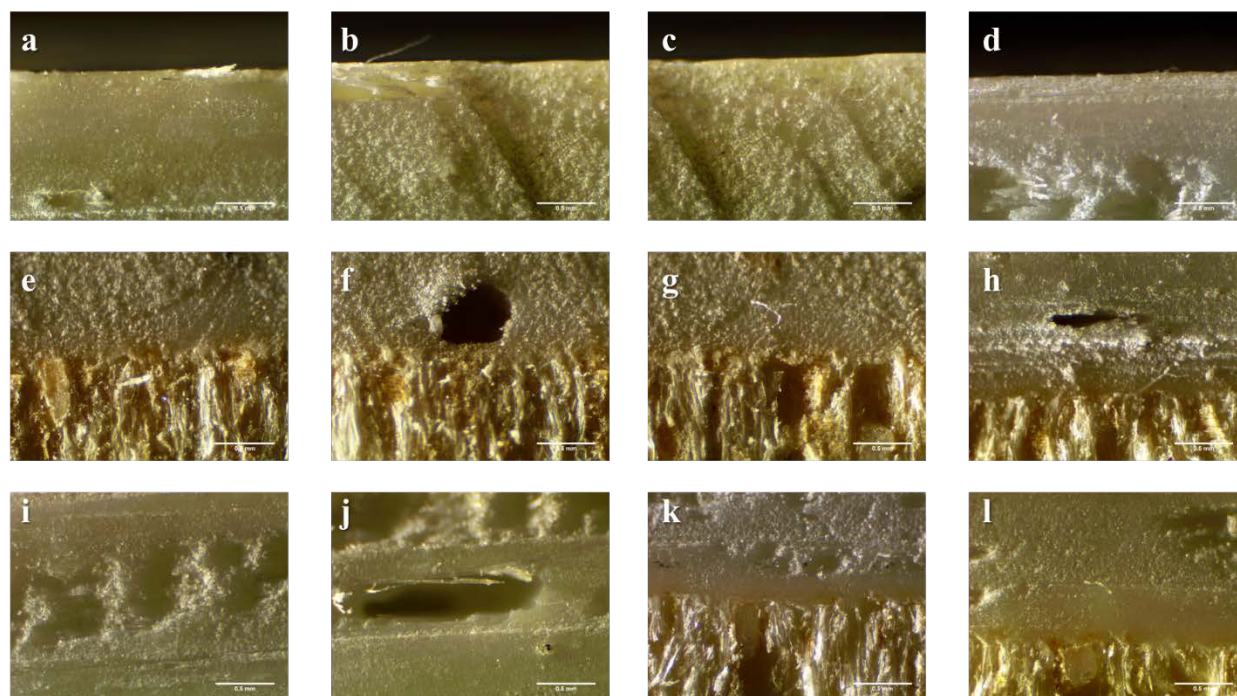
Figure 9: Optical images of the cross-section of field-deployed samples after power-line explosion.

The quantification of the bonding strengths are beyond the scope of this investigation but the survivability of the E-glass/Vinyl Ester composite panels has been shown to be superior except for the surface where surface contamination was present. Thus, based on the previously presented qualitative analysis of micrographs from new and field-deployed panels, it is advisable to ensure that the surface of the surface is clean, especially from oil contaminates.

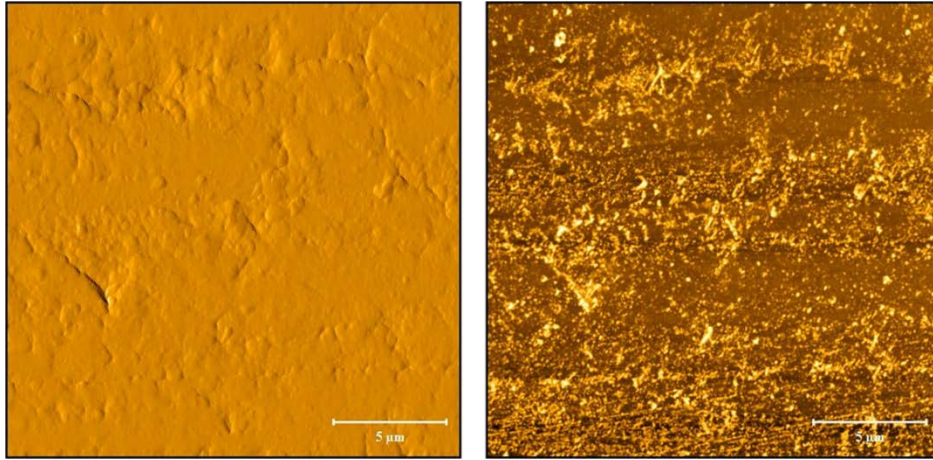
Figure 12: AFM topography (left) and phase (right) of specimen from field-deployed sample block with scan size of 20µm X 20µm.

Figures 10 and 11 show topography and phase of the surface from two different specimens that were cut from the new panel, while Figures 12 and 13 are the scans of specimens from field-deployed sample blocks. Generally, there is no significant change in the surface roughness, when comparing topographical images of new and field-deployed specimens. The aspect ratio of the surface roughness to the panel lateral dimension is very small. Therefore, it has a negligible effect on the overall mechanical performance of the composite panels in the field. Nonetheless, the contrast of the phase images from the new panels appears to be slightly darker than that from field-deployed samples. This represents change in the stiffness of the surface layer after the composite panels were exposed to harsh in-service conditions, e.g., surface contamination and power-line explosion. It is important to note here that the increase in the stiffness is only limited to the surface layer since optical images did not show any penetration of the burn marks into the thickness.

In Summary, the qualitative results supports the hypothesis of low velocity impact (low energy), which was discussed in the background section. Specifically, the absence of delamination, matrix damage, and fiber-failure, which are attributed to the lack of bending stiffness mismatch between adjacent plies, matrix cracks and matrix/fiber debonding were not observed, and low induced stress at the impact zone, respectively [8].

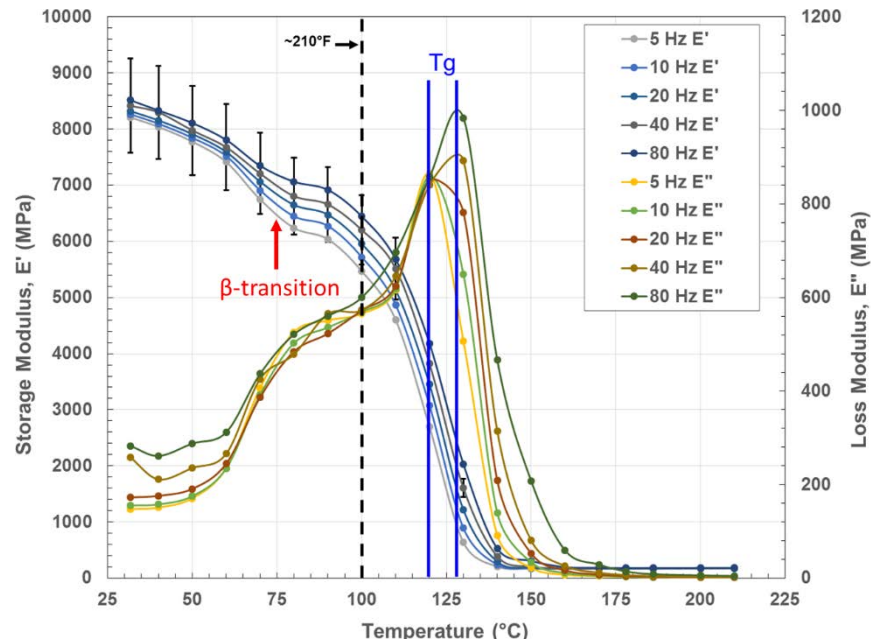
Figure 15: thermo-mechanical spectra of field-deployed specimen at different frequencies.

Similarly, Figure 15 displays the average thermo-mechanical behavior of five field-deployed specimens, where the storage modulus of these specimens was found to be 7273 ± 856 MPa at temperatures below 100°C . This change marks 21% decrease from the storage modulus reported for new specimens. It is important to note that the decrease in the storage modulus is accompanied by an increase in the loss modulus at temperatures below 100°C . Therefore, the complex modulus of the field-deployed and new panel remains the same within the experimental error. Additionally, the T_β transition is present at $\sim 75^\circ\text{C}$ but it is more distinct than beta transition in the new samples. That is, the chain sliding relaxation mechanism is more evident in the field-deployed samples. This, in turn, translates to significant increase in the resilience and toughness of the laminate. Since, T_β for new and old panels remained 75°C , it shows that the chemical composition of the laminate was not altered by the power-line explosion and associated fire. Figure 15 also shows slight change in T_g , which shifted to $\sim 120^\circ\text{C}$ at low frequency and to 127°C at high frequency. The shift in the T_g can be attributed to the change in the stiffness of the surface layer, which was observed by AFM scans.

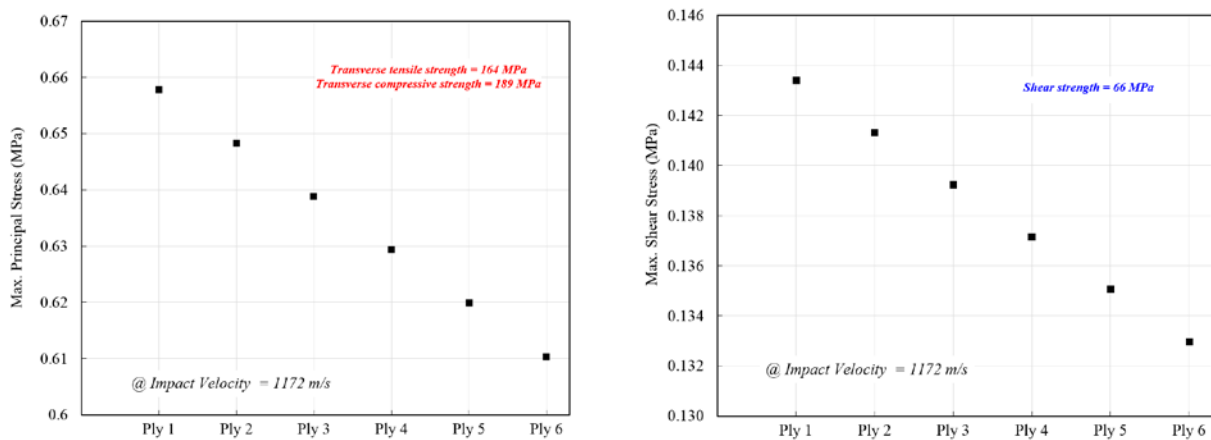
Figure 19: Maximum principal and shear stresses in each ply.

Figure 19 shows the maximum principal and shear stresses in each skin ply as well as the transverse tensile, compressive, and shear strengths. The simulation results indicate that the stresses induced due to impact loading are well below the allowable strength of each lamina and thus no ply failure was observed in the FEA simulation. This is consistent with the optical micrographs taken from the field-deployed samples, where no fiber failure was observed.
