Installation of a Riparian Forest by Means of Soil Bio Engineering Techniques—Monitoring Results from a River Restoration Work in Southern Brazil

Hans Peter Rauch¹, Fabricio Sutili², Stephan Hörbinger¹

Soil bioengineering has been applied more and more in different regions of Brazil in recent years. The study in hand presents the installation of “new” riparian forest based on soil bioengineering techniques. This riverbank restoration work was implemented in the year 2010 and two onsite vegetation surveys, one shortly after the construction, and one in 2013. Besides that, the structures of reinforcement work, and its effectiveness were evaluated. By means of the vegetation survey, the applied species were examined for their ability to establish the riverbank in an environmentally sustainable way. Most notably, the species *Calliandra brevipes* Benth. (Fabaceae, Mimosoideae), *Phyllanthus sellowianus* Müller Arg. (Euphorbiaceae), *Salix humboldtiana* Willd. (Salicaceae), *Bauhinia forficata* Link (Leguminosae), *Inga marginata* Willd. (Mimosoideae) and *Ateleia glazioviana* Baill. (Leguminosae, Papilionoideae) showed a good growth development. The proportion of spontaneous vegetati

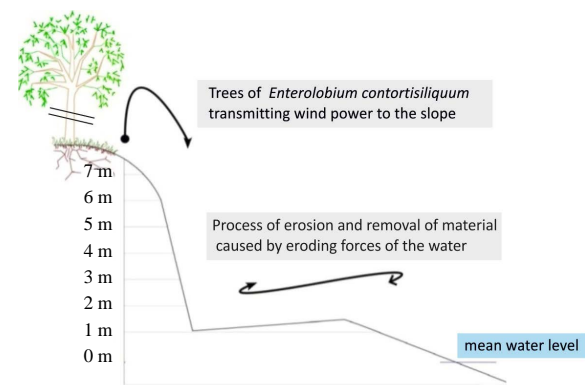
Figure 2. Sectional view, illustrating the eroding process.

The instability of the bank resulted from a continuous process of erosion, landslide, collapse and remove a lot material due to the action of the watercourse (see Figure 2).

The latter has shifted its axes outwards on this slightly curving river section. The instability of the embankment was exacerbated by the steep angle of the embankment, preventing the vegetation from spontaneous establishment. Additionally, the vegetation that was planted initially along the river at the top of the margin (trees of *Enterolobium contortisiliquum* (Vell.) Morong) did not have any stabilization effect on the site. Actually quite the reverse occurred. This vegetation formed an overhead

in the vertical axes, shifting its center of gravity in a less stable position. It captures and transmits wind power to the slope, creating a lever that certainly amplifies the dynamics of landslides, triggered by the current of the stream (Durlo & Sutili, 2005).

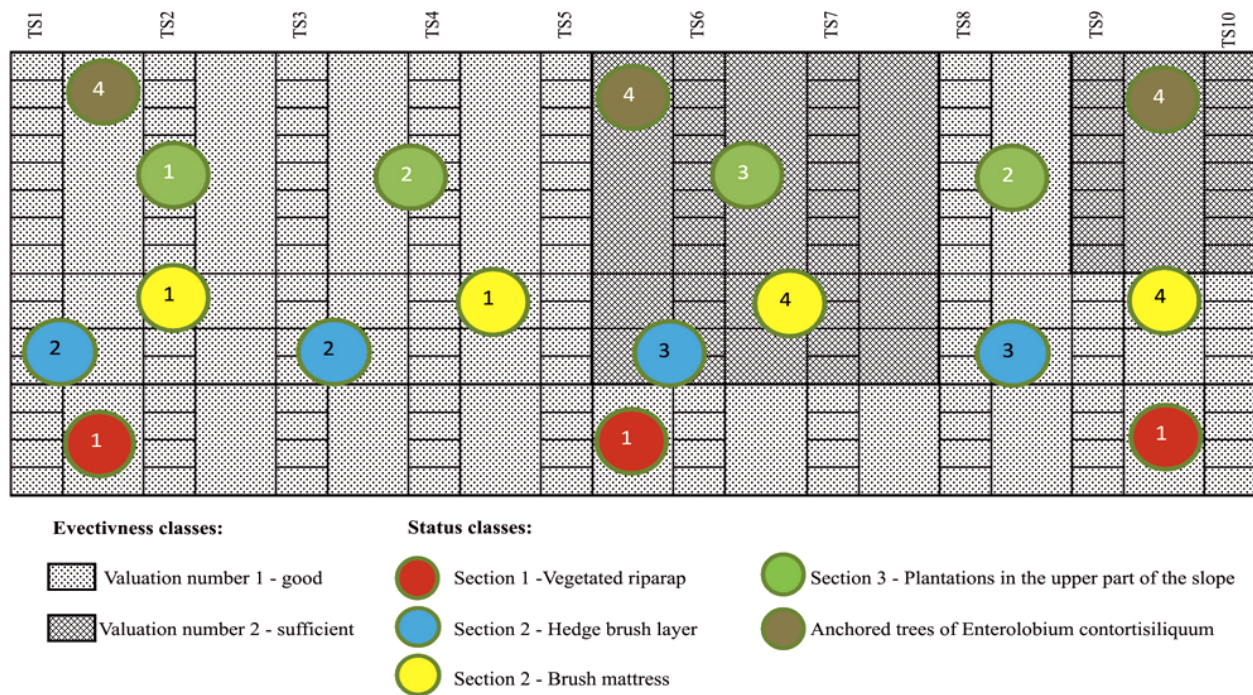
Figure 7.
Evaluation of structures.

In [Figure 6](#), the evaluation of the structures in terms of effectiveness and status is shown. As a whole, the intervention can be assessed as functional and safe. The effectiveness of the structures in conjunction with the present vegetation is rated in the classification classes 1 or 2. This means that the embankment is well protected and no imminent failure should be expected. Analyzing the structures separately showed some issues with the intervention. Only the vegetated riprap developed as it was supposed should have. In several spots, the implemented vegetation material did not or just sparsely emerge. Especially in the hedge brush layer and in the upper portion, where a wide range of species was fielded, the desired development was only partly achieved. The anchored willows showed a good development in half of the intervention, where high, vital brushes developed, making a major contribution to slope reinforce. In the other half, from transect 6 on, the brush mattresses could not develop at all. In the parts where the implemented vegetation did not develop as desired, spontaneous vegetation overtook the role of erosion protection, and therefore erosion just occurred point wise. Since the anchored trees of *Enterolobium contortisiliquum* were swept away shortly after planting, that intervention was classified with the category “destroyed”. [Figure 7](#) shows the embankment before the restoration work in 2010 and after the monitoring in 2013.

Although slope reinforcement was obtained, the high proportion of spontaneous vegetation plus uncovered areas might endanger the stability in the long term. Implemented species which significantly diminished or disappeared completely are not recommendable for further slope reinforcement constructions. The **brush mattress** showed in half of the construction very good development and seems therefore to be an appropriate construction for the use in soil bioengineering works. However, in view of its large application along the whole construction, the assertiveness against other species seems to be relatively low due to the partial occurrence of *Salix humboldtiana*. This fact should be considered in further applications of brush mattresses using *Salix humboldtiana*. In the **upper part of the slope**, which is only prone to extreme flow conditions in case of flooding, the increase of spontaneous vegetation was partly very high and several fielded species could not develop as expected. This provides important information about the assertiveness of the species used. The sweeping away of the **anchored trees of *Enterolobium contortisiliquum*** might be a result of the one-sided anchoring to the slope. A double-sided anchoring might prevent floating in case of flooding.

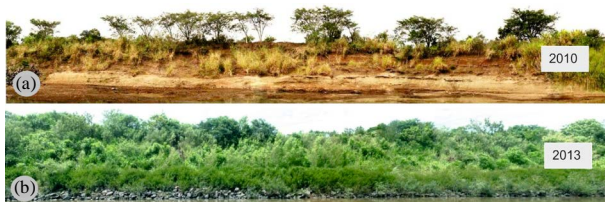
Figure 8 shows an overview of the situation before the intervention (2010) and after 3 years of plant development (2013). The “new” riparian forest based on the application of soil bioengineering techniques fulfills technical as well as ecological functions. The generated forest provides bank protection against erosion and creates new ecological habitats. Furthermore, the project shows that soil bioengineering techniques are

Figure 8. (a) Embankment before implementation of reinforcement works (Sutuli, 2010); and (b) two years after its completion (Hörbinger, 2013).
