# FONTENELLE DAM, RIRIE DAM, AND TETON DAM – AN EXAMINATION OF THE INFLUENCE OF ORGANIZATIONAL CULTURE ON DECISION-MAKING

*Fontenelle Dam, near Fontenelle, Wyoming, built by the Bureau of Reclamation between 1960 and 1964, had a serious incident in 1965 that nearly caused a breach of the structure that could have released more than 300,000 acre-feet of water. Teton Dam, near Rexburg, Idaho, built by the Bureau of Reclamation between 1972 and 1976, failed in 1976 releasing more than 250,000 acre-feet of water and causing 11 fatalities. Ririe Dam, also near Rexburg Idaho, was built in geologic conditions similar to Teton by the Walla Walla District of the Corps of Engineers between 1970 and 1976 – was subsequently transferred to Reclamation – and has performed well over its life. The dams are all located within 150 miles of each other. The story of why Teton Dam failed is more complex than the technical details surrounding its construction and destruction. The Teton disaster is a story of engineering judgment, communication, decision-making, economics, organization, culture, and individual and organizational hubris. To tell this story, one needs to examine the organizational culture

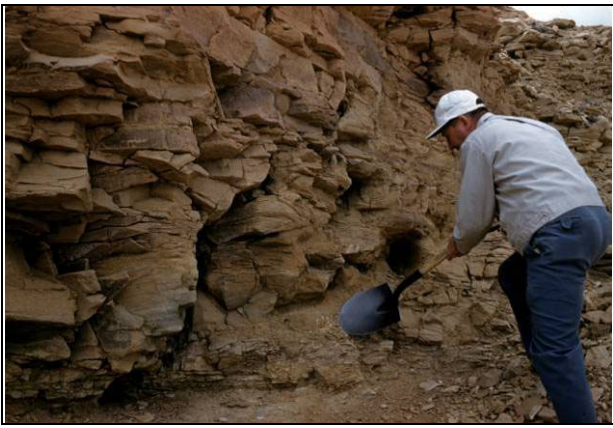
**Figure 2A.** A photo from right abutment site exploration in the 1950's showing the fractured nature of the foundation.

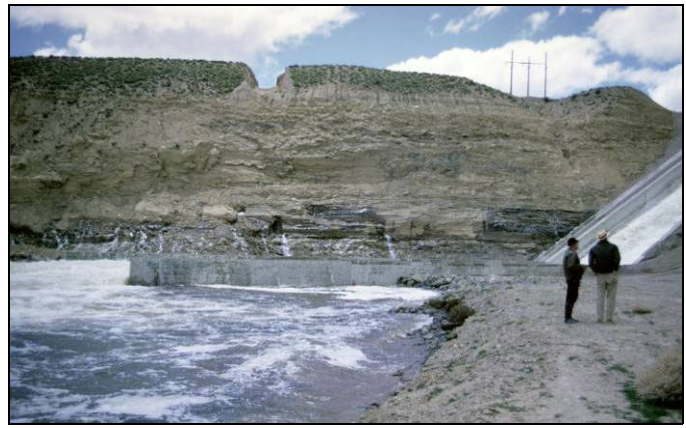
**Figure 2B.** A photo of the abutment downstream of the spillway. The seepage pattern illustrates the permeability and layering in the foundation.

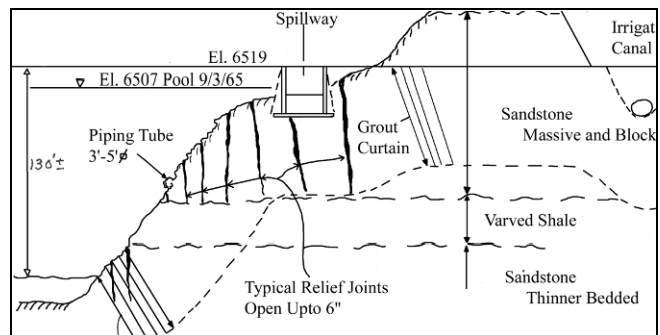
**Figure 3B.** Profile looking downstream of Fontenelle Dam, the right abutment at the spillway, and the location of the internal erosion incident.

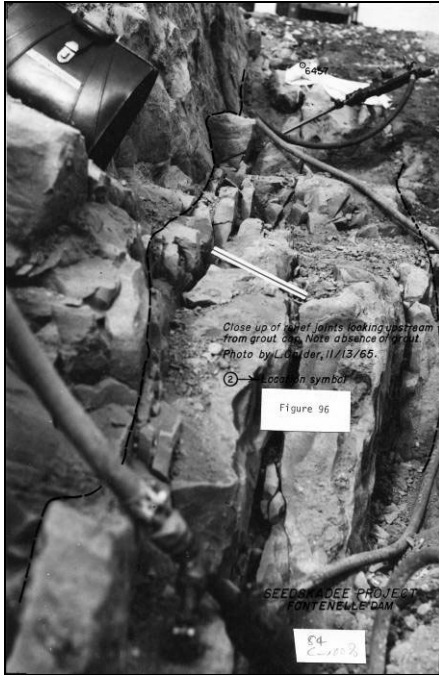
**Figure 4A.** A view from the grout cap in the right abutment looking upstream. Foundation treatment is complete, note absence of grout and openness of jointing leading towards the grout cap.

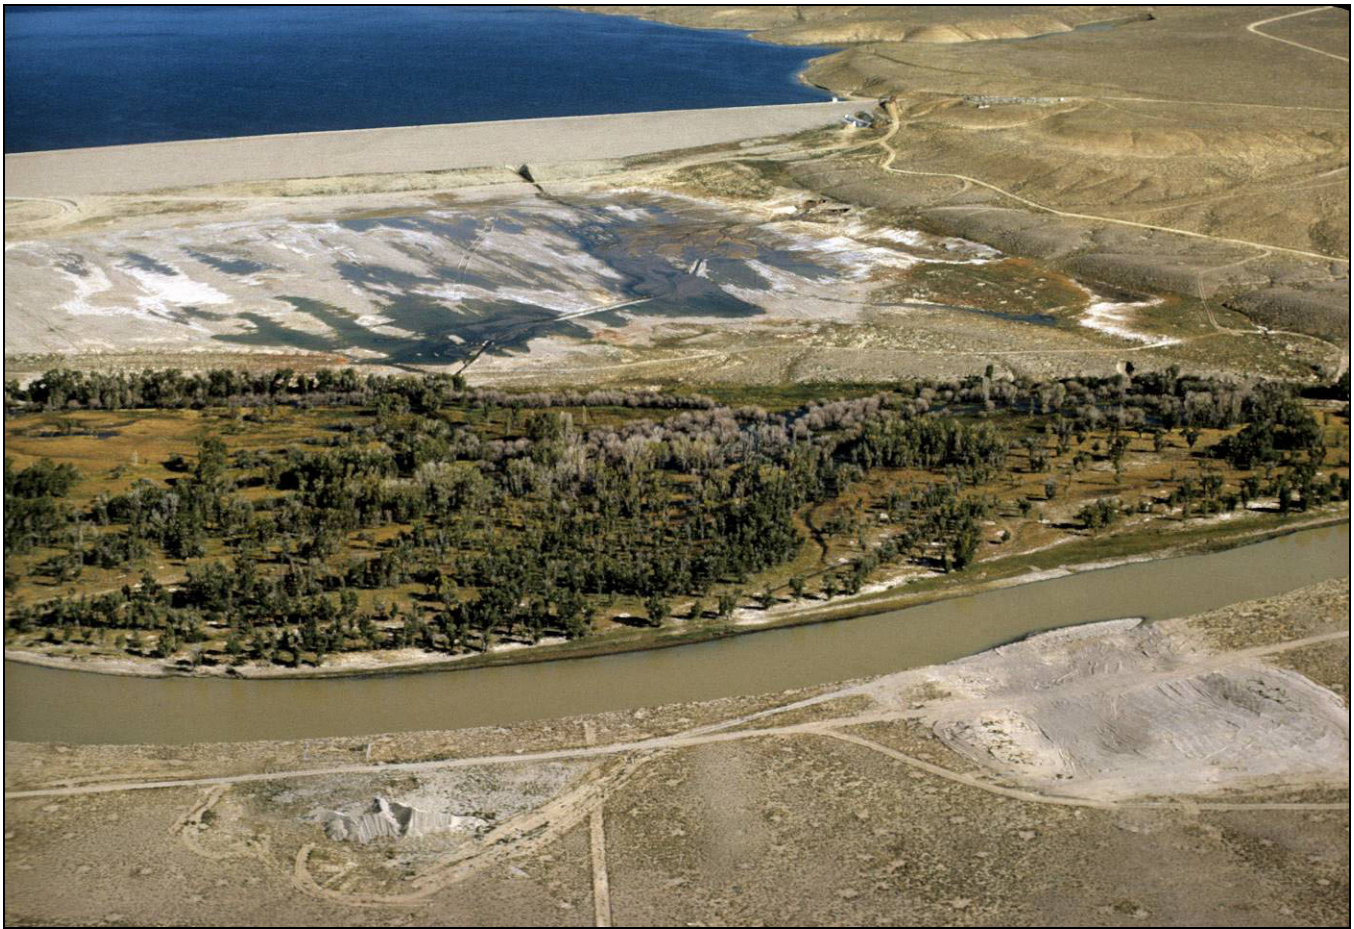
Fontenelle Dam was so close to failure, it could easily have been the event that led to changes in dam safety across the country if not for some fortuitous circumstances. In many ways the story of Teton Dam is as much about lessons not learned from Fontenelle Dam as it is about Teton itself. Fontenelle Dam was completed in 1964 and began to fill with water that same year. Soon after filling started, the dam began to have performance problems. Significant seepage was observed in the left abutment, right abutment, and downstream of the dam (Figure 5).

**Figure 5.** Fontenelle seepage downstream in 1965

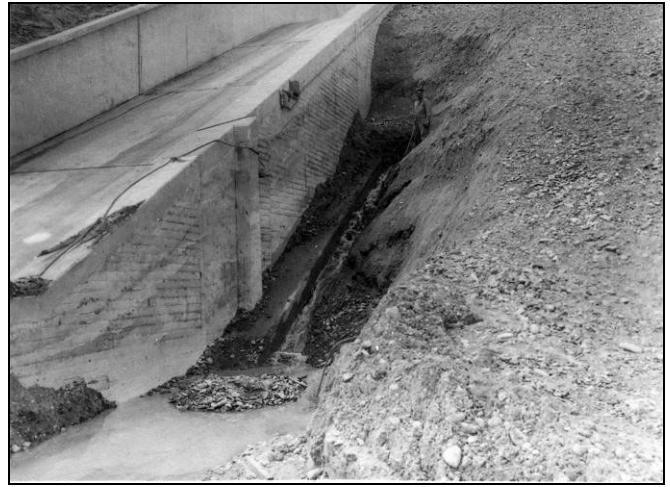
**Figure 6B.** Seepage emerging from the shale formation along the left side of the spillway chute, May 21, 1965.

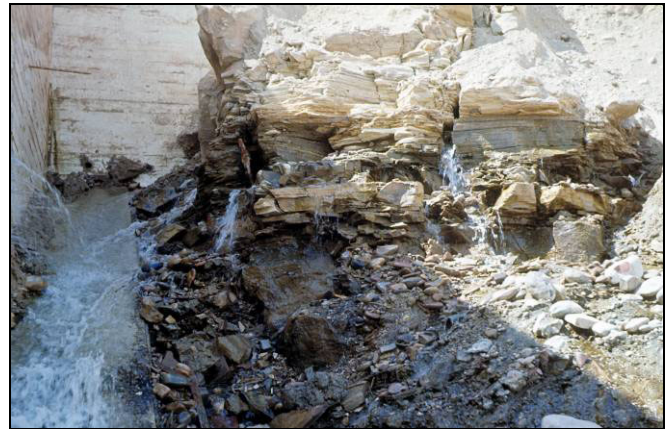
**Figure 7A.** Seepage emerging from the shale formation along the left side of the spillway chute, July 28, 1965.

**Figure 7B.** Seepage emerging from the shale formation along the left side of the spillway chute, July 28, 1965.

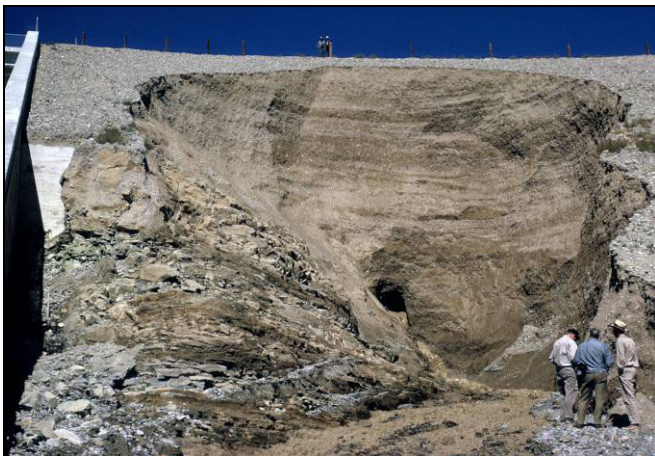
A major disaster was averted in September 1965 (Figure 8) when Reclamation opened the river outlet works and the two canal outlet works at Fontenelle in an effort to lower the reservoir as rapidly as possible. So serious was the situation that equipment and formwork were washed out of the river outlet works, which was under construction to repair scour damage to the concrete stilling basin. Fortunately, the reservoir has a significant release capacity, and the pool dropped nearly 4 feet per day until the erosion waned and then stopped. The reservoir volume at the time of the incident was approximately 300,000 acre-feet, and dam failure would have released a tremendous amount of water. While the reservoir was down, the eroded portion of the embankment was replaced and the foundation was grouted extensively through 1967.

**Figure 8A.** Muddy seepage emerging from the embankment along the left side of the spillway chute, September 15, 1965.

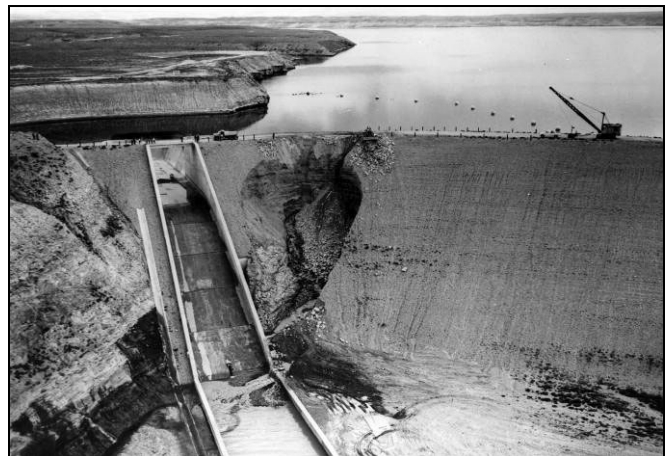
**Figure 8B.** A wider photo of the large unstable area on the left side of spillway chute, September 17, 1965.

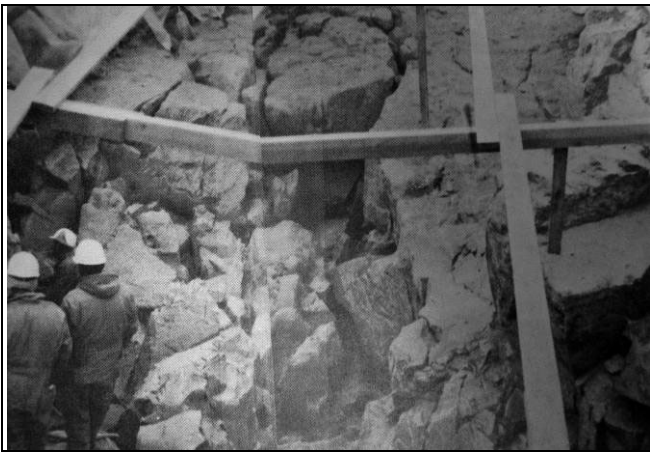
**Figure 10A.** Ririe construction photograph showing foundation in fault zone.

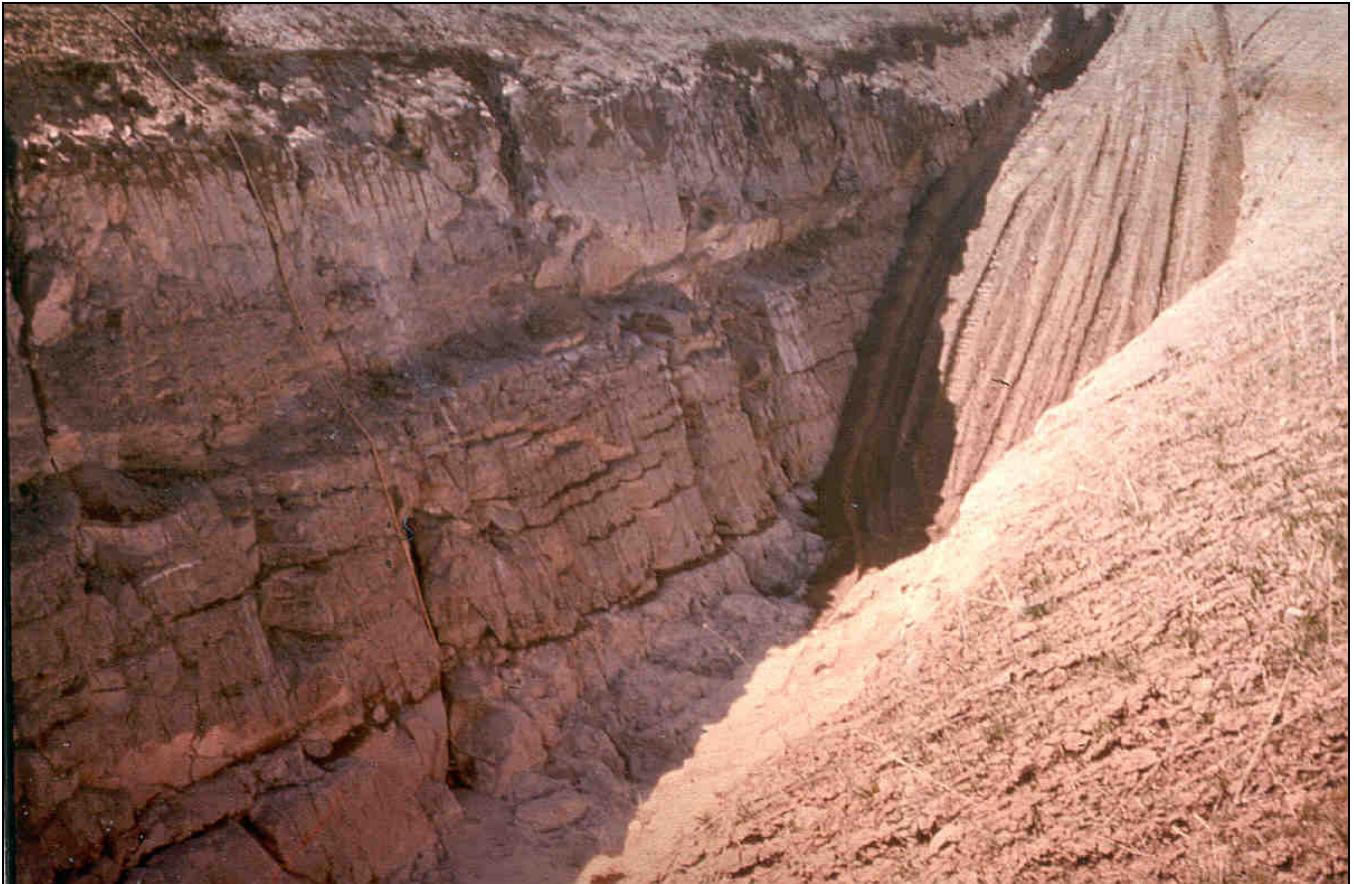
Continuous high-angle joints in the right abutment have been traced for lengths of as much as 200 feet, but most are between 20 and 100 feet long. The aperture of most high-angle joints is less than one-half inch, but many joints are as much as several inches wide and some are several feet wide. Examples of the jointing can be seen in Figures 16 and 17.

**Figure 16.** A view of the right abutment key trench showing the jointed nature of the foundation

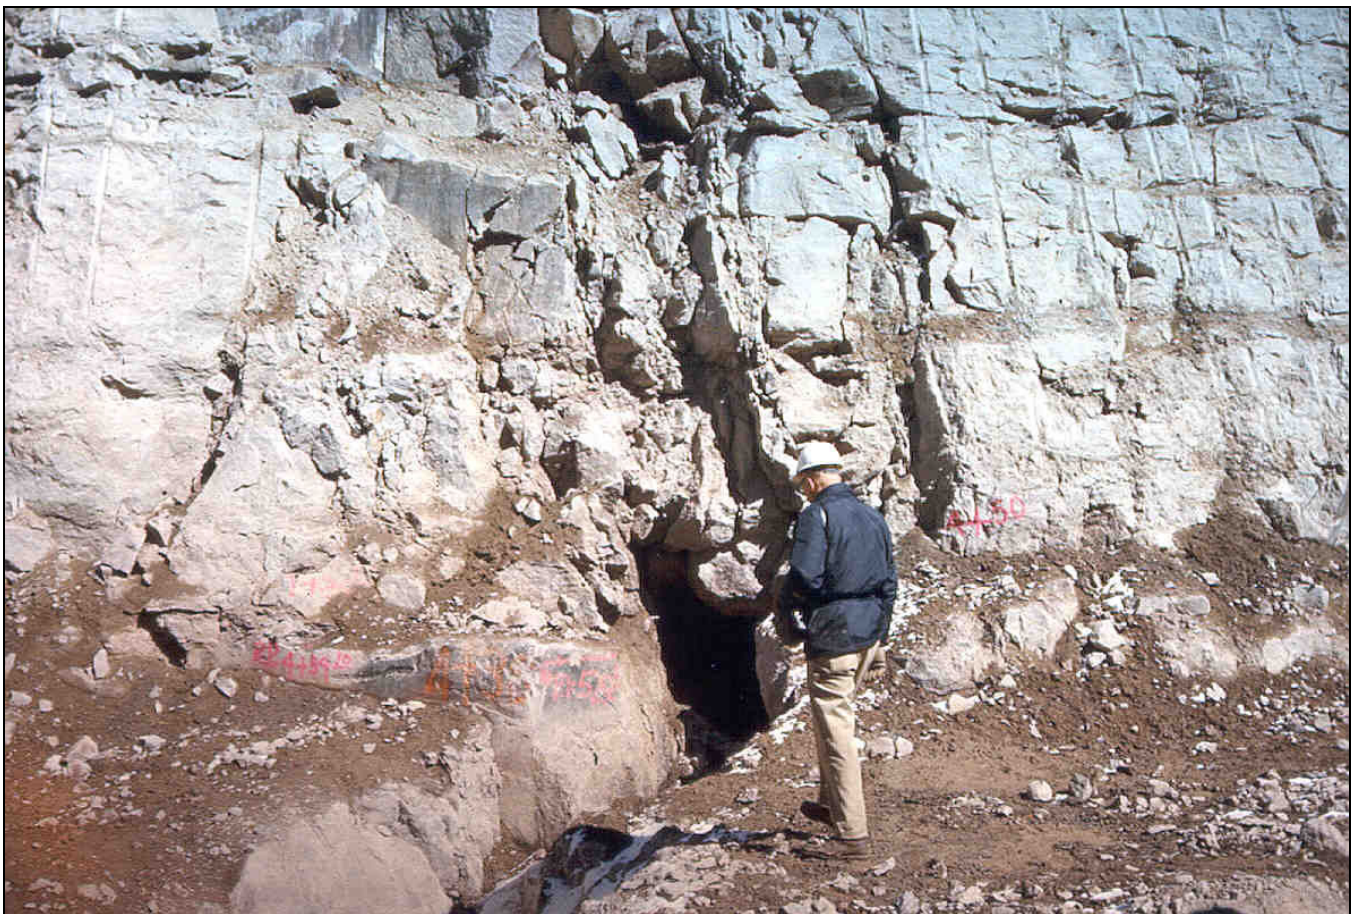
**Figure 17.** A view of a large fissure in the right abutment key trench

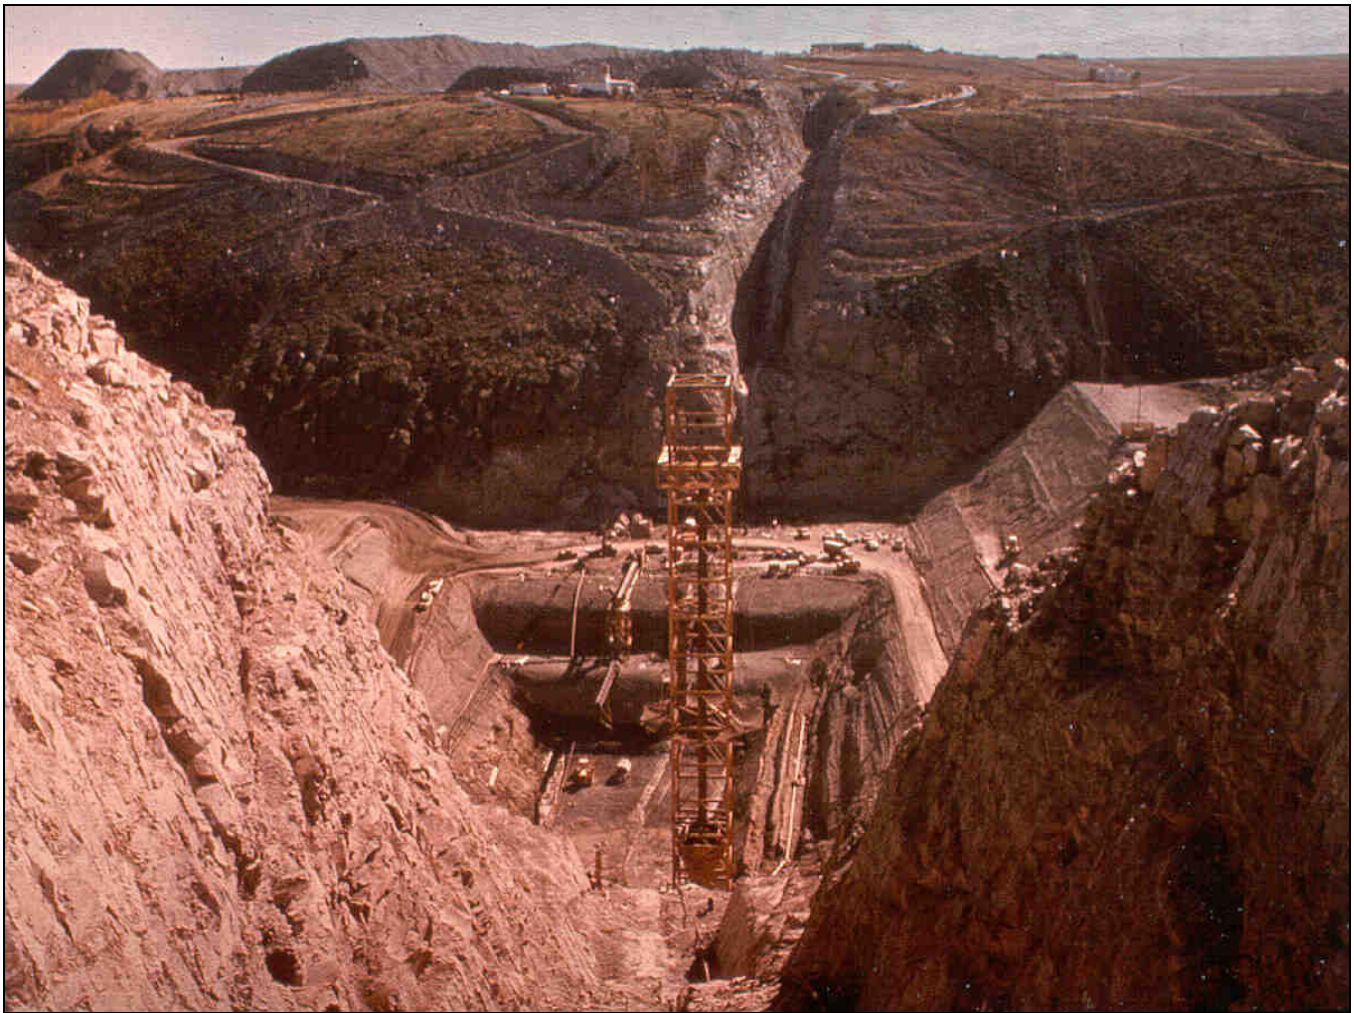
The design for Teton followed standard practices with an impervious core and progressively coarser materials used as the zoning progressed downstream. In the maximum section, a relatively shallow-sloped cutoff leads to a narrow 30-foot-wide contact with a competent foundation. The intent of the design was to rely on the grout curtain and the cutoff to create an impermeable barrier to protect the main core of the dam. As shown in Figure 19A and 19B, there are no additional defensive measures provided in either the main embankment or the abutment sections. On each abutment, the side wall of the cutoff trench steepens to 0.5H:1V. However, owing to the steepness of the abutment looking parallel to the axis, the actual sidewalls approach vertical on both abutments, which can easily be seen in Figure 20.

**Figure 20.** A view looking towards the left abutment from the right abutment.

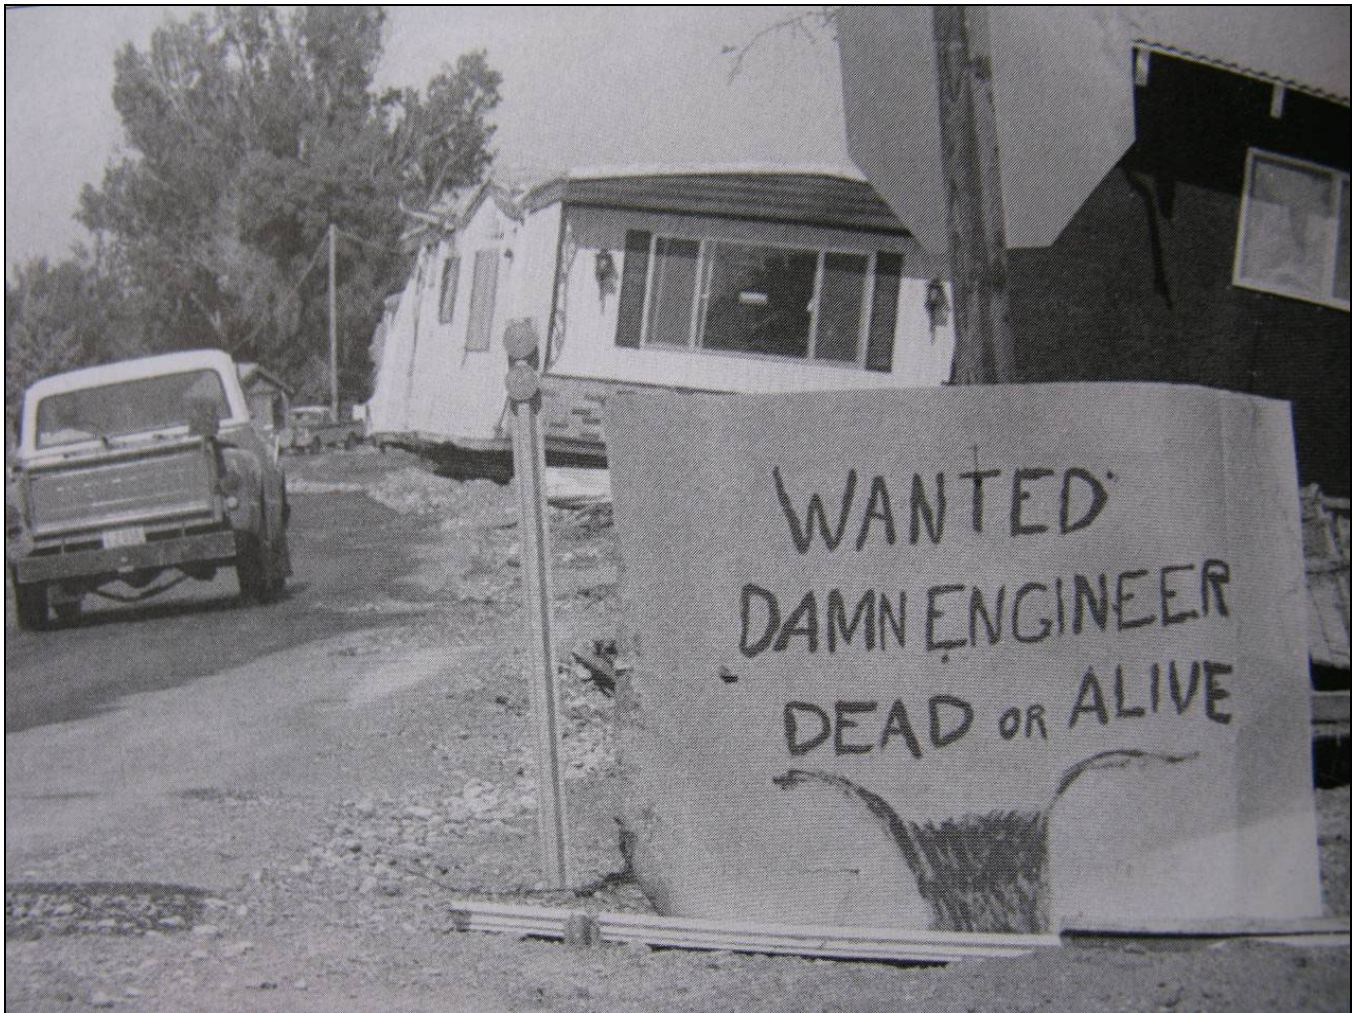
**Figure 21.** The consequences of poor design.
