PANEL ON "EXPERIENCE AND TECHNIQUES IN THE REPAIR OF REACTOR COMPONENTS" -
VIENNA - NOVEMBER 1972

PAPER NO **PL-504 - 1.**

EXPERIENCE AND TECHNIQUES IN MAINTENANCE AND REPAIR OF REACTOR COMPONENTS ON
THE DOUNREAY FAST REACTOR

J KIRK

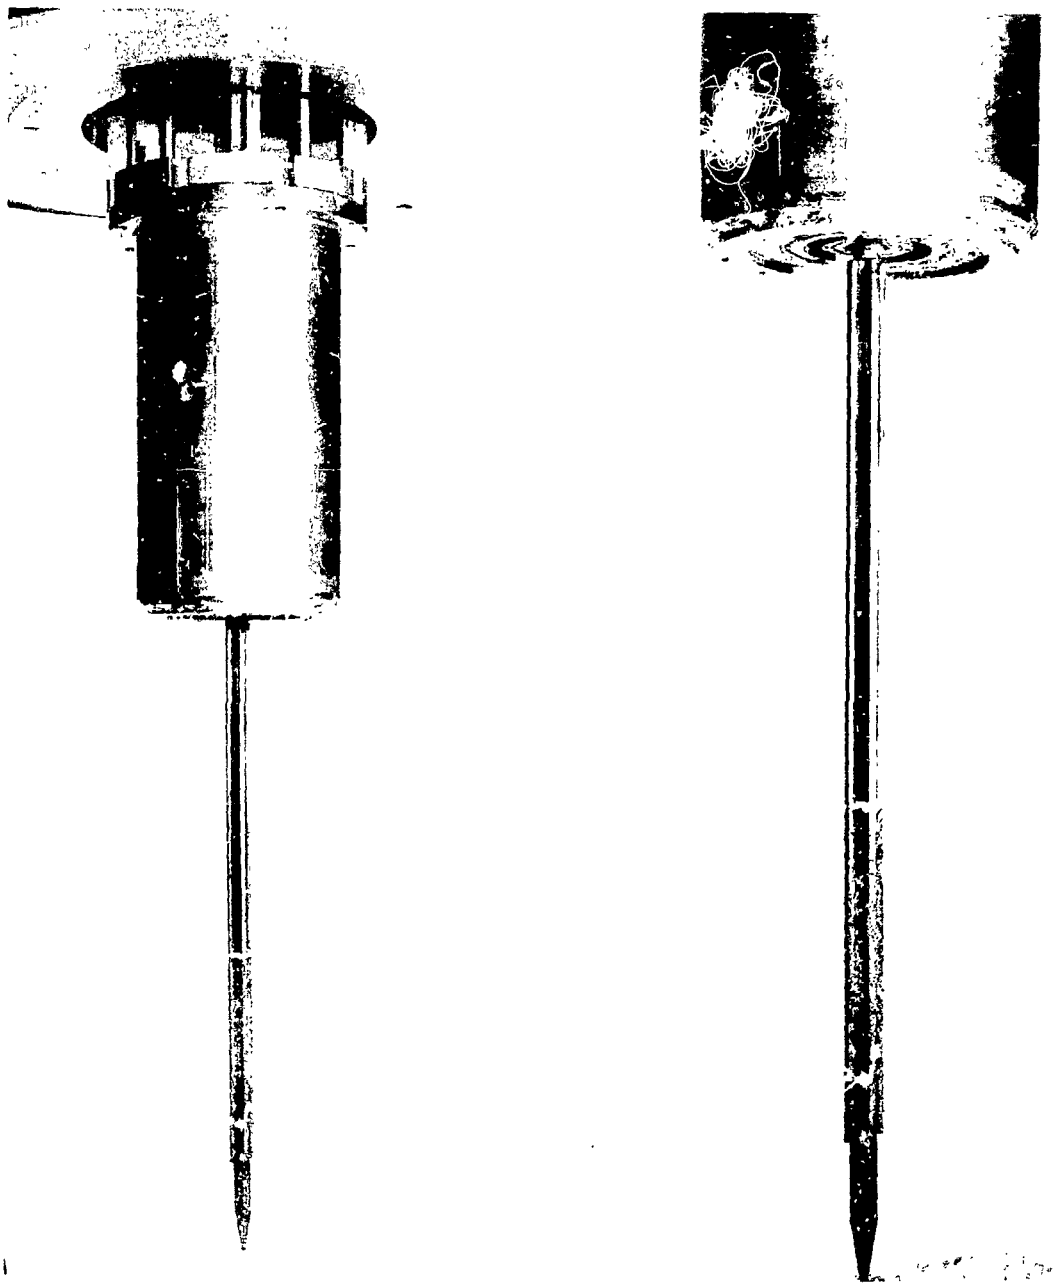
FIGURE 5 - Control rod mechanism top hat

15. Since the plant became highly active in 1962 it has never been necessary to discharge a screw and horizontal arm mechanism (see paras 5 and 8), but three top hats and seven carriers have been changed. A typical top hat discharge and replacement was undertaken during a planned reactor shut down in August 1969 (fig 5). Just prior to this a control rod could not be raised (to add reactivity) and an electrical fault had developed in the electro-magnet winding of another control rod. These faults like the previous control rod faults on DFR were 'fail safe'. They invariably involved difficulty in raising the rods to add reactivity. No fault has occurred which prevented the lowering of a rod, either by motor drive or during a trip.

16. The clutch and magnet windings were lifted out from both mechanisms and the suspected faulty stainless steel top hat was removed. The screw mechanism below the NaK surface was free and the top hat was removed from the reactor top to the

17. The beta gamma activity from the top hat with its mechanism was about 20 r/h on contact. A significant part of this came from the splined drive shaft which was cut off and put into active storage. This, together with steam cleaning to eliminate NaK and particulate contamination reduced the radiation to about 8 r/h gamma activity. The interior ball bearings of the assembly were changed on an open work bench with temporary lead shielding erected round the mechanism. The reconditioned assembly was then reinstalled in the reactor.

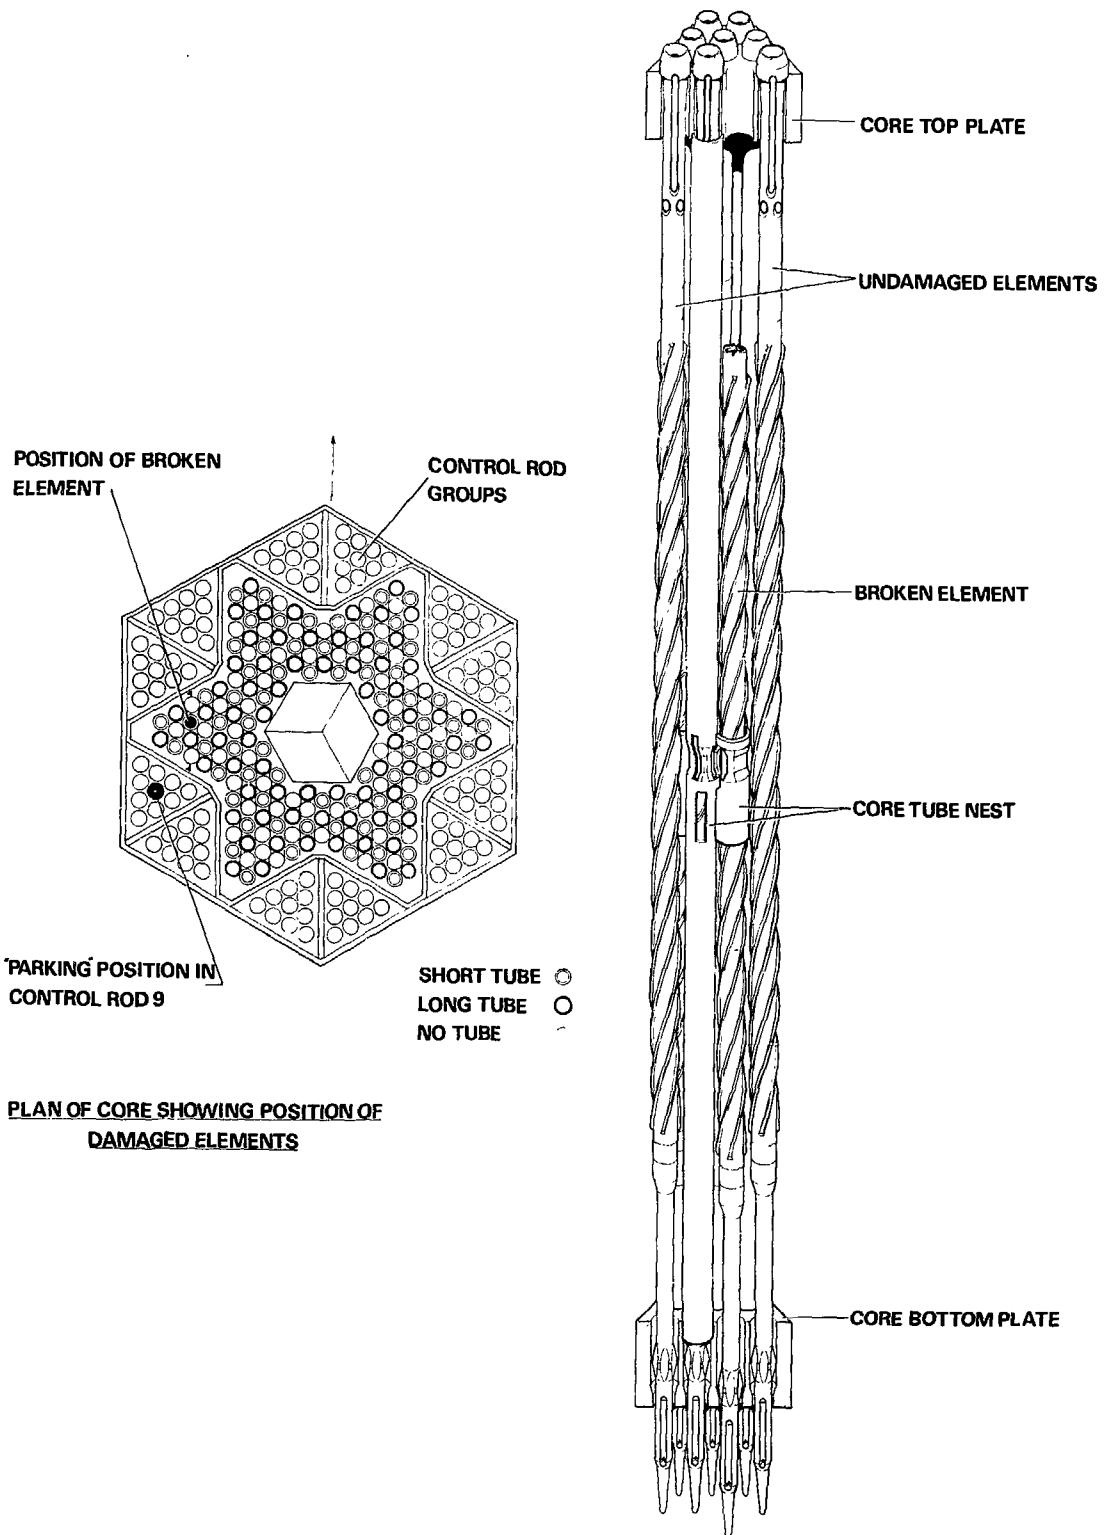
FIGURE 8 - Detail of broken element and surrounding channels

32. During a discharge operation in October 1970 a Mk IIIA element top end fitting was found resting on top of control rod carrier No 10 which was in the lowered position. In a relatively simple operation it was removed and identified as belonging to an element in a short tube channel in the fixed core. Careful probing with a dummy stainless steel element on the charge machine grab established that the remainder of the element was resting in its correct channel supported radially by the short tube and vertically by its locating projections in the retaining plate. As a first step in checking for further damage and to provide support for possible debris, all six elements surrounding the broken one were discharged and replaced by stainless steel dummies one at a time. Probing with a 8mm diameter bar on the end of a dummy element on the charge machine grab proved that it was possible to pass the bar through the whole length of the element's inner tube and to make contact with the cross wire in the bottom end fitting. Two unsuccessful attempts were then made to pick up the element with hook and bayonet devices on the end of 8 mm diameter rods, but they resulted only in deformation of the cross wire.

33. A guide tube, terminating at its upper end with a breeder element top end fitting, was then lowered into the channel by the charge machine. The lower end of the tube came to rest about 50mm from the top of the broken element while the upper end was above the NaK surface in the charge hole. The charge machine was then removed and a shielded gland plate with viewing windows was installed in its place. A hand tool terminating in an expanding collet type grab was then lowered by hand through the guide tube and the element to the bottom end fitting past the damaged cross wire. The grab was expanded so that it gripped the end fitting and an attempt was made to lift by hand with a chain block and spring balance attached to the tool to assist with and measure the pull. Resistance was encountered when the jagged end of the element started to enter the hole in the core top plate and the pull applied was about 90 kg. A few upward blows with the open palms of the operator on the bar at the top of the tool were sufficient to get the element to enter the hole and from then on it was free. The whole assembly was lifted until the element was clear of the core and then the shields were rotated to enable it

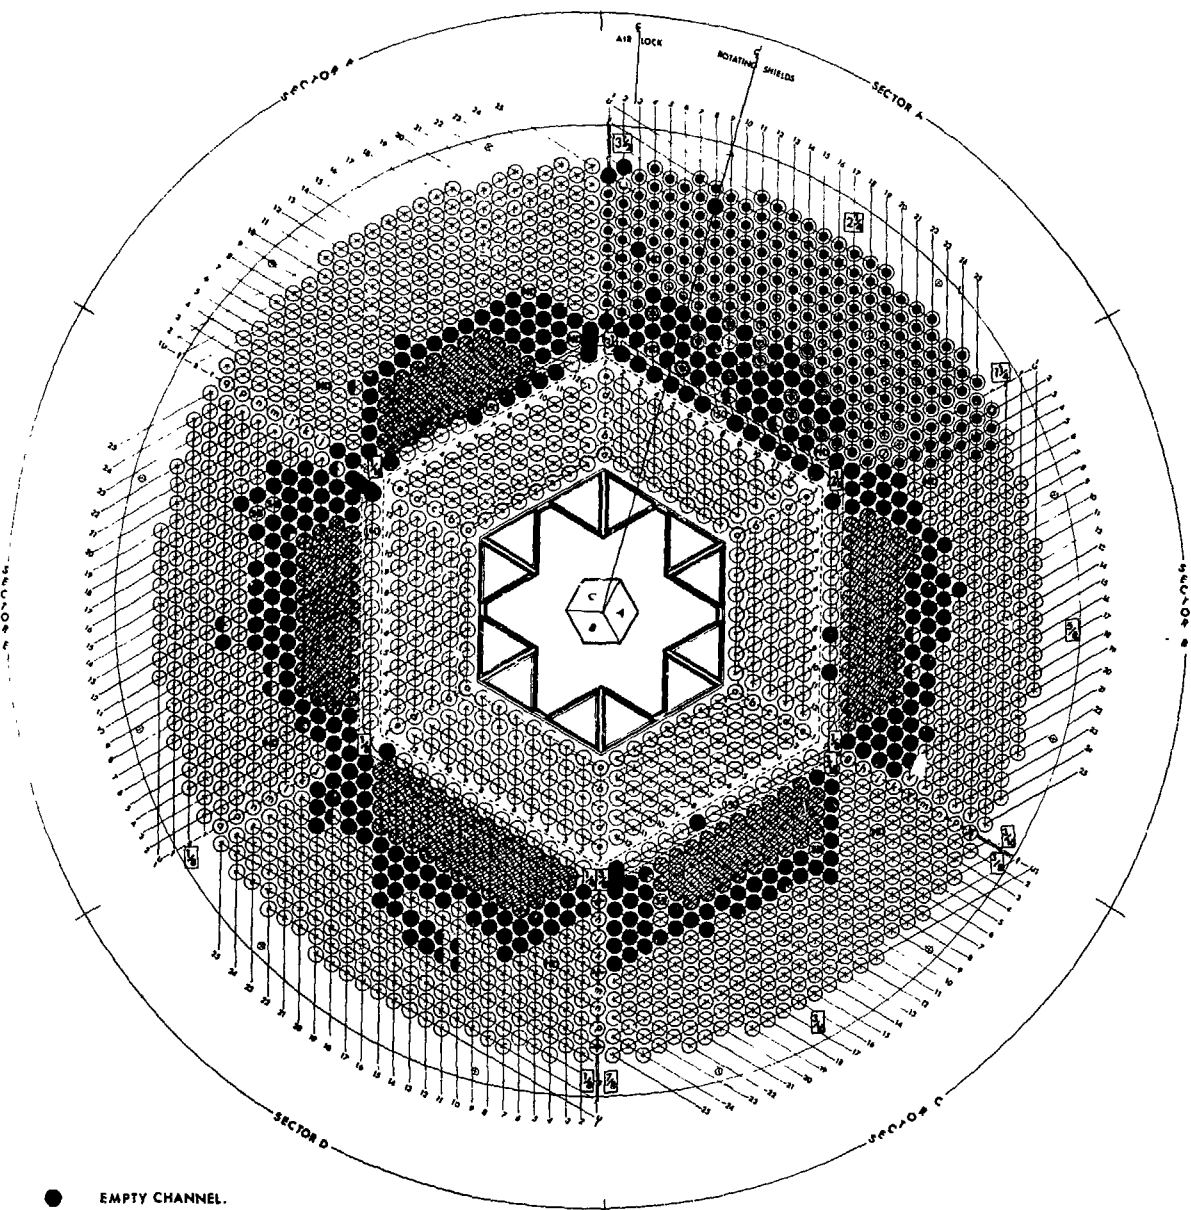
FIGURE 14 - Plan of outer breeder

34. In 1965 during a sample discharge of outer breeder elements, several were found to be jammed and could not be discharged with the normal charge machine (fig 14). There was also evidence that some objects were lying on, or protruding from, the top of the breeder and interfering with top shield rotation. The NaK level was first lowered locally by pressurising an extended liner tube in the charge hole and the objects were identified as breeder element top end pieces. The overall primary NaK level was then lowered to uncover the top breeder plate and several element top end pieces were seen completely broken off and lying on top of the neighbouring elements.

35. It was established that the jammed elements were concentrated in the innermost pitches of the outer breeder and eventually the reason for the jamming was found to be uranium swelling under high temperature thermal cycling conditions. Approximately 200 elements were discharged, chiefly around the extremities of the affected zone, using the charge machines whose normal pull is about 25 kg greater than a breeder element's weight. Then a further 200 were discharged using simple 'heavy gear' illustrated in figs 16 and 17. This equipment comprised a top plate hold down tube through which a simple expanding collet grab was passed. The upper end of the grab and hold down tube passed through a rubbing gland seal mounted in a plate bolted immediately above the reactor top valve, and the grab could be lifted by hand operated chain blocks hanging from the main crane hook. A spring balance load indicator was normally fitted between the grab rod and crane hook so that the load applied to the element could be determined and limited if necessary. The gland plate through which the lifting rod passed included a lead glass window for direct viewing of engagement of the grab.

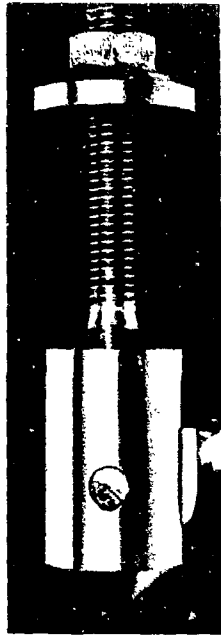
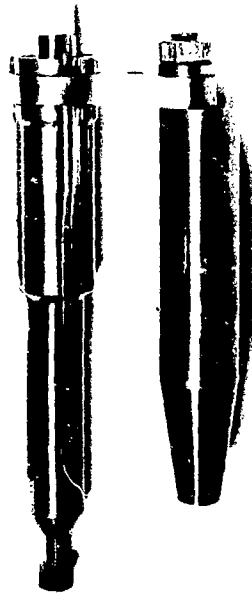
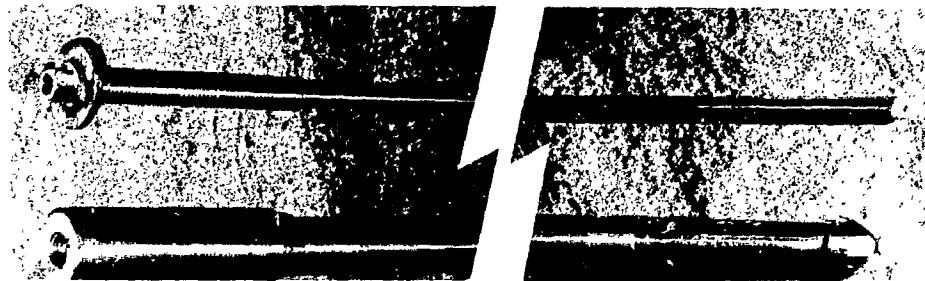
FIGURE 21 - Cut plate and element securing devices

38. In one 60° sector of the outer breeder the whole of the top plate was accidentally loosened from its screwed and dowelled supports during these operations. This allowed one end of the plate to spring upwards a maximum distance of 80 mm leaving about 200 healthy elements underneath it free to fall over sideways. These elements were pushed back towards their correct channels and extension pieces were fitted in their top ends to hold them there in the now tilted top plate. It was not possible to force the plate down to its original level so it was left tilted and a number of struts and stay bars were fitted between it and the bottom breeder header to prevent any further movement. Similar fittings were installed in the other sectors (fig 21).

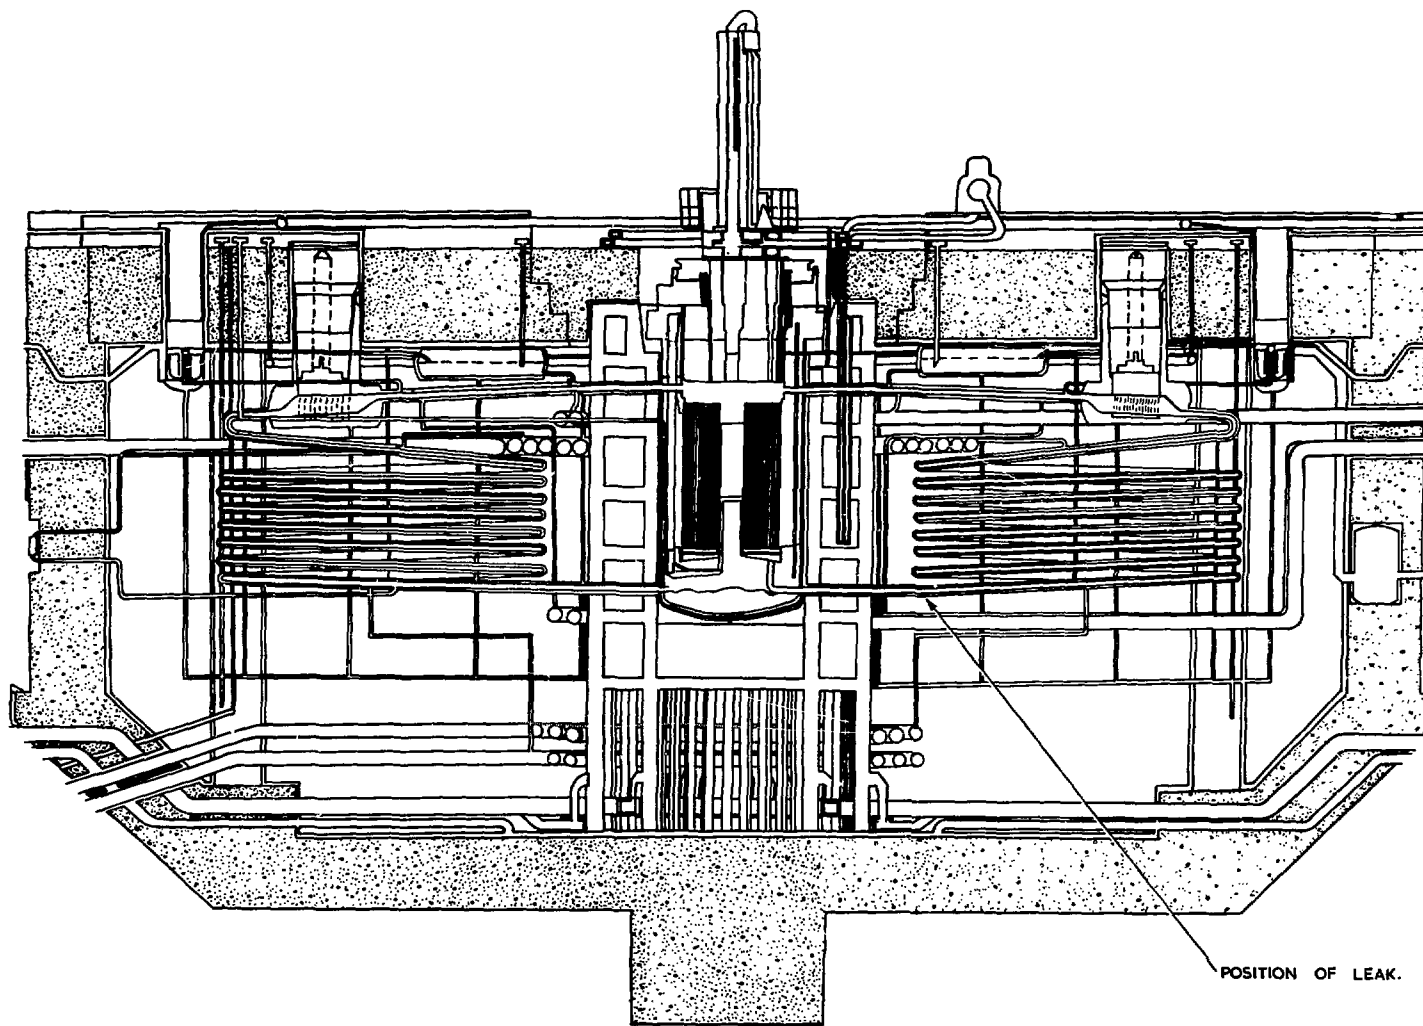
FIGURE 22 - Reactor vault showing position of leak

40. In May 1967 while the reactor was operating at full power an alarm indicated that a leak of the highly active primary coolant into the leak jacket had occurred (fig 22). As soon as the reactor was shut down the leak appeared to stop. All parts of the extremely complicated primary circuit external to the heat exchangers are double jacketted for leak detection purposes and the leak jacket system is divided into 25 different sections each of which is fitted with a conduction type leak detector probe. The section indicating the leak was the most complicated of the 25 and it included the primary vessel itself with its 49 stub-connections.

41. The initial leak was small and could not be re-produced at shut down temperatures. Gamma scans of NaK from the leak drain tank indicated that the metal was quite 'old' having been held up for some time in the complicated jacket. It was thought at first that the defect could be somewhere between the shut down and operating liquid metal levels and this was why the leak ceased on shut down. After a few minor modifications to the leak jacket external pipework, the reactor was started up again in July 1967. The leak re-appeared at full power and in the course of 12 days operation the rate of loss of primary NaK rose from 50 to 150 litres/day. At this point the rate increased sharply towards 250 litres/day and the reactor was shut down.

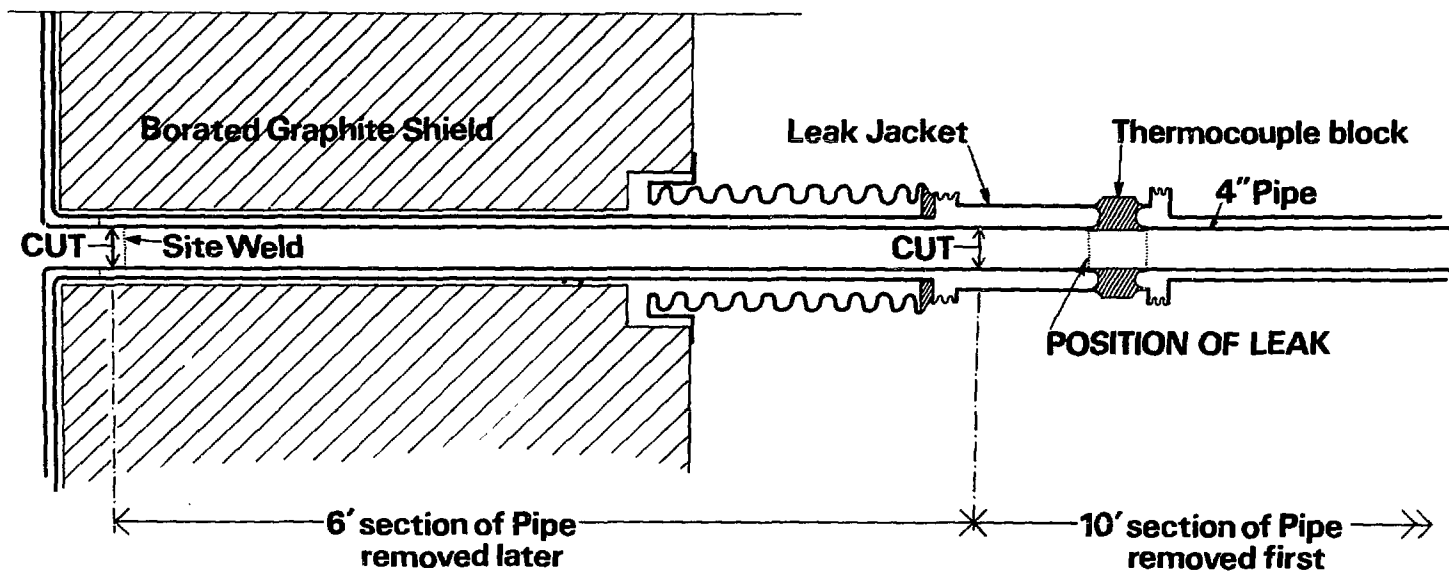
FIGURE 23 - Section of pipe that had to be removed

46. To locate the leak precisely, the leak jacket pressure was maintained at about 48 kN/m^2 while the lower portion of the primary vessel was slowly filled with NaK. Piezo-electric accelerometers were attached to all 24 vessel outlet stubs. The noise of gas bubbles entering the NaK near the outlet stub of circuit 10A was clearly detected. Finally by using an auto correlator and the accelerometers clamped to the 10A circuit and the two adjacent ones, the time difference between the arrival of signals at the accelerometers was measured. These tests showed that the leak was not in the vessel wall but in the 10A circuit pipework at a distance of about 45 cm from the vessel wall where there was known to be a construction weld (fig 23).

51. When the 3 m section of pipe was removed the actual leak was found in it at a crack in a weld near the thermocouple block and a tee by pass connection. Detailed examination of the failure showed that,

- i. A further 1.8 m section of 100mm primary pipe inside the graphite neutron shield had to be cut out internally by remote means (fig 23 and 24).
- ii. A new 1.8 m section of 100mm primary pipe had to be remotely welded into position.
- iii. Outside the neutron shield but still inside the vault a new double jacketted 3 m section of pipe had to be welded into position between the new outlet pipe stub and the heat exchanger.
- iv. The by pass connection responsible for the thermal stress had to be cut out on the faulty circuit, and, to eliminate similar leaks in the future, on six other circuits.
