SAND79-1066  
Unlimited Release

ANALYSIS OF MC2730 CLEANING PROCEDURES  
AS RELATED TO ANOMALOUS VOLTAGE DEGRADATION

G. C. Nelson and W. O. Wallace

Sandia Laboratories

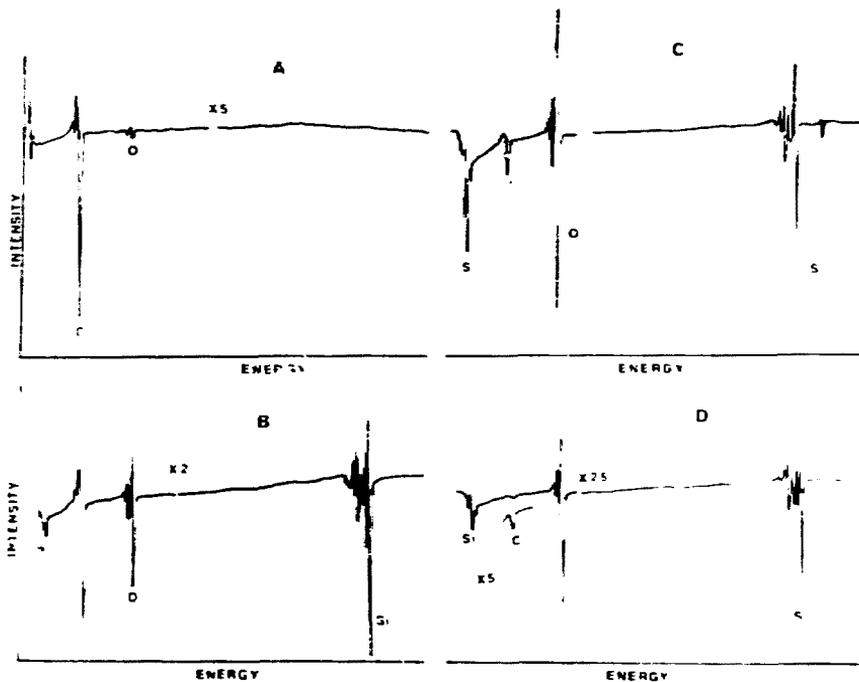
Figure 5. Auger spectra obtained from Si samples coated with photoresist after A) no cleaning, B) Method I (Table I), C) Method II, and D) Method III.

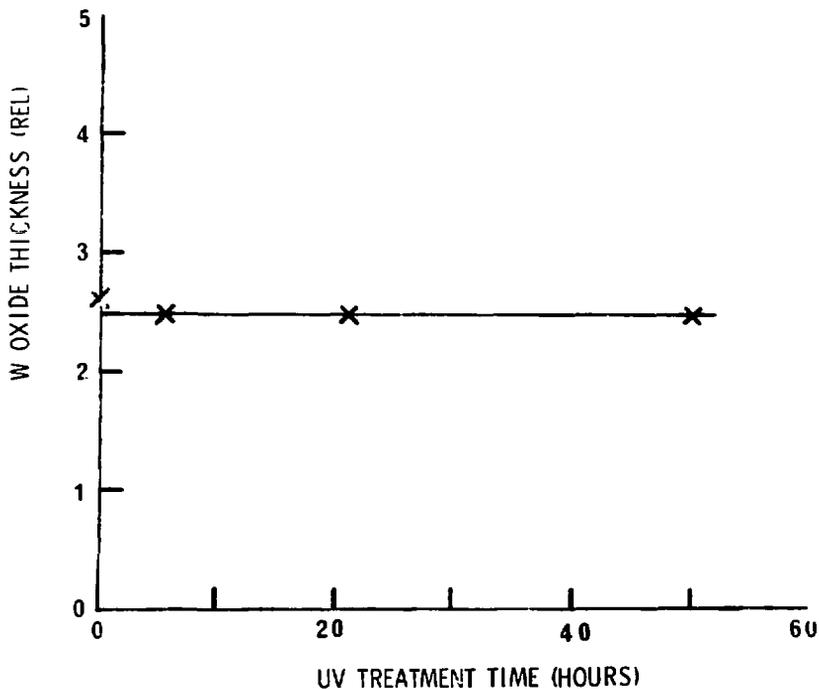
the measurement are shown in Figure 7. As this figure indicates, the depth to which the oxygen extends is independent of the sample treatment time (the oxygen level in the surface layer may change, however). The depth to which the oxygen extends is a small fraction of the total W thickness and therefore the UV treatment should not degrade the quality of the W contacts.

Figure 7. Plot of the depth (sputter time) oxygen extends into a W film as a function of UV treatment time.

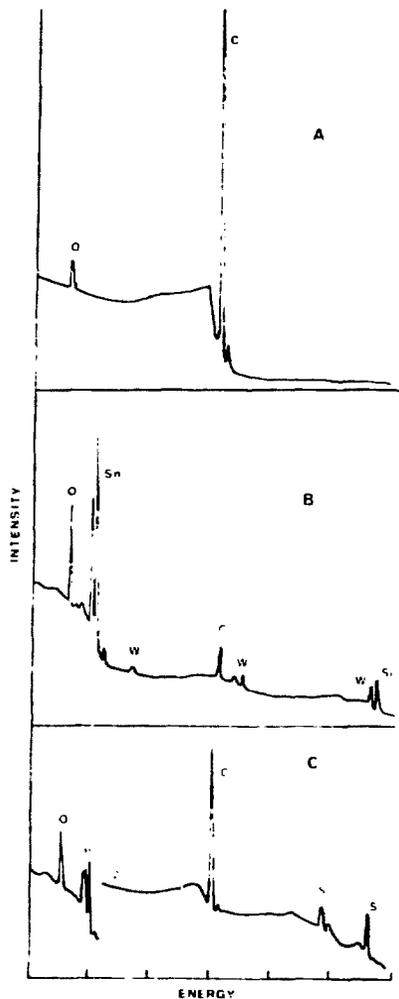
The rate at which photoresist can be removed in a "dry" process can be increased significantly by using an oxygen plasma rather than UV. As a demonstration of the effectiveness of oxygen plasma cleaning, photoresist was removed from a W film by oxygen plasma alone. Figure 8 shows a comparison of the x-ray photoelectron spectra (XPS) taken before cleaning (primarily C and O) and after cleaning at 100 watts of UV and oxygen for 15 min (very little carbon along with W, O and Sn). These data indicate that the oxygen plasma is very efficient in removing the hydrocarbon (to a level as low as that obtained by any other method). However, a significant quantity of tin was being deposited during the treatment. Data obtained by secondary ion mass spectroscopy indicated that the Sn was in an oxidized state. Bulk analysis by emission spectroscopy indicated that the photoresist (Kodak Metal Etch Resist) contained approximately 0.3 wt. Sn in the bulk. This value is much lower than that observed on the surface. Apparently during the plasma treatment the hydrocarbon portion of the photoresist is removed and the Sn from the bulk is concentrated in a surface layer on the sample. While this negates the use of oxygen plasma alone as a one step "dry" method for removing photoresist,

Figure 8. X-ray photoelectron spectra obtained from W films coated with photoresist after A) no cleaning, B) 15 minutes of oxygen plasma and C) 24 hours of hydrogen plasma.

An alternate possible means of removing the photoresist is  
the use of a hydrogen plasma. Previous work with graphite indi-  
cated that a hydrogen plasma would aggressively attack carbon  
containing volatile hydrocarbons (primarily methane). Photoresist  
samples on W were exposed to hydrogen plasma which had the same  
pressure, power as that used for the oxygen plasma. Visual  
observation indicated that the photoresist had not been removed  
by the plasma. XRF analysis confirmed this observation, i.e.,  
no C signal was detected. In addition, Si was detected  
after the plasma treatment. The Si is due to a reaction of  
the hydrogen plasma with the quartz reaction chamber to form  
silane and subsequent deposition of the silane onto the sample.  
This effect has been observed in other studies where metals have  
been treated in a hydrogen plasma. From these results it was  
concluded that a hydrogen plasma is not effective in removing
