SAND-79-1424  
Unlimited Release

POSTMORTEM METALLURGICAL EXAMINATION OF  
A FIRE-EXPOSED SPENT FUEL SHIPPING CASK

Sandia National Laboratories

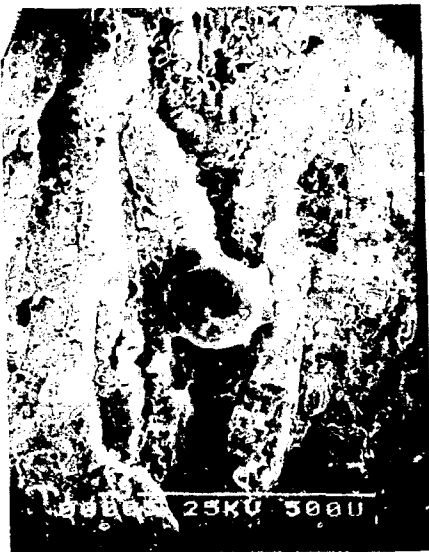
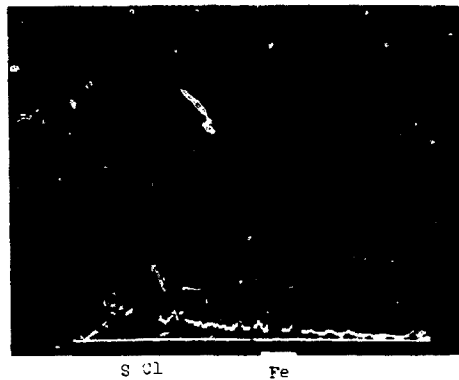
Scanning electron microscope observations support the aforementioned hypothesis that crack no. 1 was a hot crack formed in the weld fusion zone during the fire test. Elemental analysis of droplets lying on the fracture surface, e.g., those shown in Figure 8, indicated that they contain substantial amounts of sulfur, probably in the form of complex alloy sulfides. Comparing typical values for alloy sulfide melting points (1250-1475 K)<sup>(1)</sup> with measured cask temperatures suggests that these sulfides were molten under the present fire test conditions. The further requirement, an applied stress, was apparently supplied by internal pressurization of the fire-exposed spent fuel shipping cask. Indeed internal pressurization within the lead gamma shield cavity was accentuated in the present instance by a manufacturing oversight whereby passage holes from the shield cavity to appropriate expansion volumes originally provided for in the cask design were omitted during cask fabrication.

Figure 8. a) Scanning electron micrograph of crack no. 1 fracture surface.

b) Elemental analysis photograph of droplet shown in (a).

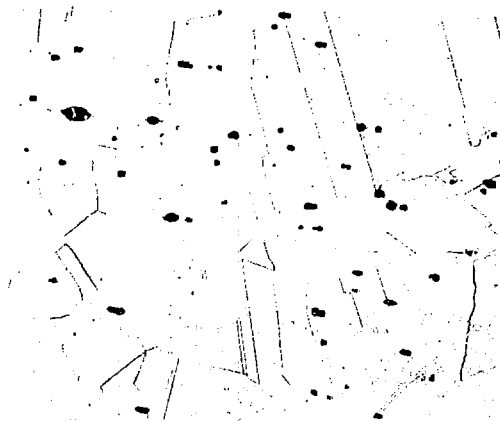
This crack was approximately 70 mm long and was located in the stainless steel base metal, Figure 9. Optical metallography utilizing procedures outlined in ASTM A262-70, Standard Recommended Practices for Detecting Susceptibility to Intergranular Attack in Stainless Steels, Figure 10, and mechanical property evaluation, Table 2, showed that the cask outer shell base metal, after the fire exposure, was in the solution annealed state.

Figure 10. Optical micrograph of 304 stainless steel cask outer shell. Magnification: 250X.

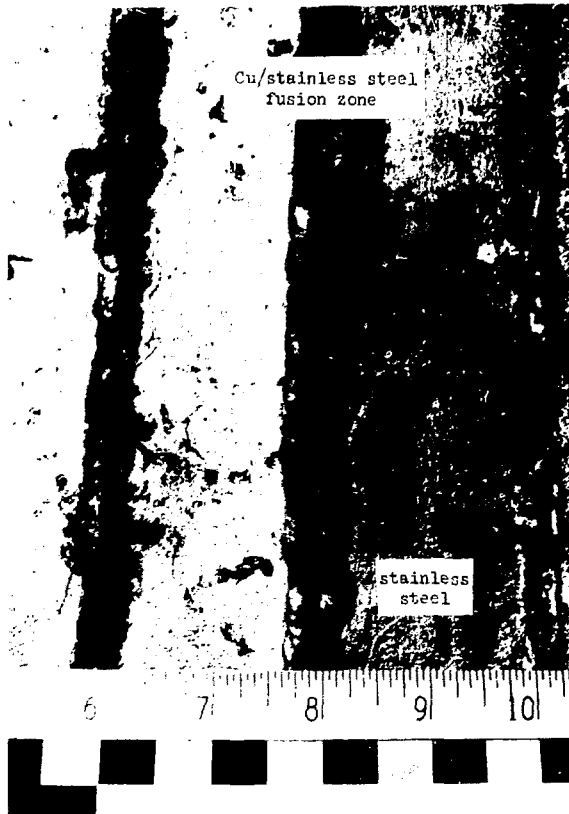
Visual observations of the inside surface of the outer shell immediately behind crack no. 2 confirmed that copper fins had been welded to the outer shell, Figure 11. Further study indicated that many of these copper/stainless steel weldments were cracked. Figures 12 and 13 present two views of such joint cracks. Detailed examination of these cracks showed that they were predominately intergranular, following the stainless steel, austenite, grain boundaries, Figure 14. Microprobe examination, Figure 15, also showed that the cracks contained significant quantities of copper

Figure 12. Enlargement of inner surface of outer shell. Arrows indicate copper/stainless steel joint cracks.

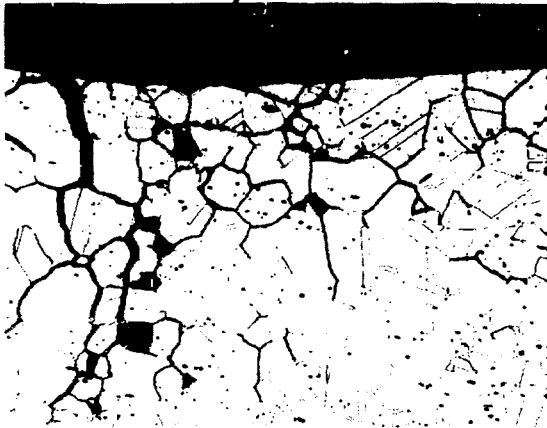
Figure 14. Optical micrograph illustrating intergranular character of cracks in stainless steel.  
Magnification: 100X.

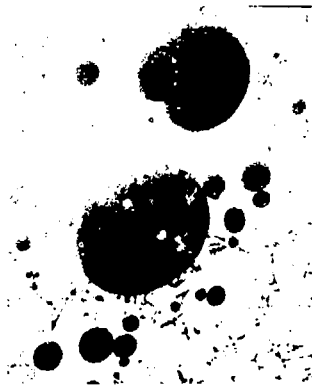
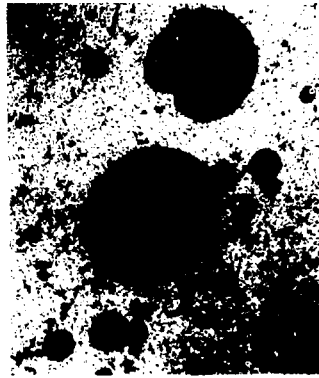
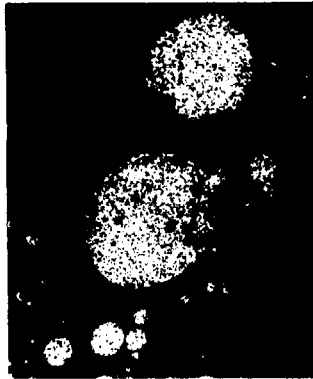
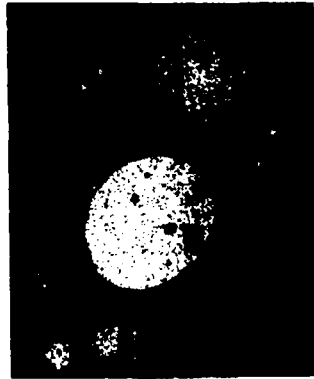
Numerous investigators<sup>(3-7)</sup> have shown that a combination of high heat input and direct contact between molten copper and stainless steel will lead to microcracking of the stainless steel during weld fabrication. Generally, successful welding of copper to stainless steel requires that low heat inputs be combined with the use of a nickel filler wire.<sup>(8)</sup> Microprobe examination of the copper-stainless steel fusion zone indicated that, in this instance, neither of these requirements had been fulfilled. The presence of a high concentration of copper and aluminum in the copper-stainless steel weld fusion zone, Figure 18, suggests that a copper base filler wire had been used to join the copper cooling fins to the cask outer shell. Further analysis of the droplets shown in Figure 18 also indicated that they contained appreciable quantities of iron and chromium. The form of these droplets and their chemistry suggest that they were formed by a high heat input which caused localized melting of the 304 stainless steel during welding.

Figure 18. Identical area elemental distribution photomicrographs of copper-stainless steel weld fusion zone. Magnification: 500 X.
