POST TEST EVALUATION OF A FIRE TESTED RAIL SPENT FUEL CASK*

H. J. Rack and H. R. Yoshimura
Sandia National Laboratories, Albuquerque, NM, USA

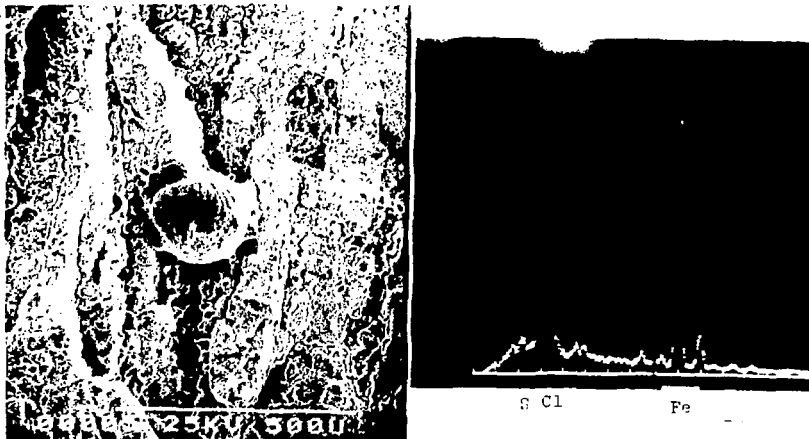
Scanning electron microscope observations support the aforementioned hypothesis that crack no. 1 was a hot crack formed in the weld fusion zone during the fire test. Elemental analysis of droplets lying on the fracture surface indicated that they contain substantial amounts of sulfur, probably in the form of complex alloy sulfides, Fig. 4. Comparing typical values for alloy sulfide melting points (1250-1475 K) (3) with measured cask temperatures suggests that these sulfides were molten under the present fire test conditions. The further requirement, an applied stress, was apparently supplied by internal pressurization of the fire-exposed spent fuel shipping cask. Indeed internal pressurization within the lead gamma shield cavity was accentuated in the present instance by a manufacturing oversight whereby passage holes from the shield cavity to appropriate expansion volumes originally provided for in the cask design were omitted during cask fabrication.

Fig. 4. (a) Scanning electron micrograph of crack no. 1 fracture surface and (b) elemental analysis photo of droplet shown in (a)

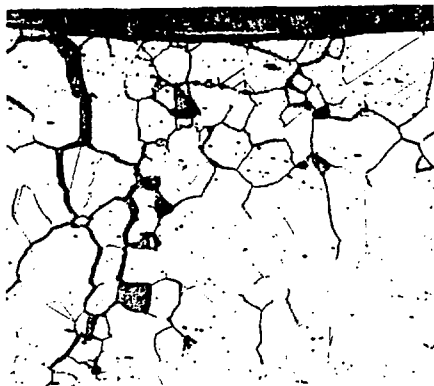
Crack no. 2, which had penetrated the cask outer shell, was approximately 70 mm long and was located in the stainless steel base metal. Visual observations of the inside surface of the outer shell immediately behind crack no. 2 confirmed that copper fins had been welded to the outer shell. Further study indicated that many of these copper/stainless steel weldments were cracked, Fig. 5. Detailed examination of these cracks showed that they were predominantly intergranular, Fig. 6, following the austenitic stainless steel grain boundaries. Microprobe examination also showed that the cracks contained significant quantities of copper and lead and lesser amounts of aluminum and silicon, Fig. 7.

Fig. 6. Optical micrograph illustrating intergranular character of crack in stainless steel. Magnification : 100x

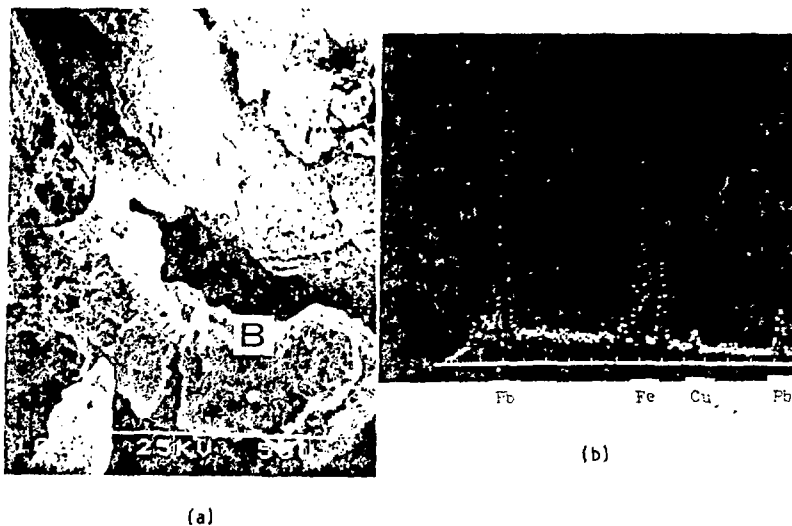
Consideration of the above suggests that crack no. 2 originated from micro-cracks formed during improper welding of the copper cooling fins to the stainless steel outer shell. This assumption was supported by elemental analysis of the crack no. 2 fracture surface, Fig. 8, where copper could be detected to a depth of

Fig. 8. (a) Scanning electron micrograph of crack no. 2 fracture surface and (b) elemental analysis of region B near mid-section of crack no. 2

approximately 17 mm, i.e., 50 pct. of the outer shell wall thickness. It appears then that final crack propagation through the outer shell wall occurred during the fire-test, the driving force for this crack propagation being supplied by the internal pressurization within the lead gamma shield alluded to previously.
