The International Corrosion Forum Sponsored by the
National Association of Corrosion Engineers / March
22-26, 1982 / Albert Thomas Convention Center, Houston,
Texas

EXAMINATION OF TURBINE DISCS FROM NUCLEAR POWER PLANTS

CARL J. CZAJKOWSKI
JOHN R. WEEKS

Department of Nuclear Energy
Brookhaven National Laboratory
Upton, New York 11973

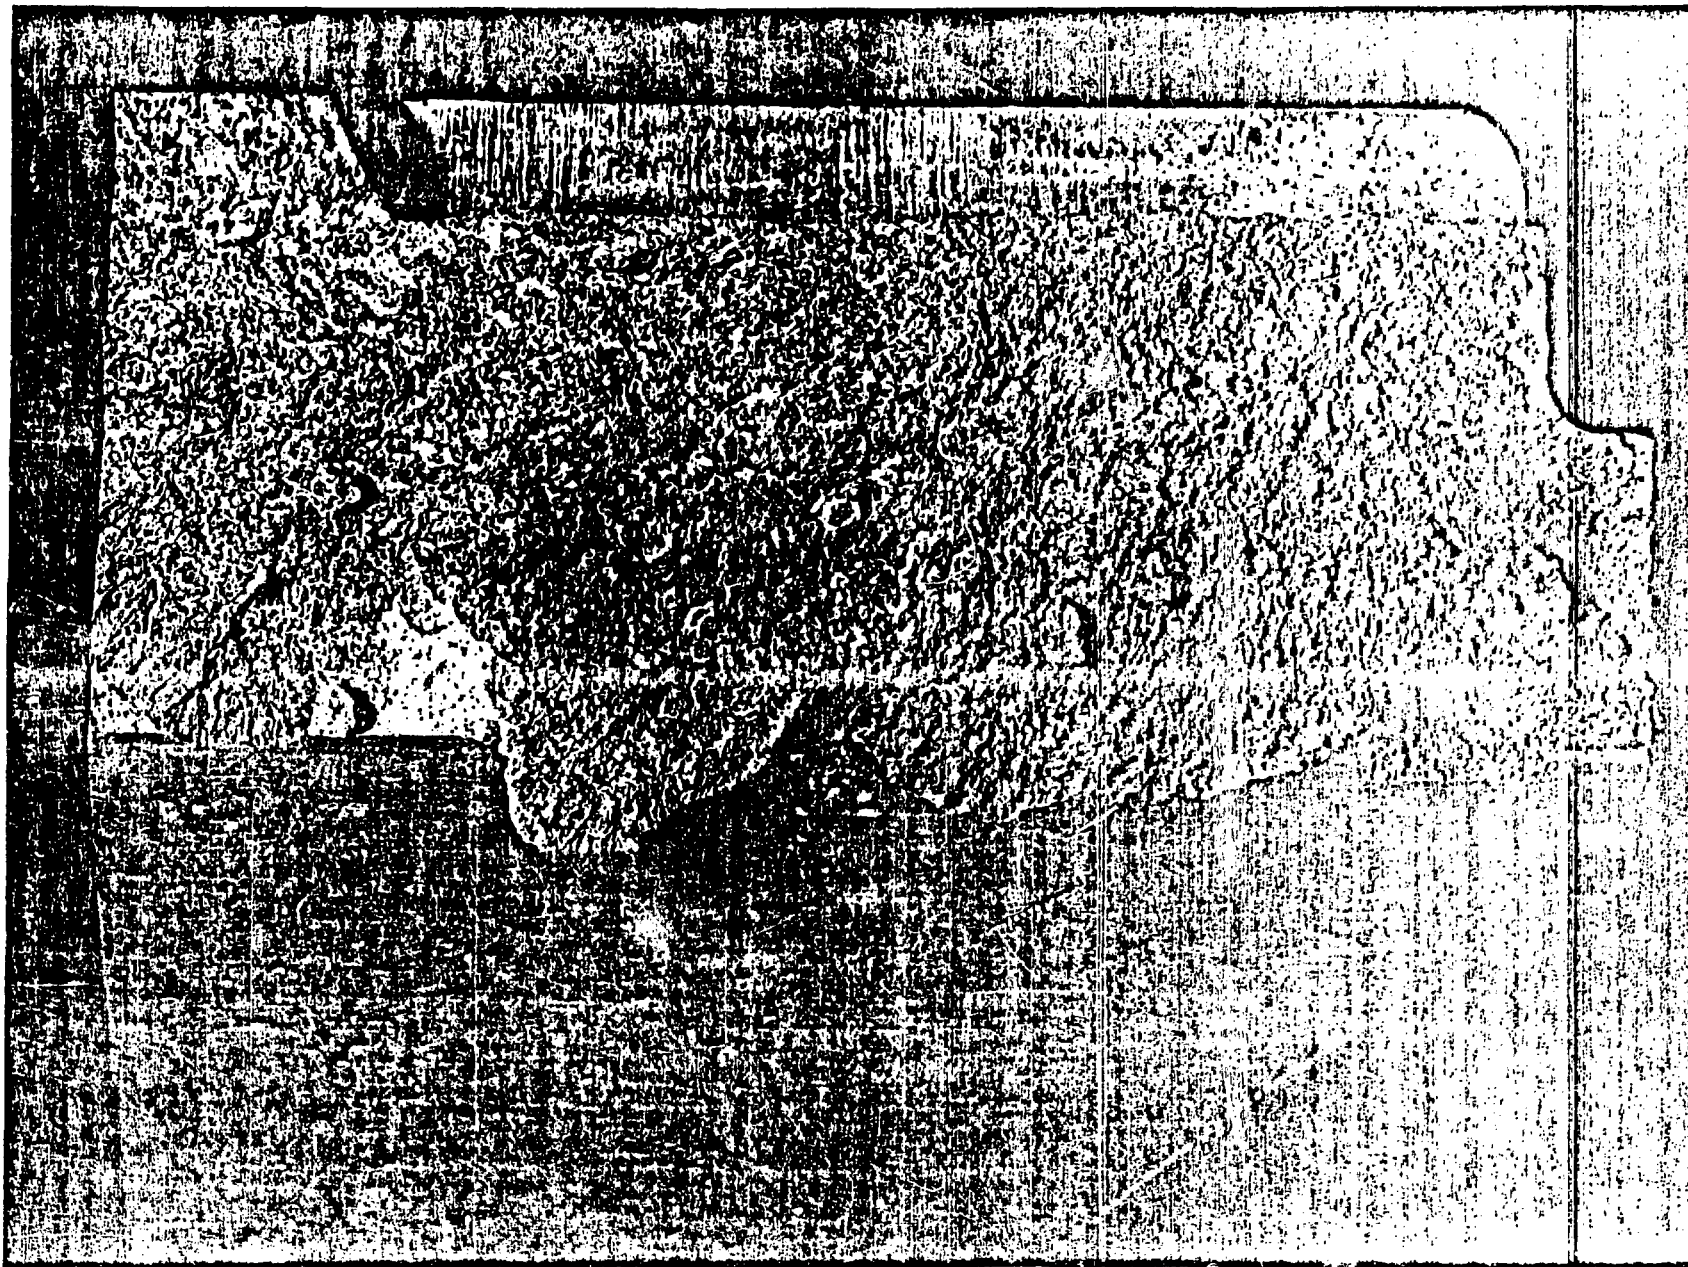
tester. The resulting fracture face is shown in Figure 2. The remainder of the turbine disc was then liquid penetrant tested again to determine if the entire crack had been removed. This examination showed that some of the cracks still remained. The disc was then cut approximately one inch further along the crack direction, and the above steps repeated. The fracture faces were then reassembled and measurements taken of the crack dimensions (Figure 3). The crack's length measured 13.45 cm (approximately 5.3") at its longest dimension, and 5.564 cm (approximately 2.1") at its greatest depth.

The crack was characterized by a black adherent film covering the fracture face and appeared to be mixed intergranular and transgranular in nature as viewed through a stereo microscope. Visual examination disclosed no arrest lines or beach marks, suggesting that once the crack initiated, it progressed with no apparent cyclic frequency.

Figure 2 Fracture face of turbine disc after opening of crack with compression tester. Cooper Turbine

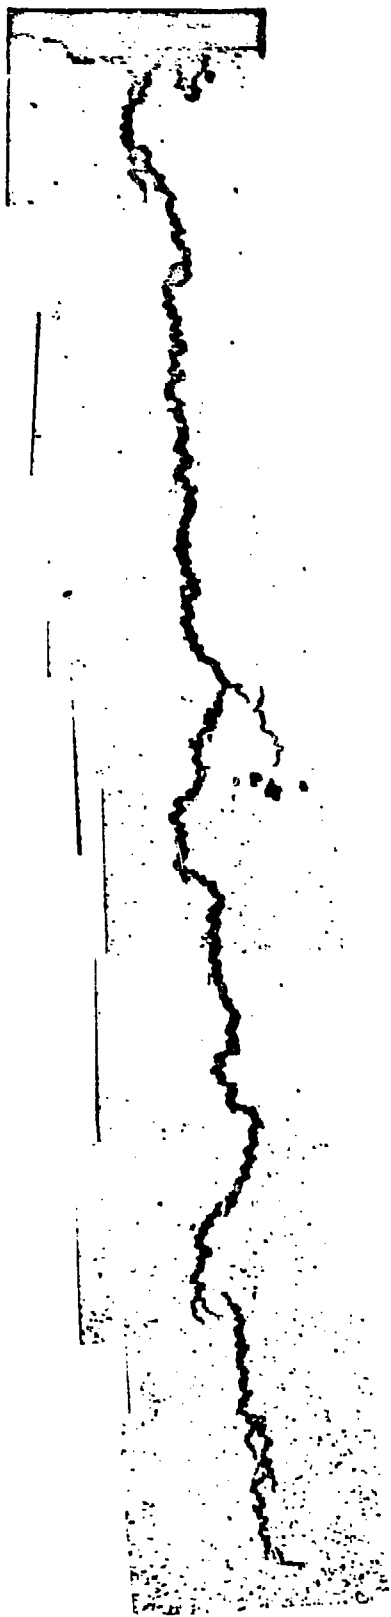
Two cracks from the generator end disc were sectioned and mounted, with the polished face perpendicular to the growth direction of the cracks. In the photomicrographs (Figs. 9 and 10), the cracks appear to be generally intergranular in nature with very little crack branching. The metal matrix appeared to be tempered martensite (bainite) with areas of proeutectoid ferrite. This structure would be consistent with that expected by quenching and tempering a low alloy high strength steel. There was no significant difference in the microstructures of the two discs.

Fig. 9 Photomicrograph of axial crack (typical) Generator End Disc, 6.7 mm in length (Yankee-Rowe Turbine)

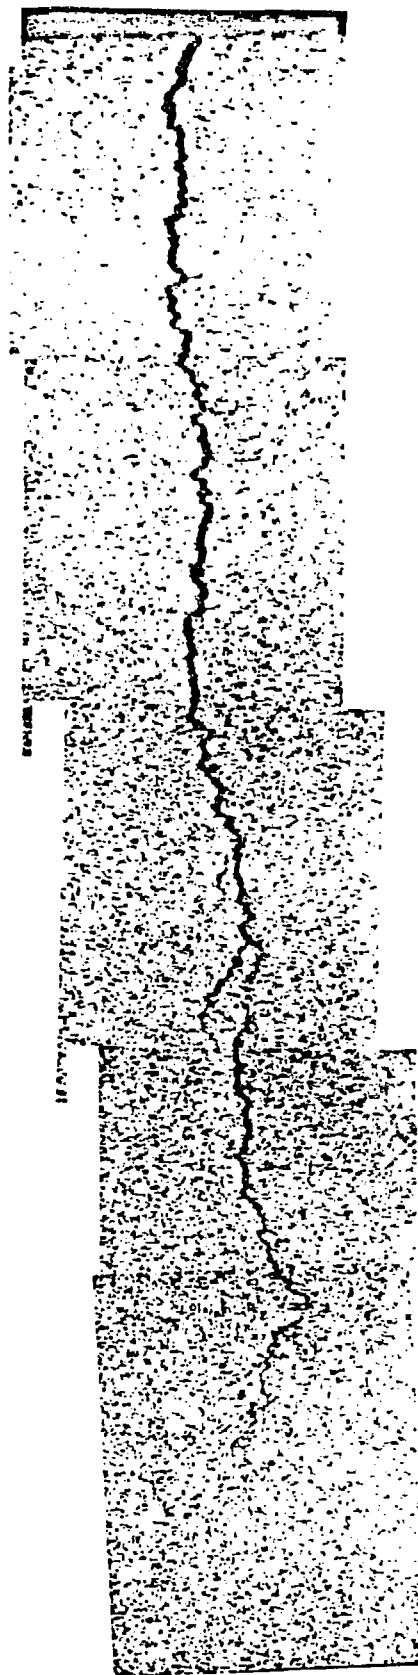
Fig. 10 Photomicrograph of second axial crack (typical) Generator End Disc, 4.1 mm in length (Yankee-Rowe Turbine)

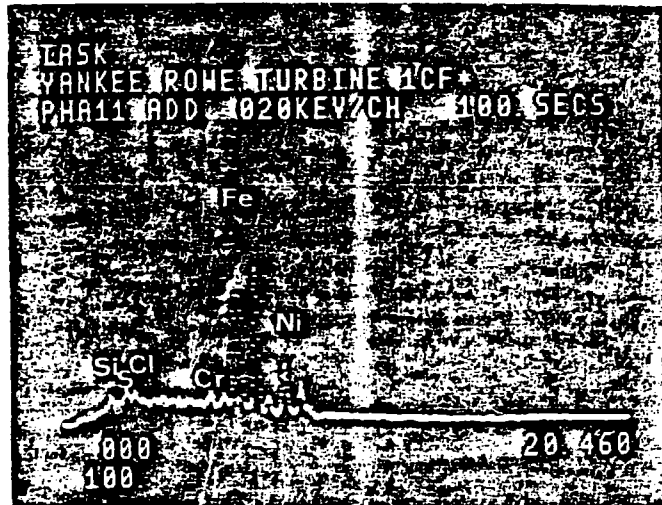
Various axial cracks from the generator disc were broken open after cooling the cut sections in liquid nitrogen. The fracture faces appeared to be generally intergranular in nature (Fig. 11) and had traces of Si, S, Cl, Mn with the Fe, Cr and Ni, as shown in a representative EDS scan (Fig. 12).

Figure 12
EDS scan showing representative elements present in fracture faces
