The Degradation of Steam-Generator Tubing and Components  
by Operation of Pressurized-Water Reactors\*

John R. Weeks and Carl J. Czajkowski

Corrosion Science Group  
Department of Nuclear Energy  
Brookhaven National Laboratory  
Upton, New York 11973

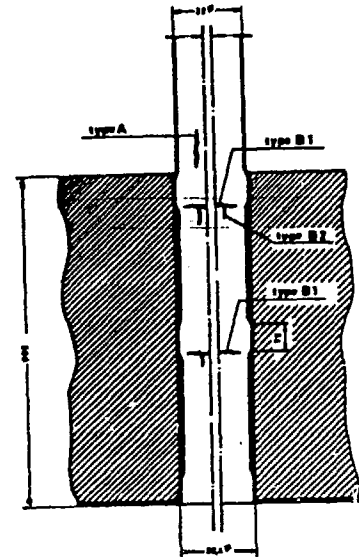
Primary Side Stress Corrosion - Stress corrosion cracking of Inconel 600 tubing originating from the primary side of the steam generator has occurred in service in areas where high residual stresses were present from fabricating the steam generator and in areas where in-service deformation occurred as a result of secondary side corrosion processes (denting). Typical locations of cracks from residual stresses have been short radius U-bends of the innermost rows of tubes in a steam generator, and where the transition zone occurs on a tube that has been partially expanded into the tube sheet hole. The U-bend cracking has primarily occurred on tubes fabricated by Westinghouse over a several year period, although it has also been observed on European plants. It appears to be associated with the details of the bending process. Cracks appear to initiate at a point of maximum gradients in residual stresses. Stress corrosion cracking where tubes are expanded into the tube sheet crevice has occurred primarily in overseas PWR's of the present time. Figure 1(a) and (b) shows typical areas where these cracks have occurred. Where in-service deformation has resulted from denting, there has been an accelerated tendency toward primary side SCC. The most significant leak developing from this cause occurred at Surry, as a result of ovalization of a short-radius U-bend, resulting from denting, as sketched in Figure 2.

FIGURE 1A: SCHEMATIC OF TUBE-TUBE SHEET AT OBRIGHEIM, SHOWING LOCATION OF PRIMARY SIDE SCC (TYPE B) AND SECONDARY SIDE CAUSTIC SCC (TYPE A)

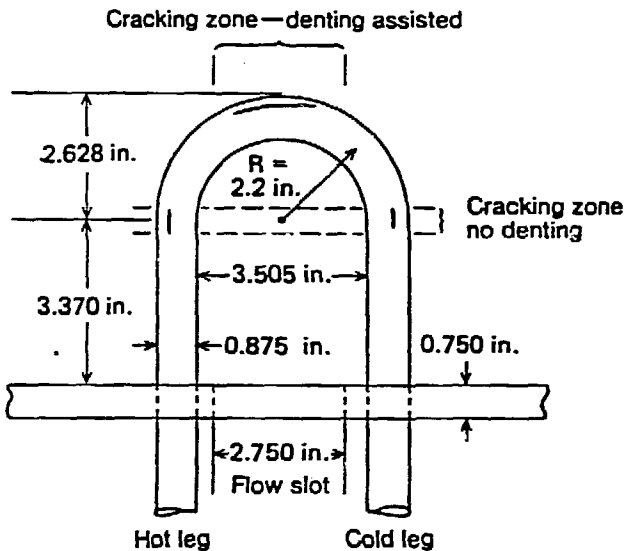
FIGURE 1B: SCHEMATIC OF U-BEND, SHOWING WHERE PRIMARY SIDE SCC HAS OCCURRED

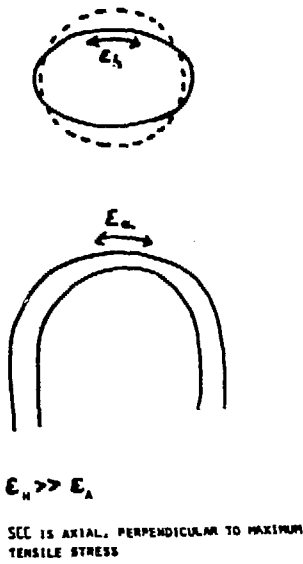
FIGURE 2: SKETCH OF OVALIZATION AT TOP OF U-BEND THAT OCCURS WHEN MOTION OF TUBE SUPPORT PLATE, RESULTING FROM DENTING, DECREASES THE DISTANCE BETWEEN THE HOT AND COLD LEGS

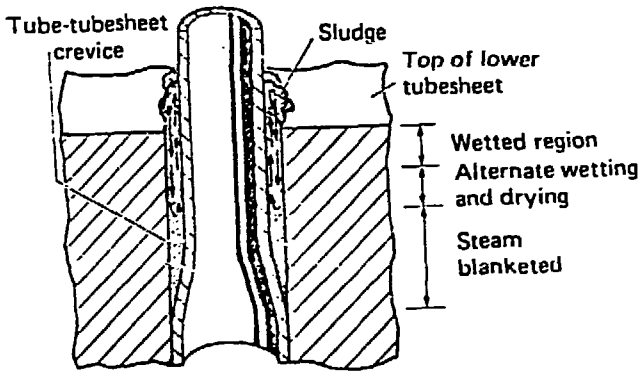
FIGURE 4: TUBE-TUBE SHEET CREVICE

Intergranular Attack-- In many older operating PWRs, the tubing is only expanded partially to the tube sheet crevice, as sketched in Figure 4. In some instances, the development of a caustic-forming environment in these crevices has led to a general intergranular attack on the Inconel tubing. A typical example is shown in Figure 5. This phenomenon has been observed in units that utilized a phosphate water chemistry (San Onofre-1), that developed a caustic environment following conversion of phosphates to an avt chemistry (Point Beach units 1 and 2), or in units utilizing an avt from startup, following leakage of caustic forming impurities (Beznau-1 in 1968). In terms of the NRC interests, itemized in Table 2, this has been one of the most difficult forms of degradation to evaluate. Research under EPRI sponsorship is just now beginning to develop an understanding of the degradation mechanism. From a safety point of view, any leaks that develop in the tube to tubesheet crevice area are likely to be small and detectable. The crevices themselves are tightly packed with corrosion product oxides, which tend to limit the rate of leakage. Further, the tube sheet crevice will restrain the tube and prevent either a fish-mouth type opening or a double-ended tube rupture. To date this type of degradation has not been observed to have progressed above the tube sheet into the sludge pile area, where the tubes (or leakage) would not be restrained. The situation in affected units, however, bears watching and requires frequent inspections to ensure that an unsafe situation has not been reached. Based on laboratory tests, Inconel tubing that has been thermally treated to improve its stress corrosion resistance to primary coolant and secondary side caustic SCC also appears to have improved resistance to intergranular attack. Several utilities have performed an extensive sleeving of the affected areas with a more corrosion resistant material in order to minimize the primary to secondary leakage from the source and the chance that an unsafe situation might develop. The newer units utilize the thermally treated Inconel tubing and have eliminated by design the crevices in which this attack has occurred.

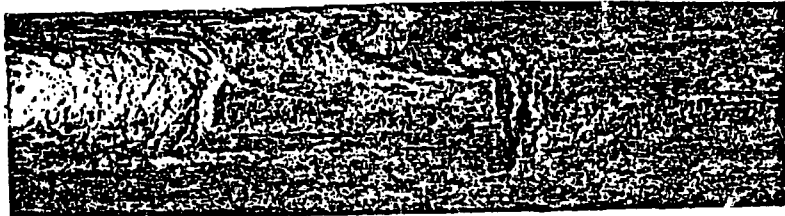
Wastage - General corrosion of the Inconel tubes in creviced areas by acid phosphates, which was a matter of some concern in the early to mid seventies, has largely been eliminated by the abandonment of phosphate water chemistry on all but two operating PWR's. Figure 6 shows the general nature of this attack. Complete removal of the phosphates however, has been difficult to achieve, and phosphate residues in the blow-down from some affected units were observed for several years following abandonment of this treatment. On the two units that continue to utilize the phosphate treatment, careful control of sodium to phosphate ratio has prevented significant further instances of either caustic corrosion cracking or rapid wastage. However, some units still in operation have many previously-plugged tubes containing defects similar to that shown in the figure. One unit (Palisades) attempted a program of sleeving to increase the residual strength of the tubing in the wasted areas.

**FIGURE 6:** Nature of Wastage of Inconel in the Vicinity of Tubing Supports in the Palisades Reactor. The Defect Shown is 35 mils Deep. Flow was from Left to Right.

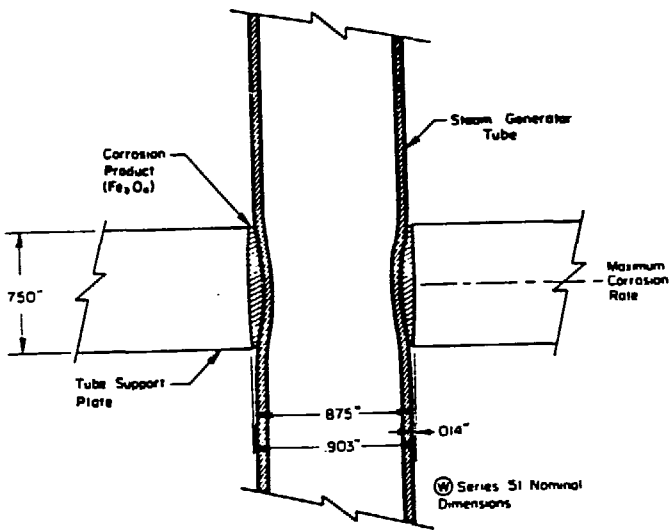
**FIGURE 7:** SCHEMATIC OF DENTING AT TUBE SUPPORT PLATE CREVICES

Denting of steam generator tubes by runaway corrosion of tube support plates was first observed in the middle 1970's and is continuing to the present in some units. Widespread denting and the related problems of inservice strain-induced primary side cracking has led to the replacement of all steam generators at both of the Surry and both of the Turkey Point units. Figure 7 shows a schematic of the denting type reactions. The nonprotective magnetite growth on the carbon steel support plate is known to be triggered by the presence of chlorides, an acid environment, and oxidizing ions such as copper or nickel. In addition to producing dents and deformation in the Inconel tubes, leading to primary side SCC, denting processes result in considerable distortion to and cracking of the tube support plate as well. To date, foreign objects that are capable of damaging tubes have not broken loose from support plates by this mechanism, but the situation bears watching in the future. Although in some units the low pH has been attributed to hydrolysis of residual phosphates, the majority of the acidity is produced by hydrolysis in the steam generator of substances such as magnesium chloride contained in sea water. Thus, plants with condensers cooled by sea water or brackish water are both by experience and prediction the more likely to be degraded by denting processes. The copper or nickel ions that are known to trigger or accelerate denting will not be produced by reaction of these metals with water. Therefore, proper oxygen control or deaeration in the condenser and feedwater lines, as well as in the steam generator, together with careful monitoring of and response to condenser leakage appear to be the best defense against denting reactions. EPRI funded research has shown that chemical treatments involving a mixture of ammonia and boric acid have a beneficial effect on reducing the rate of denting in an affected unit. The effects of this treatment on other components of the system, however, are not clear at the present time.

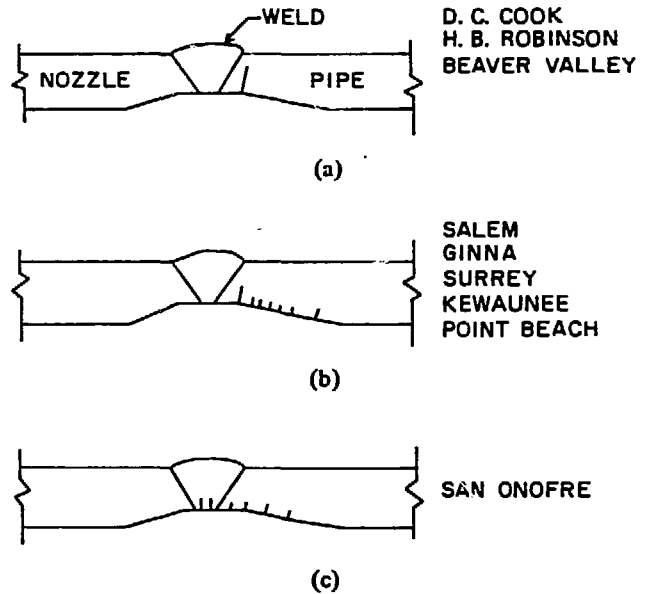
**FIGURE 8:** Schematic diagram of crack morphology by type and plant: (a) single large crack at root of the notch, (b) several small cracks in counterbore region, and (c) shallow cracks in weld and counterbore region.

Thermal fatigue processes, possibly accelerated by environmental exposure, have produced cracks and leaks in the feedwater lines to the secondary side of a number of PWR steam generators and in the steam generator vessels themselves at one unit. Figure 8 sketches the type of degradation that were observed on specimens from feedwater lines of a number of units examined in the authors' laboratory<sup>(10)</sup>. The thermal fatigue mechanism arises from the introduction to the steam generator of ambient temperature water from the auxiliary feed system at various stages during startup and shutdown of the steam generators. The obvious solution to this problem comes from proper mixing of the auxiliary and main feedwater to prevent further stratification. Quite recently a similar phenomenon has been observed in the vicinity of the cone to upper cylinder weld on the steam generators at one operating unit. The situation is under investigation at the present time, but phenomenologically the cracks are similar in appearance to those observed in the feedwater lines at several units, especially at San Onofre 1, where environmental effects appear to have been a contributory cause. It is premature at this time to conclude whether residual stresses adjacent to this weld or the thermal stresses from the introduction of cold auxiliary feed water or environmental effects (this unit has suffered considerable denting and pitting and has used a boric acid treatment to retard the progression of denting) or all three of these factors contributed to the cracking and leakage. Research into the relative importance of these three factors on
