RESULTS OF THE EXAMINATION OF CHANNEL H12/1

By E. Bauer

Translated from the French* Report RHF No. 106 dated Jan. 20, 1983

Channel H12/1 is part of the channel unit of the High-FLux Reactor (HFR) characterized by the designation: average corrosion attack. It was disassembled after the appearance of a heavy water leak.

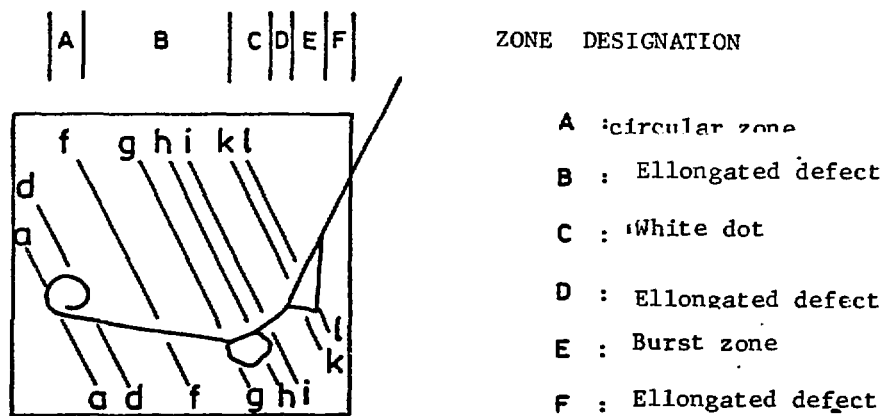
Fig. 21 - Schematic representation of the defect zone with indication of the metallograph planes (a-l)

The defect is composed of a circular zone A, of an elongated defect that connects defect A to a white dot C and of a burst zone E connected to the white dot by an elongated defect D.

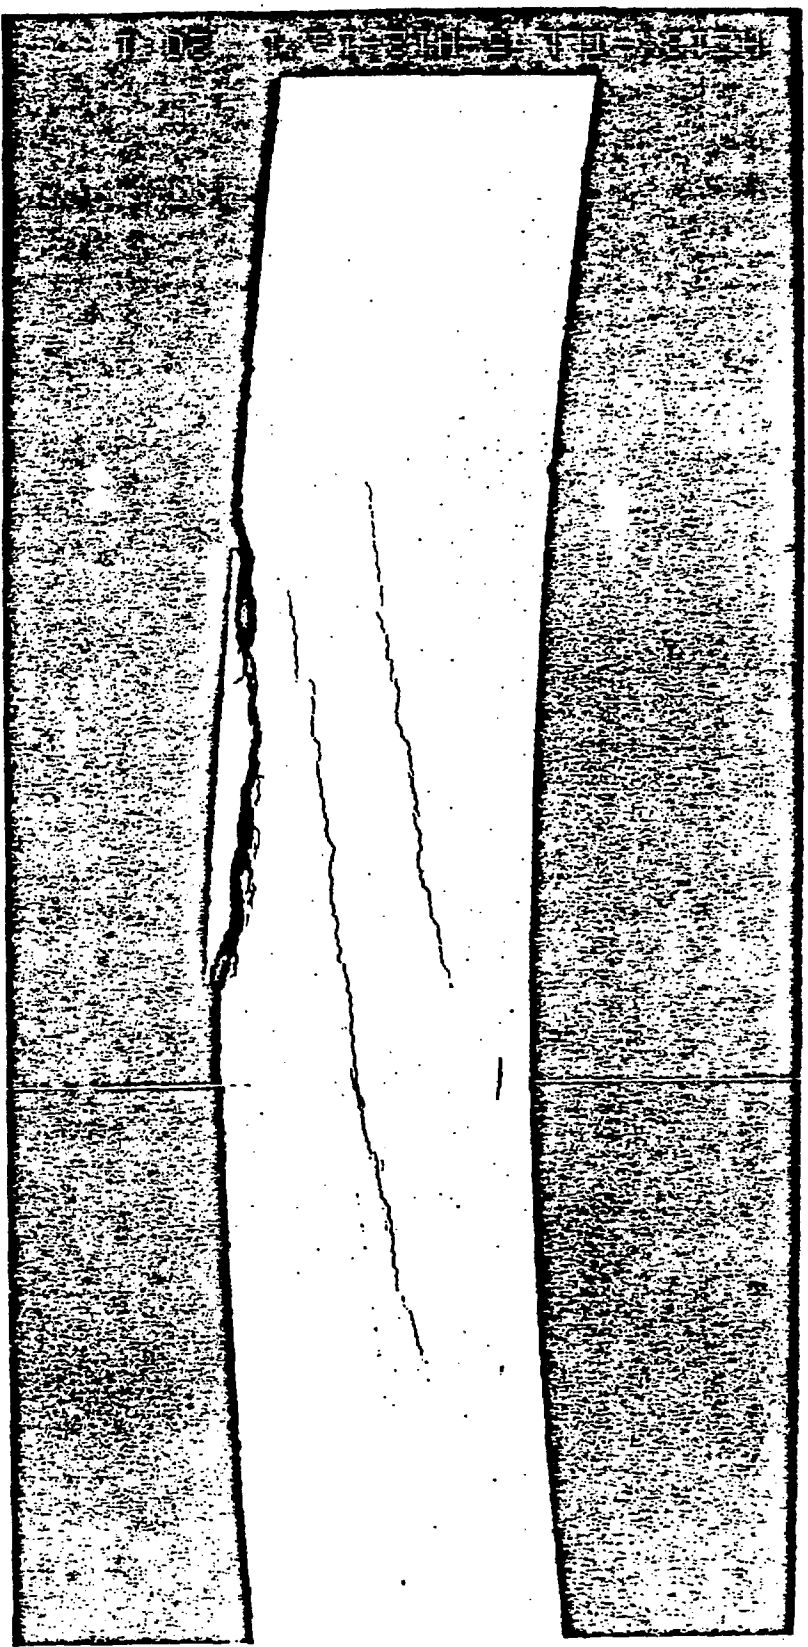
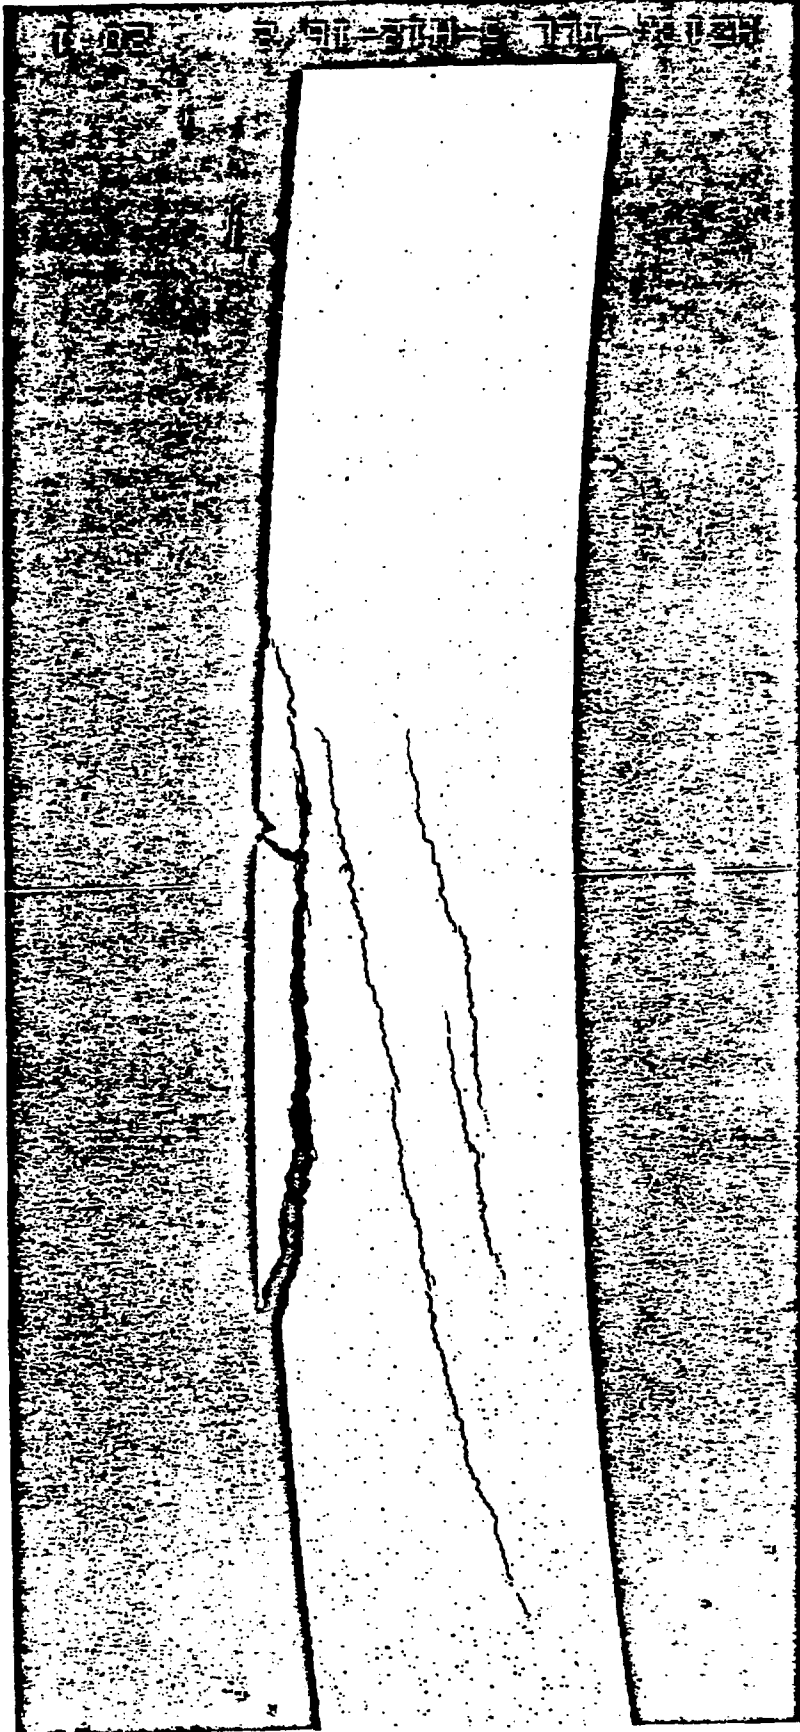
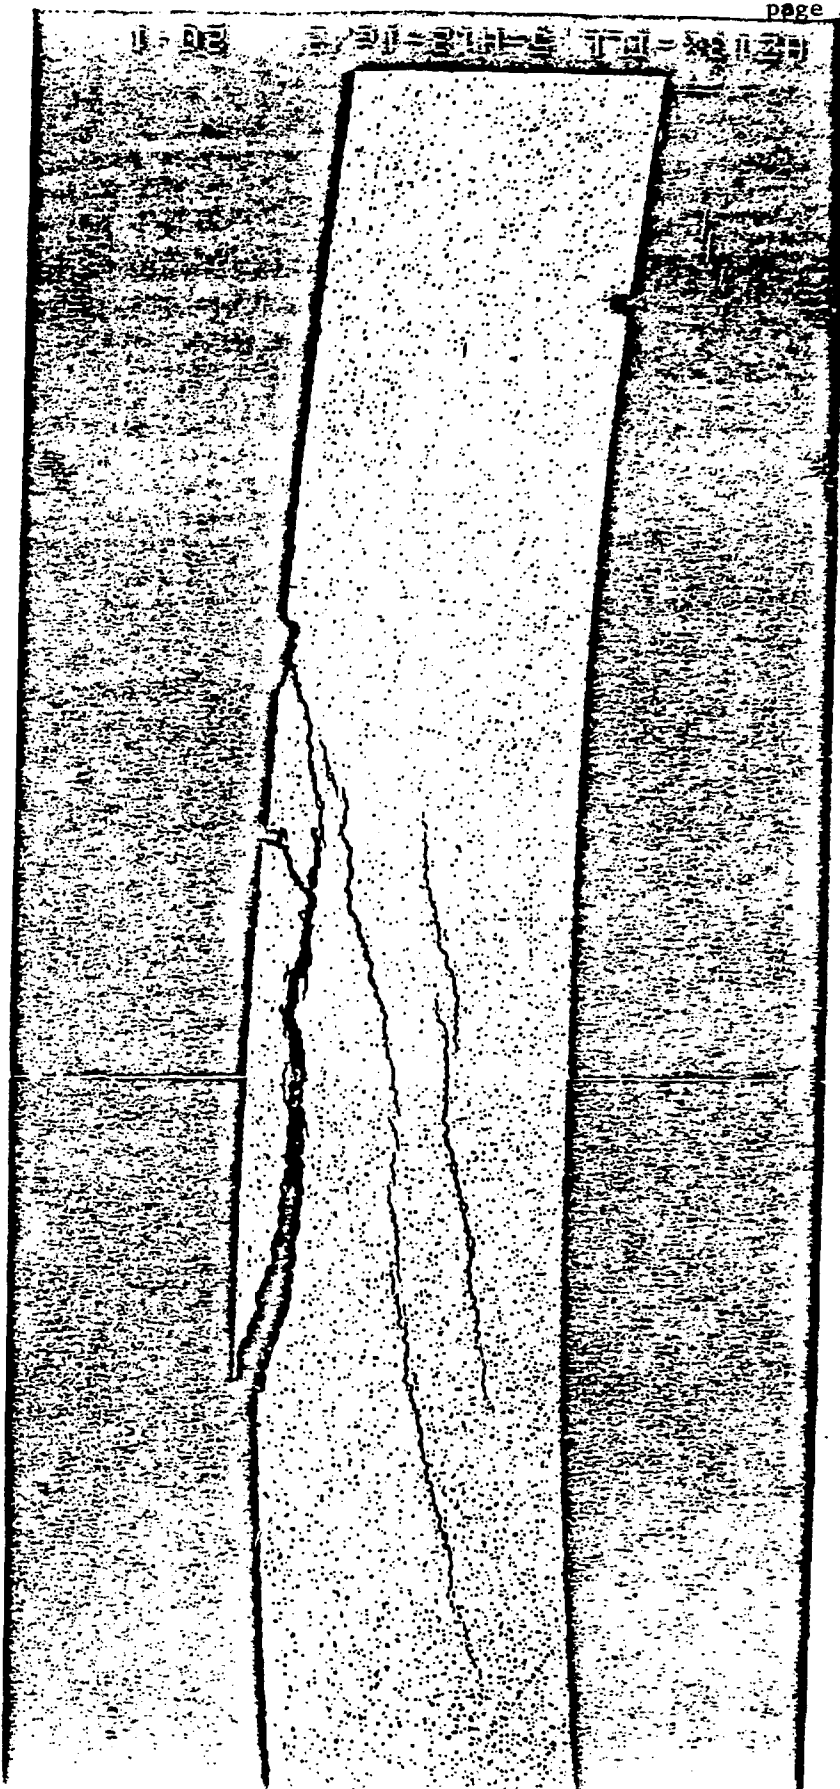
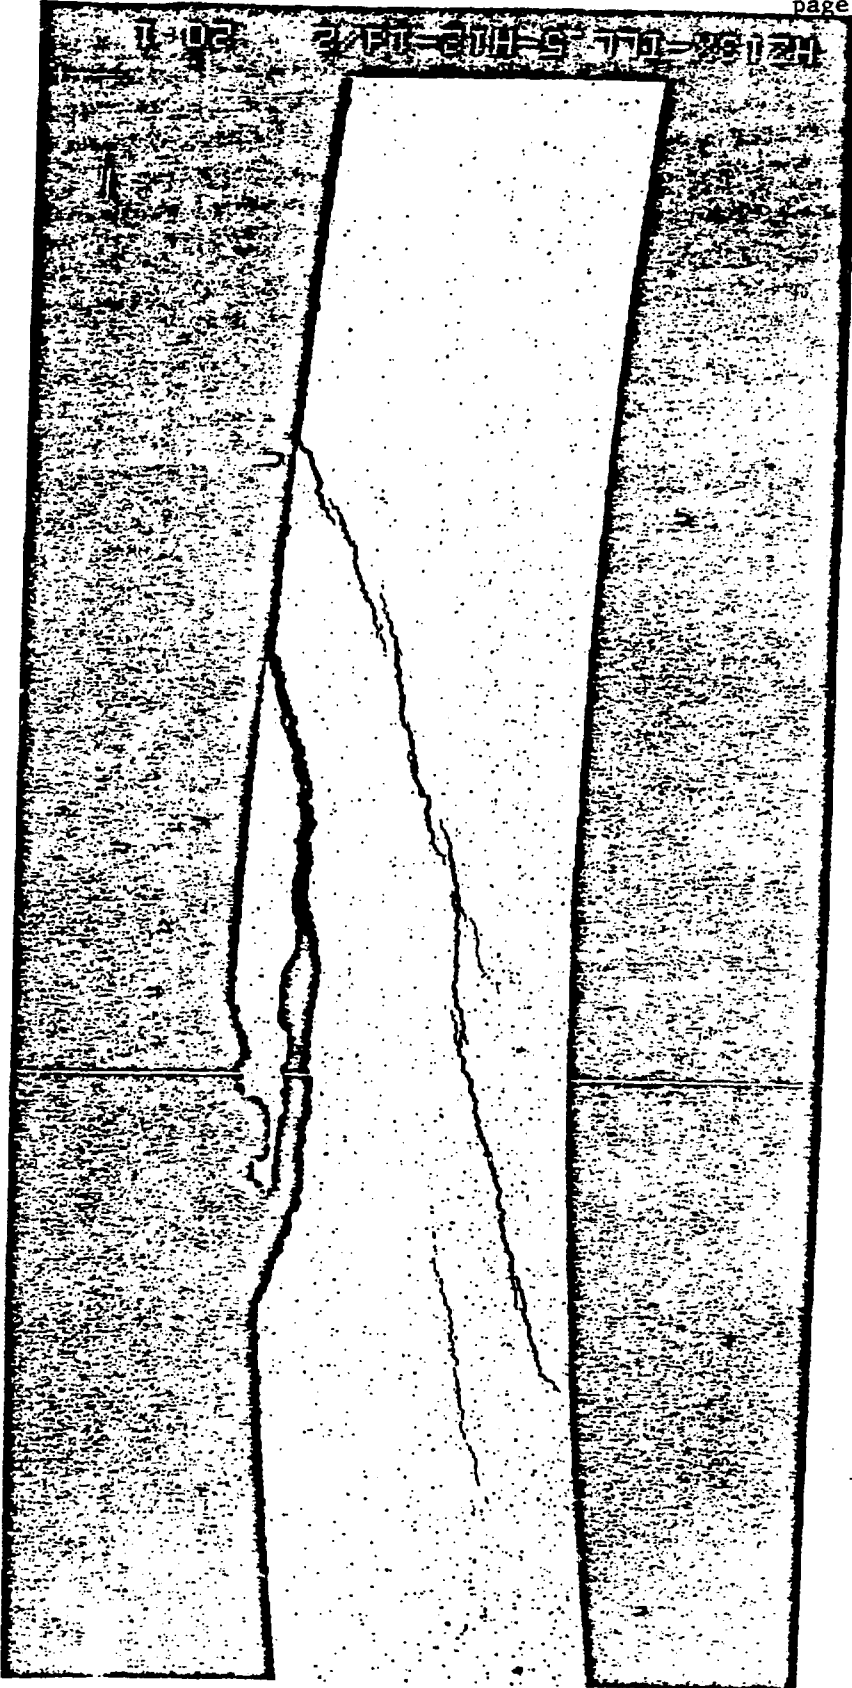
Figures 22 to 25 show the metallographs related to the circular zone A. It can be seen that the circular zone visible on figure 17 is constituted by a burst zone 0.5 mm thick maximum. The diameter can be estimated at approximately 6 mm. Below this zone separated from the base material there are two cracks oriented diagonally to the direction of the circumference.

These are essentially straight cracks, very fine, in plane "a", thicker in plane "d". The angle included between the direction of the crack propagation and the circumferential direction varies by approximately 10° (plane "a") to 15° (plane "d"). The principal crack visible in plane "d" opens to the exterior side (D_2O) and is non-opening to the interior.

Small cracks appear in the large crack separating the base material and the completely separated zone.

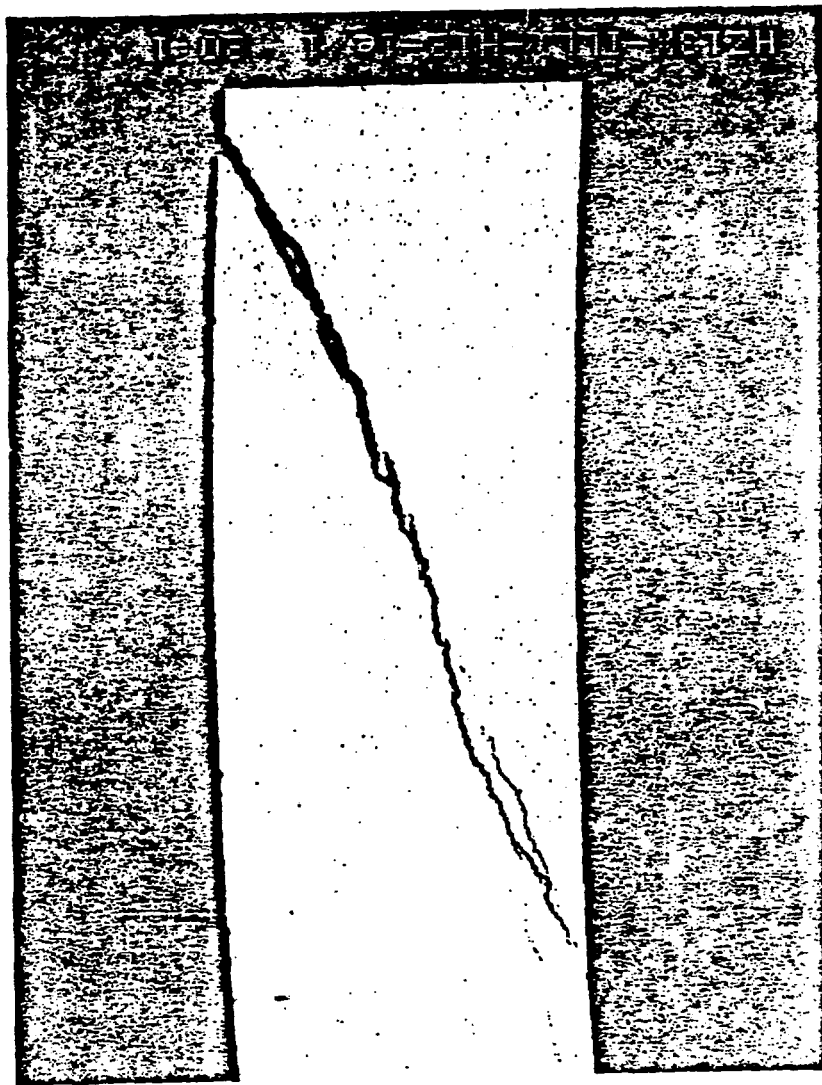
The elongated defect B, visible on figure 17, is constituted by the opening portion of the principal crack in plane "d" that takes on magnitude (figure 26) and becomes opening, also to the interior, the helium side (figure 27).

The angle between the direction of progress of this crack and the circumference direction increases to 20° (figure 26) and to 24° (figure 27). The width of the crack in plane "f" is approximately 0.1 mm. In the zone with the white dot (figure 28 and 29) the principal crack has a tendency to separate into several branches, still limited in plane "g", in a more pronounced fashion in plane "h", where two preferential orientations of propagation of the crack can be observed:

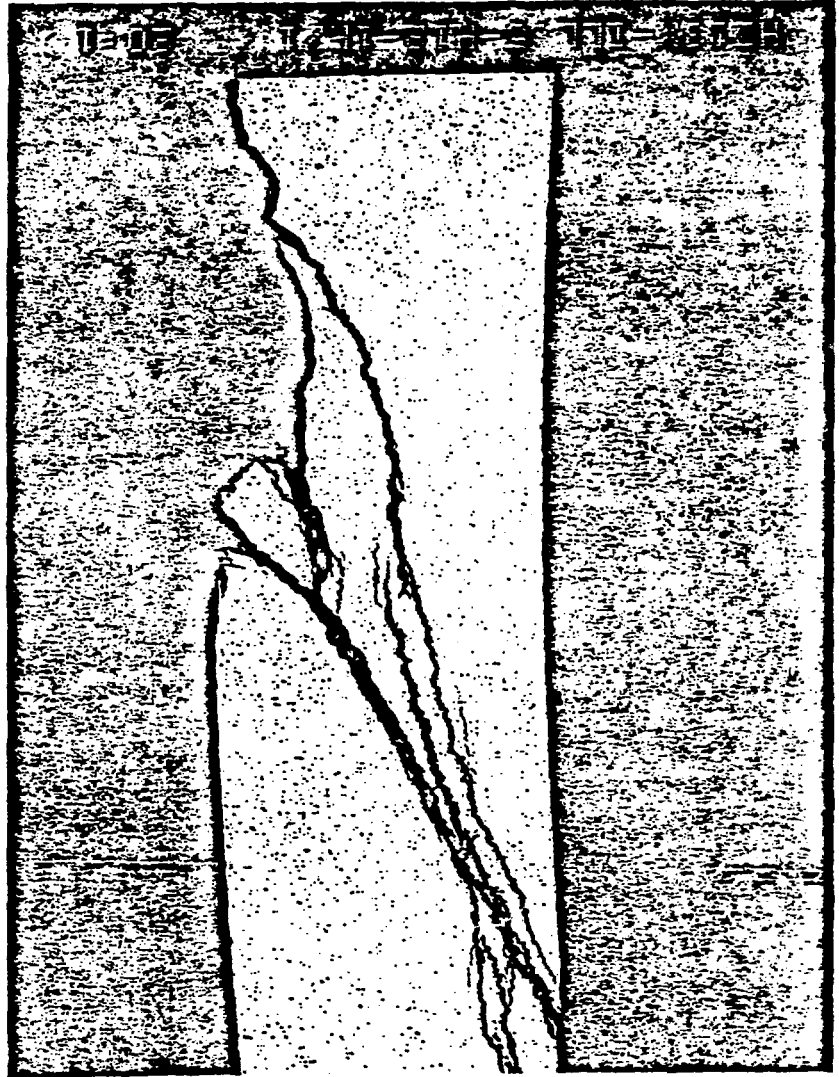
29

The depth of attack in the zone with the white dot (figure 29) is about 0.7mm. Small cracks oriented in the circumferential direction that start in the principal crack can also be observed. It can be assumed that the bottom of the white dot has been constituted from a crack oriented in the circumferential direction.

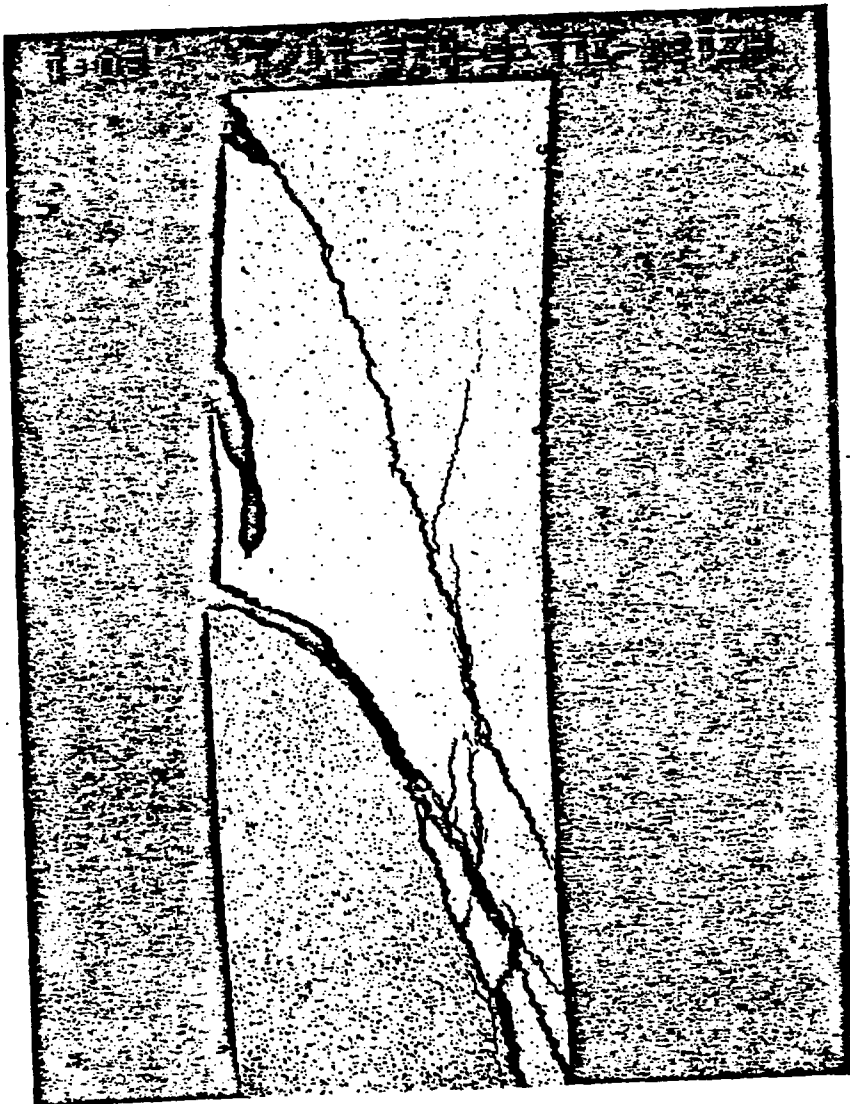
30

The elongated defect D is given by the opening portion of the principal crack. The other cracks have a tendency to disappear gradually.

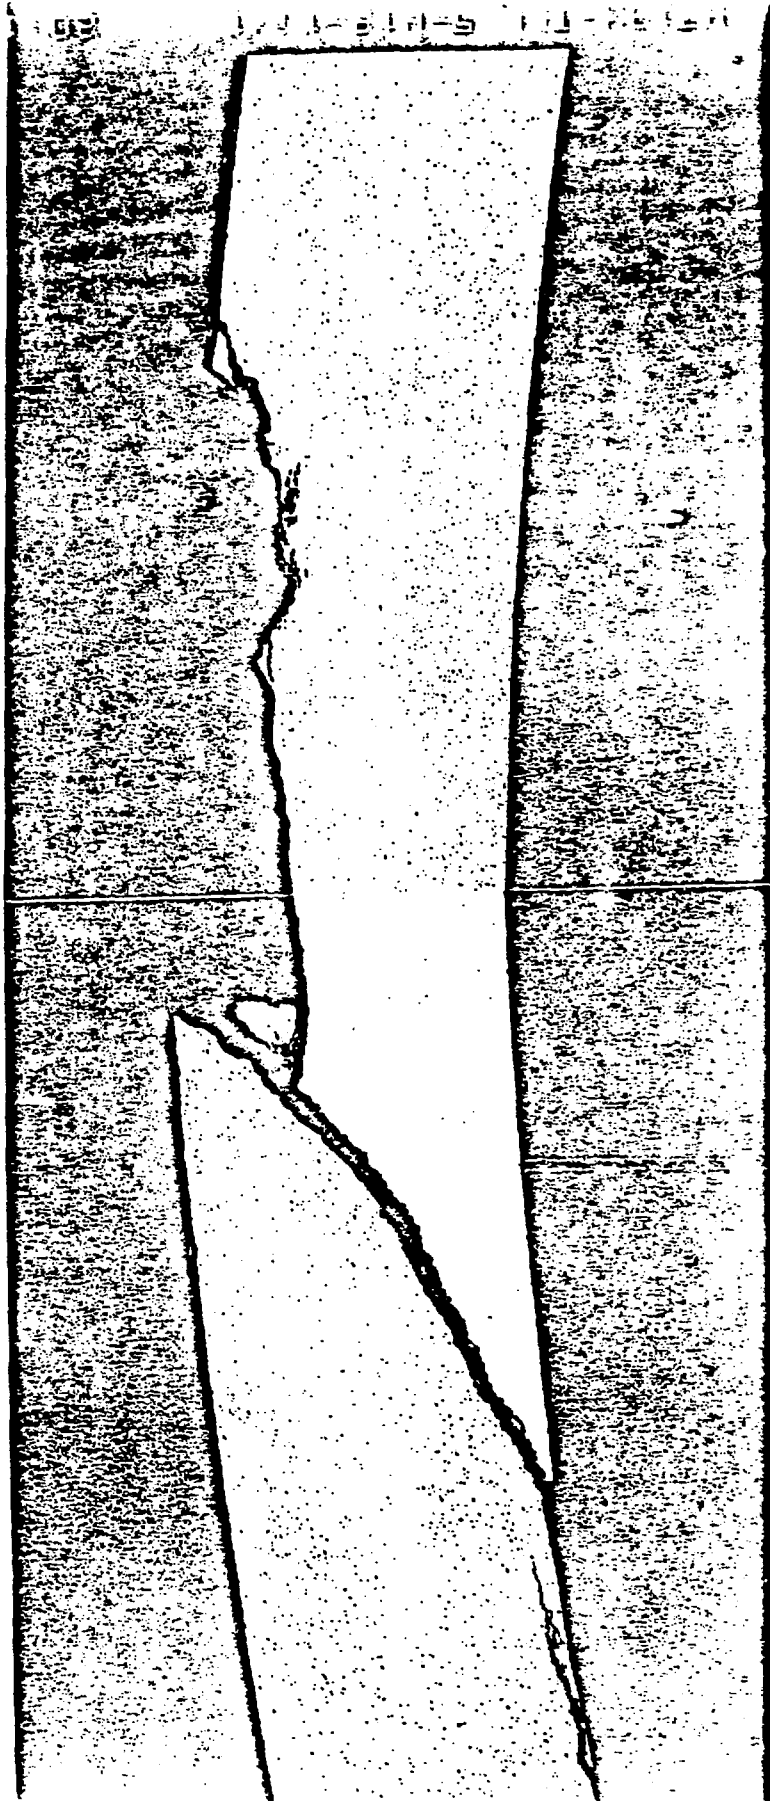
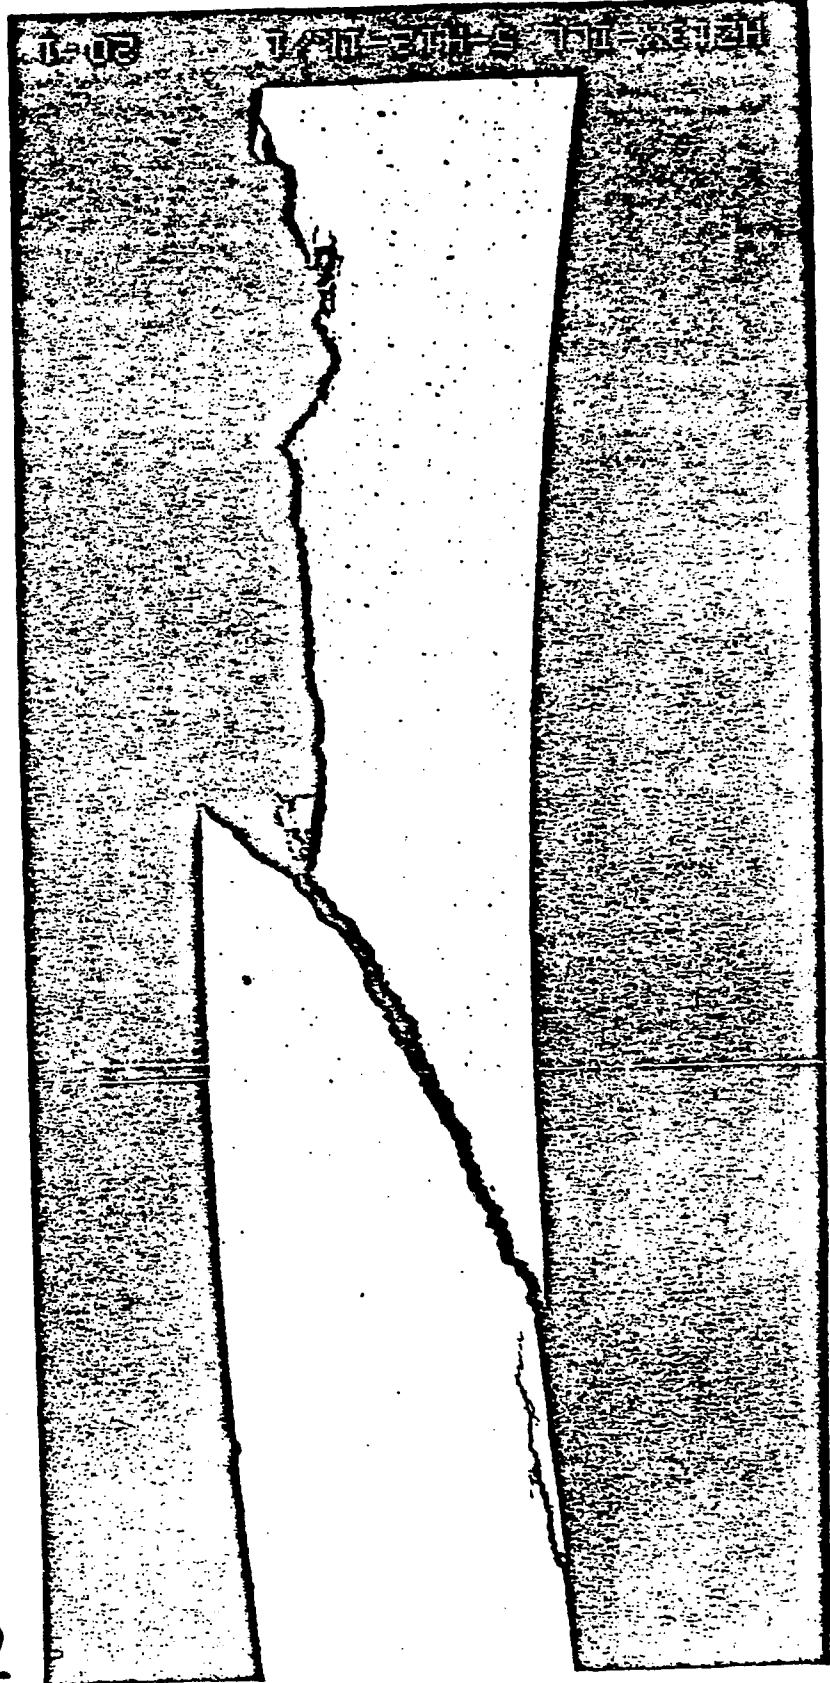
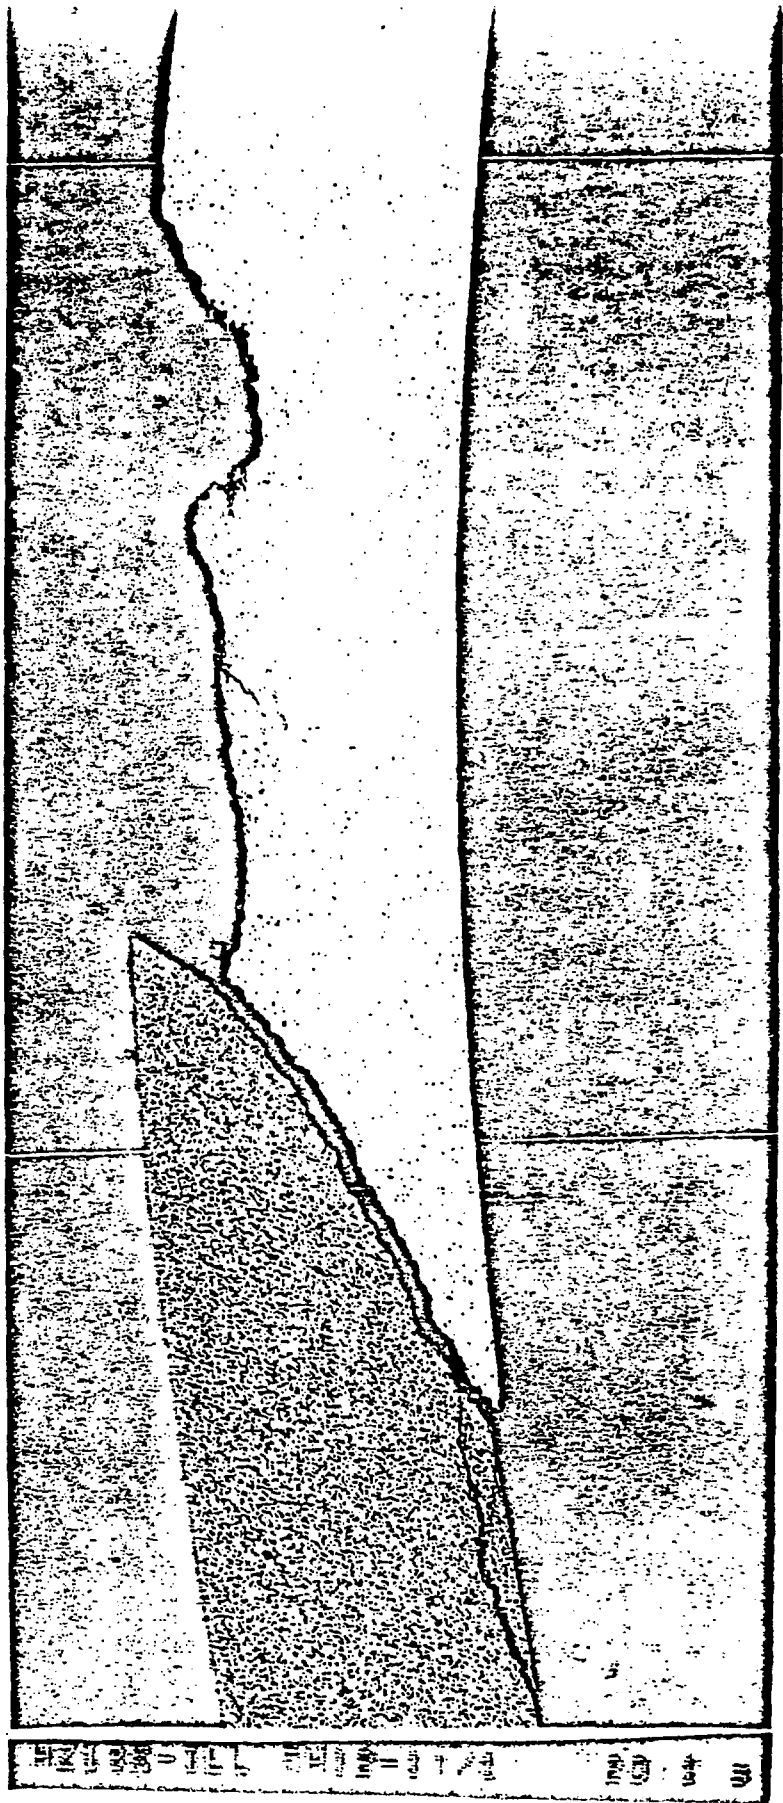
Figures 31 to 33 show the metallographs in the burst zone E. The principal crack is oriented at 28° to the circumferential direction (plane j) at 25° (plane l). The shape of the bottom of the burst zone suggests that the bursting was due to the joining of a crack oriented essentially in the circumferential direction with the principal crack.

The maximal depth of the burst zone reaches 0.9 mm (plane j), its width approximately 5mm.

The walls located on either side of the crack are off-set by approximately 0.1 mm. The width of the principal crack reaches approximately 0.2 mm (plane l).

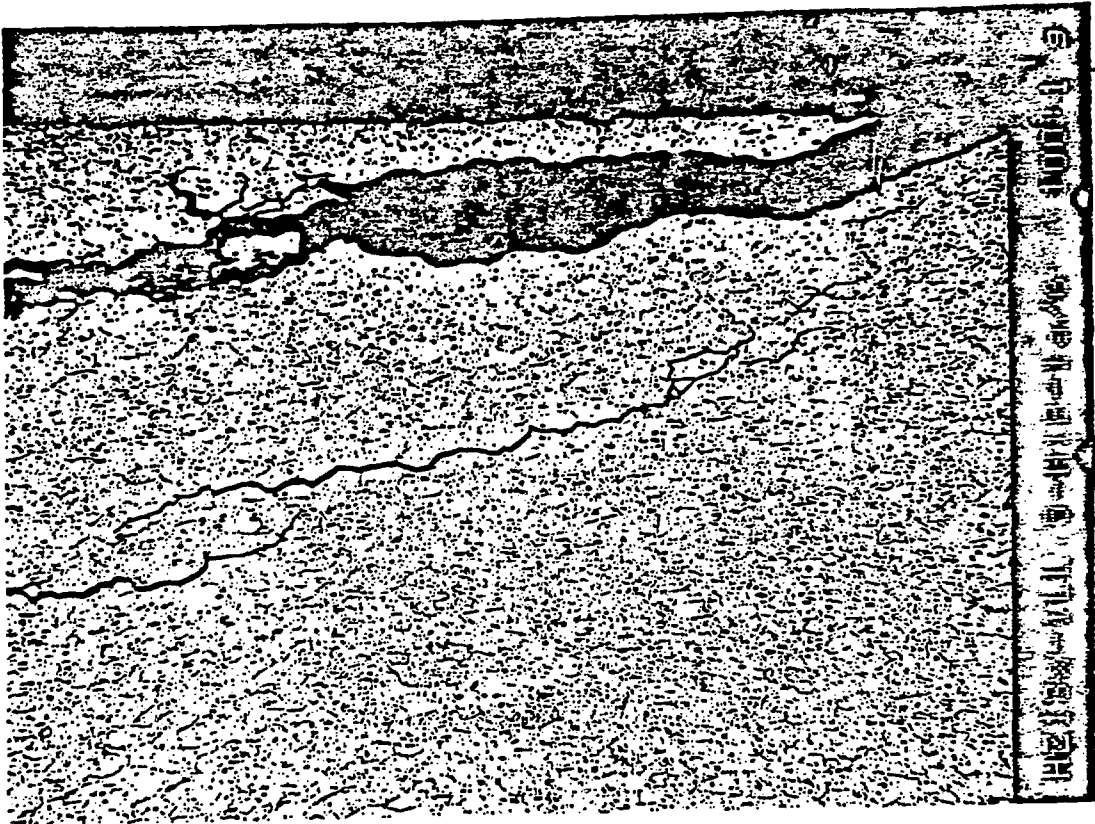
34 : Detail of crack and of detached portion (plane a)
100 : 1

Figure 34 shows the differences between fine cracks and broad cracks, such as those that separate the detached portion of the base material in plane "a".

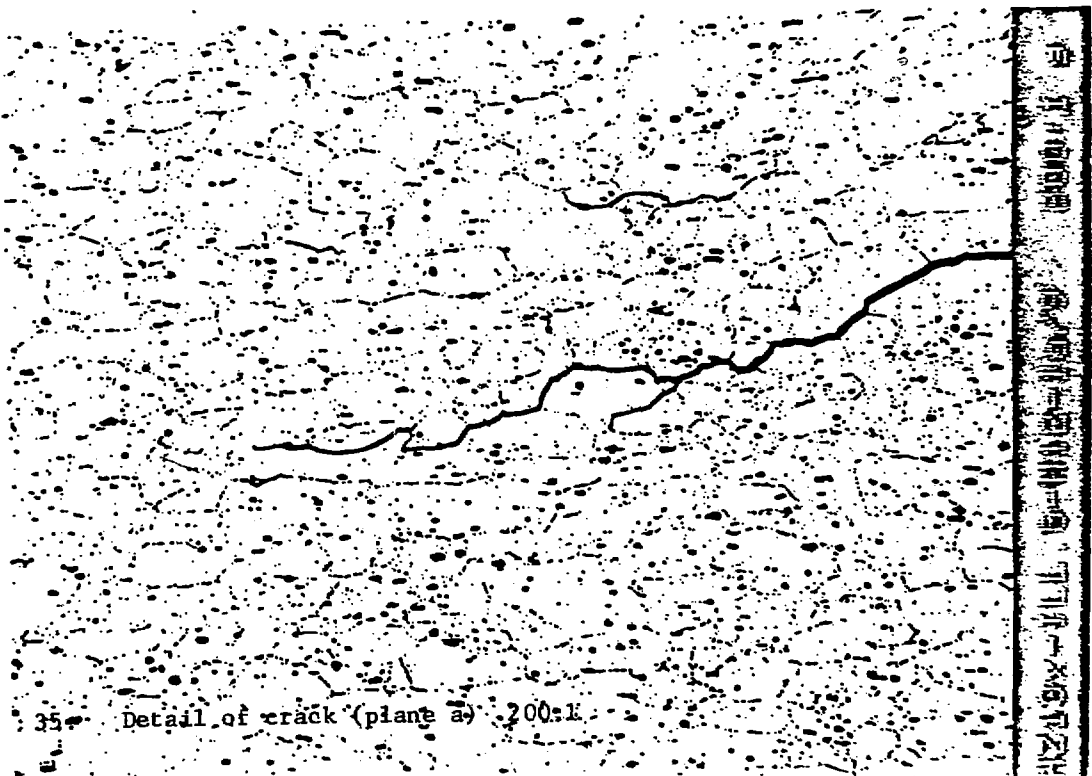
35 : Detail of crack (plane a) 200:1

The small crack follows the grain boundaries perfectly, which means that its shape is not regular. The two edges of the crack have an identical shape. The crack has a tendency to detach the grains from each other (figure 35).

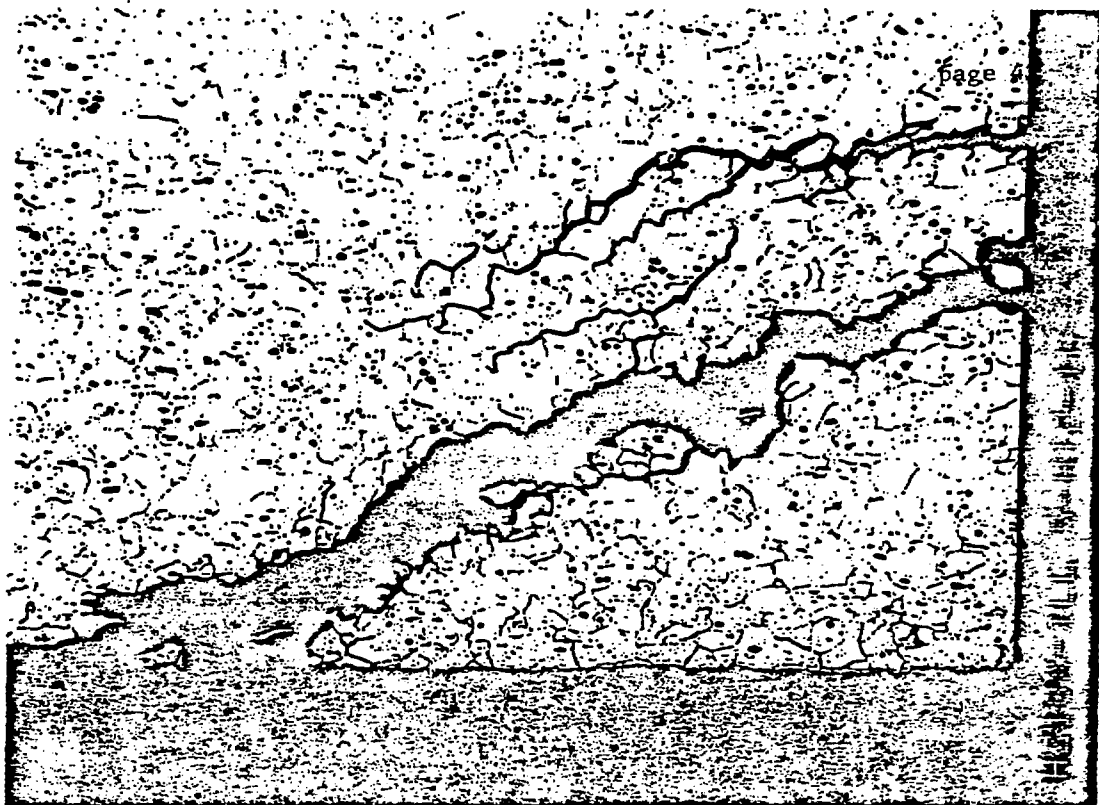
36 : Detail of cracks, inside (plane n)
200 : 1

The small crack at the top of photo 36, as previously, has a shape that perfectly retraces the grain boundaries. Its edges have identical shapes.

The principal crack has edges that are rather rounded and the two edges do not have an identical shape.

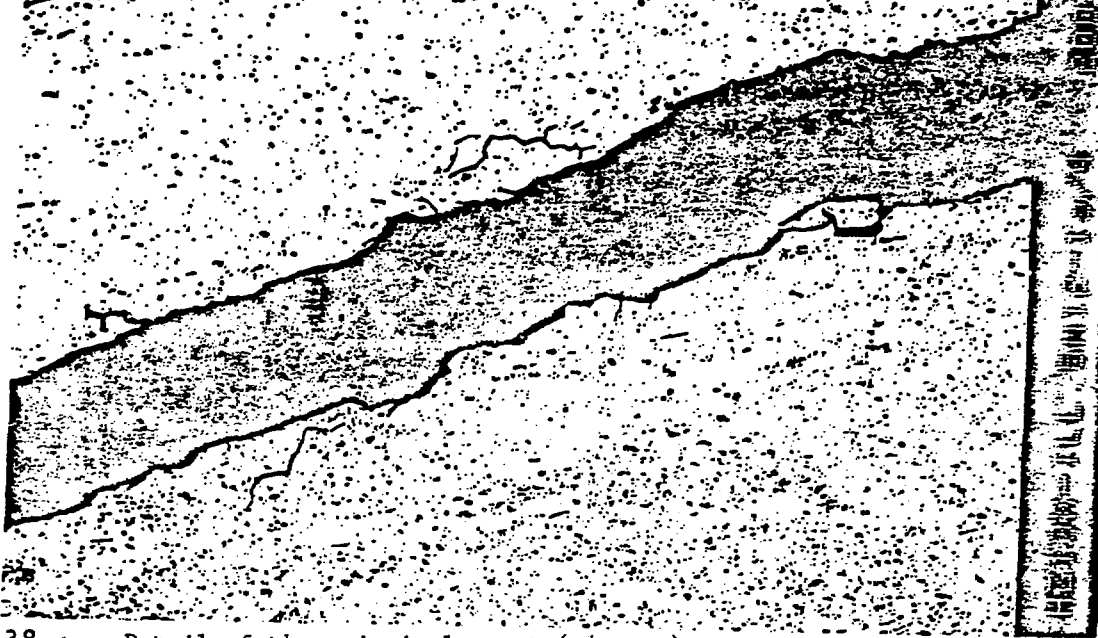
38 : Detail of the principal crack (plane g)
200 : 1

Figure 38 showing the principal crack in plane "g" hardly allows the shape of the grains the limit the crack to be recognized.

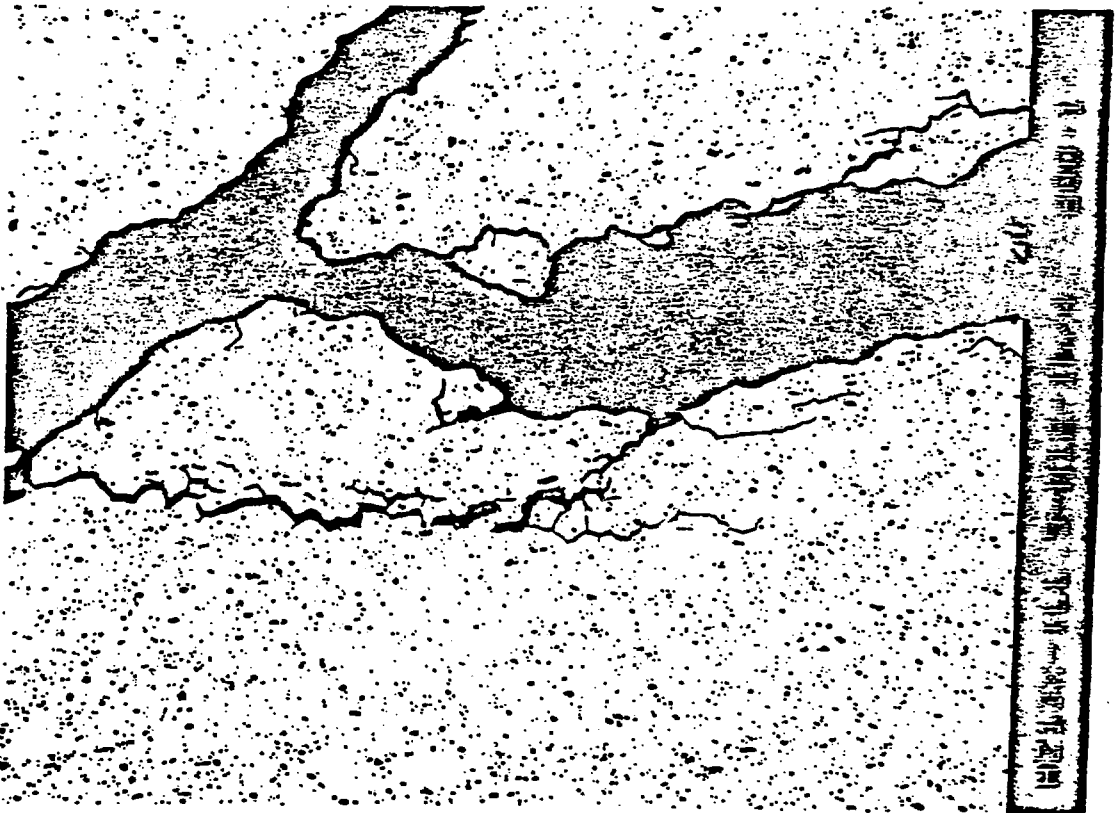
39 : Detail of the principal crack (plane h)
200 : 1

The principal figure of plane "h" (figure 39) gives rise to the same remarks. In addition, we see the formation of small caves on the edges of the principal crack. In places, these caves become small cracks

that have the same appearance as the small cracks previously presented.

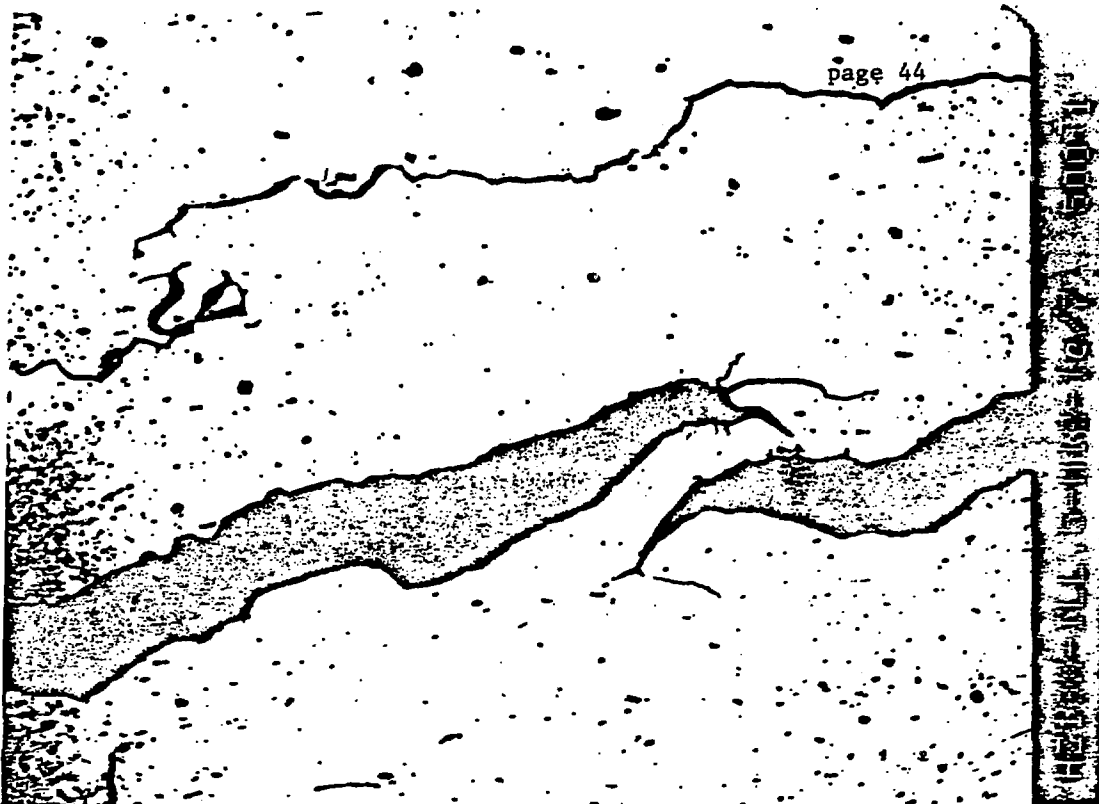
40 : Detail of cracks (plane c)
 Ordinary light 500 : 1

The cracks with a normal appearance (figure 40) show, under polarized light, a clean structure that indicates that the crack is filled with material.

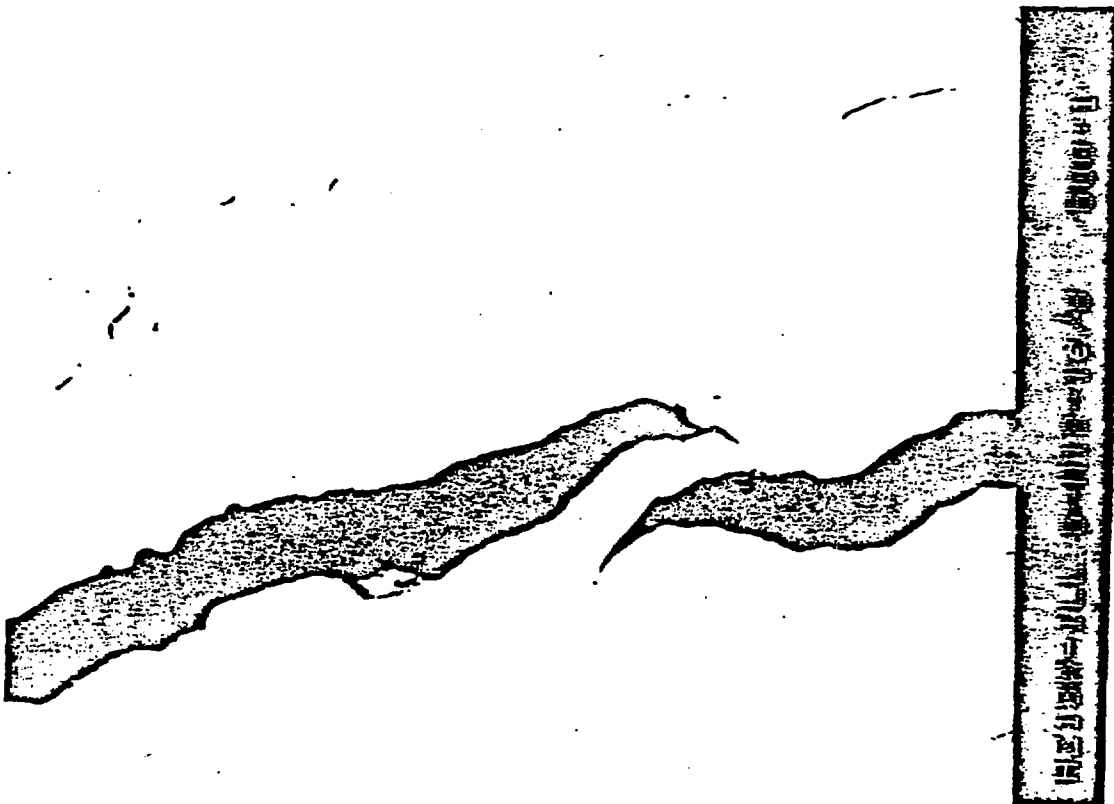
41 : Detail of cracks (plane c)
 Polarized light 500 : 1

The structure gives the crack the appearance of being filled with plugs delimited by perpendicular planes in relation to the edges of the crack. Given that, in figure 41, the two ends of the cracks are involved, this material that fills the crack must be constituted by corrosion products.

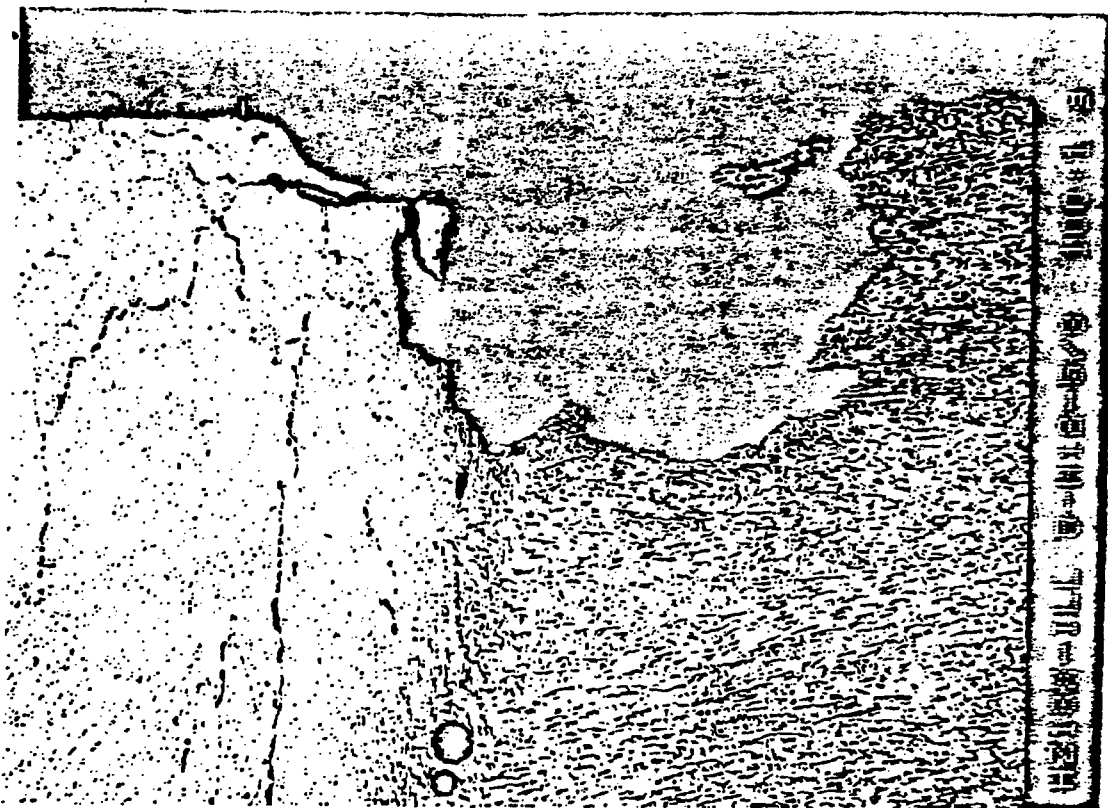
45 : Weld Bead - attacked zone
100 : 1

The depth of the visible attack is approximately 0.5 mm. Figure 45 gives a detail of this corrosion zone. The appearance of this zone differs clearly from the appearance of the white dots or the cracks previously examined. It is rather a caving attack, with a smooth and rounded bottom. In no case can the formation of fine cracks starting from this cave be noted.
