# The Axial Location of Cladding Failure During a Slow Transient Overpower TREAT Test

R. J. Page, W. F. Murphy and J. W. Holland

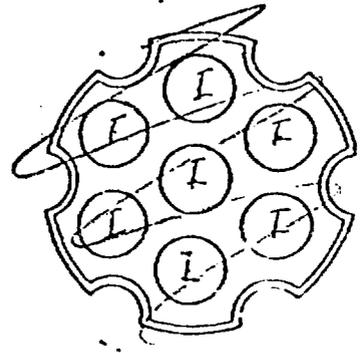
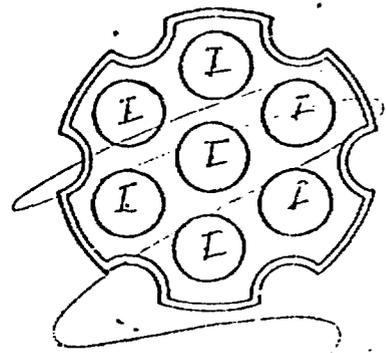
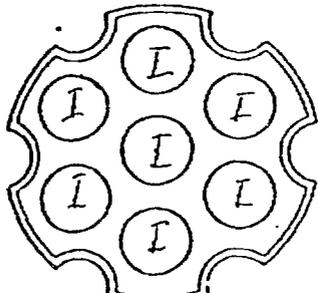
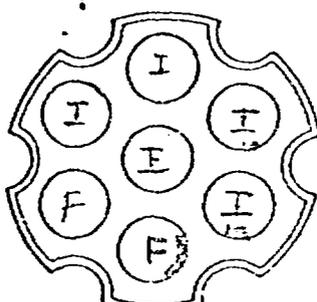
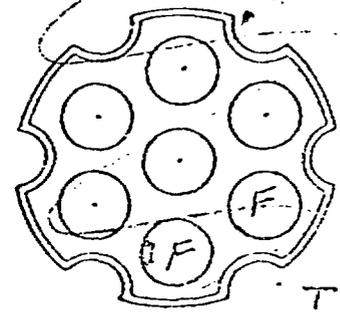
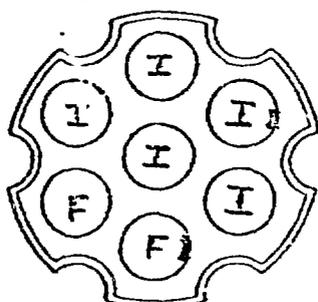
Fig 1

The fuel pins at 2, 4 and 6 o'clock failed. The failures started at the tops of the fuel columns and extended upward along the insulator pellets for a total length of about 20 mm. Cladding failures tended to be toward the outside of the cluster with a bias toward an adjacent pin. The fuel expelled from one pin may have contributed toward failure of an adjacent element. The fuel expelled from the three failed elements was not enough to make a significant blockage to coolant flow.

The axial and circumferential locations of cladding failure are showed schematically in Fig. 1. Also shown are the locations of fuel pellets and insulator pellets, indicating the extent of fuel expansion. Fig. 2 is a cross-section of the fuel pin bundle about 10 mm above the top of the original active fuel column.

Cladding failure locations for the J1 test.

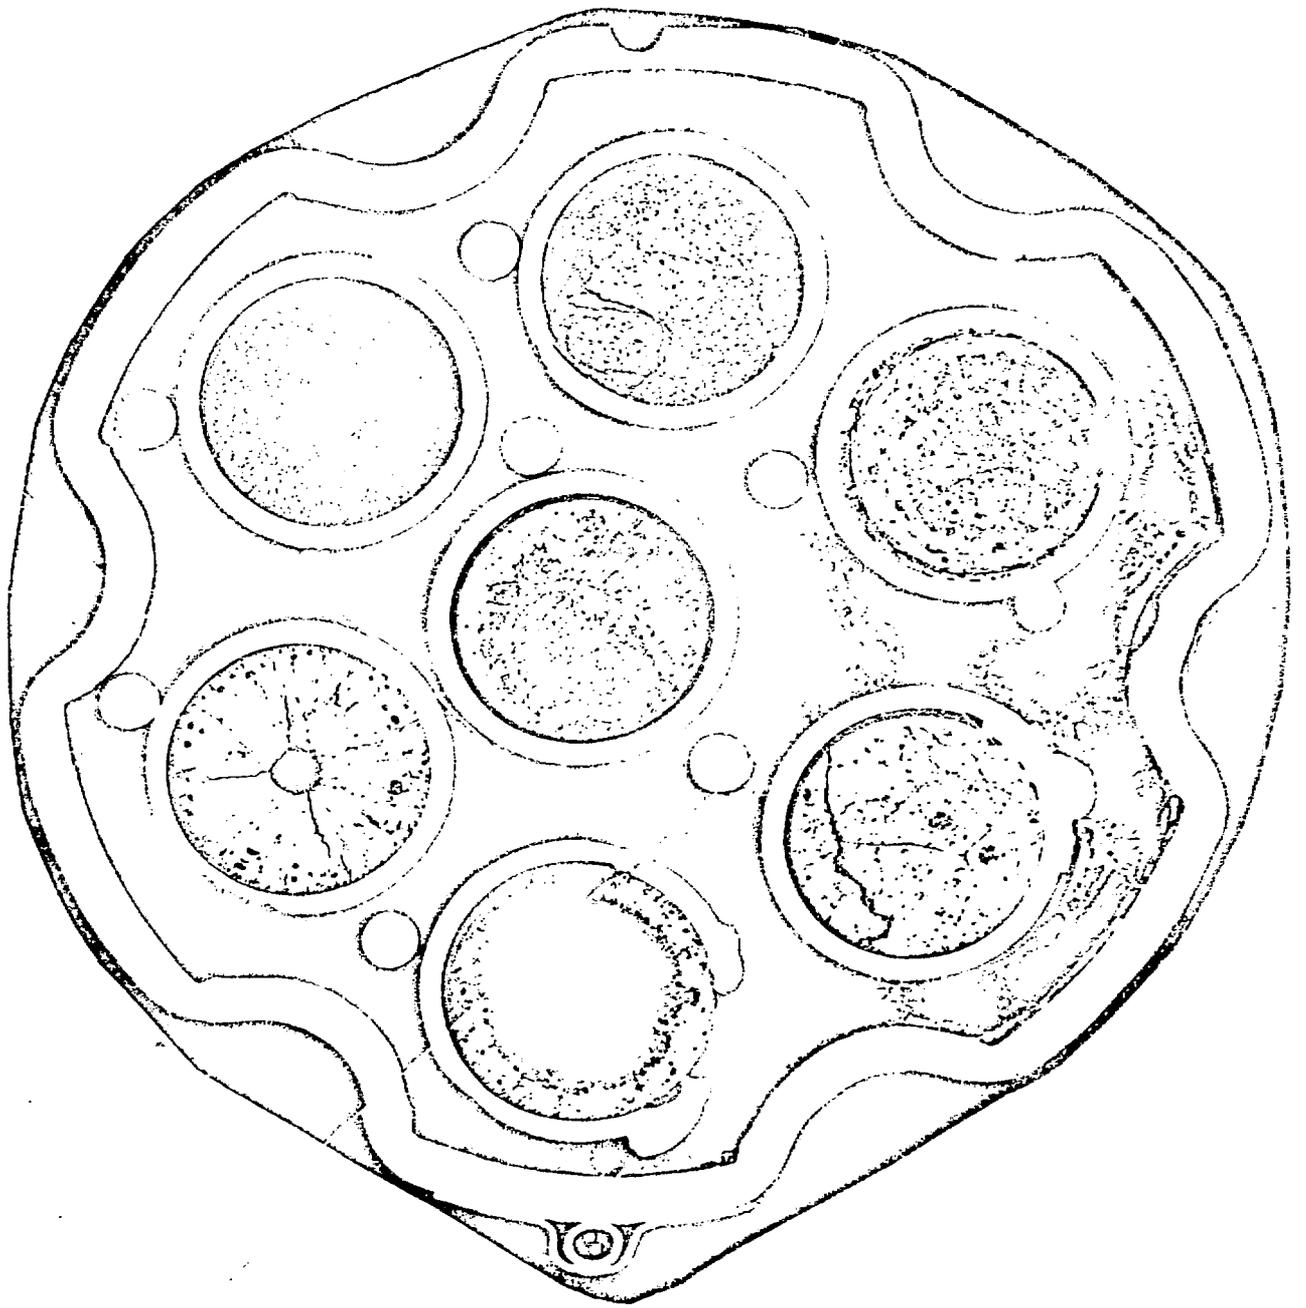
Fig 2. Cross-section of J1 fuel pin bundle at  $x/L = 1.03$ .
