ENVIRONMENTAL EFFECTS ON MATERIALS IN  
OPERATING NUCLEAR POWER REACTORS\*

JOHN R. WEEKS

DEPARTMENT OF NUCLEAR ENERGY  
BROOKHAVEN NATIONAL LABORATORY  
UPTON, NEW YORK 11973

(OUTLINE OF TALK GIVEN IN BRUSSELS, BELGIUM, 9/24/84)

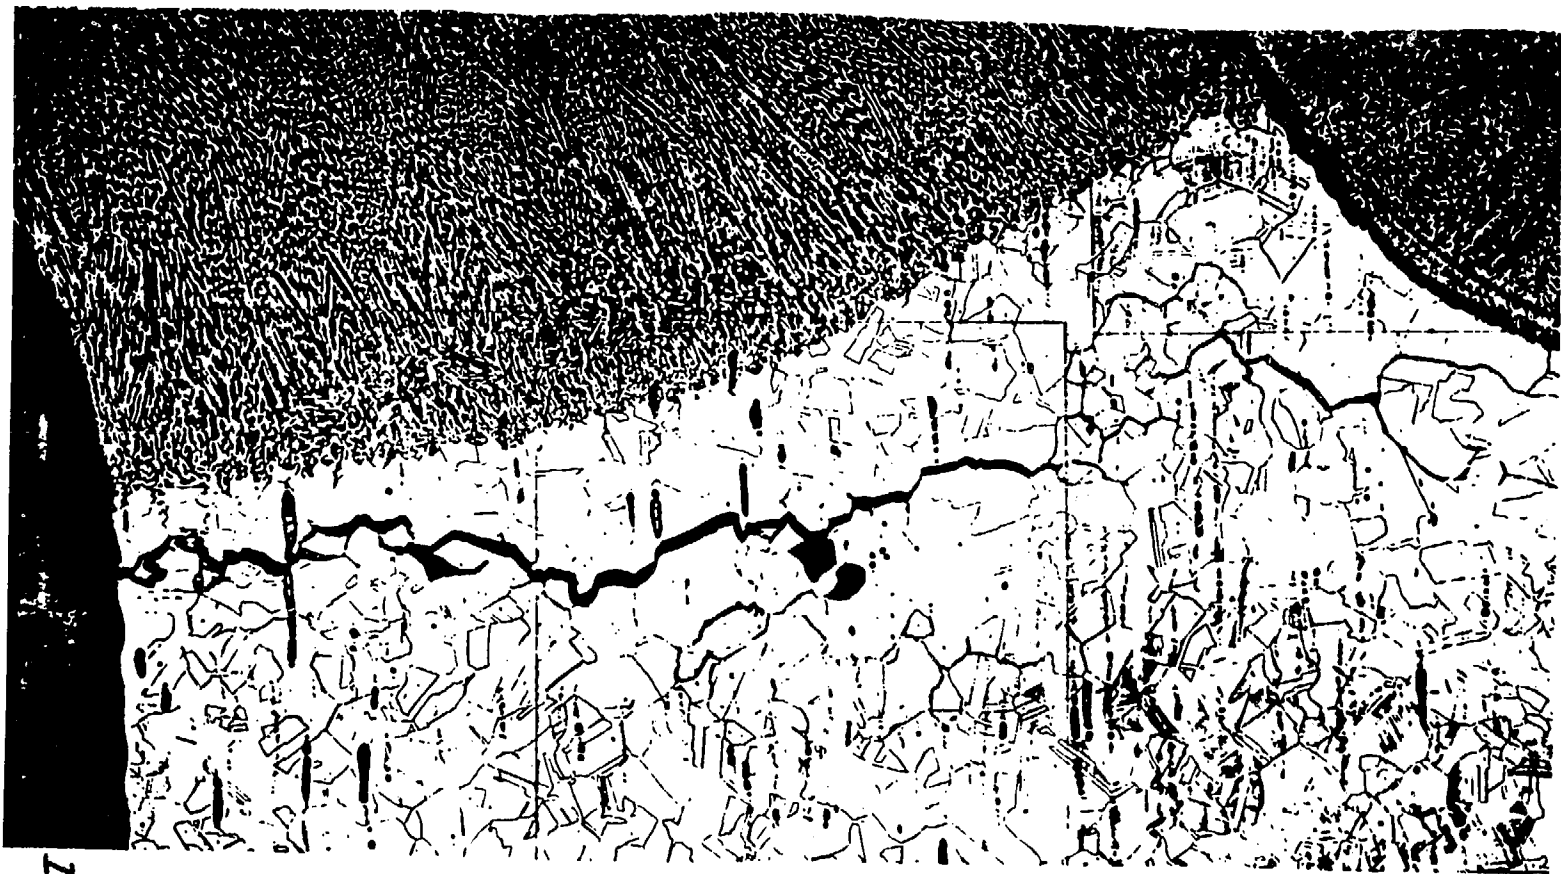
SLIDE 10

SLIDE 9 & 10 - HAZ & CRACKING IN WELDS - DRESDEN-2; NOTE:  
WITH 4" (SLIDE 9) AND 10" LARGER DIA. PIPE,  
CRACK IS CLOSER TO WELD IN LARGER PIPE.

INTERGRANULAR CRACKS IN HAZ D-II LOOP A 10K14 MAG 50

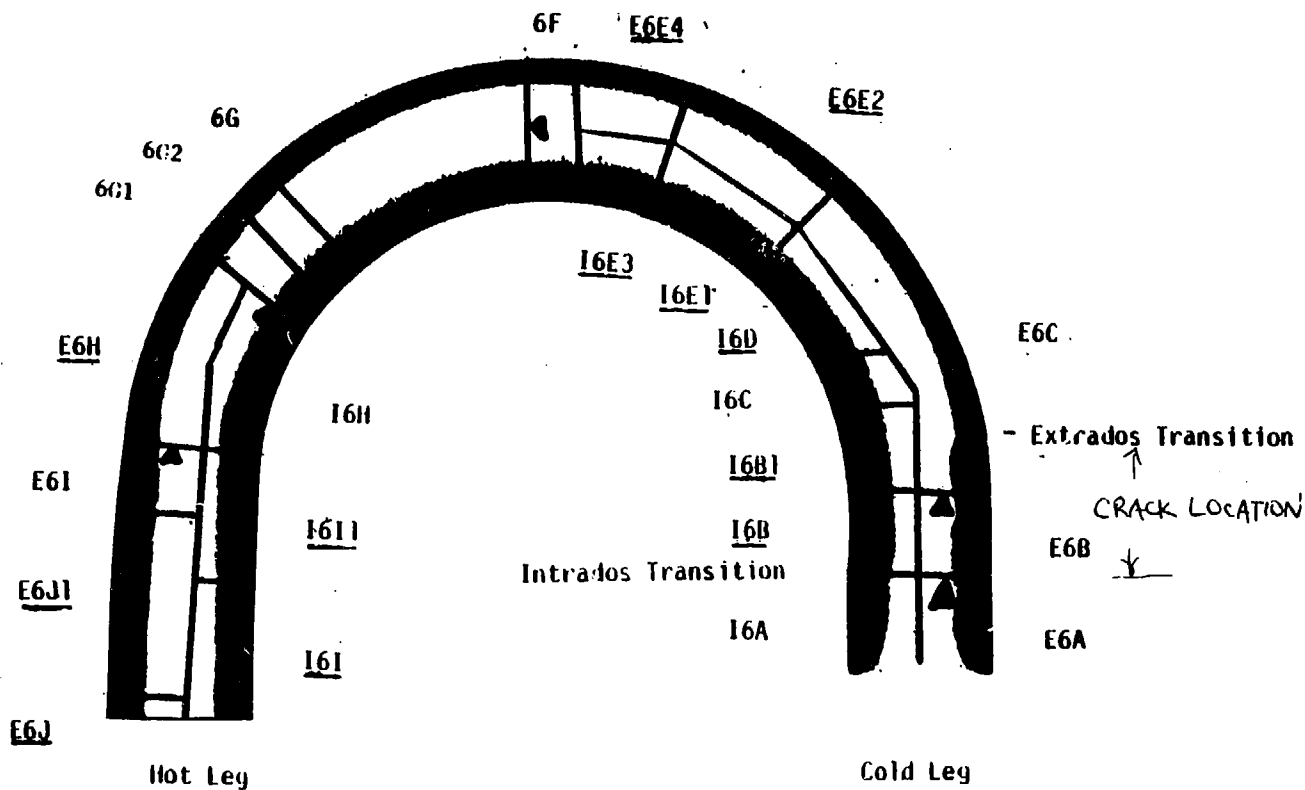
SLIDE 25 - WHERE OCCURRING - U-BENDS, RADIOGRAPHS

Figure 5 Print of double wall x-ray radiograph of RI-C6. Solid lines show approximate locations of major cuts; sections are identified; surfaces polished for metallography are designated by ▲. Underlined sections were flattened and their ID surfaces examined at 5X. Further cuts of E6C are given in next figure.

- WHAT TO DO? PLUG TUBES, STRESS RELIEF, H<sub>2</sub>O  
CHEM. CHANGE, MATERIAL CHANGE.

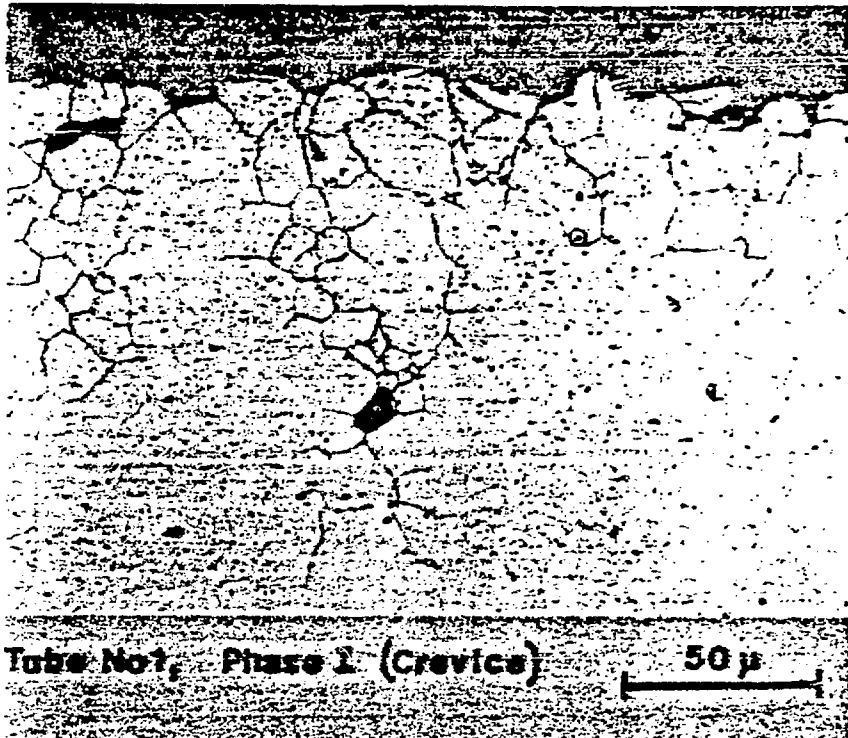
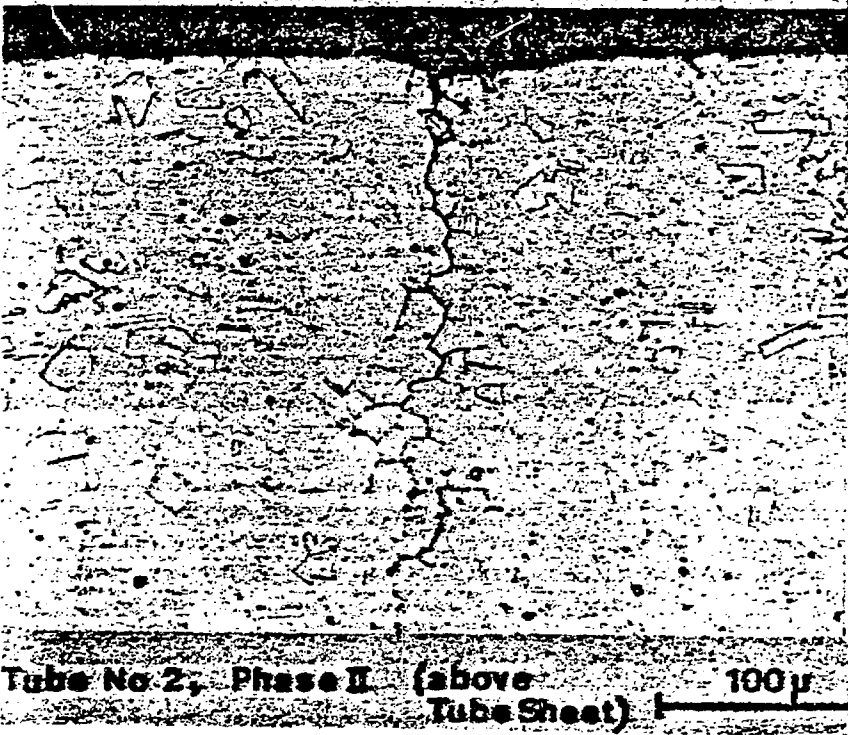
SLIDE 29 - BEZNAU - IGA & SCC

Micrographs of Stress Corrosion Cracks. Beznau Nuclear Power Plant

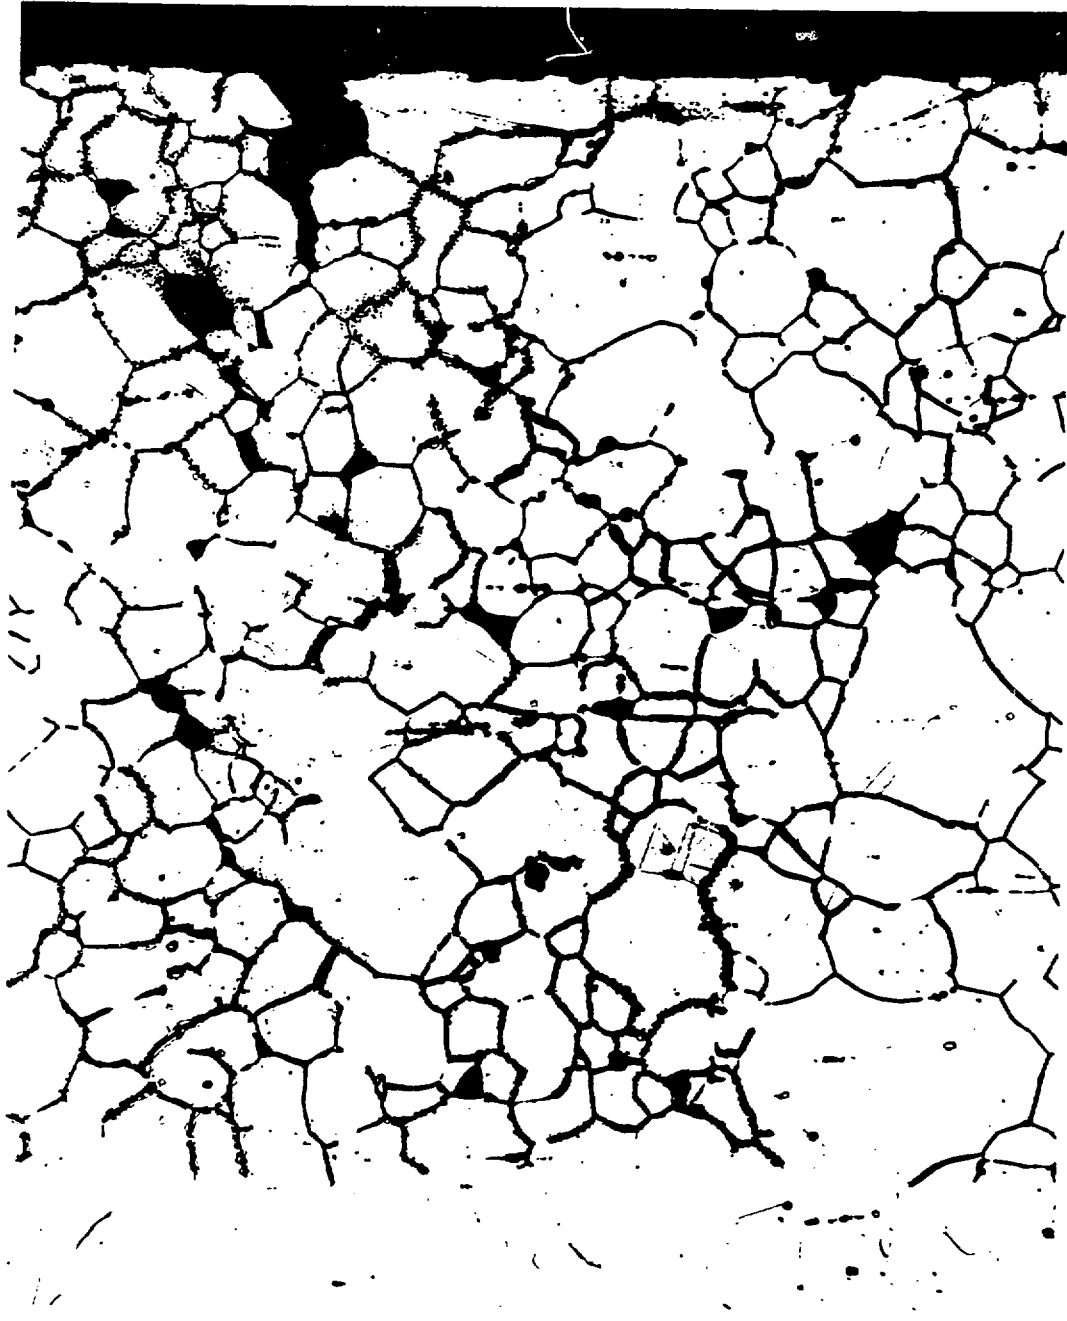
SLIDE 34 - PALISADES - IGA.

- THE SOLUTIONS ARE ALL ENVIRONMENTAL FOR AN OPERATING PLANT, AND CONSIST PRIMARILY OF TIGHTER CONTROLS ON CONDENSER LEAKAGE AND ON OXYGEN LEVELS IN THE SECONDARY COOLANT.

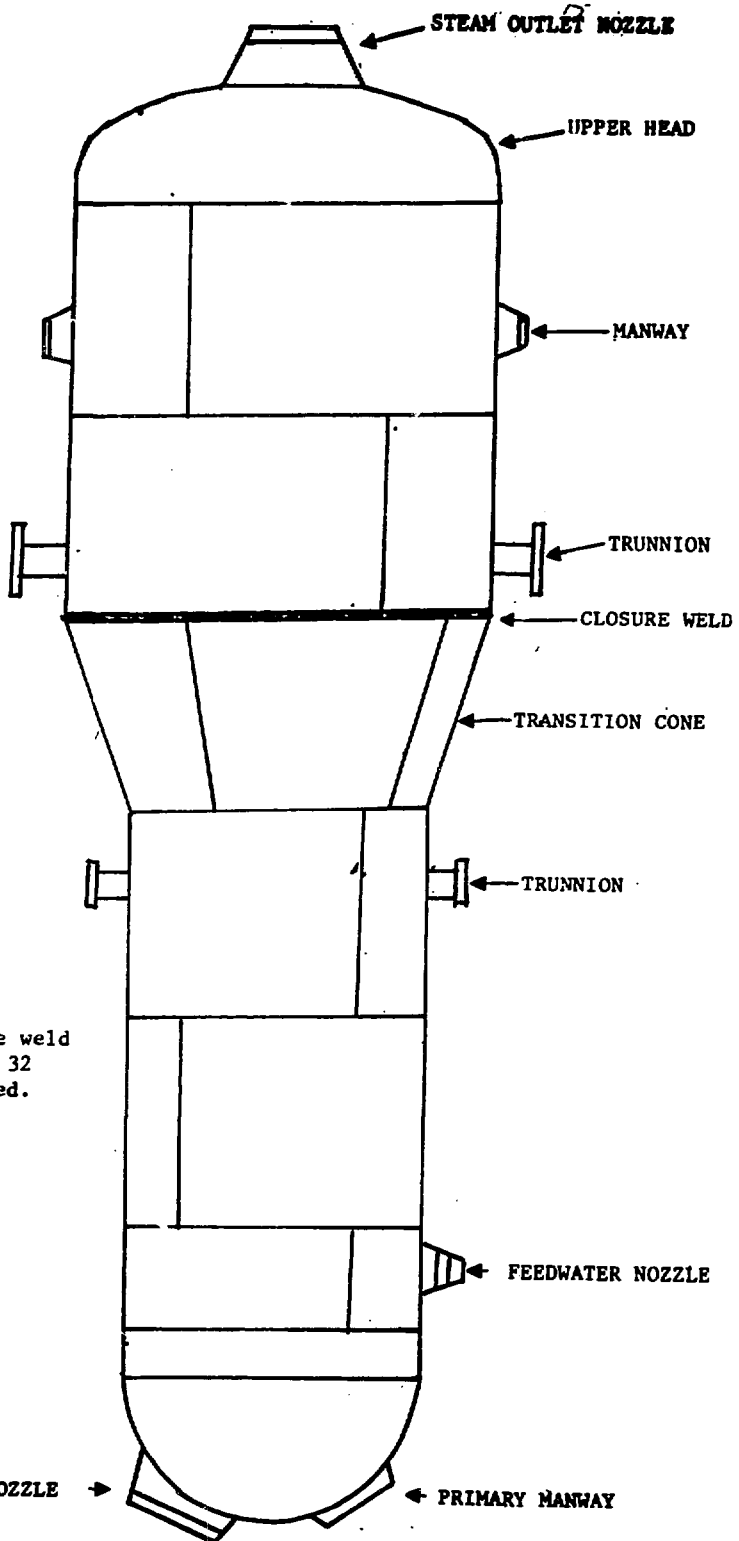
SLIDE 39 - STEAM GENERATOR VESSEL, SHOWING LOCATION OF  
CLOSURE WELD.

Figure 1. Schematic depicting the closure weld of Steam Generator # 32 where the leak occurred.

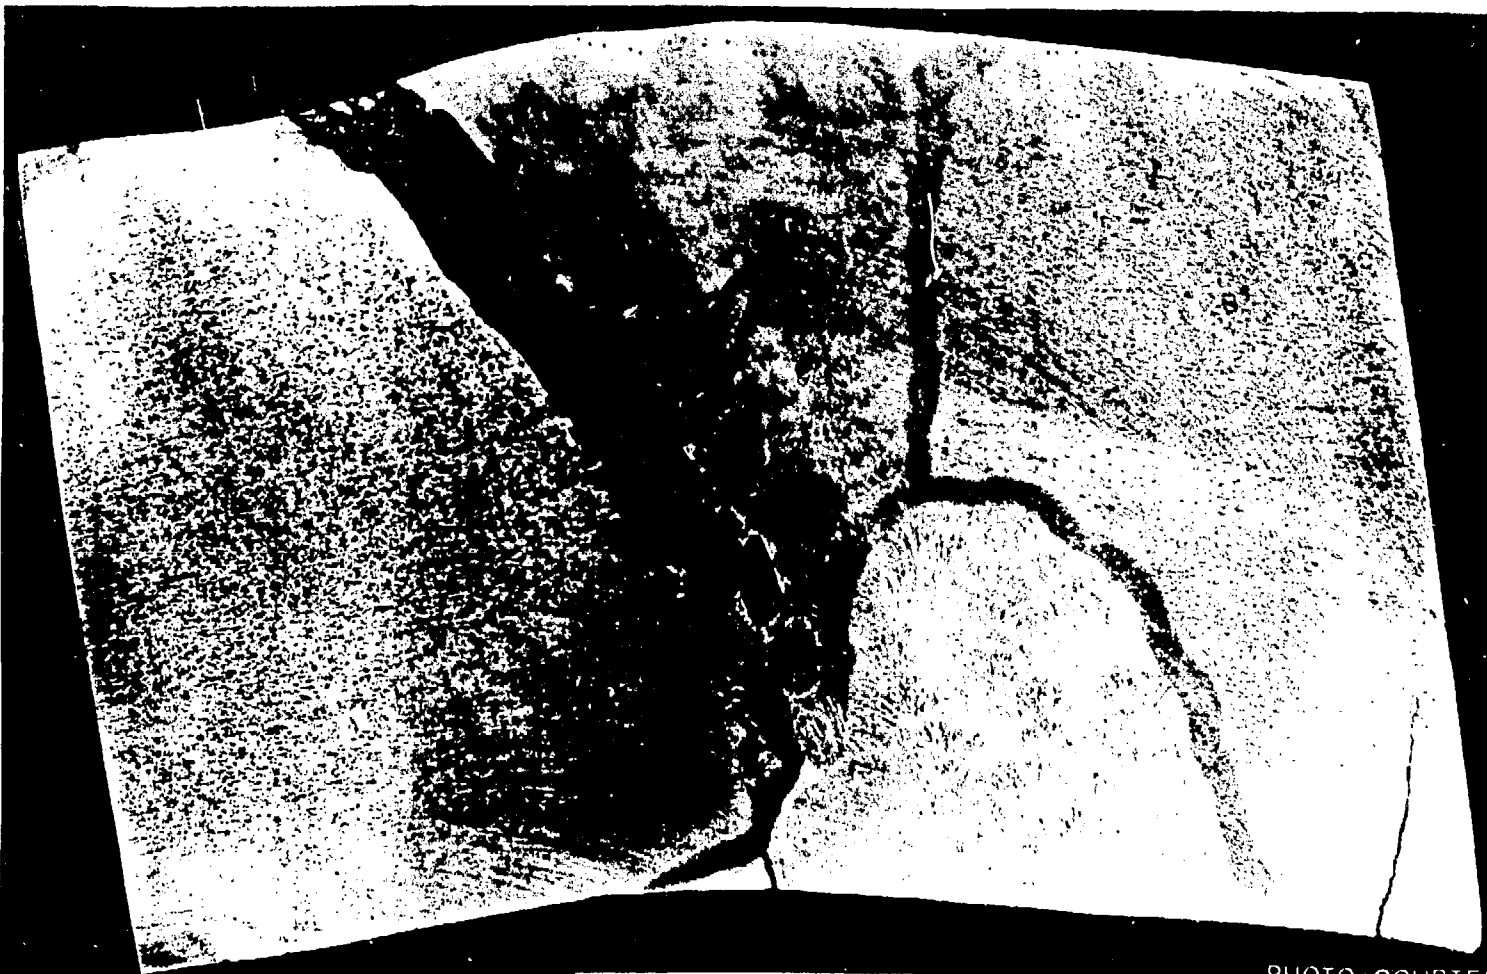
SLIDE 40 - INDIAN POINT-3 VESSEL CRACK (THROUGH-WALL)  
STRESSES - RESIDUAL - INCREASE IN HARDNESS NEAR  
WELDS. ENVIRONMENT - CL<sup>-</sup> O<sub>2</sub> CU<sup>++</sup>

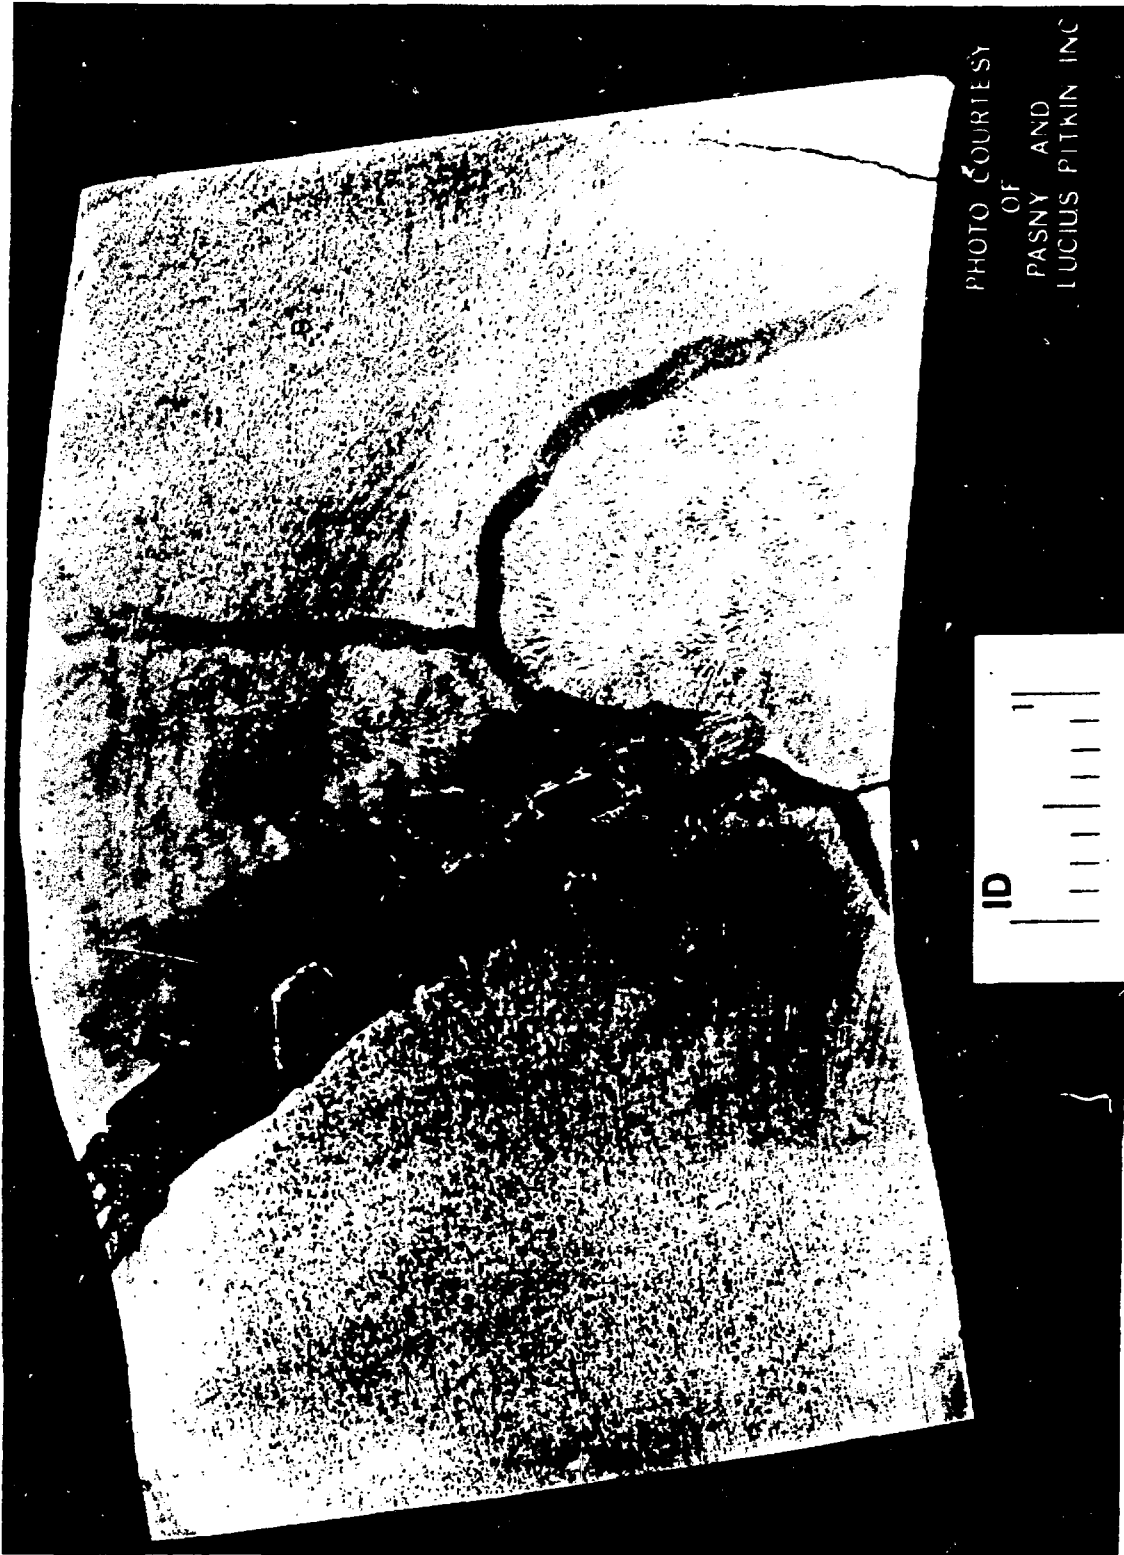
SLIDE 41 - INDIAN POINT-3 - PART THROUGH-WALL CRACK.  
MATERIAL UNLIKELY TO CHANGE. WE'RE SETTING UP  
NOW TO INVESTIGATE SOME OF THESE PAST VARIABLES  
IN OUR LABORATORIES.

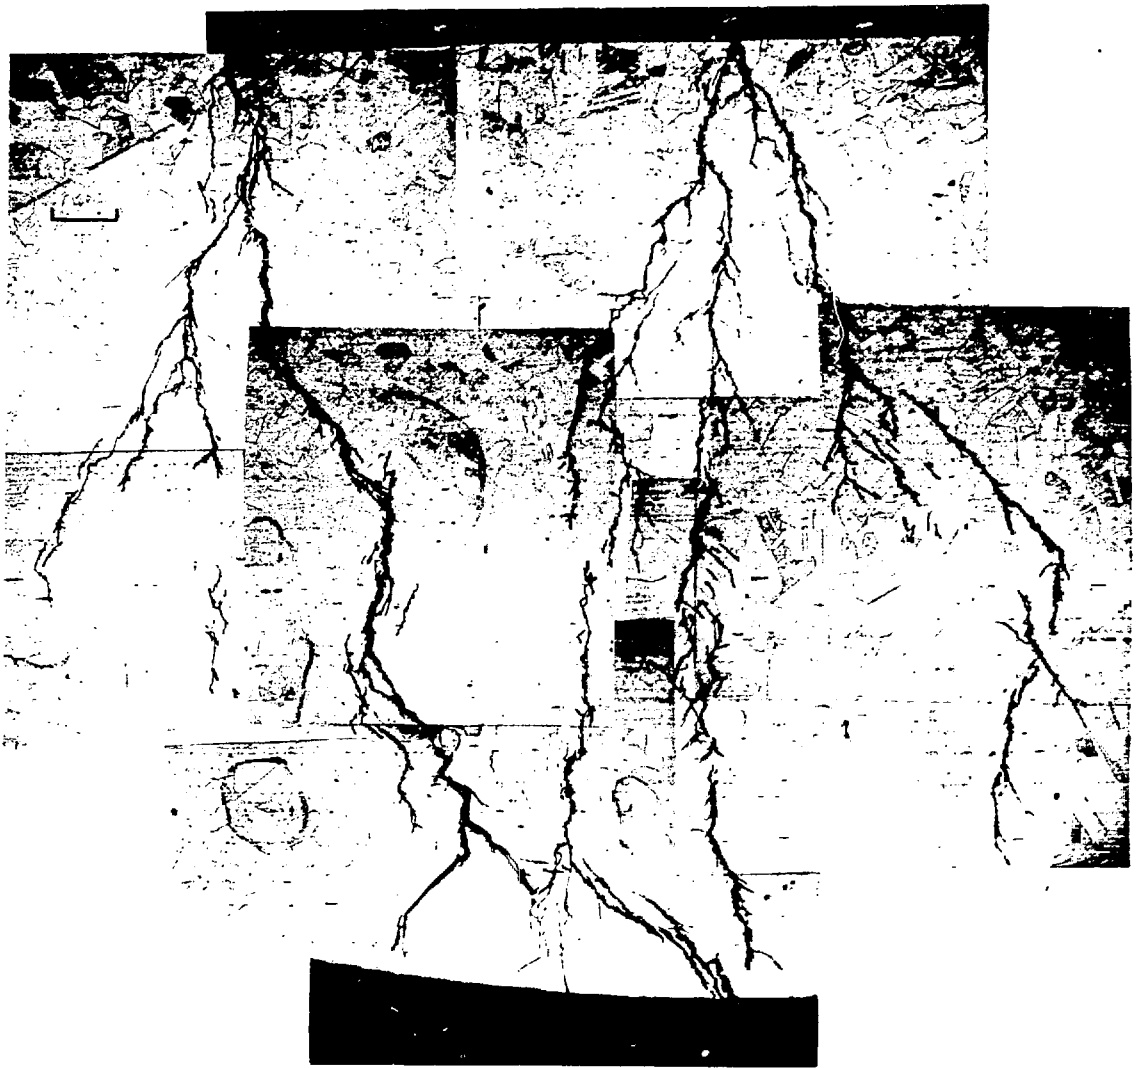
SLIDE 42 - NINE MILE POINT - STAINLESS STEEL PIPING - 2ND  
SIDE CRACKING - CL<sup>-</sup> CONTAMINATION.

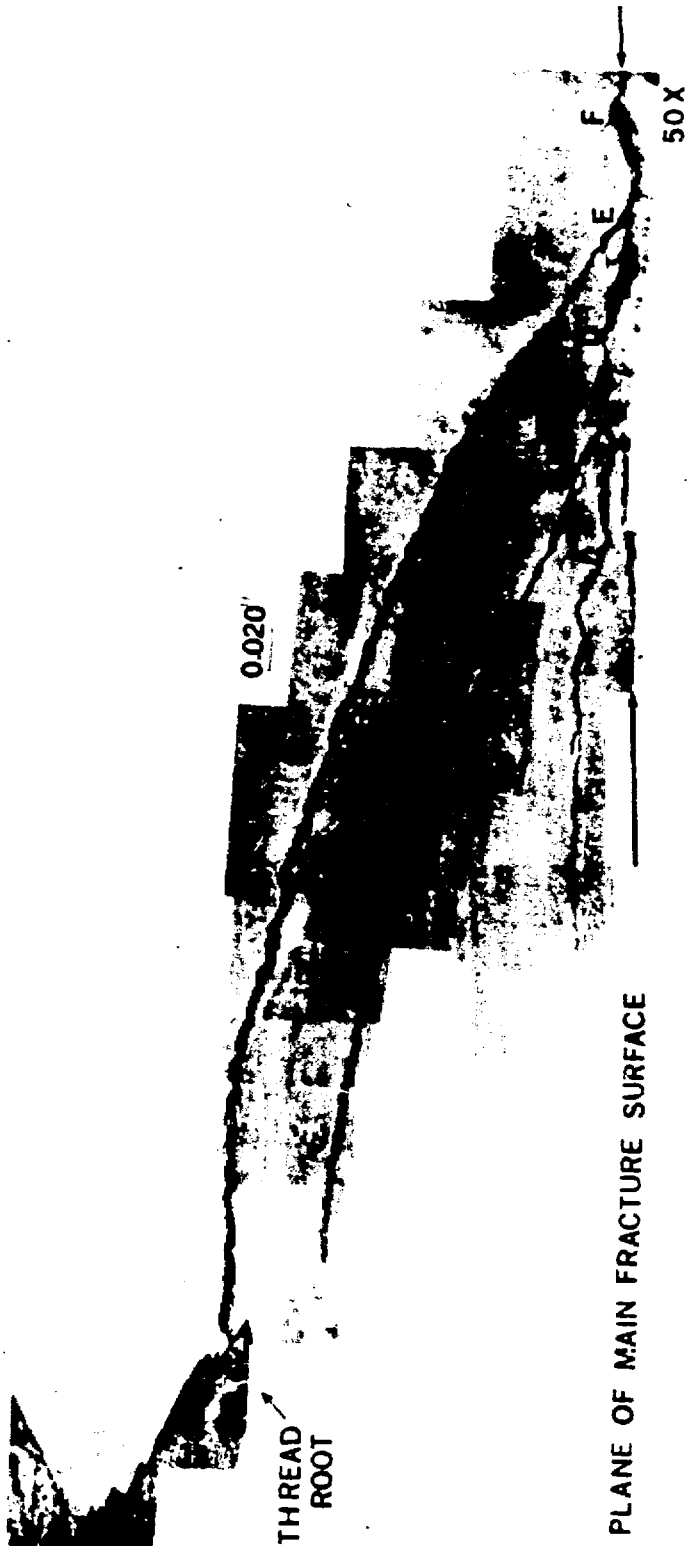
SLIDE 46 - CRACKED MAINE-YANKEE BOLT.

MoS<sub>2</sub> - NOTE: BRANCHING CRACKS.

Micrographs of bolt section depicting extensive secondary fracture. The secondary fracture surfaces were formed like branching in target secondary fracture.

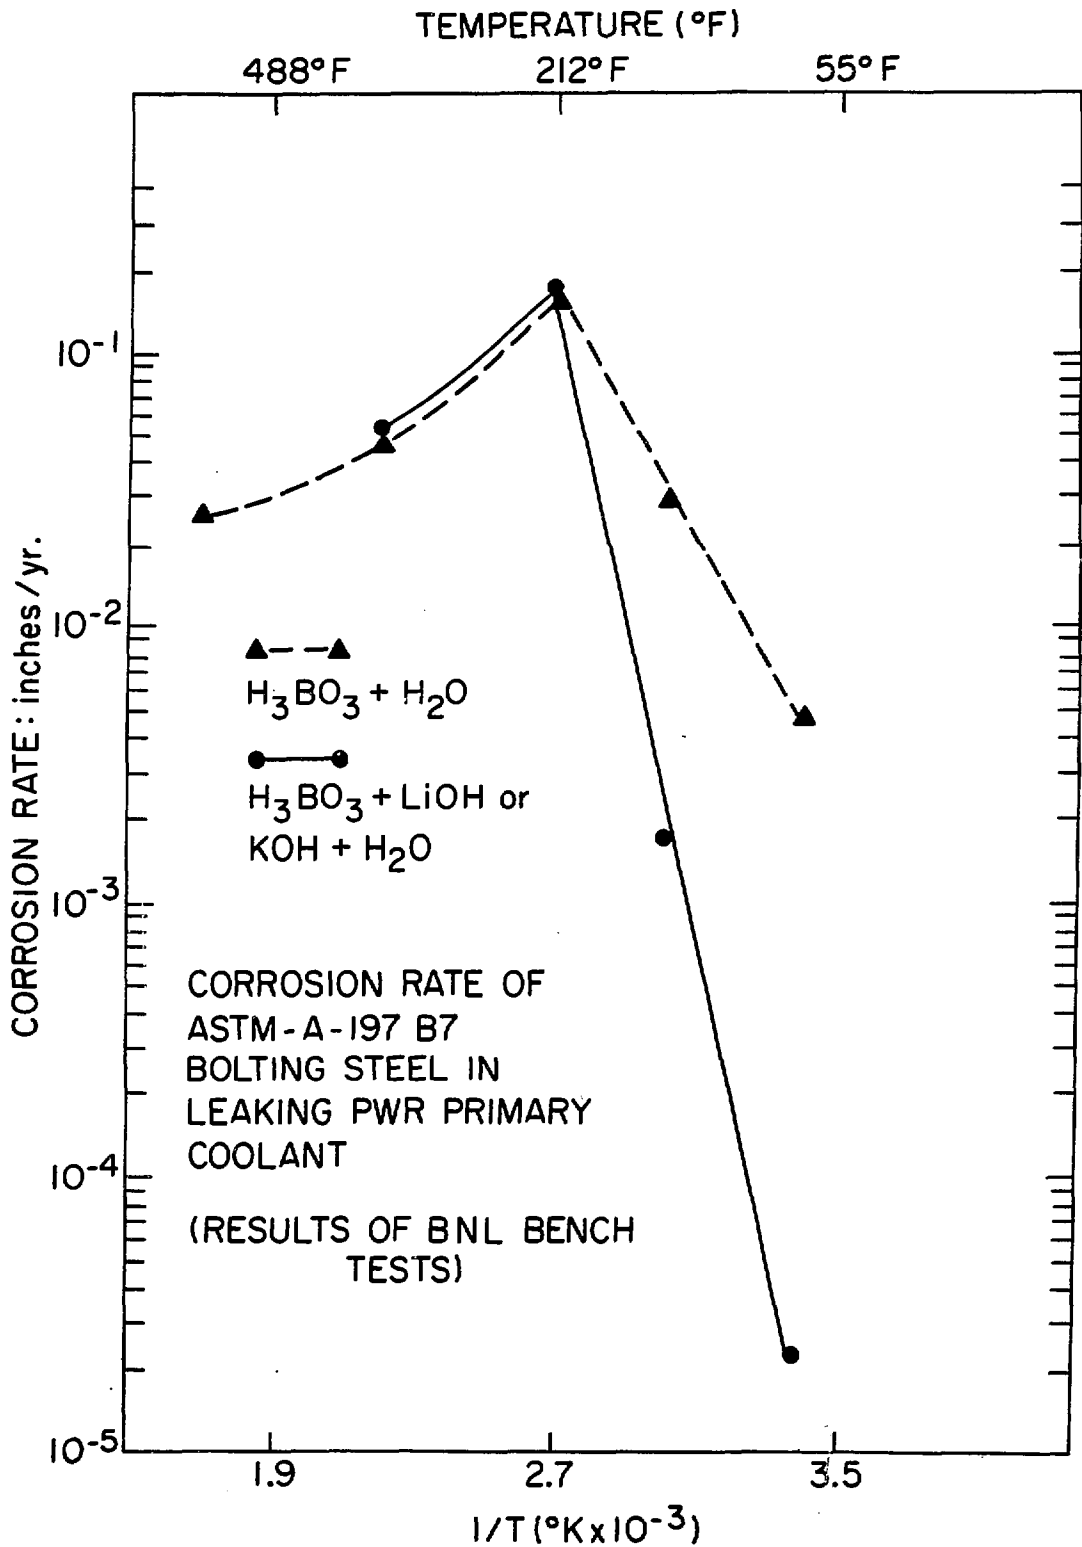
SLIDE 47 - BORIC ACID WASTAGE - OUR LAB. DATA REPRODUCED  
RATE AT CALVERT CLIFFS. 0.2-0.3 INCHES/YR.  
CURRENTLY HELPING NRC DRAFT POSITION.
