OHRD METALLURGICAL INVESTIGATION OF  
PRESSURE TUBES REMOVED FROM  
PICKERING 'B' UNIT 8

Report No 85-293-K

A number of tubes were removed from Pickering Unit 8 due to excessive depth of fretting damage at dummy fuel bearing pad positions. Fifteen of these tubes were designated for destructive examination at three sites: AECL-CO, OHRD and CRNL. Examination of parts of six tubes from channels E08, F15, G10, J12, K18 and L14 were carried out at OHRD. The objective of the examination was to determine the extent of microcracking in the fret zones and to confirm the previously observed hydride distributions near fret marks. Results of the investigation show that there is no significant microcracking at the fret marks. However, secondary marks probably due to fretting by particles in the PHT coolant being trapped near bearing pads or under bundles, have been identified. These marks were studied in detail to determine their shapes for subsequent stress analysis. This report summarizes all these examinations.

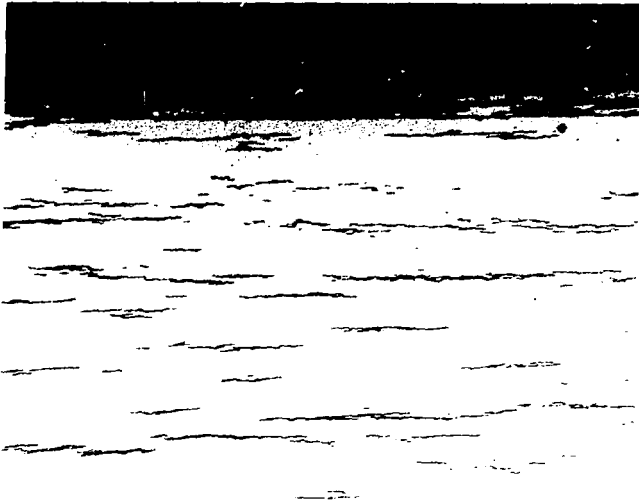
The microscopic examination of the cross sections through the broad, usually smooth areas produced by the bearing pad contacts on the pressure tube revealed a surface that was rougher than in the normal pressure tube. Features typical of those seen in many cross sections are shown in Figure 3(a-e). The apparent peak-to-peak surface roughness observed in the cross section shown in Figure 3(c) is in the range of 20-30  $\mu\text{m}$ . A new pressure tube has a surface roughness more than an order of magnitude smaller. The axial-normal cross section shown in Figure 3(b) shows a fine crack parallel to the surface intersecting the surface at each end. In circumferential-normal section particles composed of alternate layers of metal and oxide, appear semicircular (Figure 3(c)). In other areas the particles are absent but the very small pit remains (Figure 3(a)). In many areas, especially in the more heavily hydrided areas, there were areas of the surface which were apparently solid hydride (Figure 3(e)) in a very thin layer ( $\sim 5 \mu\text{m}$ ).

FIGURE 3(a) - Surface roughness and hydride distribution in E8-1-4; transverse normal section (100 X).

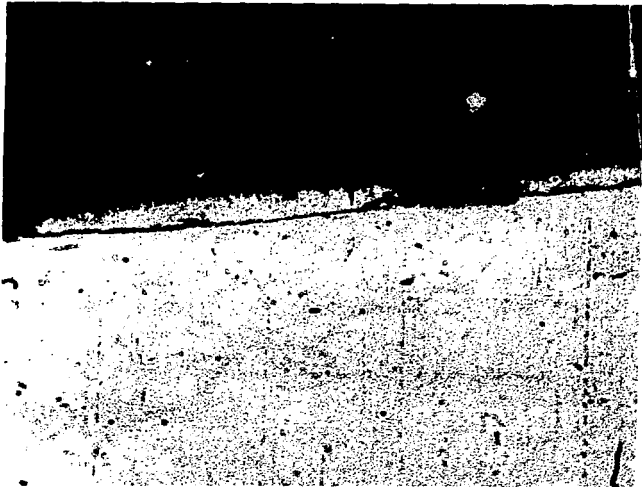
The metallographic evidence appears to indicate that material removal occurred by a mechanism involving formation of small cracks parallel to the surface (Figure 3(b)) followed by rolling up of the platelet formed by the cracking. These rolled up platelets (Figure 3(c)) were then carried away by the water. This mechanism is described in the literature as delamination wear/3,4,5/. In this case since the hydride forms platelets more or less parallel to the surface, the presence of such platelets close to the surface could accelerate the formation of the crack which produces the wear particles. Thus the wear rate and hydrogen pickup rate may be coupled in a complex way.

FIGURE 3(b) - Axial Normal Section showing crack parallel to surface in section E8-1-2B (1000 X).

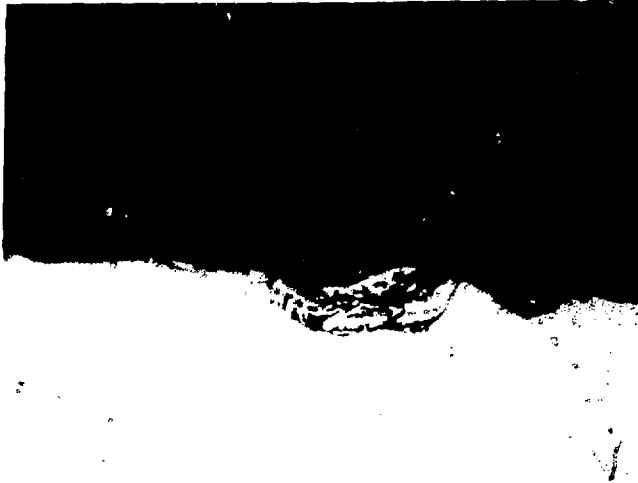
FIGURE 3(c) - Particle made up of rolled-up oxidized platelets in transverse normal section of sample E8-1-4B (1000 X).

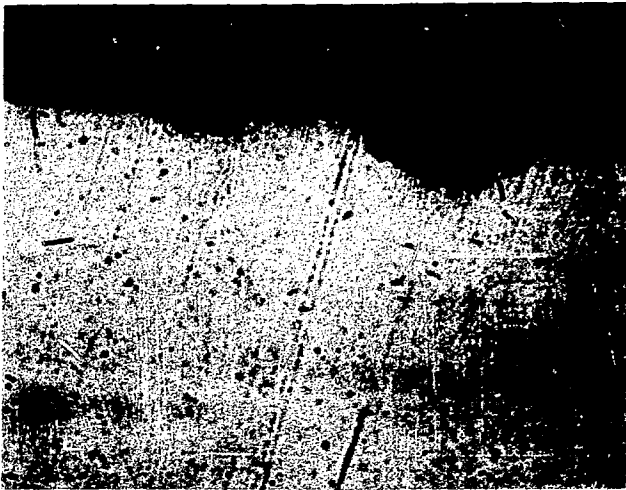
FIGURE 3(d) - Small surface pit remaining after oxidized particle has been presumably washed away (1000 X).

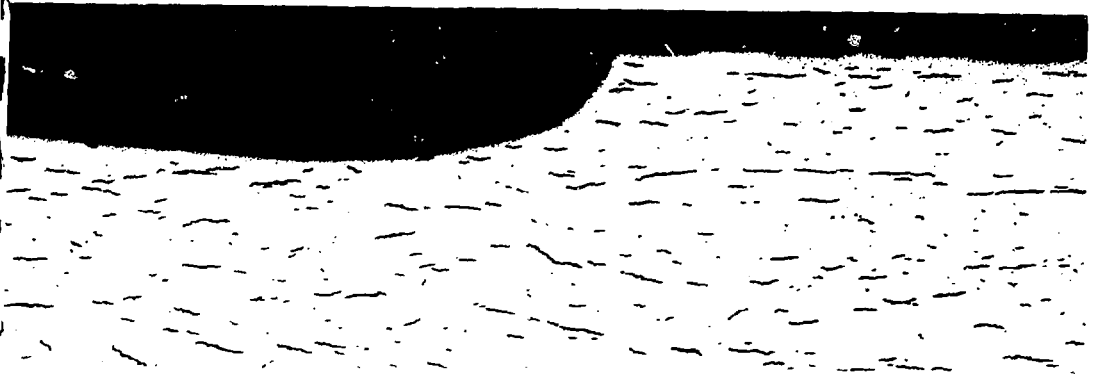
The tube surface geometries associated both with the axial ridges within the broad fret marks and with the circumferential ridges associated with the ends of the fretted zones were also examined. Of all the cross sections examined, those shown in Figure 4 are the most severe in terms of the abruptness of the change in section.

FIGURE 4(a) - Ridge geometry in axial-normal cross-section in G-10 at the first fret mark (100 X).

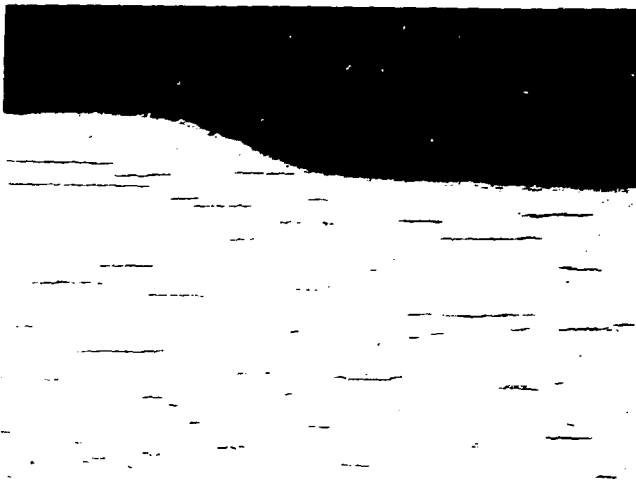
FIGURE 4(b) - Transverse ridge due to cast iron contact in F15-2-1 (100 X).

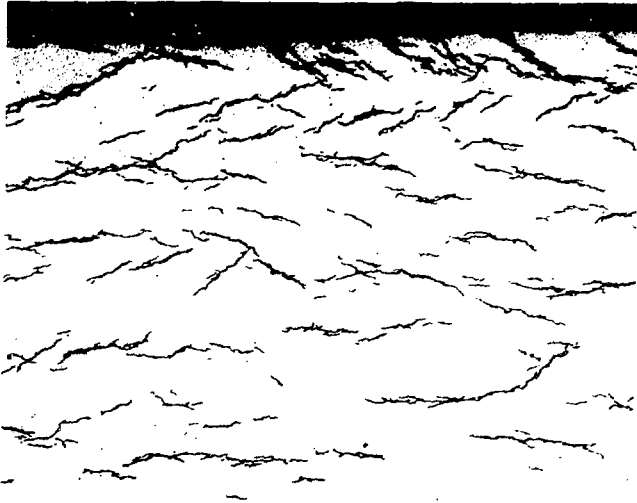
In many of the figures already presented, the hydrides are visible because the micrographs were taken from etched samples. Clearly in Figure 3(a) there is a very high density of hydride immediately beneath the fretted area. Figure 5 shows another area of the first fret mark in E08. There are some large packets of hydrides intersecting the surface at about a 45° angle in this section (axial normal). The hydride distributions through the wall thickness of all tubes were studied. As noted in the examination of the first tubes removed from Unit 8/2/, the distribution of hydride depended upon the fretting wear. In sections with relatively deep marks, there was more hydride near the surface where the fretting took place than towards the outside surface of the tube. In other sections where the fretting was less severe, there was less hydride and it was more uniformly distributed through the thickness. In most tube sections, the hydrides have orientations which vary from circumferential to close to radial in parts of the pressure tube wall (Figure 6(a)). This distribution of orientations is significantly different from the predominantly circumferential orientation observed in pressure tube sections hydrided in the laboratory without stress. In one tube from channel J12 there were distinctly radial hydrides towards the outer surface of the pressure tube (Figure 6b).

FIGURE 5 - Hydride distribution at surface of pressure tube in the first fret mark in channel E8 (100 X).

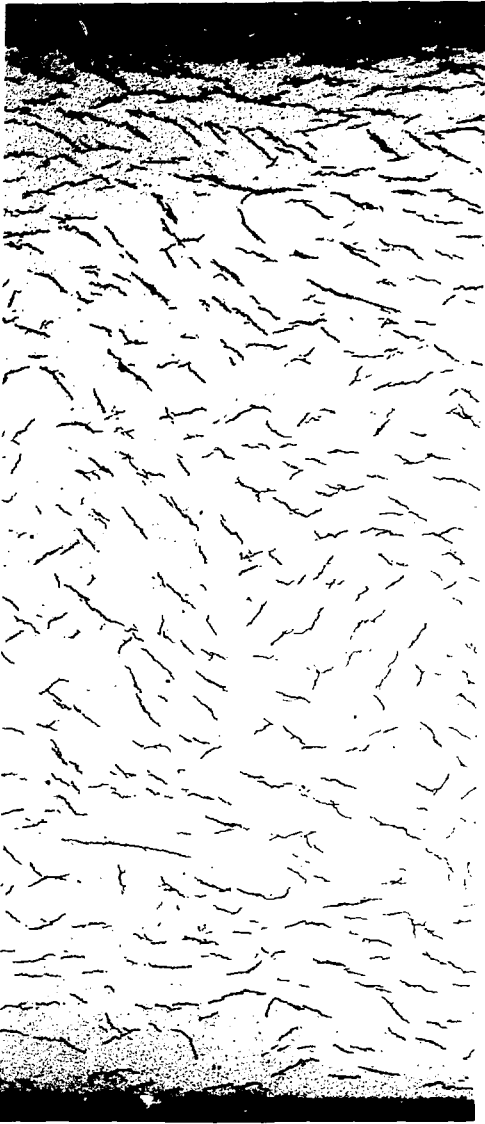
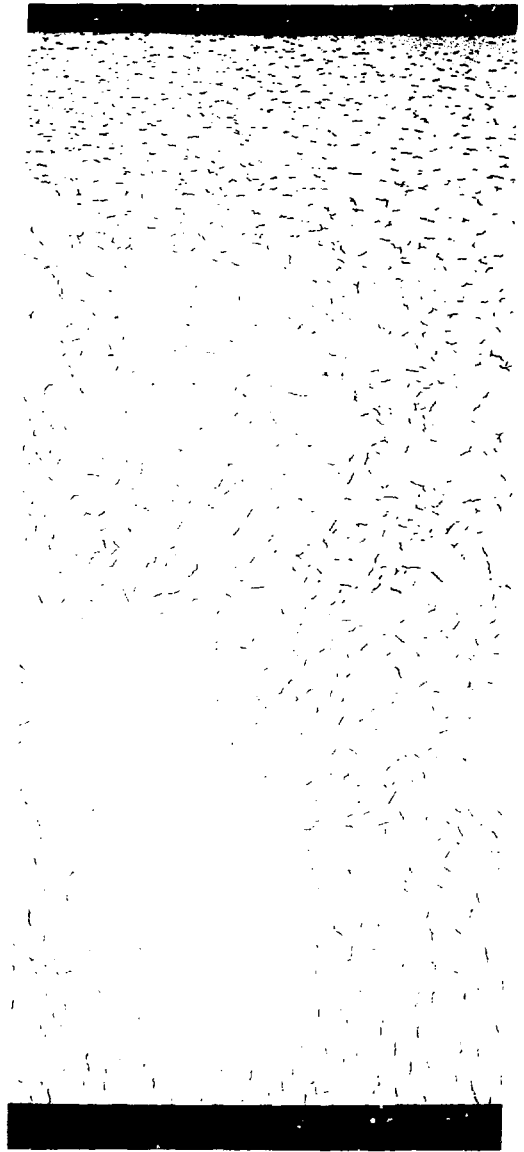
The presence of the zone of completely radial hydride under the fret mark in the J12 tube can be rationalized using the OHRD results which indicated a threshold stress of 180 MPa. Parts of J12 tube apparently retained significant residual stresses from manufacture. These were made apparent upon axial slitting of rings of material.

FIGURE 6 - Through-wall hydride orientation distributions under fret marks in tubes from Channels E8(a) and J12(b), (50X)

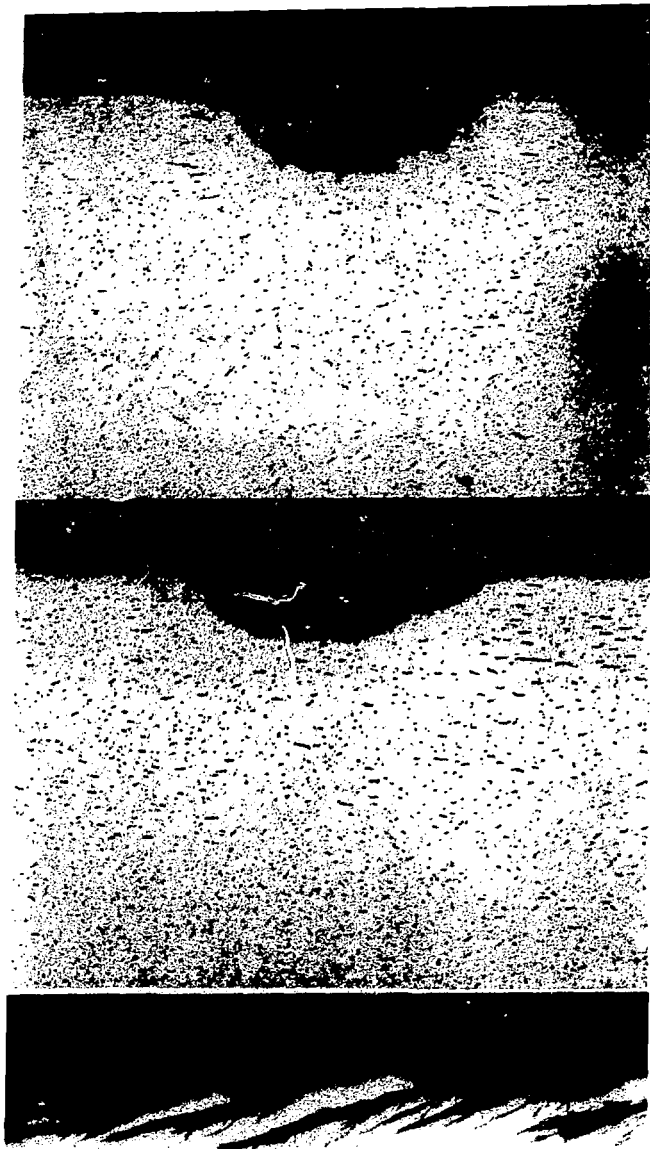
Several cross sections of the mark designated F15-5-1 which was seen at the beginning of the fifth fretted area in channel F15 are shown in Figure 8(a-c). There is a small lip on one side of the gouge. Again the hydride concentrations appear to be only slightly higher than as-received pressure tube. Slightly larger hydrides appear to form a halo around the gouge. This may indicate that the fretting action which produced the mark also introduced hydrogen. Very little distortion in the grain structure adjacent to the gouge was observed. After removing significant material (1.71 mm) the cross section included what had appeared as a furrowed path in the visual examination. In cross section this is shown (Figure 8(c)) to be distorted material which contains both laps formed by mechanical damage and small oxide-filled cracks which are about 0.07 mm deep.

FIGURE 8(a) - Cross-section through secondary mark F15-5-1 (50 X).  
(b) - After removing 1.25 mm of material (50 X).  
(c) - After removing additional 0.44 mm (200 X).

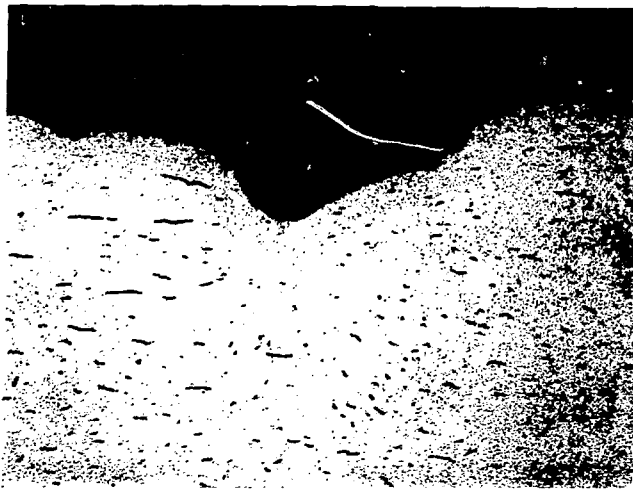
The secondary mark in channel G10 was pit-like as most of it disappeared after removal of 1.25 mm of material from the cross section shown in Figure 9. The micrograph shows a hydride concentration slightly greater than the as-received level as well as some tendency of the hydride to be oriented due to the stress field of the pit. Hydrides beneath the pit are finer than those a distance away.

FIGURE 9 - Cross-section through secondary mark G10-3-1 (100 X)

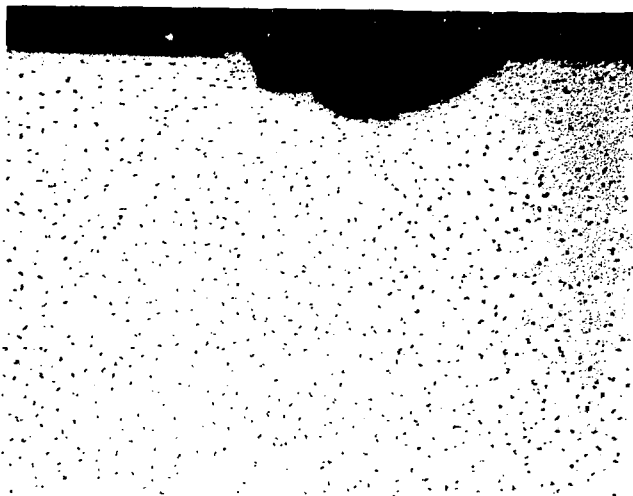
A cross section at the deepest part of the pit seen visually in channel J12 is shown in Figure 10. Again the hydrides are fine, characteristic of as-received material. There are a few finer hydrides close to the pit. The pit itself has a sharp corner at about one-half the maximum depth.

FIGURE 10 - Cross-section of secondary mark J12-5-1 at deepest point (50 X)

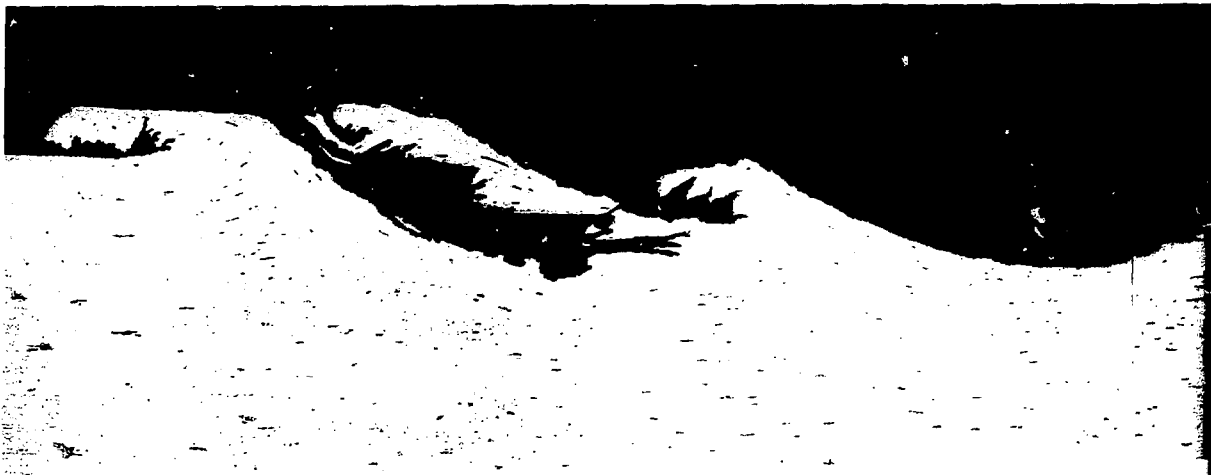
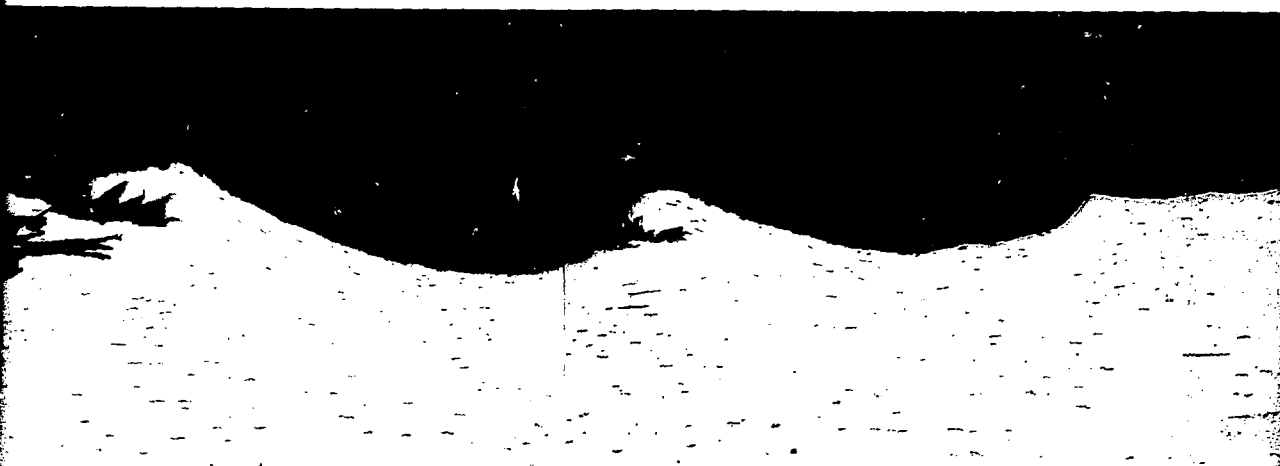
Three secondary marks were seen visually in channel K18. The cross sections through these marks (Figure 11(a-c)) exhibit characteristics which are somewhat different from those seen in marks in the other channels. Mechanical damage in these marks is more pronounced as indicated by the presence of significant upheaval of material which now is lapped over the edges of the pits. There is clear evidence of mechanical flow of material in Figure 11(a). Surrounding the mark designated K18-15 there is a large zone in which the hydrides are very fine.

FIGURE 11 - (a) Montage (transverse normal) through secondary mark in K18-1-6. Note material flow (100 X)

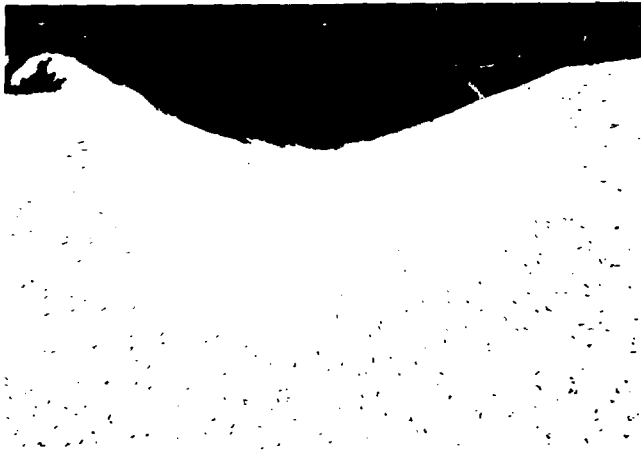
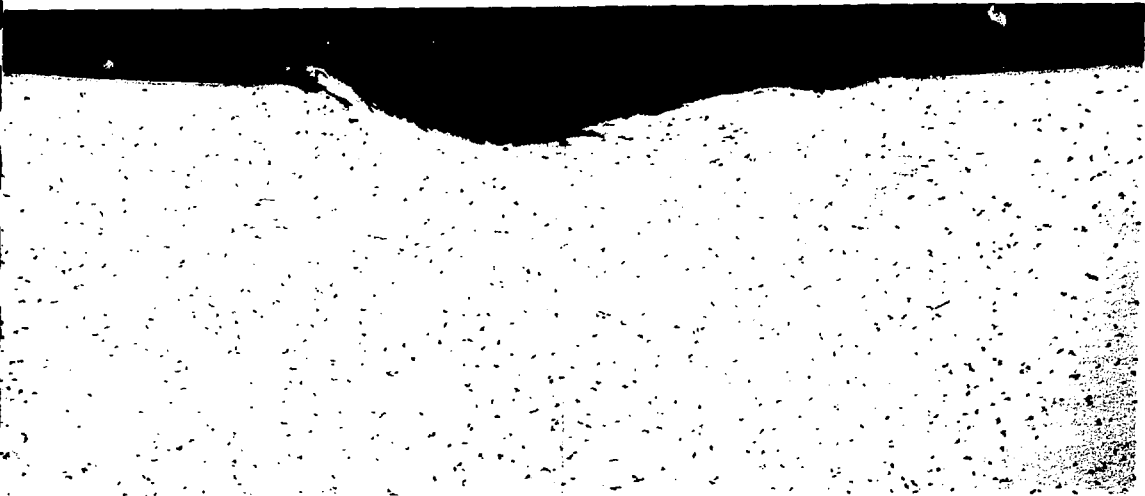
FIGURE 11 - (b) - Cross-section through K18-15 at deepest point.  
Note fine hydride zone (50 X).

(c) - Cross-section through K18-16 (50 X).

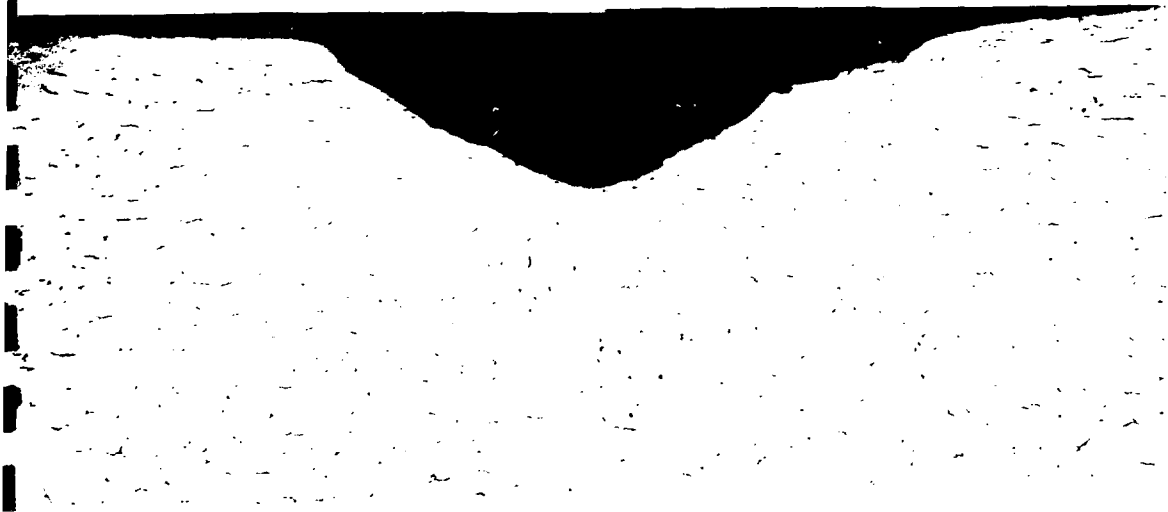
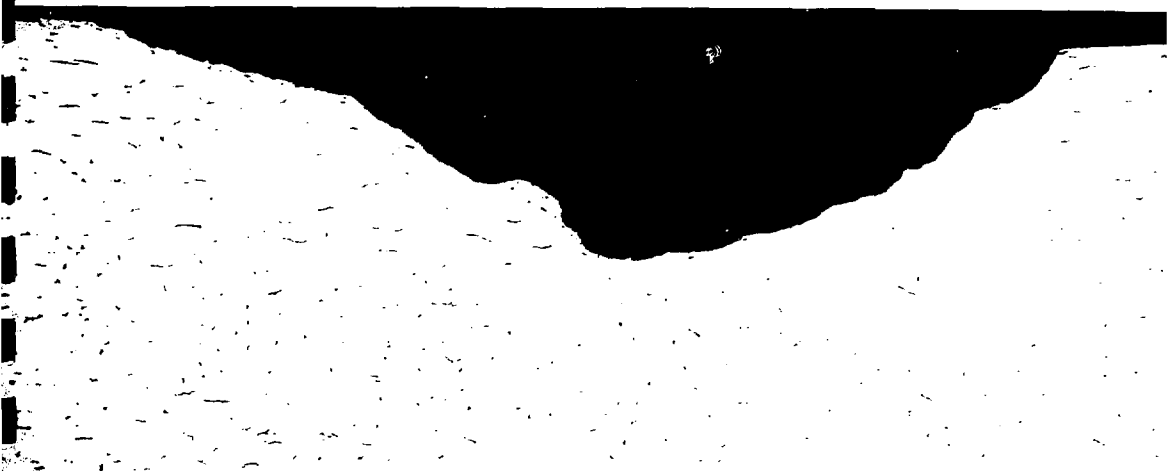
The deepest mark seen in any of the channels examined at OHRD was that in channel L14 which is shown in cross section in Figure 12. Hydrides in the cross section shown in Figure 12(a) tend to exhibit orientation due to the presence of the defect. However at the deepest point (Figure 12(b)), this hydride orientation is not evident. Hydride sizes are consistent with a hydrogen level slightly above the as-received level. The cross sections of three other secondary marks in L14 are also included in Figure 12.

FIGURE 12(a) - Cross-section through secondary mark in L14-3-1 (50 X).

(b) - Same mark at deepest point (50 X).

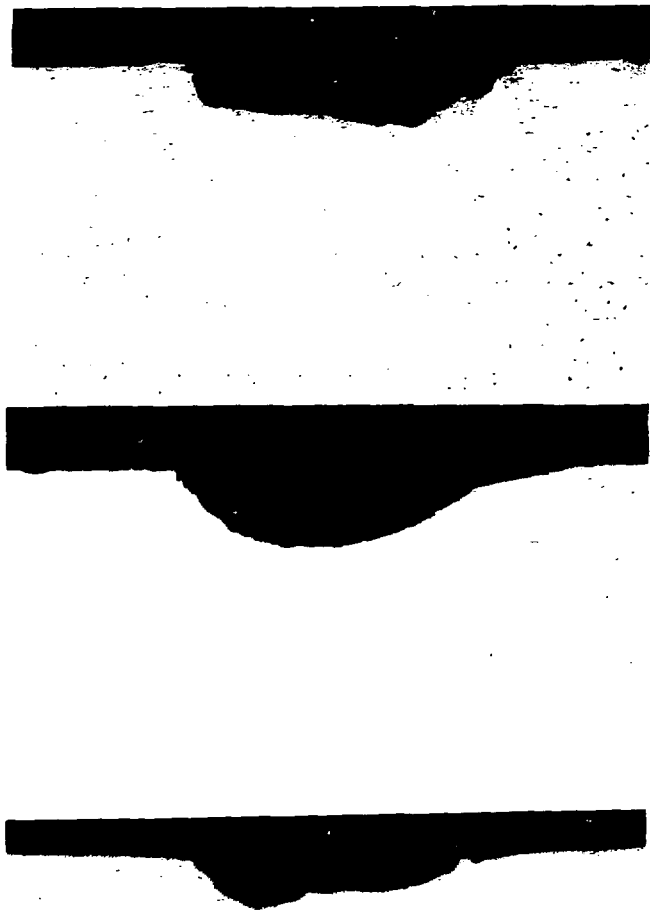
FIGURE 12(c) - Section through L14-3-2 at deepest point (50 X).  
(d) - Section through L14-3-3 at deepest point (50 X).  
(e) - Section through L14-3-4 at deepest point (50 X).
