**EVALUATION OF BONDING IN KAMINI PLATE TYPE FUEL ELEMENTS
USING ULTRASONIC IMMERSION TESTING AND METALLOGRAPHY**

B.A.R.C. - 1472

BHABHA ATOMIC RESEARCH CENTRE
BOMBAY, INDIA

1989

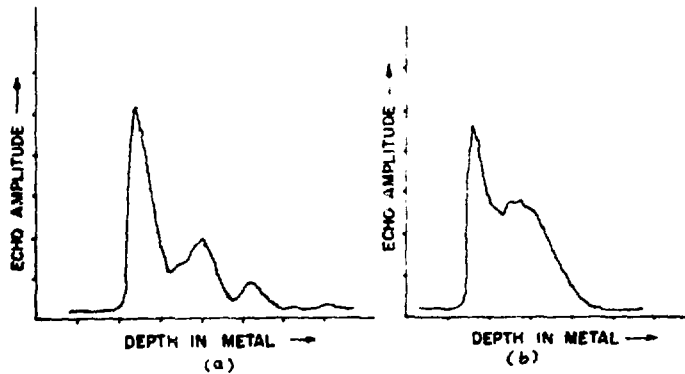
With the appropriate setting of the ultrasonic flaw detector the signals received from the simulated non-bond regions in the reference standard are presented in Fig. 4a,b & c. The actual fuel plates were then tested and lack of bond signals intercepted were compared to those recorded from the simulated non-bonds for classification. Typical non-bond signals from a fuel plate are presented in Fig. 5 a&b.

Fig.5. Lack of bond indication from defect regions in a typical plate fuel element.

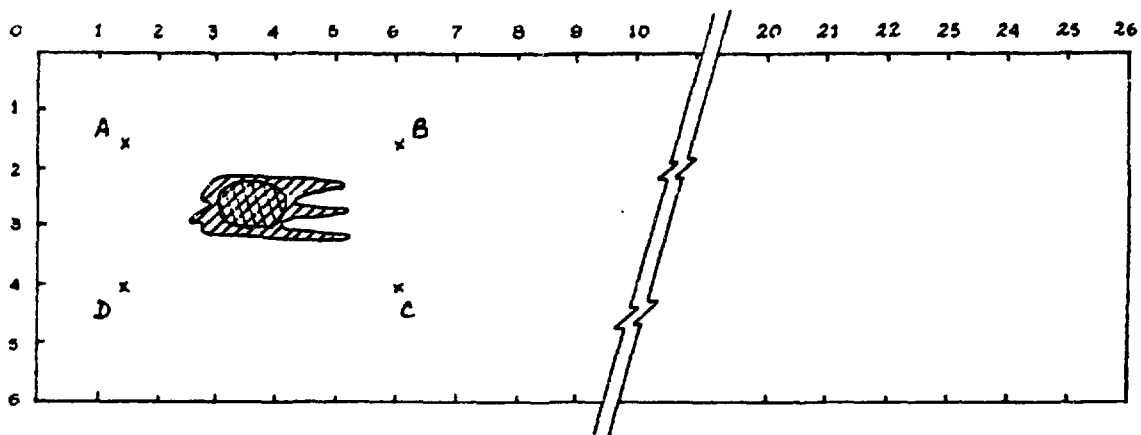
To verify the sensitivity achieved, the test was applied on a fuel plate which was earlier subjected to a blister test and showed a visible blister of about 1 sq.cm. in size. After complete mapping using the ultrasonic scanner (Fig.6) the fuel plate was thoroughly examined metallographically.

Metallographic verification of the lack of bond present in the fuel plate was carried out by sectioning the portion marked ABCD in Fig. 6, containing the flaw indicated by ultrasonic examination. The piece was mounted in cold setting resin to expose the edge AB, showing the thickness of the plate. Standard metallographic procedure was followed for mechanical polishing, and successive parallel sections of the specimen were observed by grinding in steps till the edge CD was reached. Electrolytic polishing technique was standardised to avoid flow of material so that fine planer indications of non-bond was not lost during preparation.

Fig.6. Ultrasonic test map of a blister on a plate type fuel element. The region ABCD was used for metallographic verification.

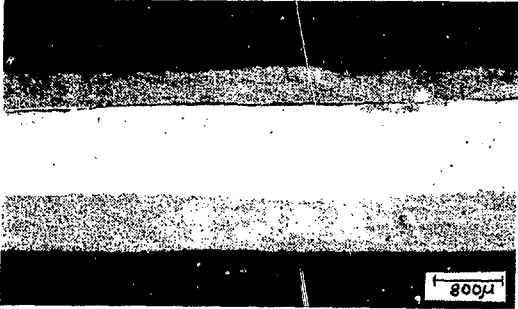
Fig. 7. Photomicrograph of a lack of bond section in a fuel plate.

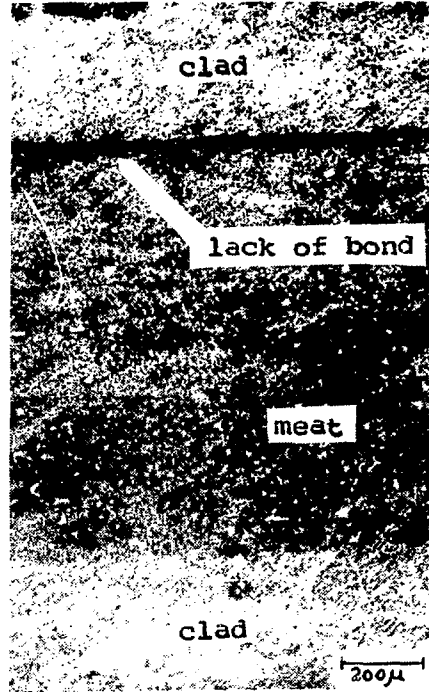
Fig. 8. Photomicrograph showing a good bond (lower region) and a lack of bond (upper region).

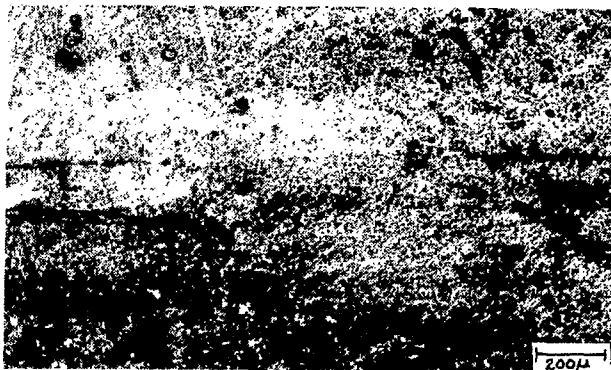
In a few sections, a discontinuous line of lack of bond (Fig.9) was revealed beyond the length indicated by the ultrasonic test. Representative photomicrographs of lack of bond regions intercepted in fuel plates are presented in Fig. 7 to 9.

Fig. 9. Photomicrograph showing discontinuous line of lack of bond.
