STRESS-ASSISTED, MICROBIAL-INDUCED
CORROSION OF STAINLESS STEEL PRIMARY PIPING
AND OTHER AGING ISSUES AT THE OMEGA WEST
REACTOR

ANTONIO ANDRADE

TOPICAL SEMINAR ON MANAGEMENT OF AGEING OF
RESEARCH REACTORS - GEESTHACHT, GERMANY

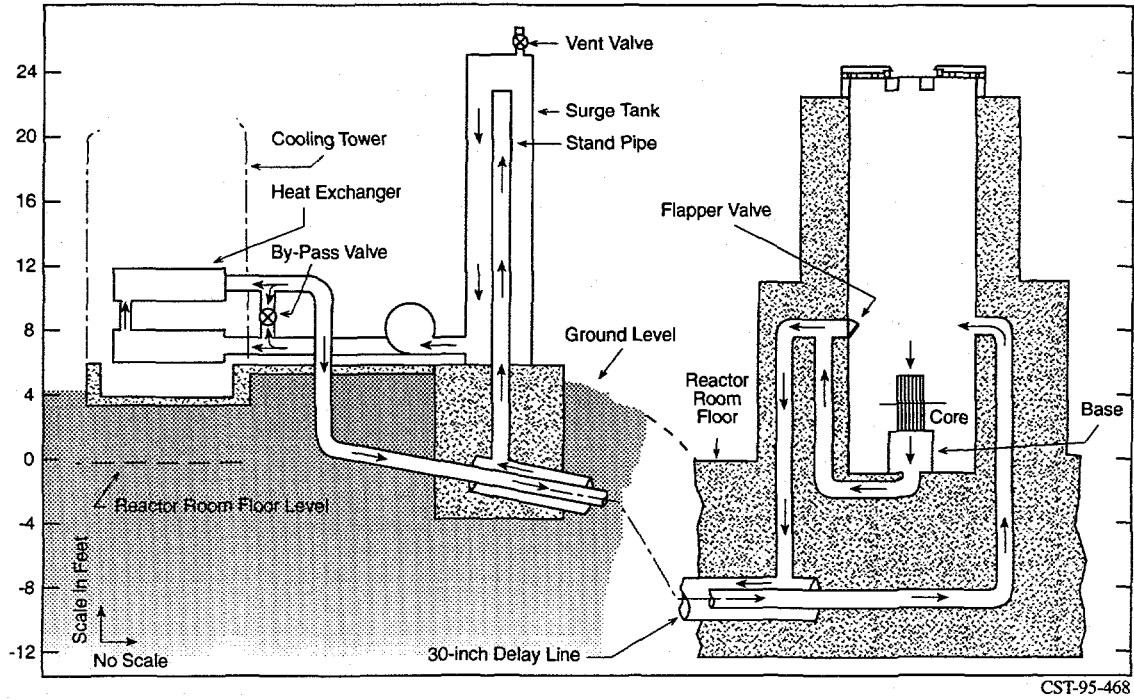
Measurements of the rate of change of the leak rate in the 76.2-cm diameter, 33.5-m long delay line, from the time the line was full to the time that the rate approached zero, provided information regarding the probable location of the of the problem. Once this location was determined, an excavation effort was started to unearth the pipe. The pipe was buried at a depth of approximately 2.5 m under the reactor building and extended horizontally under the reactor room approximately 8.0 m. The remainder of the pipe inclined upwards and away from the reactor room at an angle of about 6 degrees until it connected with the surge tank stand pipe as partially depicted in Figure 1.

The sections of pipe that were to be inspected were the 76.2-cm diameter pipe stubs that existed at both the surge tank concrete foundation end and the foundation under the reactor (see Fig. 1). In addition, the 30.48-cm diameter pipes that attached to the delay line at both of these points were to also be inspected. It was decided that direct ultrasonic and visual inspections would be sufficient to determine the integrity of the piping. However, manned entries into the delay line pipe stubs would be necessary to obtain the most reliable inspection data.

The inspections of the larger diameter pipe also yielded no signs of corrosion up to a point at approximately 2 m from the endcap. At this point, pitting and small amounts of corrosion deposits were encountered. Upon review of construction drawings for the OWR, it was noted that the same concrete foundations that had been utilized for the Clementine fast reactor had also been used as part of the foundation structure for OWR. This condition resulted in the fact that the first two meters of delay line piping had been encased in concrete during construction. Hence, this concrete had apparently protected this last section of delay line piping from exposure to the earth. The remaining piping was not protected as such and was evidently subjected to the same microbial activity described above.

Fig. 1. The OWR vessel and external cooling system elevations showing the ends of the N-16 delay line on both the surge tank and reactor ends.

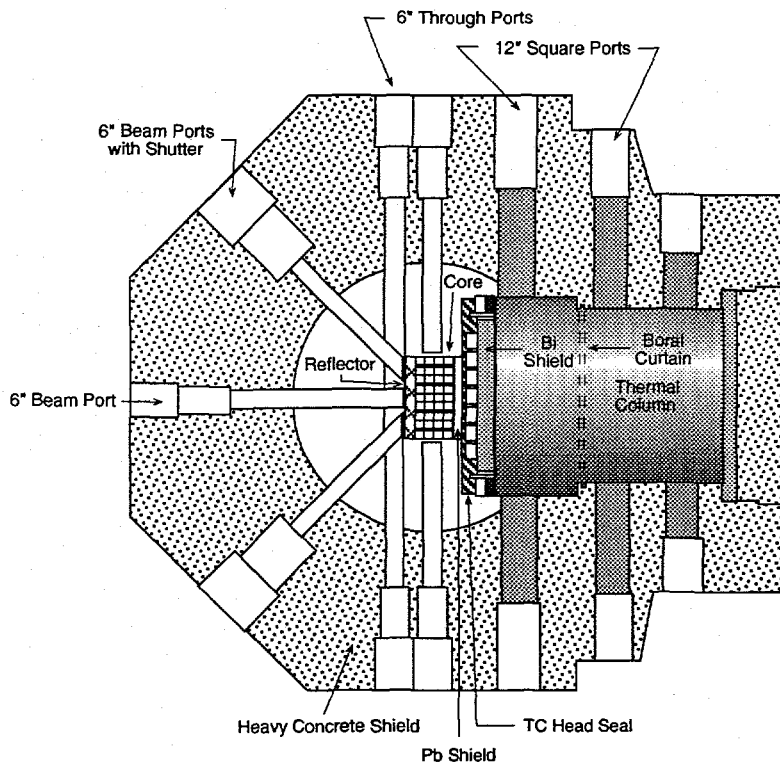
Fig. 2. A vertical cutaway drawing showing the OWR thermal column components and ports.

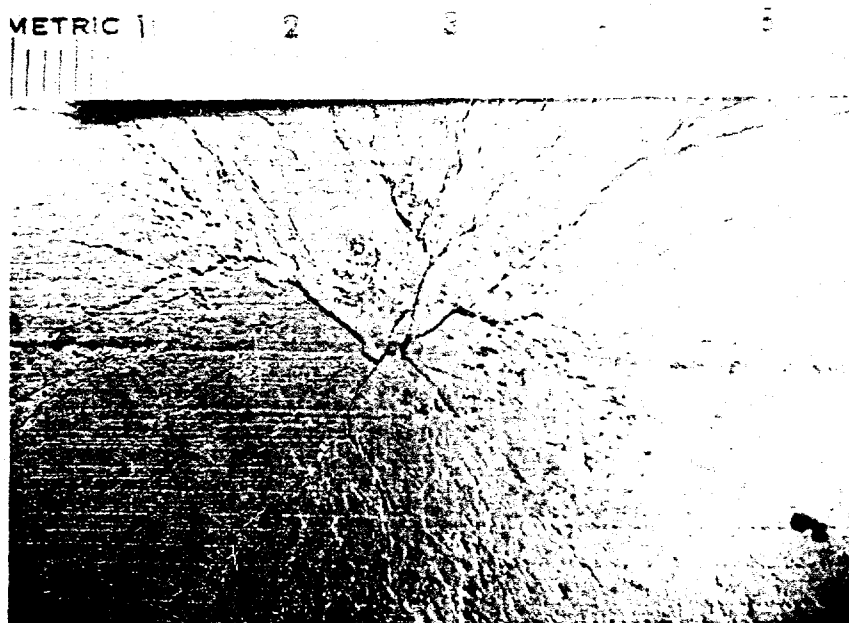
A typical cleaned pipe surface sample (no corrosion products left on the surface) is shown in Fig. 5. As can be seen, the cracking runs in many directions. Indeed, when the samples were sectioned and polished, micrographs showed the cracking to be both intergranular and transgranular and, also, running both perpendicular to and in-plane with the rolling direction. Note that energy dispersive X-ray spectroscopy (EDS) was utilized to confirm the elements ratio to positively identify the stainless steel as being type 304.

Fig. 5. A micrograph of a clean pipe surface sample (no corrosion products left).

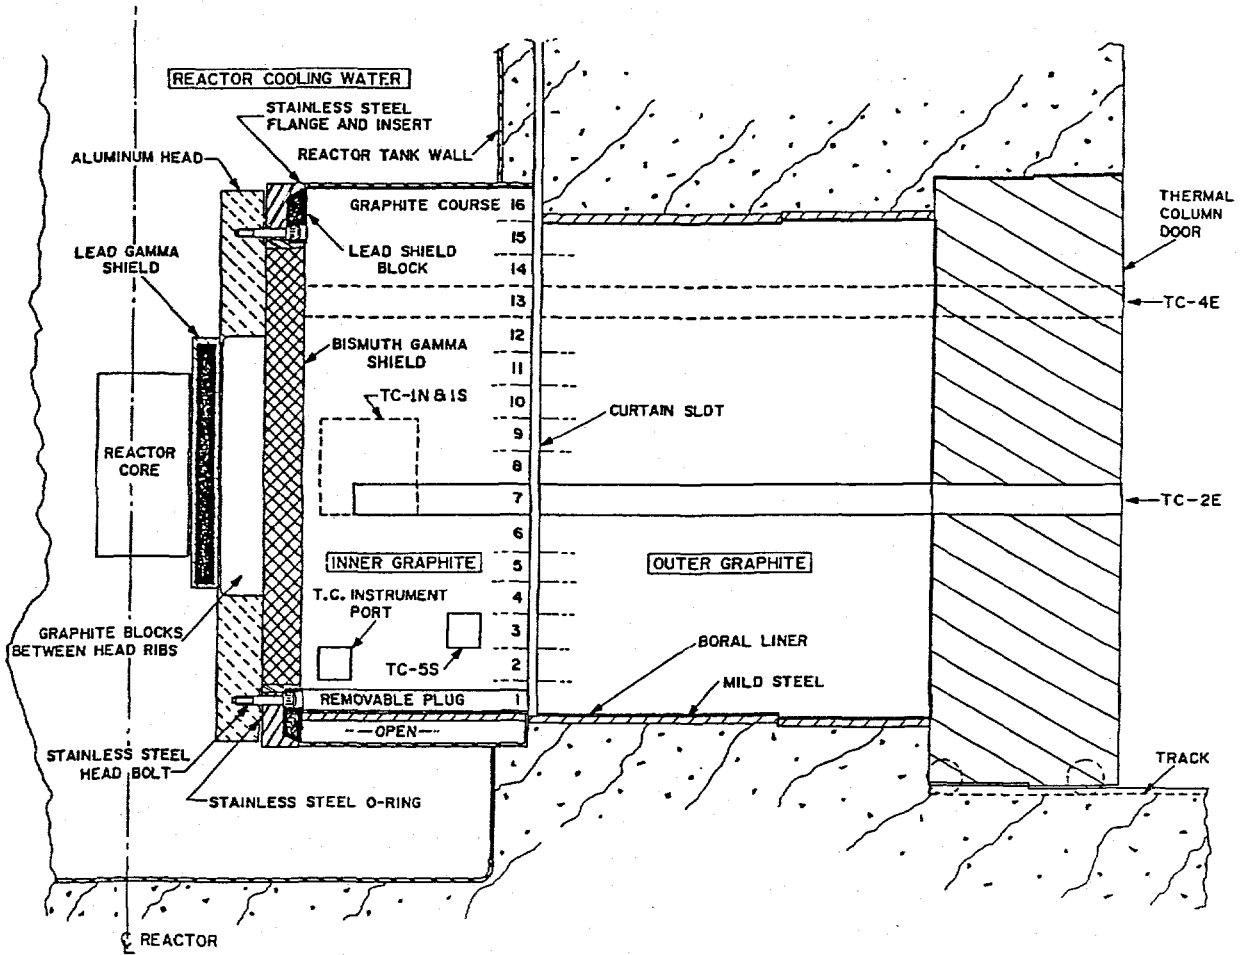
The end of the thermal column adjacent to the core is closed by a ribbed aluminum head that is 1.83 m in diameter and 15.24-cm thick (Fig. 2 & Fig. 6). The aluminum head is bolted to a stainless steel flange, and the seal is formed by a hollow stainless steel O-ring. The aluminum used for the head (Al-6061) has survived fluences up to 20 times the OWR fluence to date and, hence, there appears to be no likelihood of radiation failure under any conceivable future operations scenario.

When the OWR was first operated, intermittent water leakage past the O-ring seal was observed, but none has been observed since 1957 when the head bolts were tightened. However, because of it is possible that the original leak was caused by scrubbing of the O-ring resulting from differential expansion between the aluminum head and the stainless steel flange, it is possible that the leak could recur. Replacement of the O-ring would be a major undertaking. To gain access to the head bolts, it would be necessary to partially unstack the thermal column, which is accessible via a large shield door at its other end. In this operation, gamma-ray levels of a few hundred R/h would be encountered. Because most of the gammas are from Co-60 induced in stainless steel, the dose rate would decrease very slowly. Hence, there appears to be no way to perform the repair without significant exposure to personnel.

The most serious problem identified during the course of the aging studies was a failure of the cooling for the bismuth gamma shield (Figs. 2 & 6). The 1.53-m diameter, 12.7-cm thick bismuth shield is cast in a stainless steel rim. It is located between the inner end of the thermal column and the thermal column head. There have been no problems associated with the shield to date. However, failure of the bismuth shield cooling system could lead to overheating and possible melting. Note that the bismuth cooling temperature and flow are monitored during normal operation.

Failure could result from blockage of the cooling tubes or from degradation of the bismuth sufficient to raise the temperature differential required for heat transfer to the cooling tubes by an unacceptable amount. Replacement of the shield would entail removal of the aluminum thermal column head, thereby presenting the same difficulties noted with the leakage problem above.

Fig. 6. OWR thermal column.
