An Overview of Stress Corrosion in Nuclear Reactors from the Late 1950s to the 1990s

Spencer H. Bush
Alan D. Chockie

February 1996

SKI

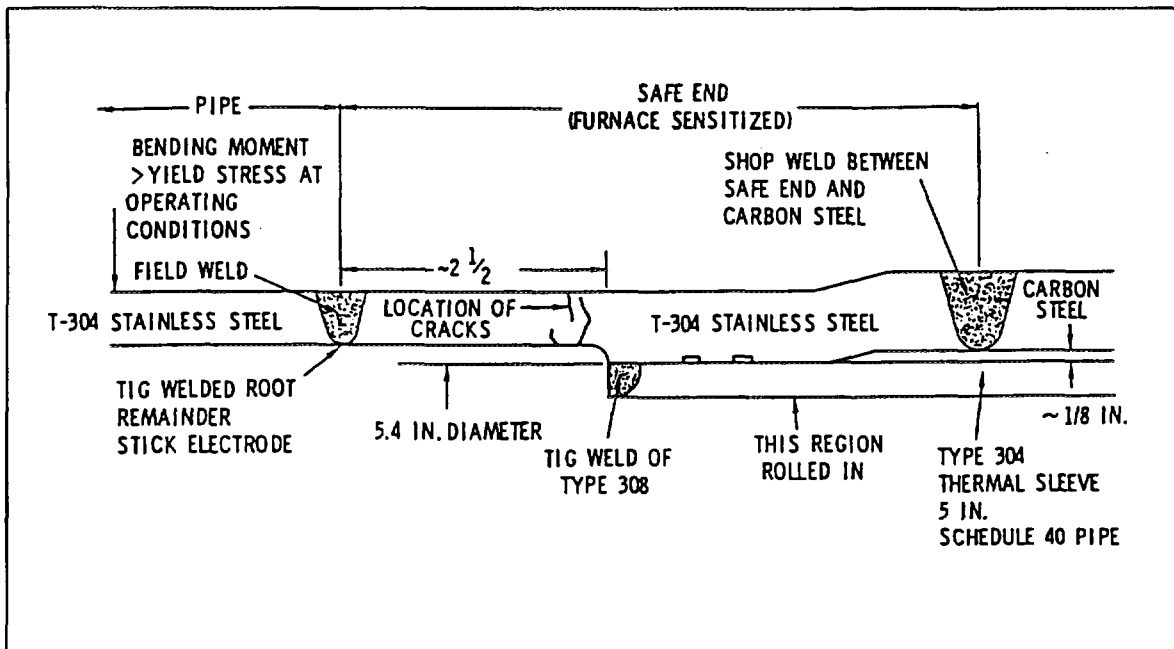
The stress relief temperature of 6200°C (11500°F) led to severe sensitization of the 304 stainless steel. Table 4 presents this phenomenon. As can be seen, 13 reactors representing almost all the older domestic BWRs operating had a total of 244 sensitized safe ends. The calculated failure rate is quite high; however, most sensitized safe ends were removed or weld clad on the inside. Nine Mile Point 1 nearly suffered a double ended guillotine break (DEGB) after three months of commercial operation. A design error placed supports on the 10-inch core spray line without accounting for the change in height of the vessel due to heat-up. As a result very high bending stresses, combined with the severe sensitization, led to extensive cracking. The crack was detected during an outage because of water leaking through the IGSCC cracks. Figures 1 and 2 illustrate the geometry of safe end and crack size, and the micrograph in Figure 3 illustrates a through-wall crack.

Figure 1: Schematic diagram showing safe end configuration.

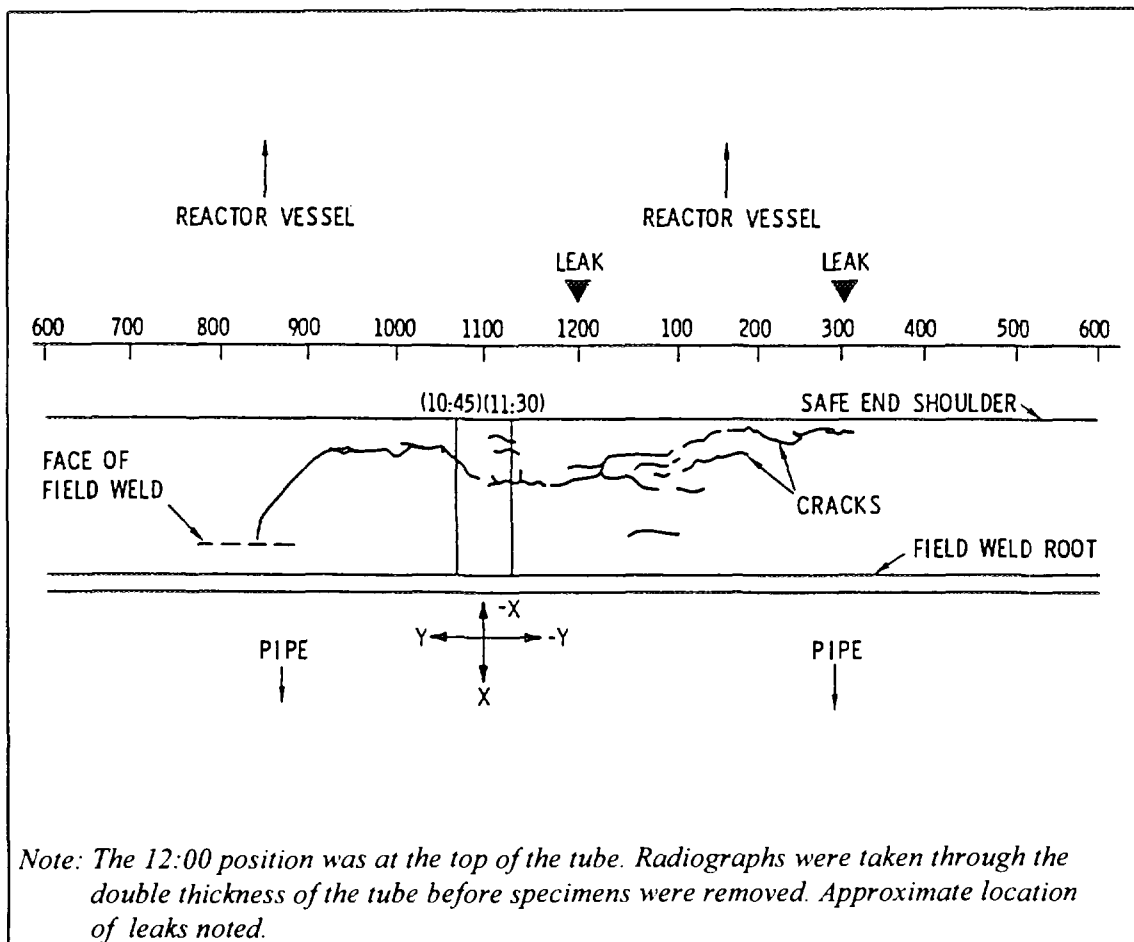
Figure 2: Schematic description of radiographic indications from safe end showing location of cracks.

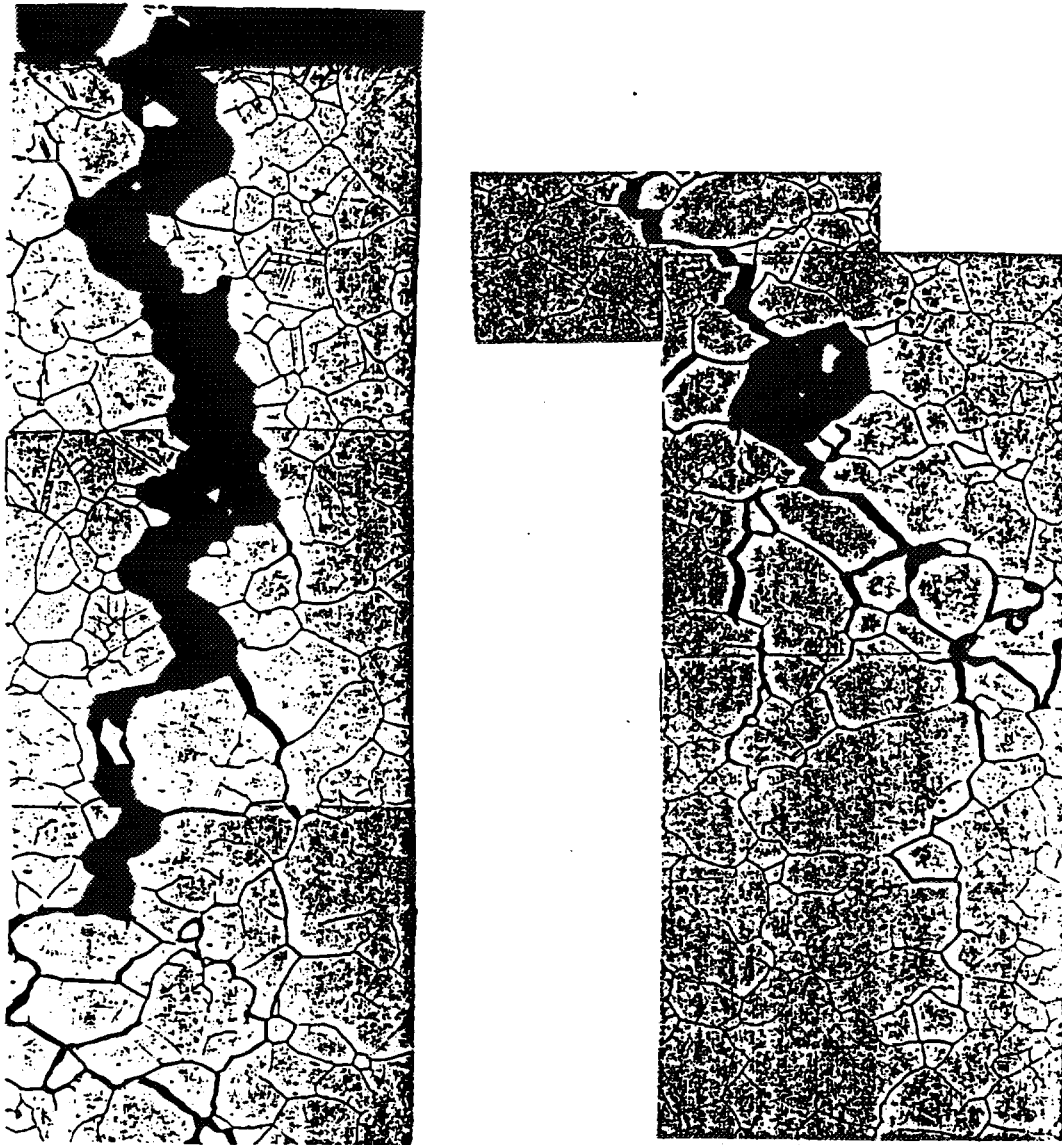
Note: Face being examined is parallel to pipe axis. Left figure is initial portion of crack, right figure is bottom. The bottom of the left figure and top of right are exactly contiguous.

Figure 3: Optical micrograph of crack starting at inside surface and extending toward the outer surface.

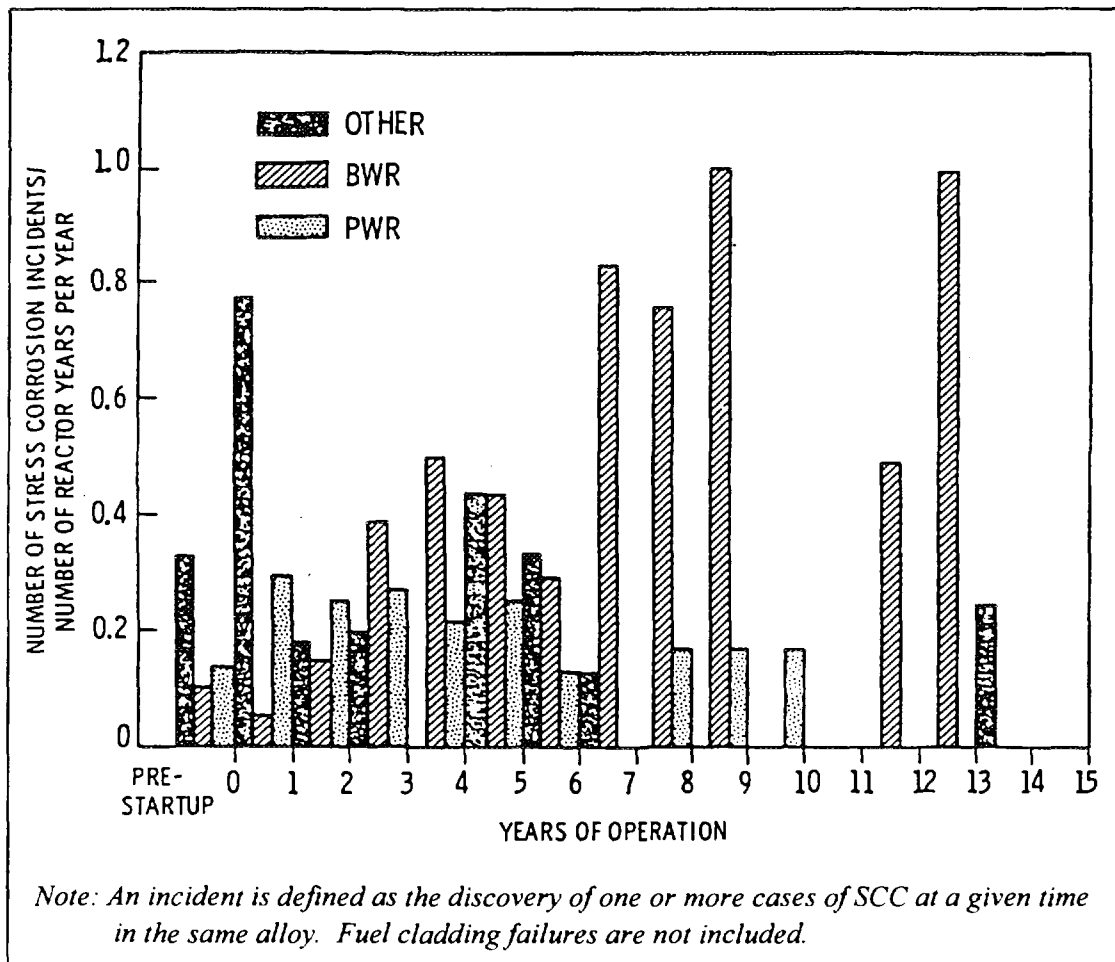
The general opinion among nuclear scientists and engineers in 1974 was that the SCC in 4-inch, 6-inch, and 8-inch lines in Dresden 1 was unique to that plant. In fact, General Electric scientists remarked that the trends that indicated increasing cracking rates for longer periods of time were not valid because of the corrective actions taken to minimize sensitization and cold work (Bush, 1973). The plants cited are the BWR-3s, which are discussed below. Figure 4 presents a graphical presentation of SCC incidents by years of operation.

Figure 4: Stress corrosion cracking incidents (limited to US data).

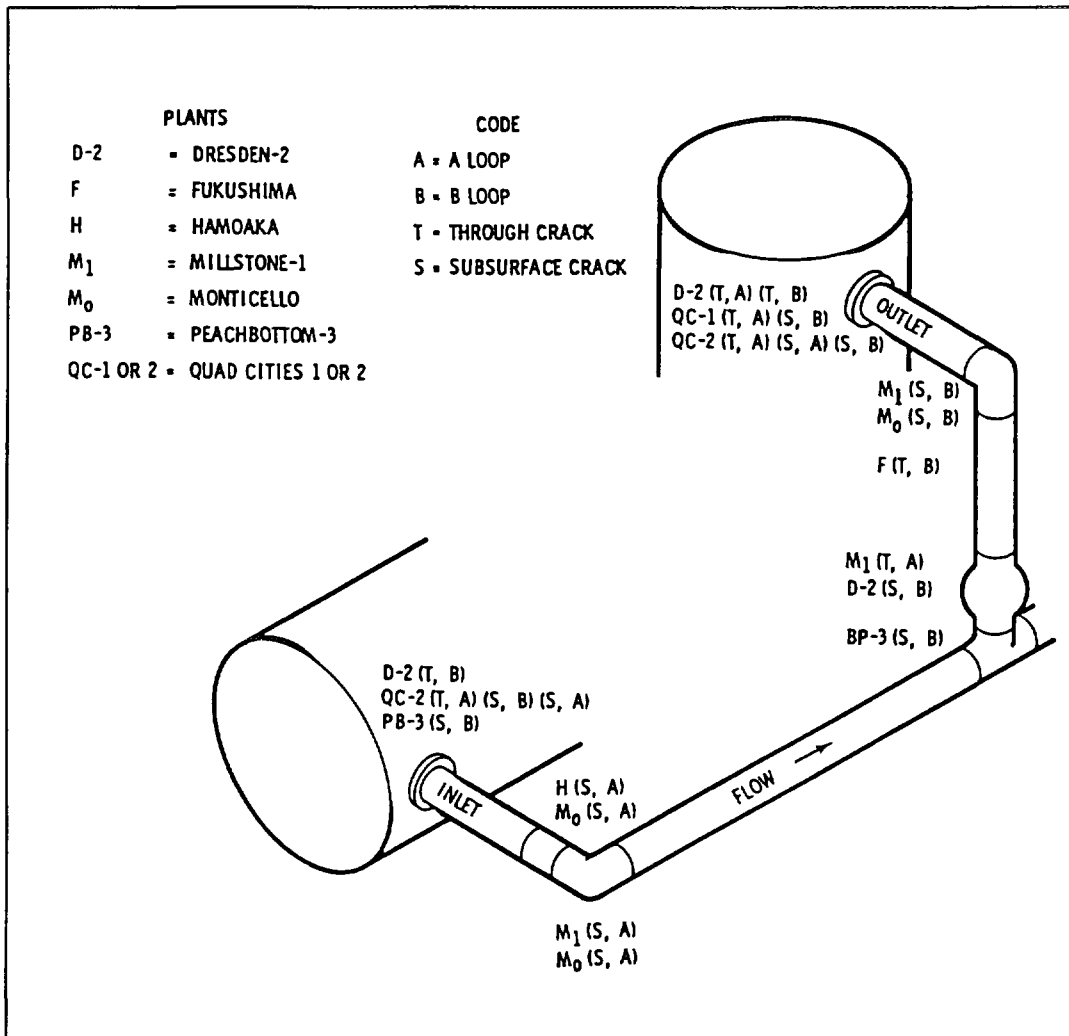
Figure 5: Record of recirculation bypass cracks.

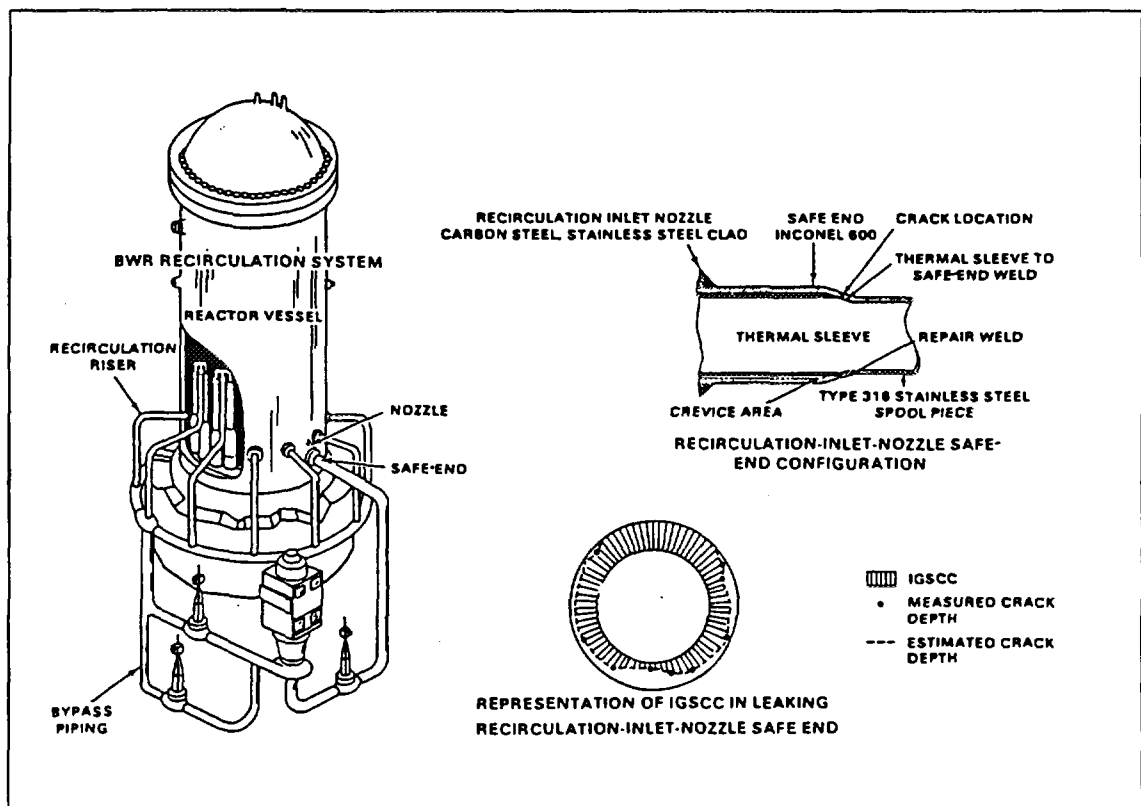
The significance of cracking in the Inconel-600 safe ends at Duane Arnold merits an in-depth review. The cracking could be classified as a near miss double-ended pipe break for one or more of the safe ends. Figure 6 illustrates a typical BWR recirculation system, i.e., the configuration of the Duane Arnold Recirculation-Inlet Nozzle Safe End including location of a repair weld and a representation of IGSCC in the leaking recirculation inlet-nozzle safe end. The nozzle is approximately 10 inches in diameter. The repair weld occurred because of an error in the fabrication drawing that resulted in the machining of a groove in the outer surface of all eight safe ends. Repair consisted of filling with weld metal. Since the safe ends were attached to the vessel nozzles prior to stress relief, they underwent two $1100 \pm 25^\circ\text{F}$ ($595 \pm 15^\circ\text{C}$) stress relief treatments. Note the thermal sleeve that was installed to direct coolant flow into the vessel. It also resulted in a long, narrow crevice ending at the tip of the attachment weld. This crevice led to a stagnant chemical environment conducive to IGSCC. A severe resin spill produced an acid sulfate that was trapped in the crevice as confirmed by the presence of sulfur and low pH.

A combination of the chemical environment, oxygen, high residual and operating stresses, and sensitization led to severe IGSCC. Figure 6 represents the one leaking

safe end. Note the 360° circumferential crack that is through-wall in one section and 50-75% through-wall over most of the remaining circumference. While Figure 6 illustrates the leaker, the other seven safe ends were cracked almost completely around the circumference. Duane Arnold and Nine Mile Point represent the two cases of SCC in nuclear power plants that could have led to a DEGB. Therefore, the lesson learned is to avoid crevices (probably by not installing thermal sleeves) and conduct inservice inspection (ISI) in conformance with NUREG-0313.

Figure 6: Example of severe intergranular stress corrosion cracking in Inconel-600 safe end.

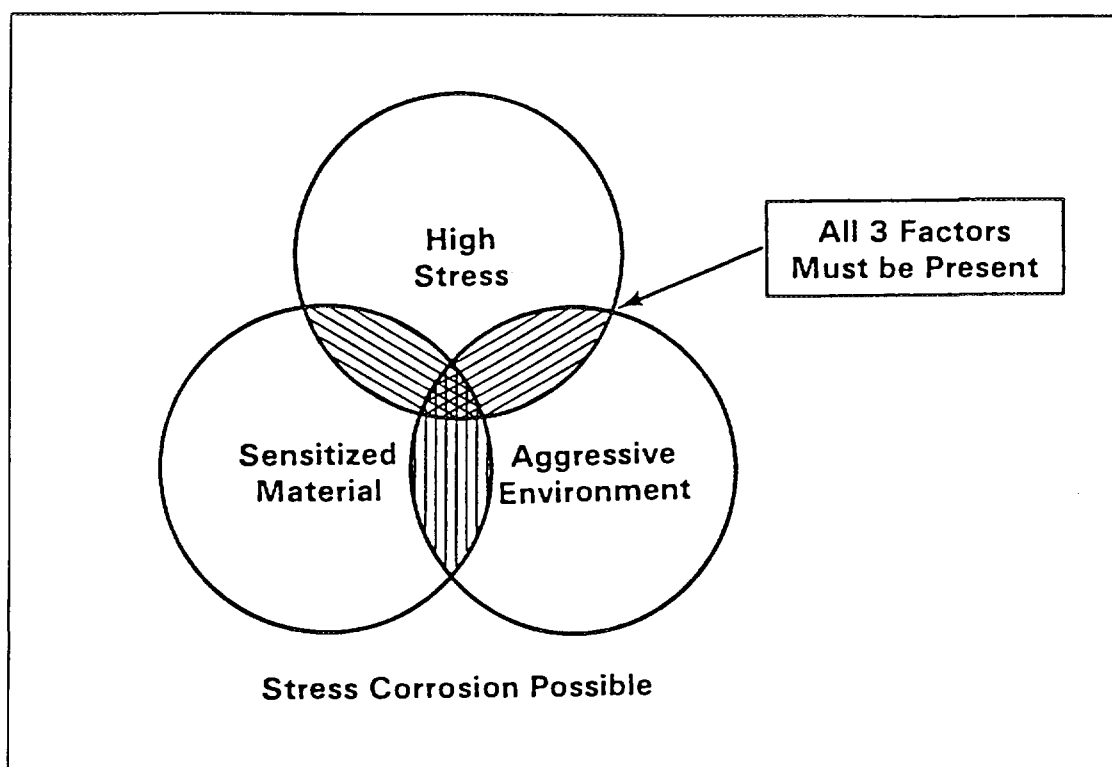
Figure 7 illustrates the interdependence of material, environment, and stress factors most correctable by long-term solutions. Generally, action on two or preferably all three variables is preferred.

Figure 7: *Conditions leading to stress corrosion.*

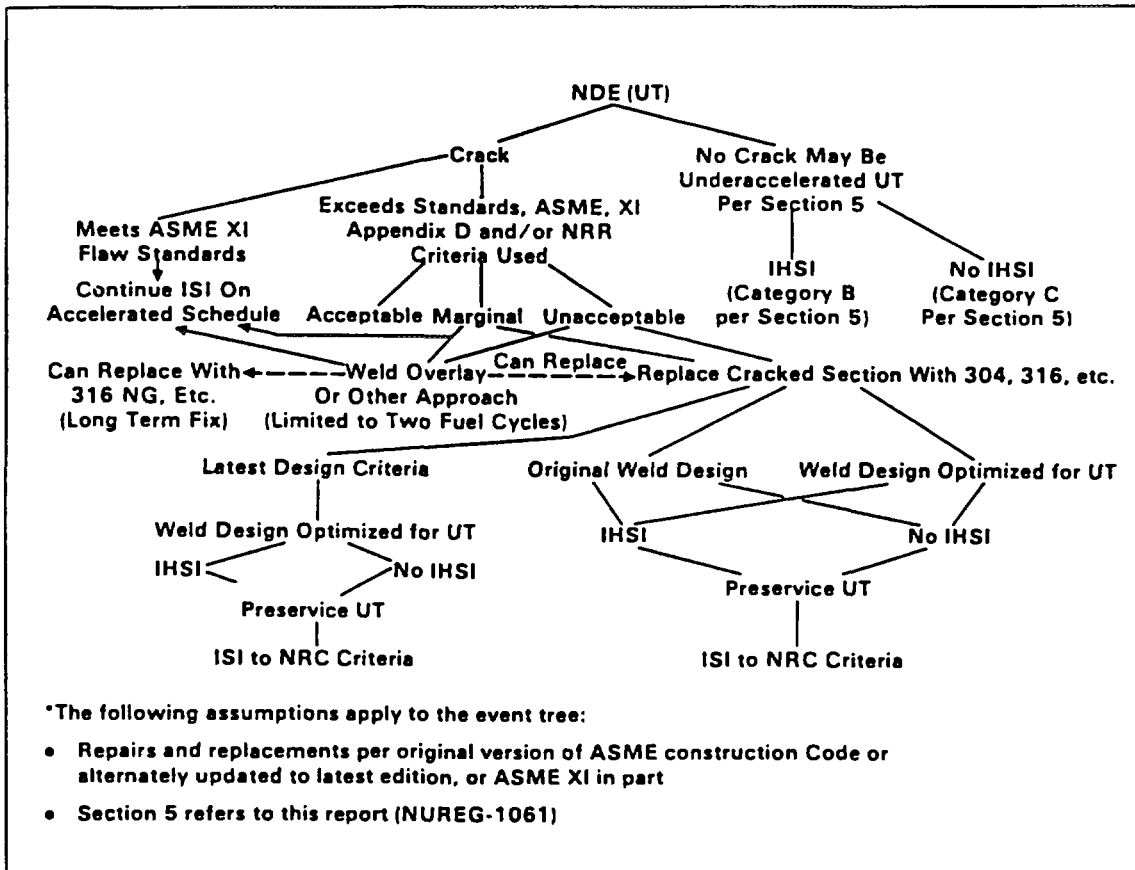
Figure 8: Short-term solutions for replacement, repair, or continued operation without repair.

Figure 8 shows both near-term and long-term solutions, as well as suggested actions related to volumetric examination and enhanced leak detection. The long-term materials solution is Type 316NG stainless steel in most countries, except Germany where a Type 347 NG is preferred.

Short-term solutions include induction heating stress improvement (IHSI), clam shell reinforcements and last pass heat sink welding (HSW). In Japan, IHSI on uncracked pipe is considered a permanent fix by reducing-reversing residual tensile stresses.

The third variable, environment, can be corrected with hydrogen water chemistry.
