**THE POST-IRRADIATION EXAMINATION OF FUEL IN SUPPORT OF
BRUCE A NUCLEAR DIVISION FUELING WITH FLOW PROGRAM**

J. Montin*, S. Sagat*, R. Day†, J. Novak†, H. Bromfield†

* Atomic Energy of Canada Limited, † Ontario Hydro

AECL-11464

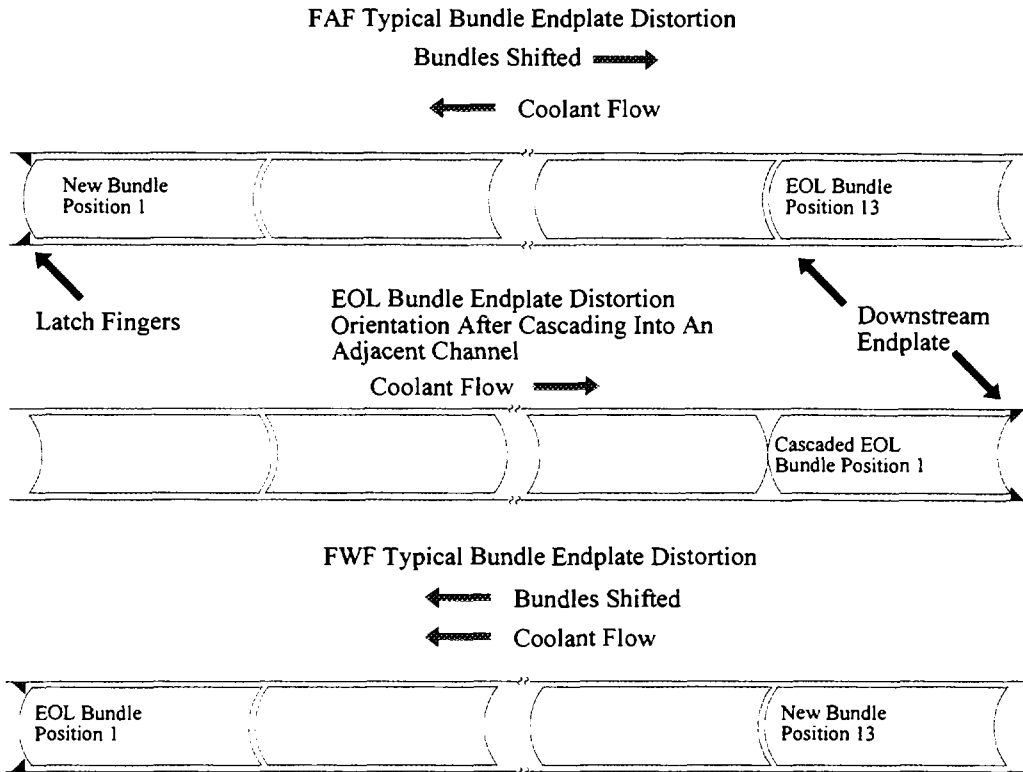
The Unit 2 cascaded bundles had incipient cracks at the endplate-to-endcap welds, while the benchmark bundles did not have any incipient cracks. The incipient cracks (thirty in total) were equally divided between the two manufacturers. The cascaded and benchmark bundles had comparable equivalent hydrogen concentrations and irradiation histories. The cascaded and benchmark bundles were subjected to the same pressure tube DHC-avoidance maneuver. The cascaded bundles were placed in a high-stress situation at the EOL, when they were cascaded into an adjacent channel in position 1. In this position, they were placed against the channel end latch fingers, and the bundle endplate orientation was reversed to the normal situation (Figure 1).

Figure 1: Endplate Distortion For FAF and FWF

Consequently, the design of the outlet shield plug was changed to support all three rings of the fuel bundle, to minimize stress and prevent endplate cracking. Also, an ultrasonic endplate inspection tool (UT) was developed and located in the fuel bay, to inspect fuel-bundle endplates for cracks. A second test was done, involving a series of four bundle cascades, from positions 10 to 13 into positions 4 to 1 of BAND Unit 4 channels, that had a redesigned outlet shield plug. The four bundle cascades also reduced the stress on the position 1 bundle associated with the dome-on-dome endplate situation. The position 1 bundles were discharged after a pressure-tube DHC avoidance maneuver, and checked using the UT. No through-wall cracks were observed, and the UT did not detect any incipient cracks. Twenty-two Unit 4 elements were selected for PIE at CRL to qualify the performance of the new UT and the new outlet shield plug design. The Unit 4 elements came from locations at or adjacent to radial web junctions that are more susceptible to cracking. Three bundles from the Unit 2 test were also examined using the UT, and incipient cracks were detected. Eight elements were selected for PIE, to qualify the performance of the new UT.

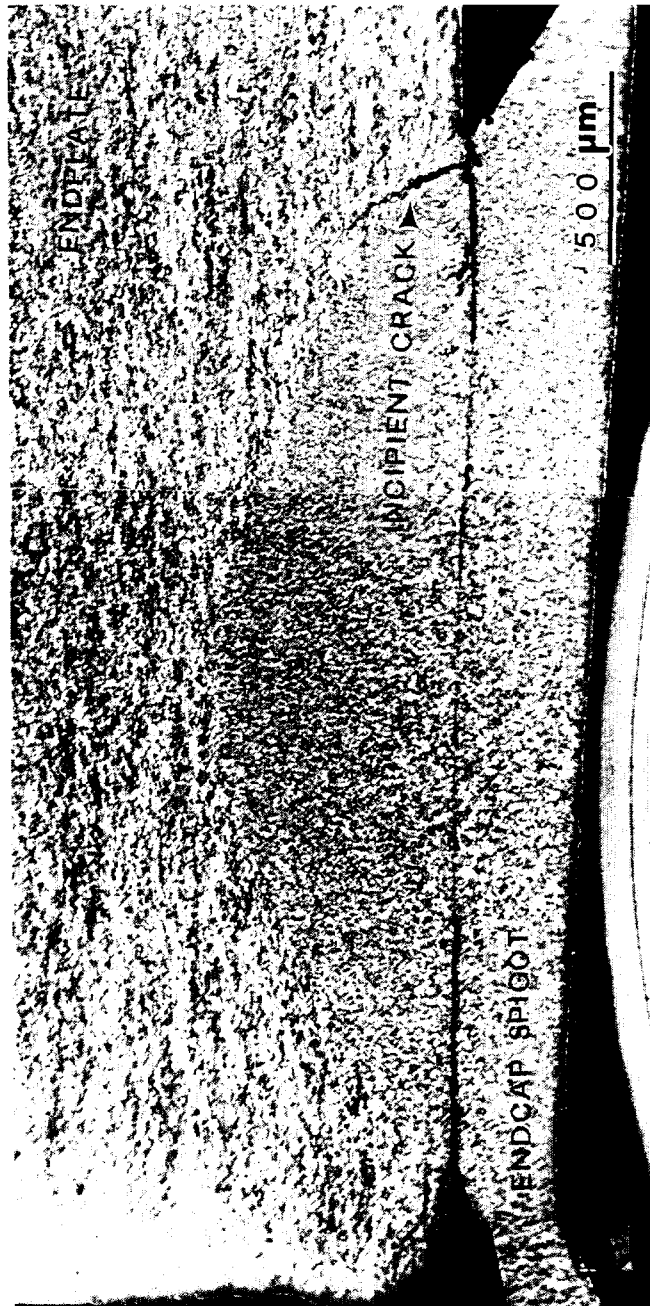
Incipient cracks propagating into or along the heat-affected zone (HAZ) were observed. The microstructures for all the cascaded and benchmark EOL bundles were comparable and no anomalies were detected. Figures 3 and 4 show typical micrographs of the microstructure and

3. Evidence of DHC arises from the metallographic and fractographic examinations. Features typical of DHC, such as the accumulation of hydrides at the crack tip and around the crack, and brittle features on the fracture surface corresponding to fractured hydrides, were observed.

Figure 3: L32803C-18 Non-Monogrammed Endplate Weld Microstructure with an Incipient Crack (50X, GG30G8-G9)

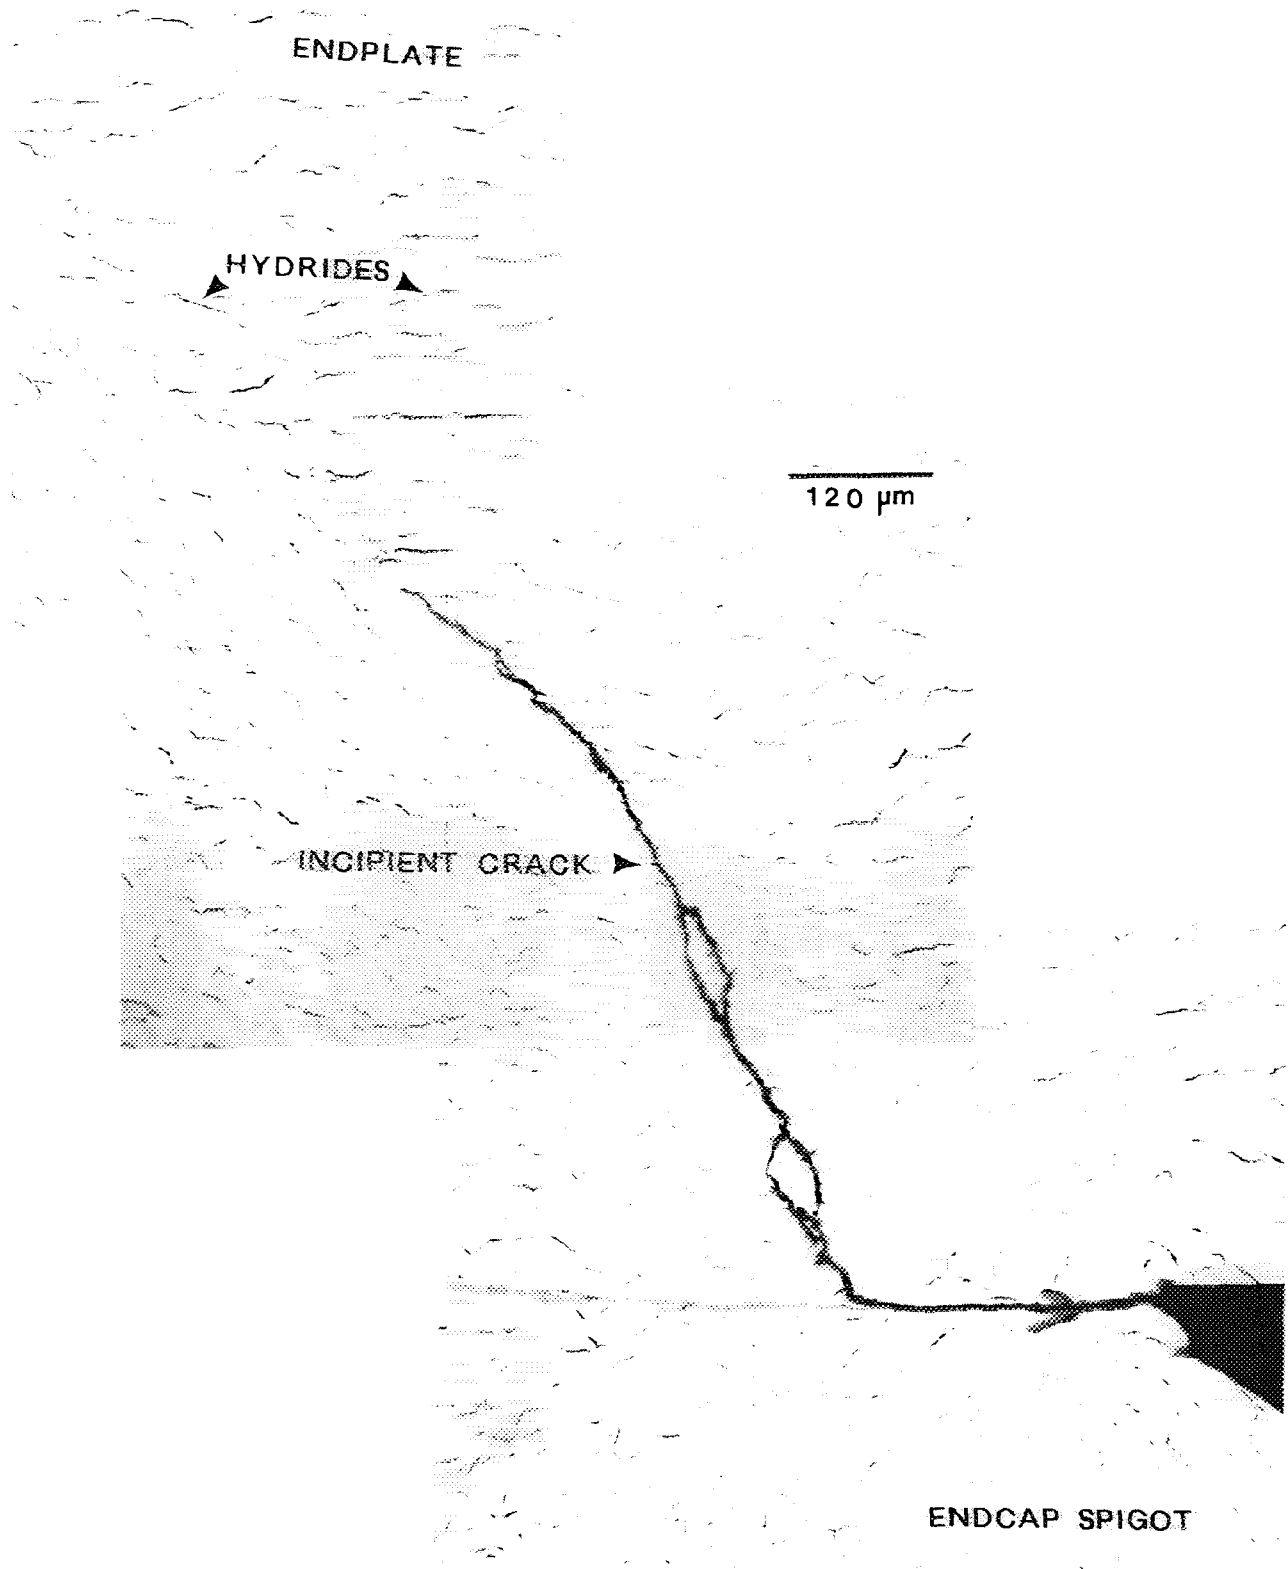
Figure 4: L32803C-18 Non-Monogrammed Endplate Hydride Distribution Around the Incipient Crack and in the Bulk of the Weld (150X, GG30G13-G14, G20)

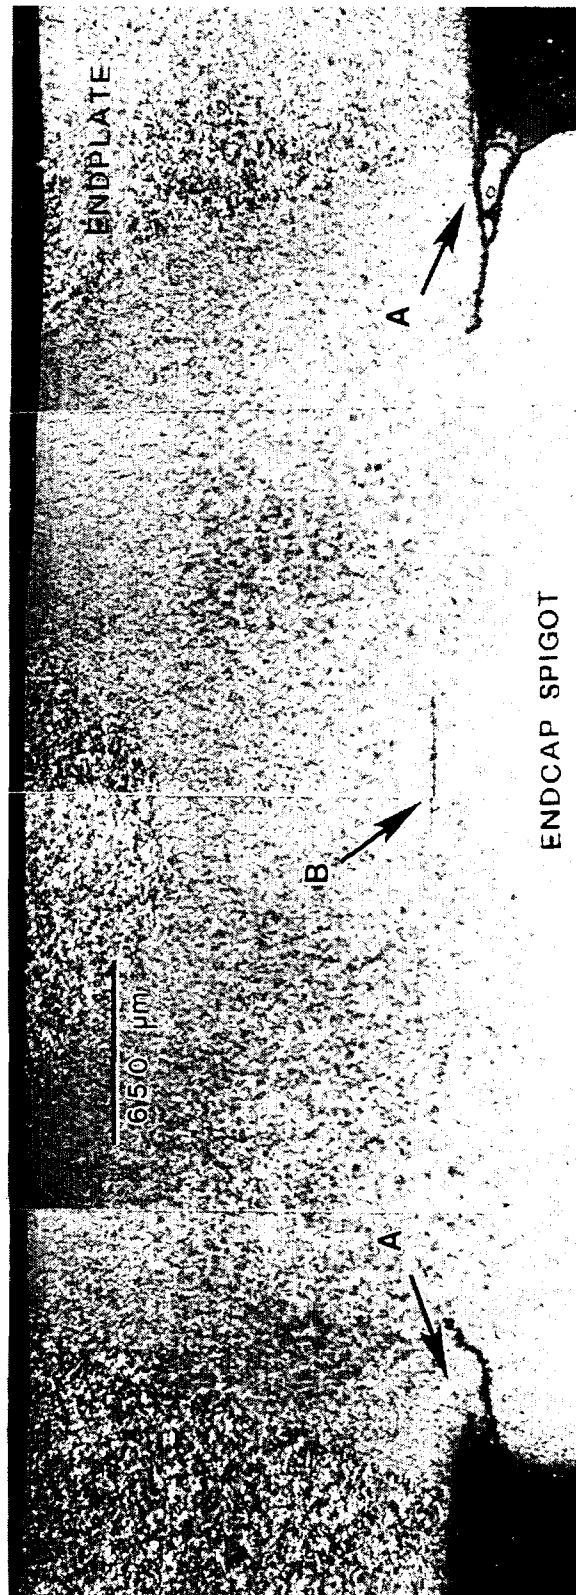
the hydride distribution of an assembly weld with an incipient crack. Less-than-ideal welds (Figure 5) were also found in the cascaded bundles from both manufacturers. Less-than-ideal weld micrographs show weld expulsion at the notches, and incomplete bonding along the weld line.

Figure 5: A Typical Less-Than-Ideal Assembly Weld (A. Weld Expulsion, B. Incomplete Weld), (L58277C-5 Non-Monogrammed Endplate, 50X, HH2K3-K6)

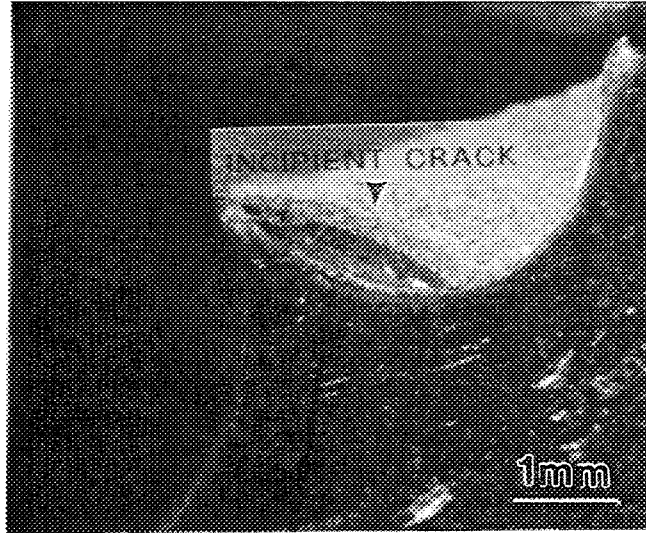
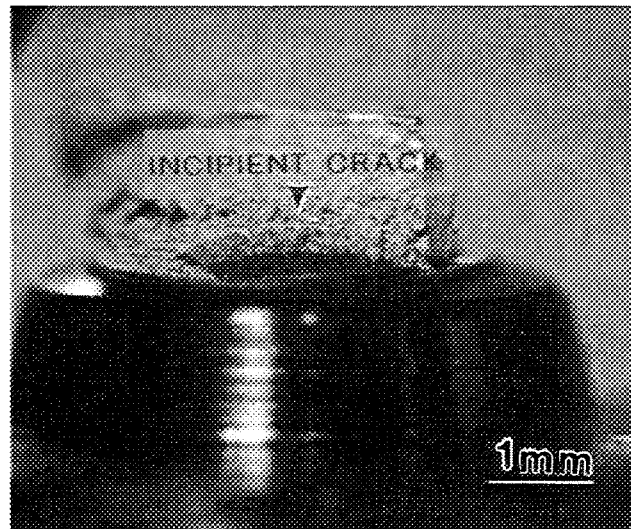
Figures 6 and 7 show a typical example of an incipient crack detected using the peel test that had dark patches of oxide exhibiting two zones with different colours. The two colour zones are the result of different oxide thicknesses on the fracture face, and indicate that the cracks grew in two discrete steps, likely associated with the two cool-down steps experienced by these bundles.

Figure 6: Typical Incipient Crack Detected Using the Peel Test Showing a Two-Colour Zone Dark Patch on the Endplate (J85503Z-23 Monogrammed Endplate, 13.6X, 910A-21)

Figure 7: Mating Two-Colour Zone Dark Patch on the Endcap (J85503Z-23 Monogrammed Endplate, 13.6X, 910A-22)

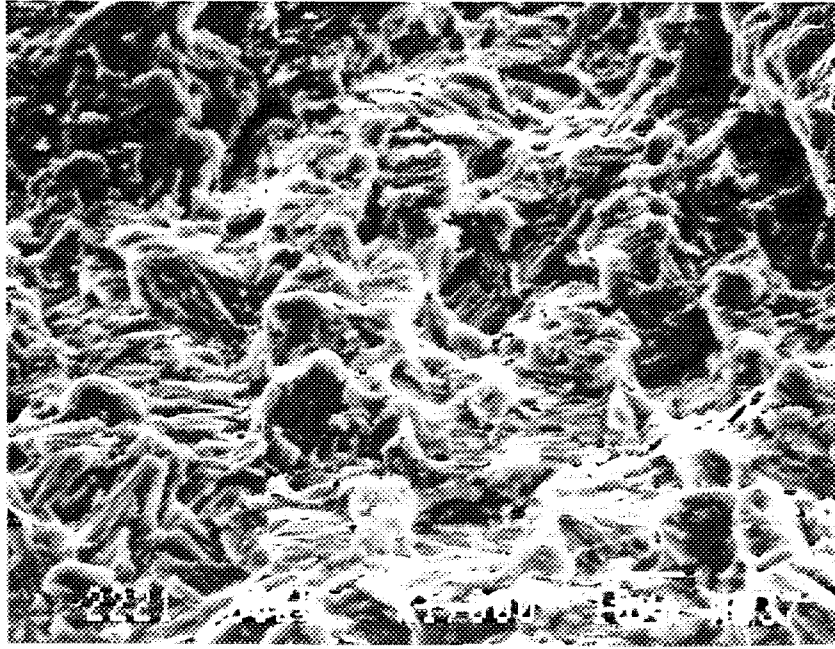
Two fracture faces were examined using the SEM. Figure 8 shows a SEM photograph that contained areas of ductility (pulled-out features) and crystallographic facets. The fracture faces from these two elements do not resemble the river- and beach-mark patterns observed for the beginning-of-life fatigue cracks from the DNGS N12 investigation [2]. These cracks are not fatigue cracks.

Figure 8: Fracture Face at High Magnification (L32803C -3 Non-Monogrammed Endplate, 1000X, 2221)
