## **PROBLEMS EXPERIENCED DURING OPERATION OF THE PROTOTYPE FAST REACTOR, DOUNREAY, 1974–1994**

A. CRUICKSHANK, A.M. JUDD  
British Nuclear Fuels Ltd,  
Risley, Warrington, United Kingdom

### **Abstract**

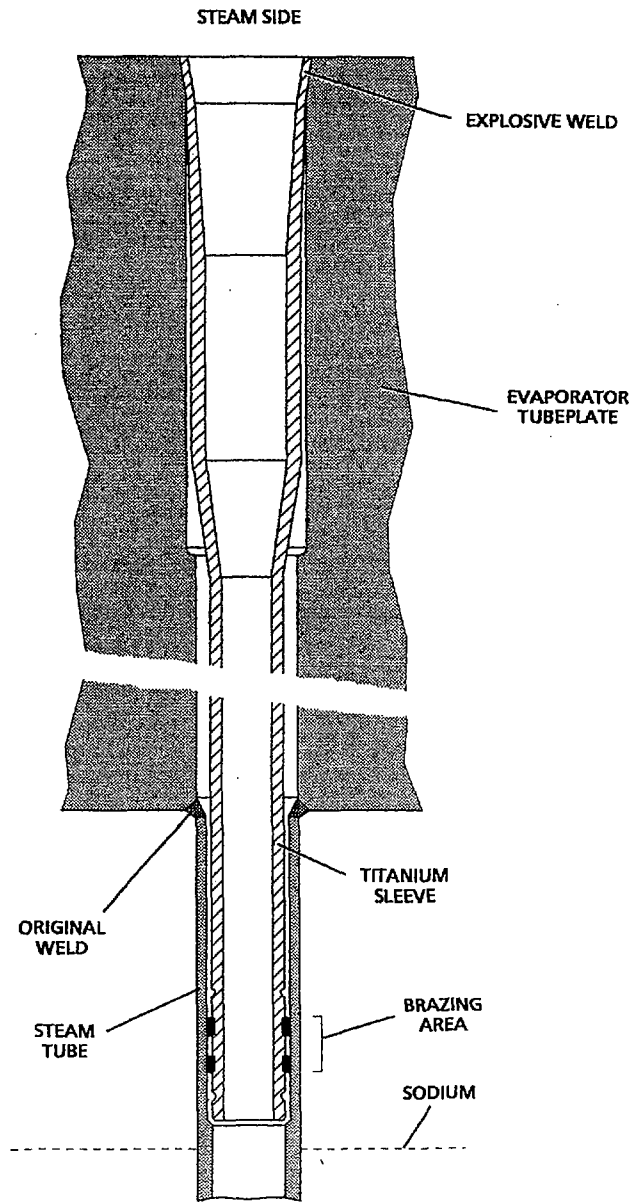
*Figure 1.4. A PFR Evaporator Weld Repair Sleeve*

The evaporator gas space leaks were all associated with cracking of the tube-to-tubeplate welds. These were hard and had high residual stresses because there was no post-weld heat treatment. None of the evaporator leaks gave evidence of wastage damage to the neighbouring tubes, probably because they were detected early by the installed gas-space hydrogen detection system. This was based on katharometers and was very sensitive, being capable of detecting leaks as small as 0.1 mg/s. The leaks were repaired by plugging the affected steam tubes.

Nevertheless it appeared that one leak would, after a few days or weeks of further operation, cause others. It was concluded that residual caustic reaction products in the gas space above the sodium caused further cracking of welds and initiated more leaks after an incubation period. Sodium flooding of the tubeplate at a temperature in excess of 400 °C for periods in excess of 24 hours had some success in removing reaction products. It was also required to wash out sodium hydrides which could lead to false hydrogen detection signals when they dissociated at high operating temperatures.

This did not cure the problem completely, however, and eventually it was concluded that washing with hot sodium did not remove caustic material from the roots of pre-existing fine cracks in the welds, so that in the presence of the residual stresses corrosion continued and the cracks grew to give rise to further leaks.

The problem was finally solved by the fitting of sleeves which spanned the original welds, as shown in Figure 1.4. In all 3000 sleeves were fitted over a 14-month period. The work was completed early in 1984. While sleeving was underway the station operated on a single circuit. Following sleeving no further problems were experienced with the evaporators.

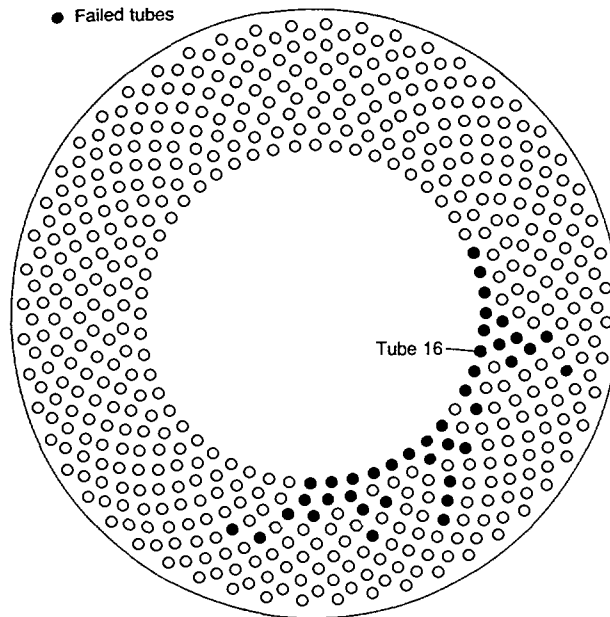
Figure 2.2 The Failed Tubes in PFR Superheater 2

The entire tube bundle was then dismantled and forty steam tubes were found to have ruptured, with longitudinal gapes of such a size as to be effectively equivalent to double-ended guillotine breaks. The locations of the failed tubes are shown in Figure 2.2. Sixteen of the failures were in the row adjacent to the central sodium duct and faced towards the duct. Four of the failed tubes had wear flats facing the central baffle and on one of these (tube 16) a circumferential crack at right angles to the main fracture was apparent. This was opposite a small wastage pit in the baffle, and it is concluded that this was the initiating leak.

1. A total of 40 tubes failed, 39 due to overheating in a period of 8 seconds following the plant trip. The remaining tube, which initiated the event, failed due to fretting damage caused by tube vibration.
2. The primary small leak grew after passing steam for some tens of seconds. Finally it grew rapidly to give a leak rate of 0.5 to 1.0 kg/s for a period of a few seconds.
3. This induced a plant trip by rupturing a steam-side bursting disc. Isolating valve closed, causing the steam flow to stop, but the steam pressure fell relatively slowly over a period of about 10 seconds.
4. Other tubes already weakened by fretting failed quickly, within a second or so, causing an increase in the heat generated by the sodium-water reaction.

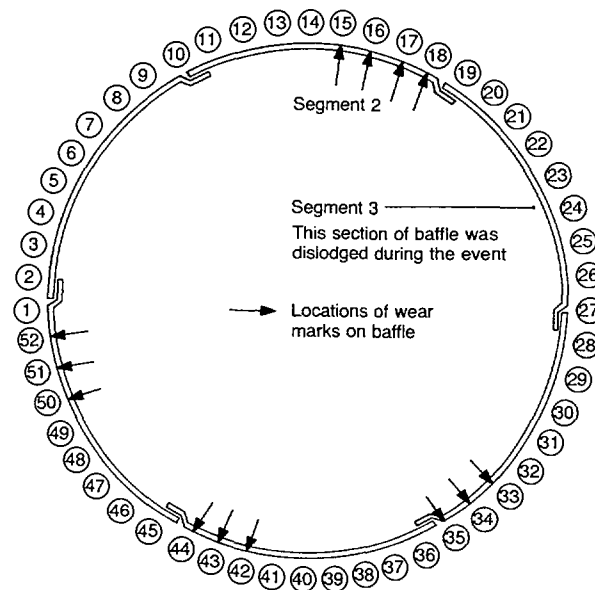
Figure 2.3 The Location of Fretting Marks on the PR Superheater 2 Central Baffle

Evidence of fretting on a further 13 tubes adjacent to the baffle was found, all close to the seams between the six plates forming the baffle. It was concluded that sodium leakage through the seams, shown in Figure 2.3, caused flow-induced vibration of the tubes resulting in contact with the duct and giving rise to wear and the eventual failure of tube 6.

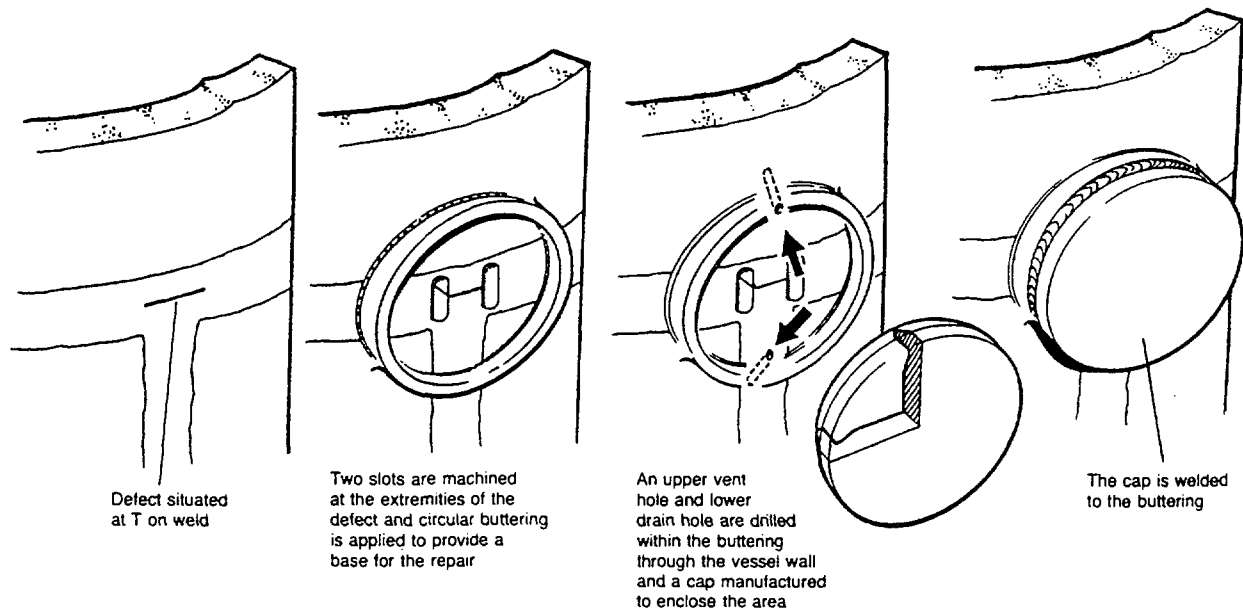
*Figure 3.2. The Repair Technique for Cracks in the PFR Steam Generator Vessels*

Detailed optical and scanning electron microscopic examination of samples cut from reheaters 1 and 2 and superheater 2 were carried out in 1987. In all cases the cracks were associated with deep weld rectifications in the circumferential weld seams. The cracks either passed along the fusion line of the rectification or were on or close to the fusion line of the original rectified weld. Cracks passed through the parent steel along or closely parallel to the fusion line and through the weld material. Cracking was intergranular.

The cracking mechanism was identified as delayed-reheat or stress-relief cracking. Titanium stabilised type 321 steel is subject to this form of cracking, caused by dissolution of titanium carbide close to a weld fusion line as a result of the high temperatures attained during welding. Subsequent re-precipitation of the carbides on dislocations produced by weld shrinkage during high temperature operation locks the dislocations and hardens the matrix. Relaxation strains occurring during operation causes intergranular failure.

Repairs were made by removing the cracked region and welding on a stub nozzle with a blanked end. The technique is illustrated in Figure 3.2. It was chosen because it allowed all the work to be done from outside the vessel (so that it was not necessary to open the vessel to the atmosphere, which would have required scrupulous removal of all the sodium residues), and because it facilitated thorough ultrasonic inspection of the repair. Smaller defects were either ground out or backfilled and fitted with strain gauges for monitoring during operation. The PFR vessels were considerably overdesigned and although the excessive vessel thickness may have contributed to the cracking it was helpful when it was necessary to grind out defects.

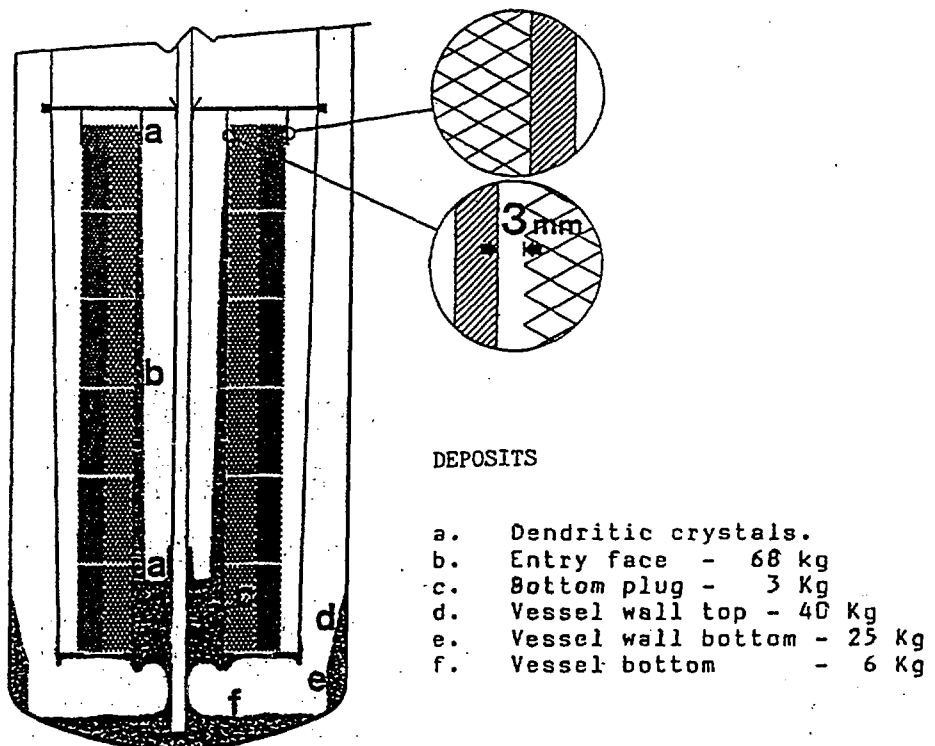
Figure 4.2. The Location of Deposits in the PFR Secondary Cold Trap

The deposits are pyrophoric and present a hazard that prevented close examination in air. On this occasion the trap was removed and kept under argon purge while an introscope examination was carried out. This gave an initial picture of the nature of the deposit before it was disturbed by being broken up.

Inefficient operation of the PFR secondary cold trap led to impurity loadings below the theoretical maximum. Improved trapping techniques aimed at avoiding cooling the sodium too far below its saturation temperature, and more careful operation solved the problem after 1981.

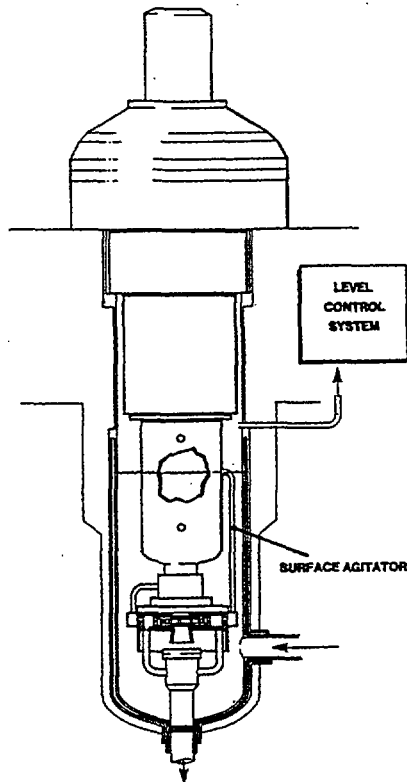
Figure 5.3. Modification of the PFR Primary Cold Trap Pumps

Each time a pump seized attempts were made to remove the sodium mechanically or melt it by use of the trace heating, but on no occasion did this succeed. Pumps had to be removed, decontaminated and stripped down in order to free the pump shaft.

During maintenance it was noted that oxide or hydride could be seen floating on the surface of the sodium in the pump tank. It was considered that such material, if raised inadvertently into the vent or feed lines, would contribute to the blocking of the gas valves. In 1988 both main and standby pumps had seized during the year, so during refurbishment a modification was carried out on the pumps to deal with the accumulation of these solid impurities. A jet of sodium was diverted from the discharge sides of the pumps to disperse the deposits and prevent valve blockages, as shown in Figure 5.3. This modification was not entirely successful in preventing further blockages and the pumps seized again in 1989 and 1990.

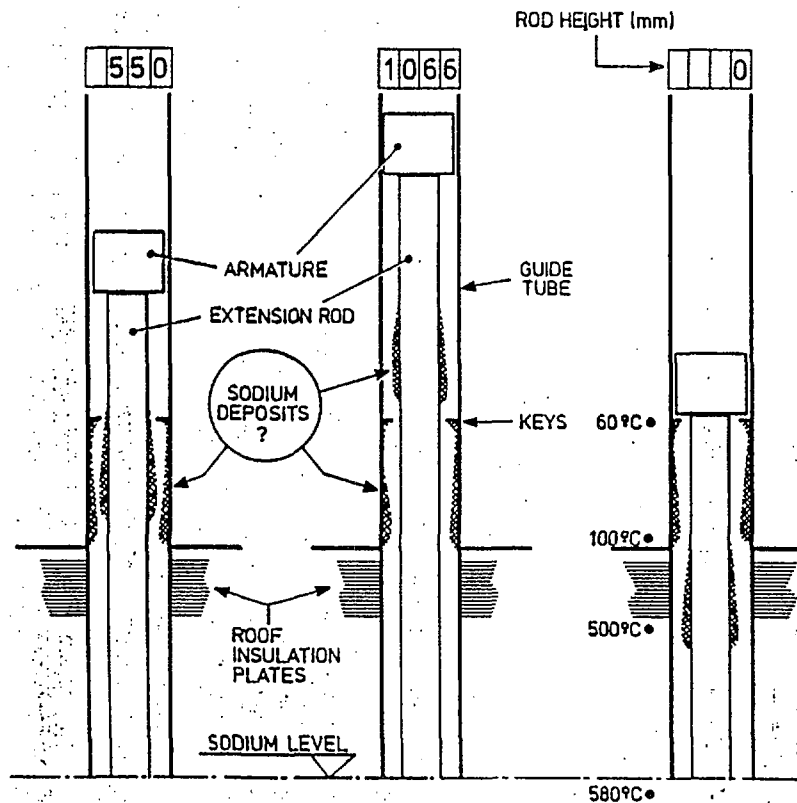
Figure 6.4. Location of Sodium Aerosol Deposits on a PFR Absorber Rod Mechanism

The friction is believed to have been caused by the buildup of sodium aerosol deposits on the inside of the liner tube and on the extension rod of the absorber in the cool region of the rotating shield, as shown in Figure 6.4. Lowering the rod moved the deposit on the guide tubes into the warmer region below the roof insulation where it melted off, reducing the friction.

In 1988 a special glove box was made which allowed examination of the liner tubes and the extension rods. Examination of a number of rods confirmed that sodium deposits were present but in smaller quantities than expected and confined to the keyway of the extension rods. None were found on the liner tube as originally hypothesised. The sodium was soft and easily removed. Although the absence of deposits other than in the keyways was surprising, when they were removed the friction of the restored rods to normal. It took some 40 efpd of operation for friction levels to begin to rise noticeably.

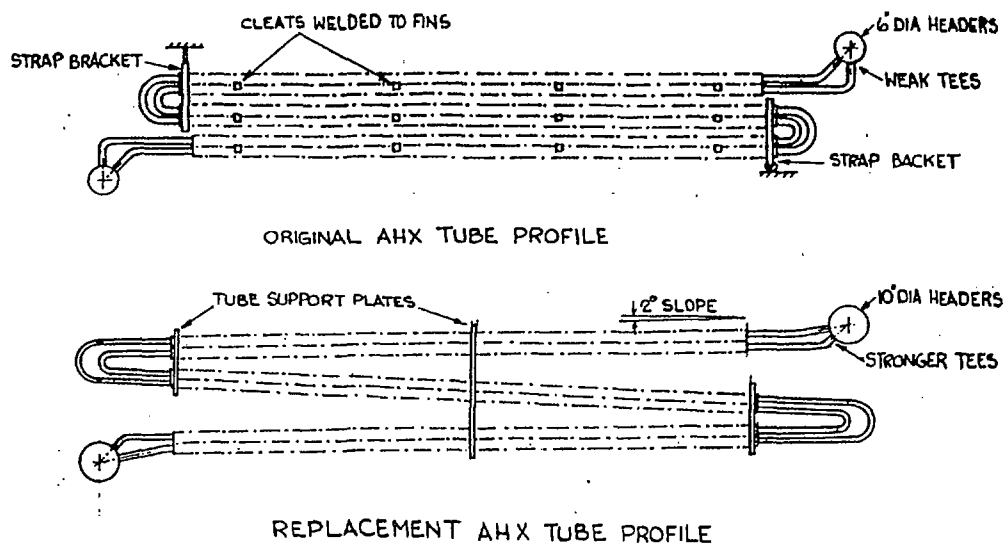
Figure 7.2. The Original and Replacement PFR Thermal Syphon Air Heat Exchangers

Although the thermal syphon system operated well, by 1984 it had become apparent that the AHXs suffered from a systematic fault leading to failures and leaks. Each AHX consisted of forty serpentine parallel tubes welded to pulled tees in two headers, as shown in Figure 7.2. The tubes were finned along the straight lengths but plain at the bends, which were clamped together and supported. Further rigidity was provided by cleats which were welded to the tops of the fins on adjacent tubes. Flow of NaK was from the top down. Leaks were occurred at the welds between the tubes and the pulled tees in the headers.

The measurements indicated that the problems occurred essentially because the AHX tubes were in parallel, and were horizontal with no fall to ensure good filling. When the AHXs were filled gas locks were occurring at the pipe bends. The gas-locked tubes remained cold, and as a result oxide impurities could be precipitated causing permanent blockages. Because of temperature differences between a cold blocked tube and the adjacent hot tubes to which it was clamped, large stresses were imposed. As a result the weakest point in the system, the weld between the tube and the header, was stressed, suffered cracking and eventually leaked.

Replacement AHXs (RAHXs) were manufactured to an improved design which avoided the problem of gas locks and afforded greater toleration of loss of flow in individual tubes. The following changes were made and are shown in Figure 7.2.

1. A 2° slope was given to the tubes to give better venting and drainage.
2. Each tube was given individual support,
3. The tube-header connections were reinforced.
4. Larger diameter headers were fitted to give better NaK distribution.

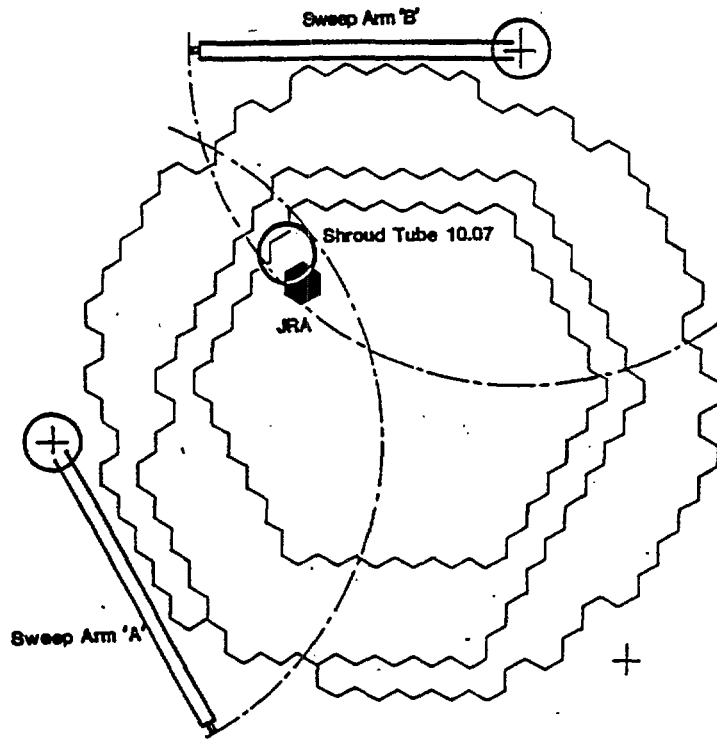
Figure 8.1. Location of an Elongated Subassembly in the PFR Core by the Sweep Arms

Immediately before refuelling operations in PFR three sweep arms were employed to ensure that there were no obstructions above the core which would prevent rotation of the rotating shield, as shown in Figure 8.1. At the start of a reload in 1988 the sweep arms were found to contact or partially contact objects in two core positions. These positions were identified as containing subassemblies with cold-worked EN58B steel wrappers, with a calculated dose of greater than 60 displacements per atom (dpa).

Using a special tool the heights of all subassemblies of the same material were checked. A distinct trend of rapid increase of growth at doses above 50 dpa was revealed as shown in Figure 8.2, although not all subassemblies were affected. Two subassemblies in particular, "JRA" and "GYN" (see Figure 8.2), had measured growths of about 40 mm. As a result all components with predicted doses likely to exceed 50 dpa by the end of the next run were removed from the core. Considerable difficulty was experienced in handling the severely distorted components and special tools had to be manufactured for their extraction and removal from the reactor.

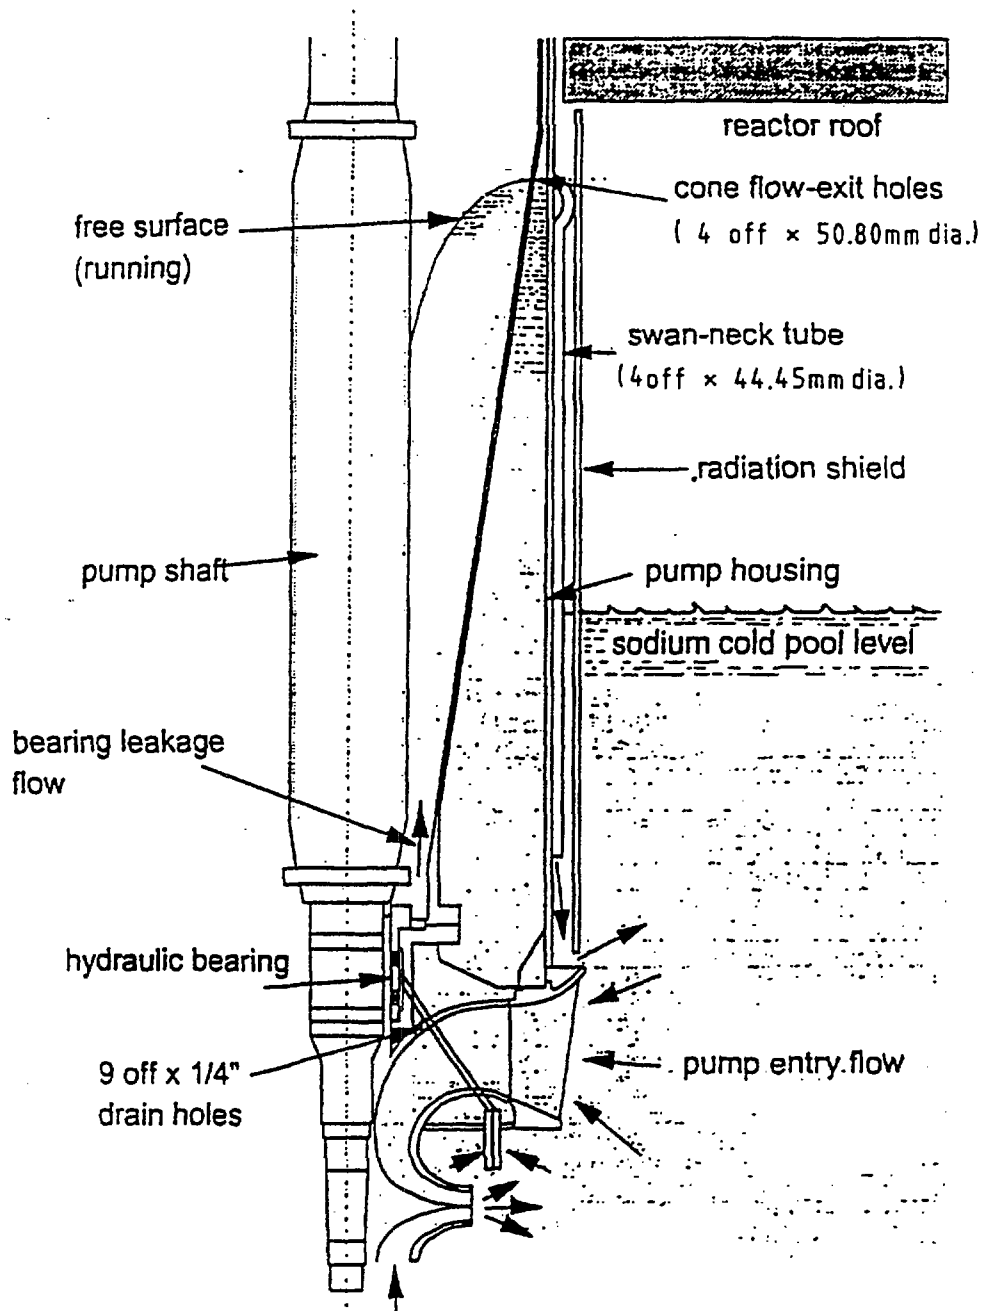
Figure 9.3. Detail of a PFR Primary Sodium Pump Housing

During this period of operation some 65 litres of oil had been lost from the pump upper seal oil systems, part of which is believed to have entered the reactor vessel. When the reactor was taken critical no effects of the oil were observed. It is suspected, however, that as a result of the spill the filter on PSP 2 valve ("O" in Figure 9.2) failed due to high differential pressure because it became blocked by oil-sodium reaction products. It is also thought that partial blockage of the pump casing overflow pipe (Figure 9.3) was to lead to the major problem in 1991.
