BACKFITTING OF THE FRG REACTORS

W. Krull

GKSS-FORSCHUNGSZENTRUM GEESTHACHT GMBH

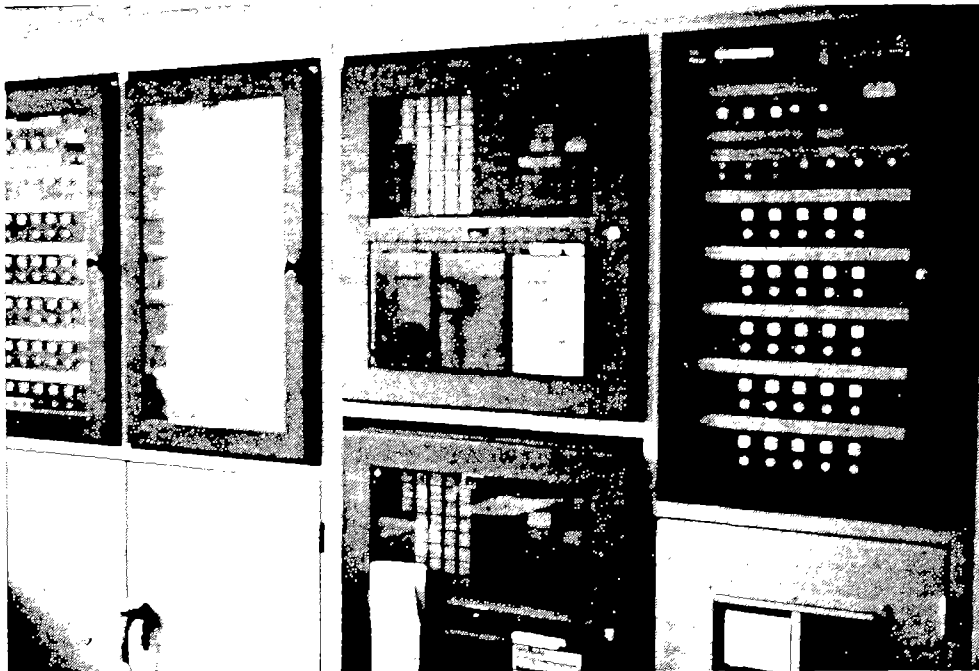
Fig. 4

The gap between an old building and new standards on fire protection has to be closed

1. all three stairways have to be separated from the floors
2. the fire resistance for some walls and doors has to be increased
3. not used cables from cable channels must be removed
4. smoke flaps and smoke ventilators have to be installed
5. cable penetrations must be fire protected
6. a fire detection monitoring system in all technical rooms and a fire alarm control panel was installed (fig. 4).

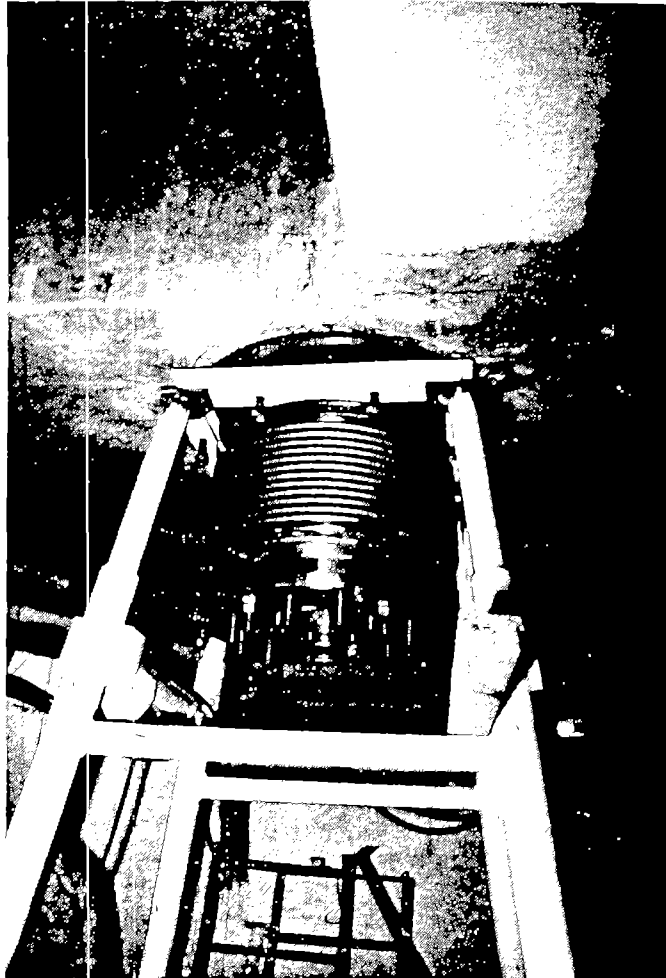
Fig. 5

The piping, valves, pumps etc. of the FRG-1 are located in the cellar below the FRG-1 reactor pool. Between ceiling and the first valve there was nothing to stop leaking water. For this reason between the ceiling and the first automatic operated valve a double tube has been installed for the water inlet and water outlet pipings.

In fig. 5 the double tubing and an auxiliary construction can be seen. This auxiliary construction is necessary to fix the double tubing in place in case of a leak in the first piping. Then the double tubing has to withstand the pressure of 10 m water above. In the space between the tubes 3 water detectors (heated thermocouples) have been installed giving an alarm in 2 out of 3 mode.

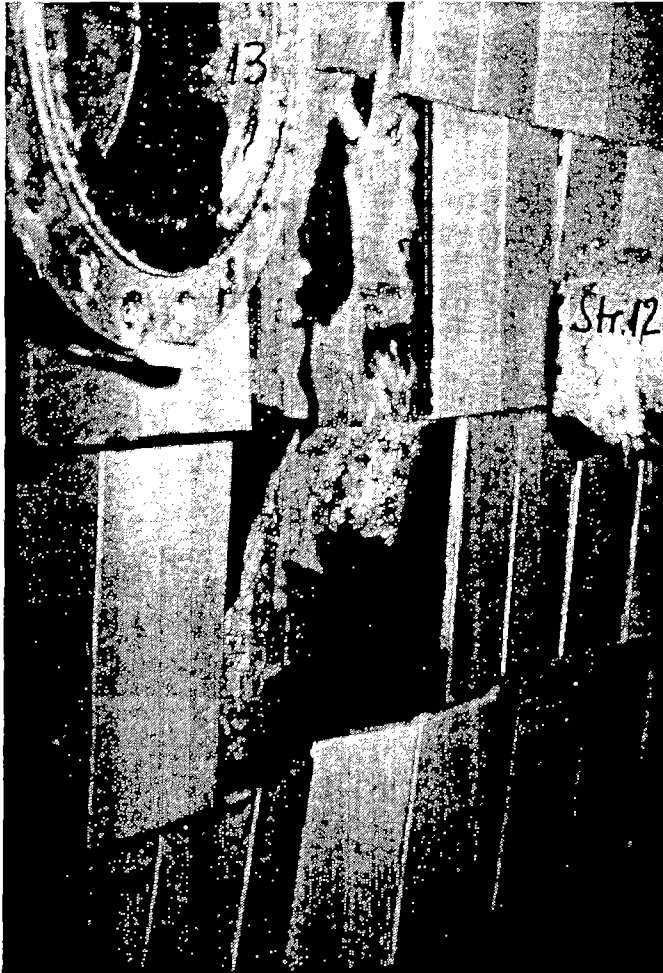
Fig. 6

Two kind of damages were known before starting the repair action: Water leakage from the ceiling in the cellar below the reactor pools and some defect tiles (fig. 6) at the walls of the FRG-1 pool.

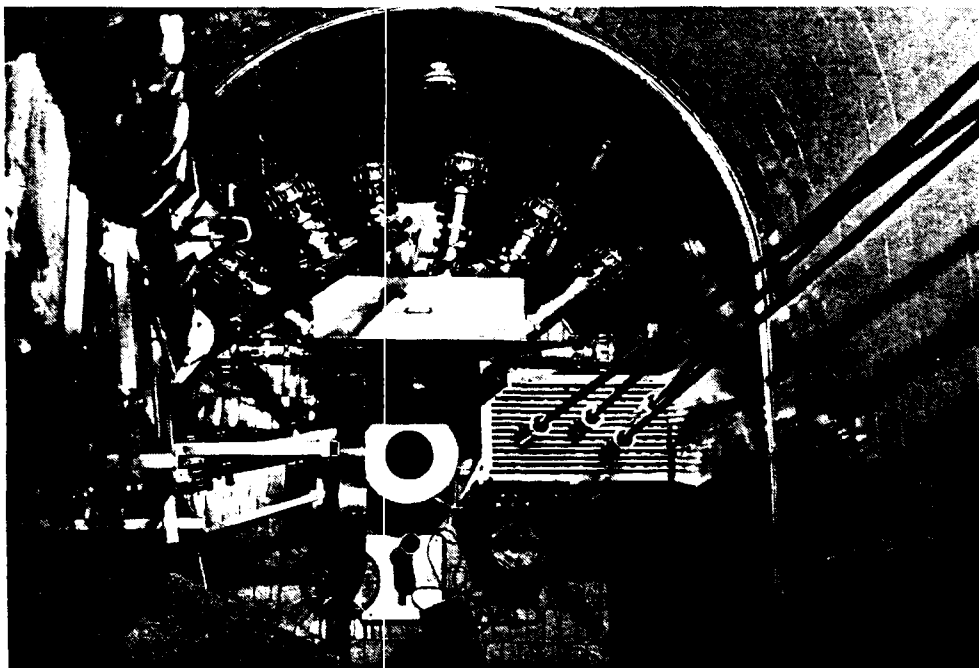
Fig. 10

The next fig. 10 shows the repaired pool:

- the beam tubes in place
- a Be block reflector installed
- and the inpile part of the cold neutron source.

6. The polyurethane has been injected with high pressure to tighten the thiokol seal between steel liner and Al beam tubes. For this purpose holes have been drilled through the concrete near to the thiokol. In these holes polyurethane was pressed. There are 20 of such penetrations of the liner and concrete and per penetration as a minimum 2 holes must be drilled to get a high confidence in this work.

7. After repairing the concrete, sealing the concrete with - at this time - unsaturated polyester (as this polyester is better γ -resistant than epoxy resin), the tiles have been placed and the pool cleaned up.
