Assessment of Core Structural Materials and Surveillance Programme of The Dalat Research Reactor

**TM on Assessment of Core Structural Materials and Surveillance Programme of
Research Reactors
14–18 June 2010, IAEA, Vienna, Austria**

Nguyen Nhi Dien, NRI, Dalat, Vietnam

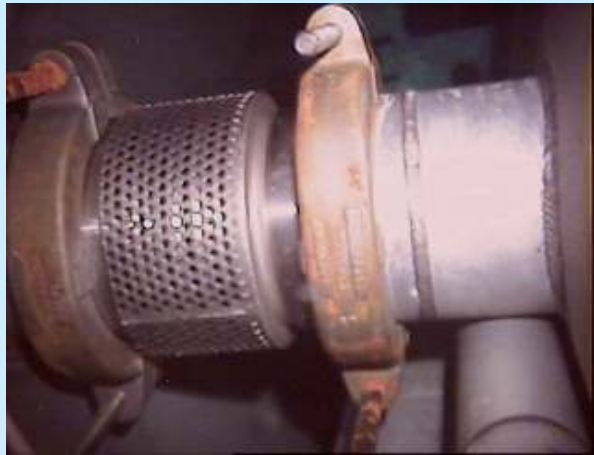
- + **The most concerns are with beam port No #4** because two of four steel bolts to tighten-up the flexible joint (the bellows assembly flange of beam port) were rusted and the results shown that this rust was slowly developed.
- + It means **the electro-chemical corrosion still happens with these bolts.**
- + However, it was difficult to explain clearly because **only two of four bolts are rusted, but two others still have a shining color of original stainless steel.**

Rusts of two bolts tighten-up the flexible joint of the beam tube No.4

(down side)

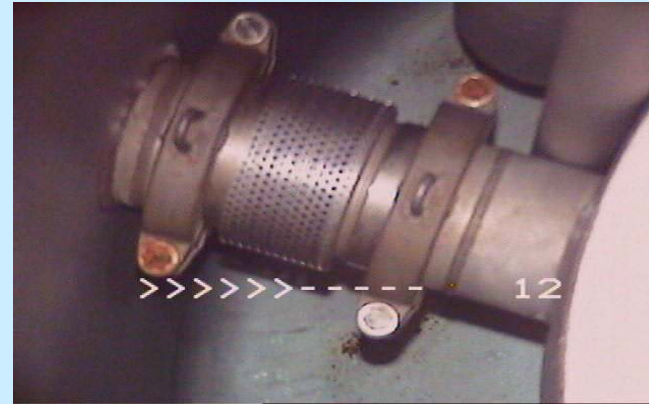
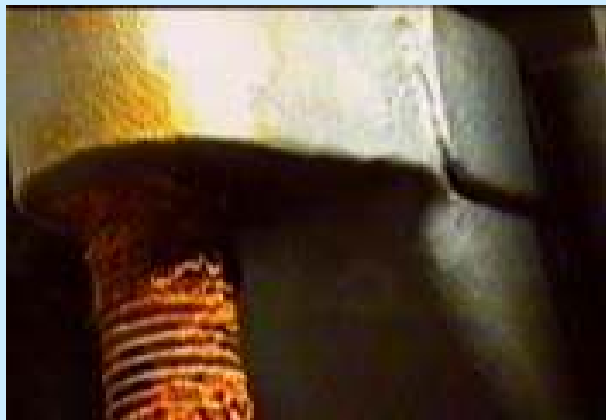
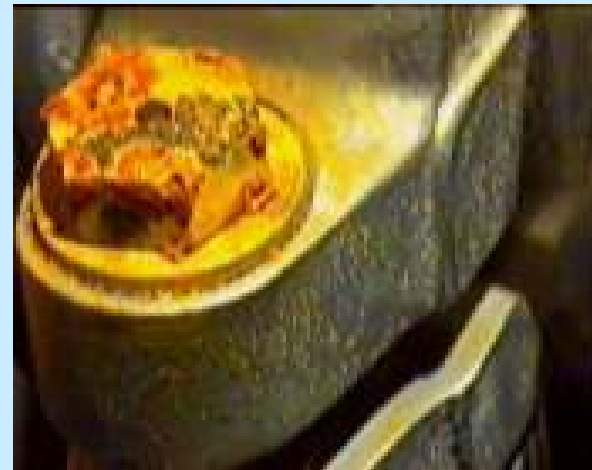
(up side)

→ Only two of four bolts are rusted, two others still have a shining color of stainless steel ?.

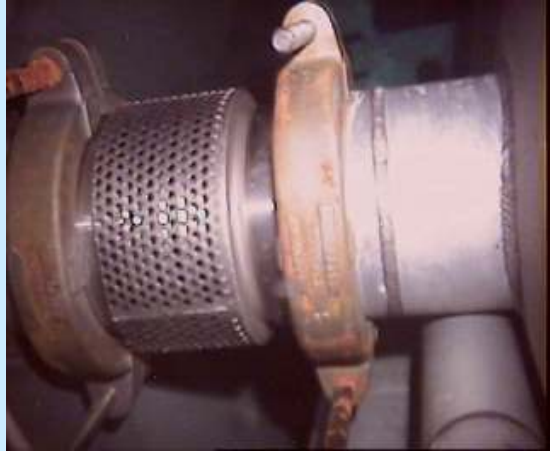
(2009)

Rusts of two bolts inspected by years

→ It seems to be slowly developed.

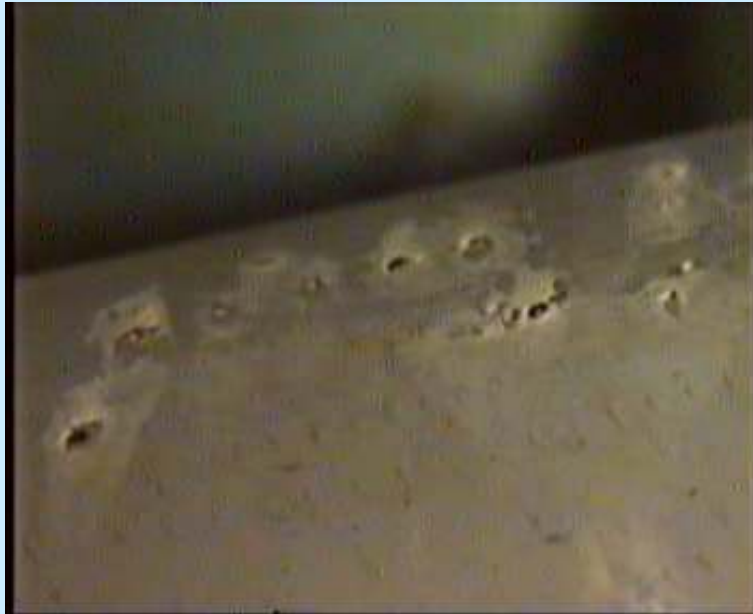
- + There were some pitting corrosions with 2-3mm in diameter on the outside surface of beam port No #3.**
- + It is due to surface scratches or mechanical defects happened when the re-installation of reactor structures done during the years 1982-1983.**
- + Based on the result assessment it could be noted that corrosion phenomenon still happens but slowly develops.**

Pitting corrosion on the surface of beam port No #3.

(upper
surface)

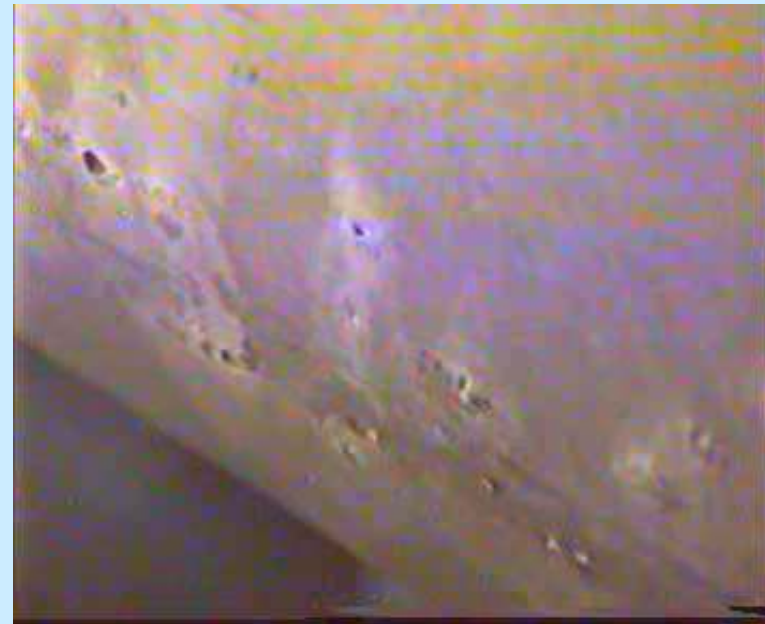
(side surface)

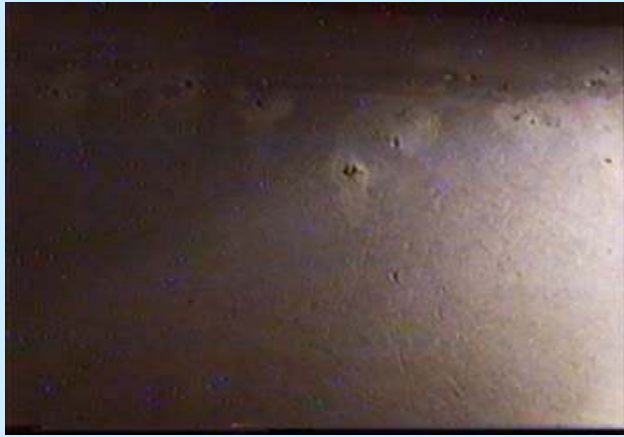
(2001)

Pitting corrosion on the surface of the beam tube No.3

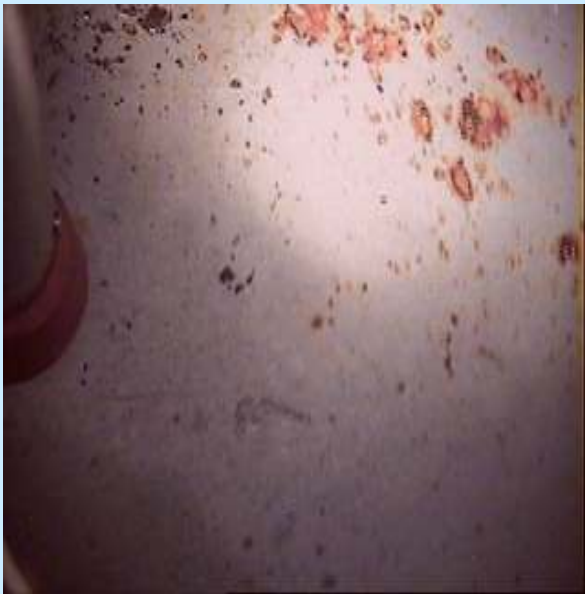
+ There are small steel components which have probably fallen accidentally into the pool tank (washers, bolts, etc.), leading to oxide particles deposit **on top of the thermal column and beam ports, and on the bottom of the pool tank.**

(oxide particles deposit on the pool bottom next to beam port No #3)

- The surface of the aluminium pool liner and in-pool structures is regularly cleaned and deposits fallen objects are removed by a sucking pump;
 - The visual inspections are regularly carried out.

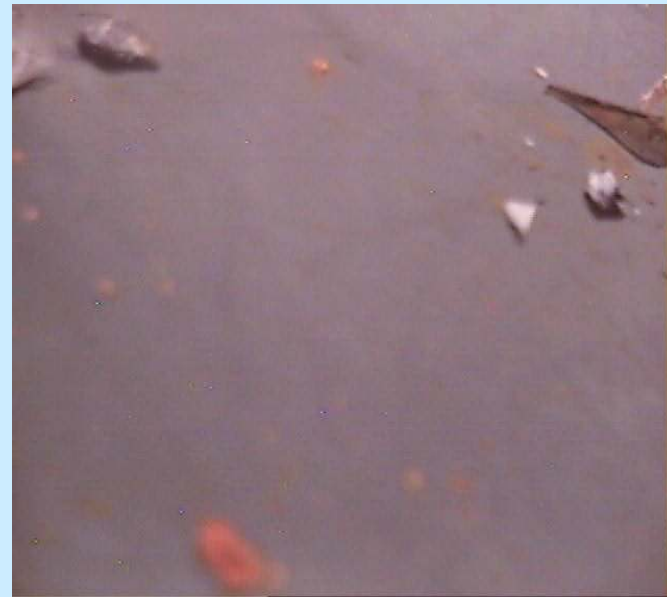
(Some defects on the pool bottom around the reflector leg)

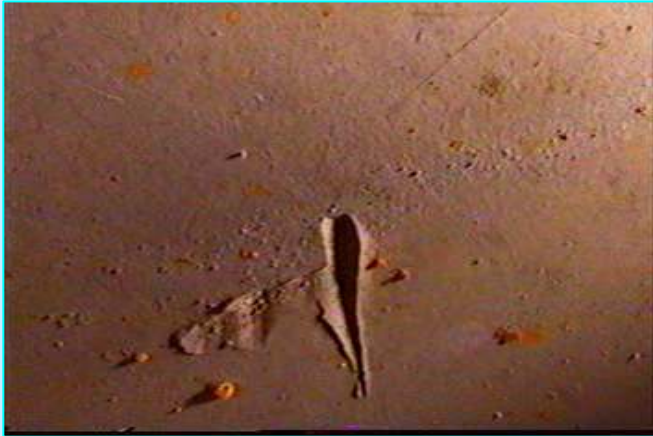
Mechanical defect on bottom of the pool

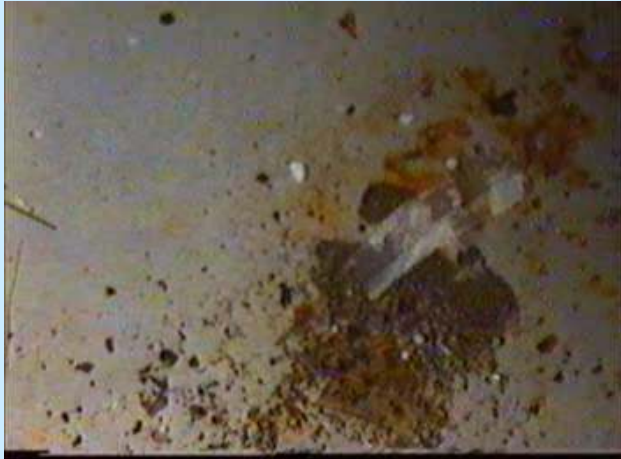
On the pool bottom before cleaning (2001)

Cleaning the reactor pool by home-made system

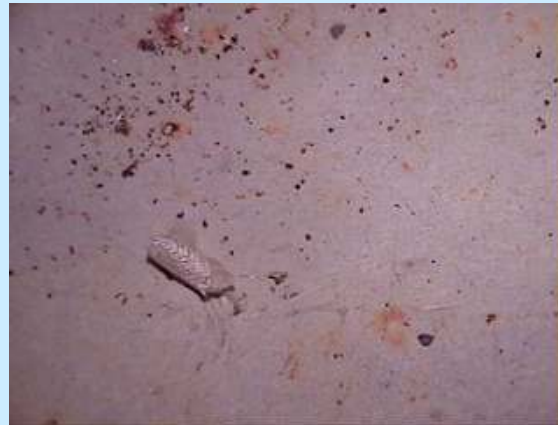
On the pool bottom after several cleanings (2008)

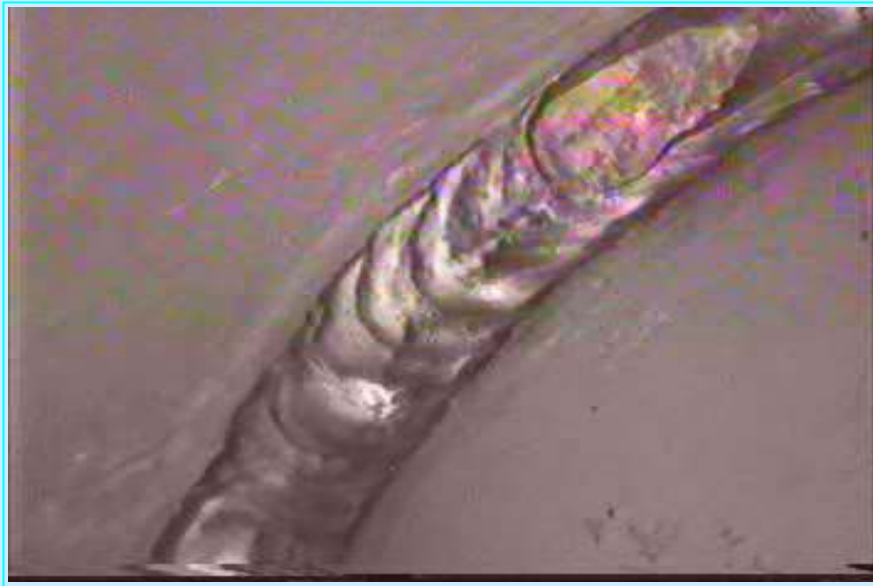
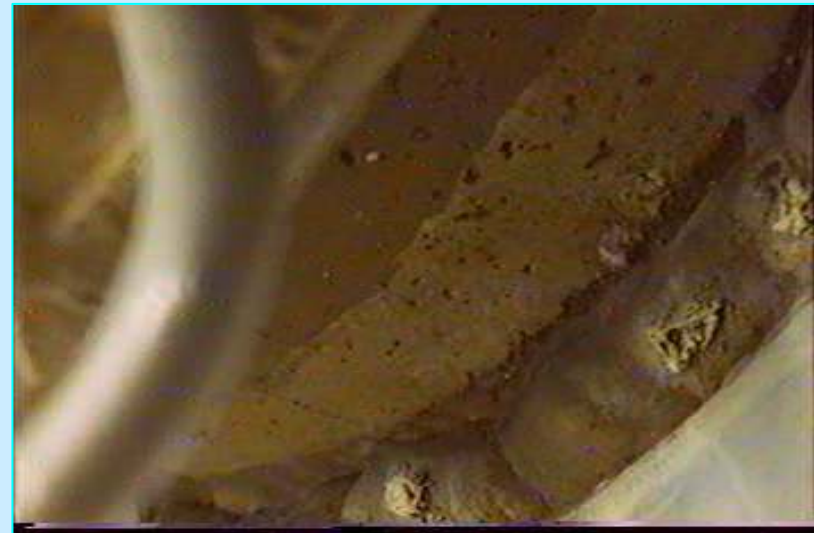
+ There are small defects that could be stress corrosion cracks or mechanical cracks, mainly along the welds, but corrosion products have not been watched.

Defect corrosion on the welding line of beam tube No.4

→ It seems that corrosions were not developed from year to year.

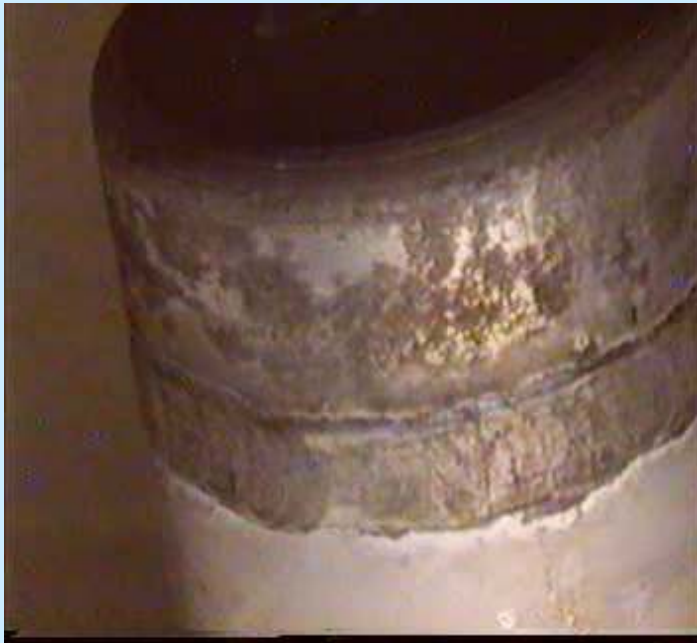
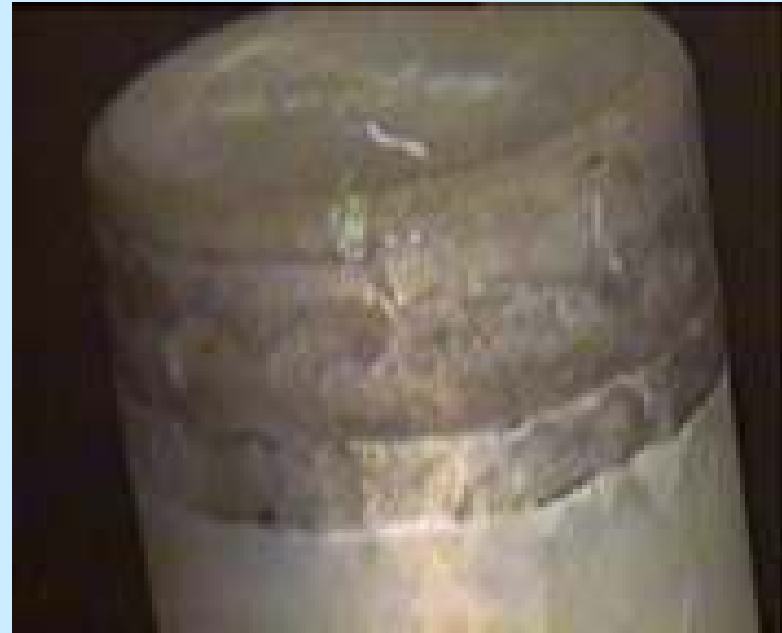
+ There are corrosion phenomena on surface at the bottom part of aluminium detector housings.

(Corrosion on the outside surface at the bottom of neutron detector housing)
