Induced Vibrations In the Pumps

Experiences with Sodium Pumps in the KNK

by Erich Zimmermann, Kernkraftwerk-Betriebsgesellschaft m.b.H.

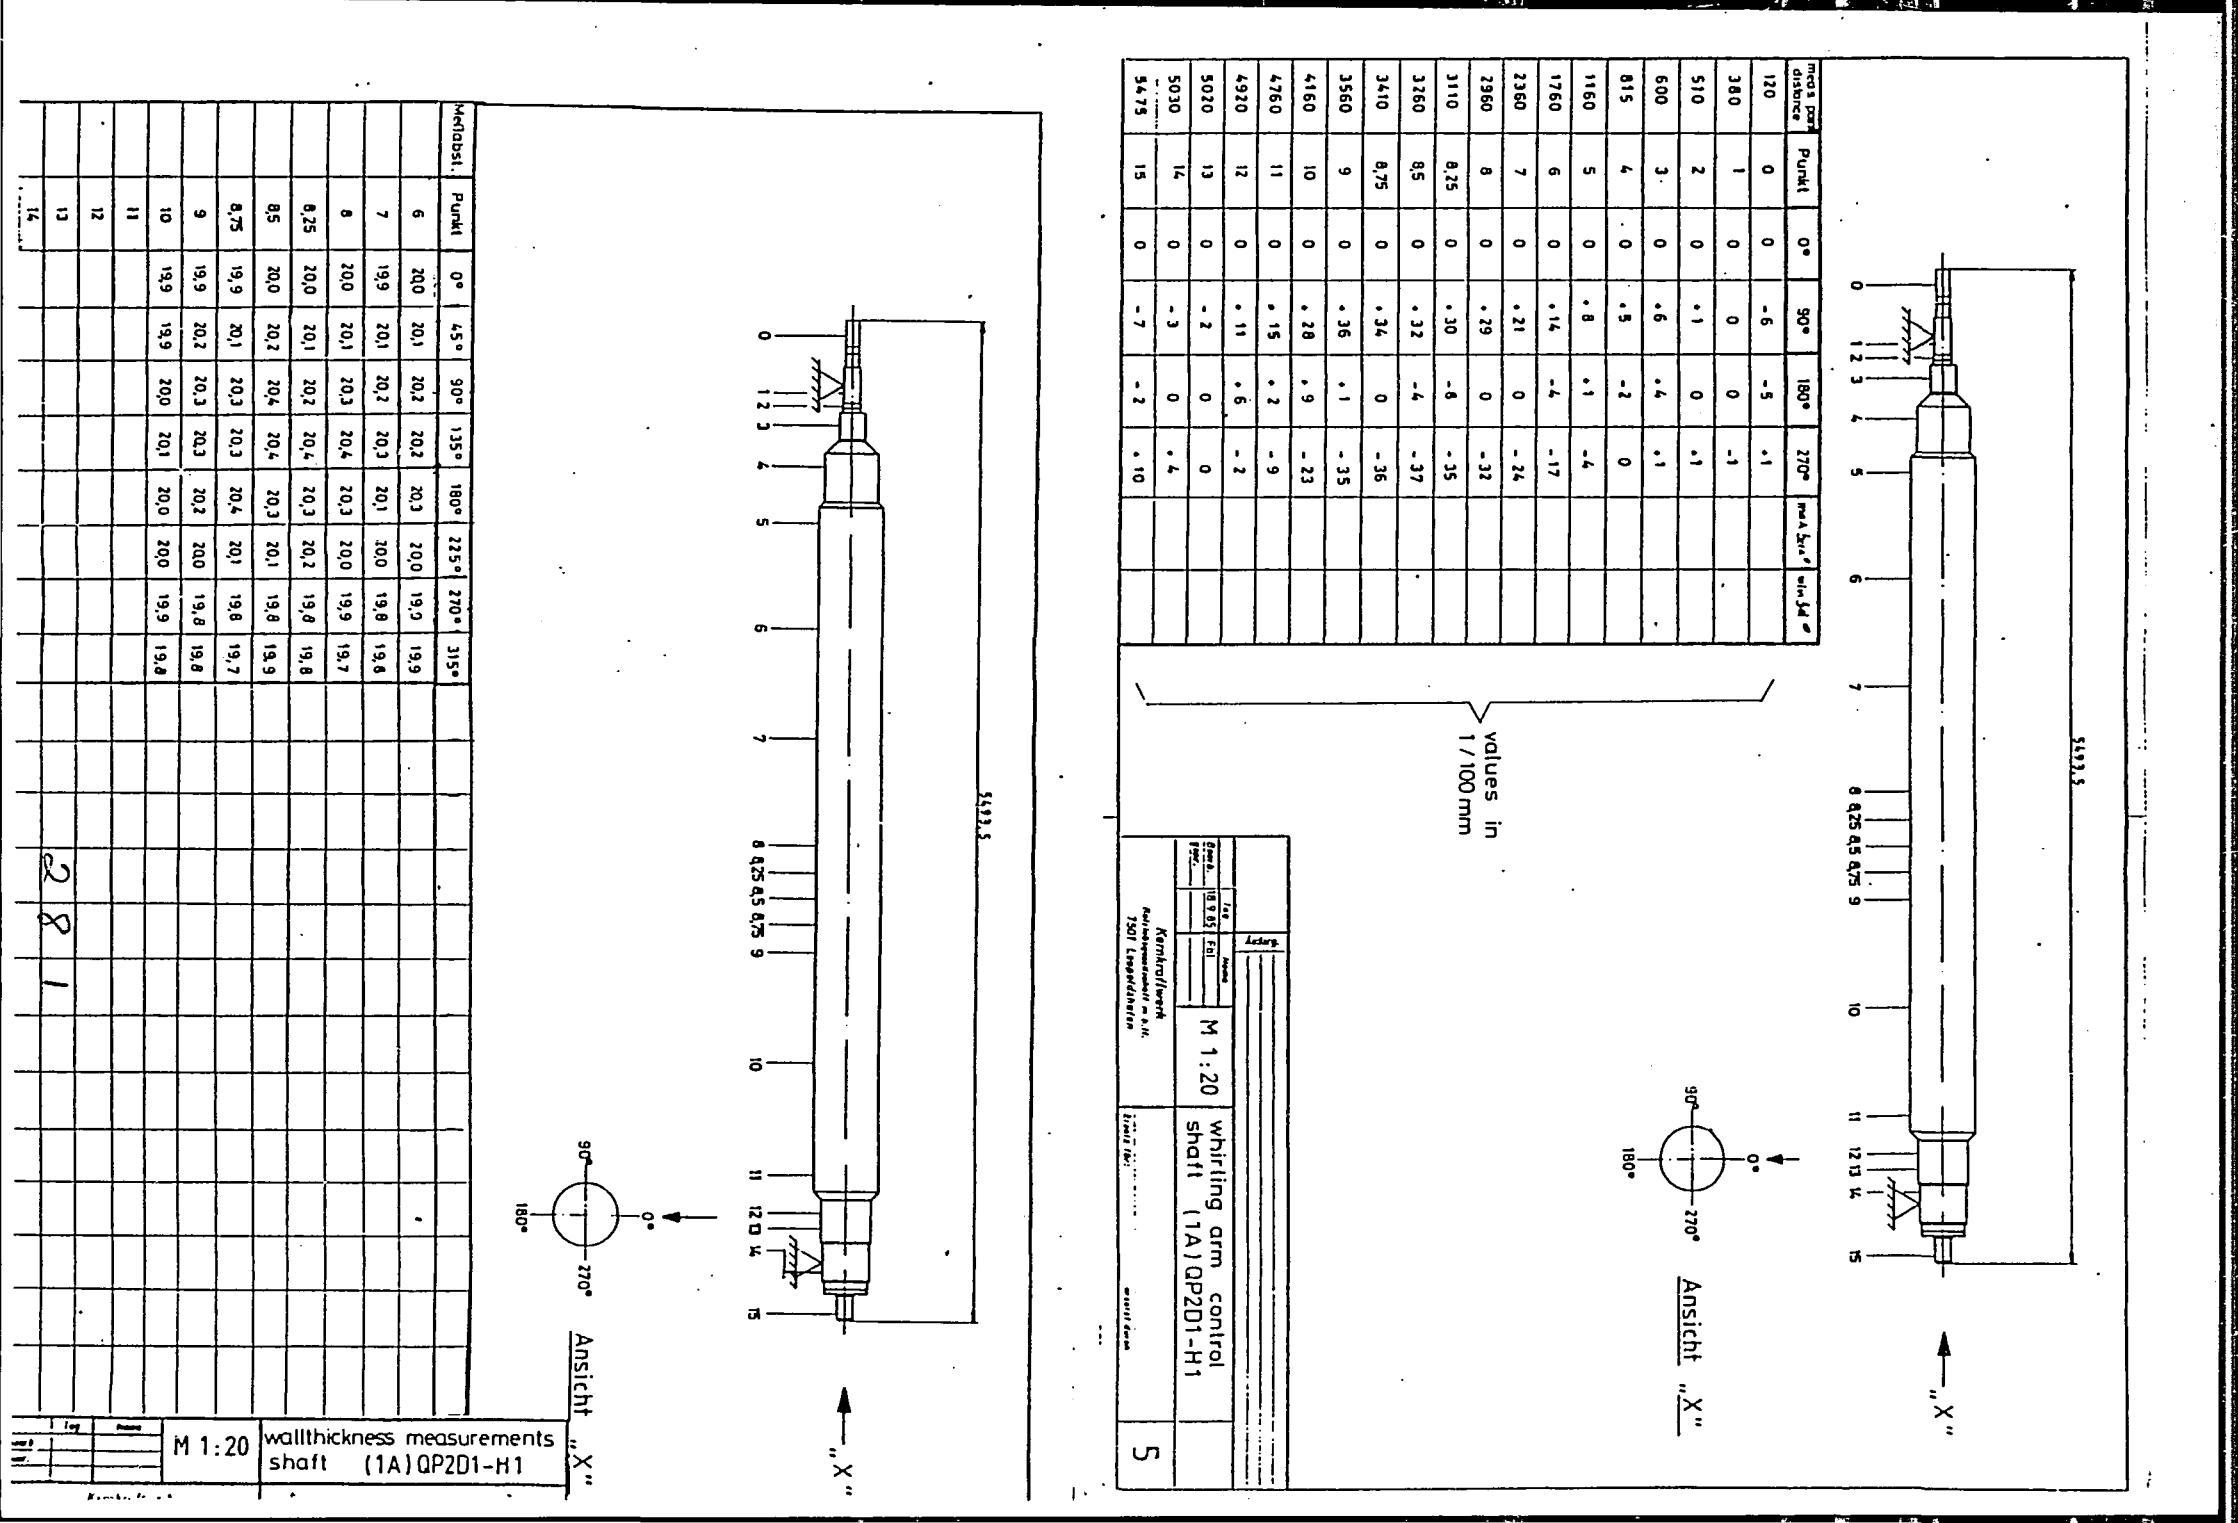
In 1984 we have changed the rotor runner (pict. 3) after about 80 000 working hours and at a vibration level of 250 μ m. After demounting and cleaning of the parts we have controlled and measured them. Dimensional discrepancies we have found at the spindle (pict. 5). In the half length of the shaft we have noted a bending of abt. 0.4 mm. The measurements of wall thickness (pict. 6) have shown different values. In our opinion the continuous increasing of vibrations refers to two facts:

In all probability we have here the same defects on the new manufactured shaft as on the old shaft. Therefore we will have only still a short working life for the new shaft until the limit vibrations of 300 μ m. For this reason we have to repair the removed part. The buckling is nearly exact over the greatest wall thickness. (Compare pict. 5 + 6).

The irregularities will be removed by grinding.

We hope to get by this method equally wall thickness and reduced unbalance. By reduced unbalance the creeping behaviour will be improved. We also hope with this corrections to get the necessary quietness for the sodium pump in primary circuit 2.

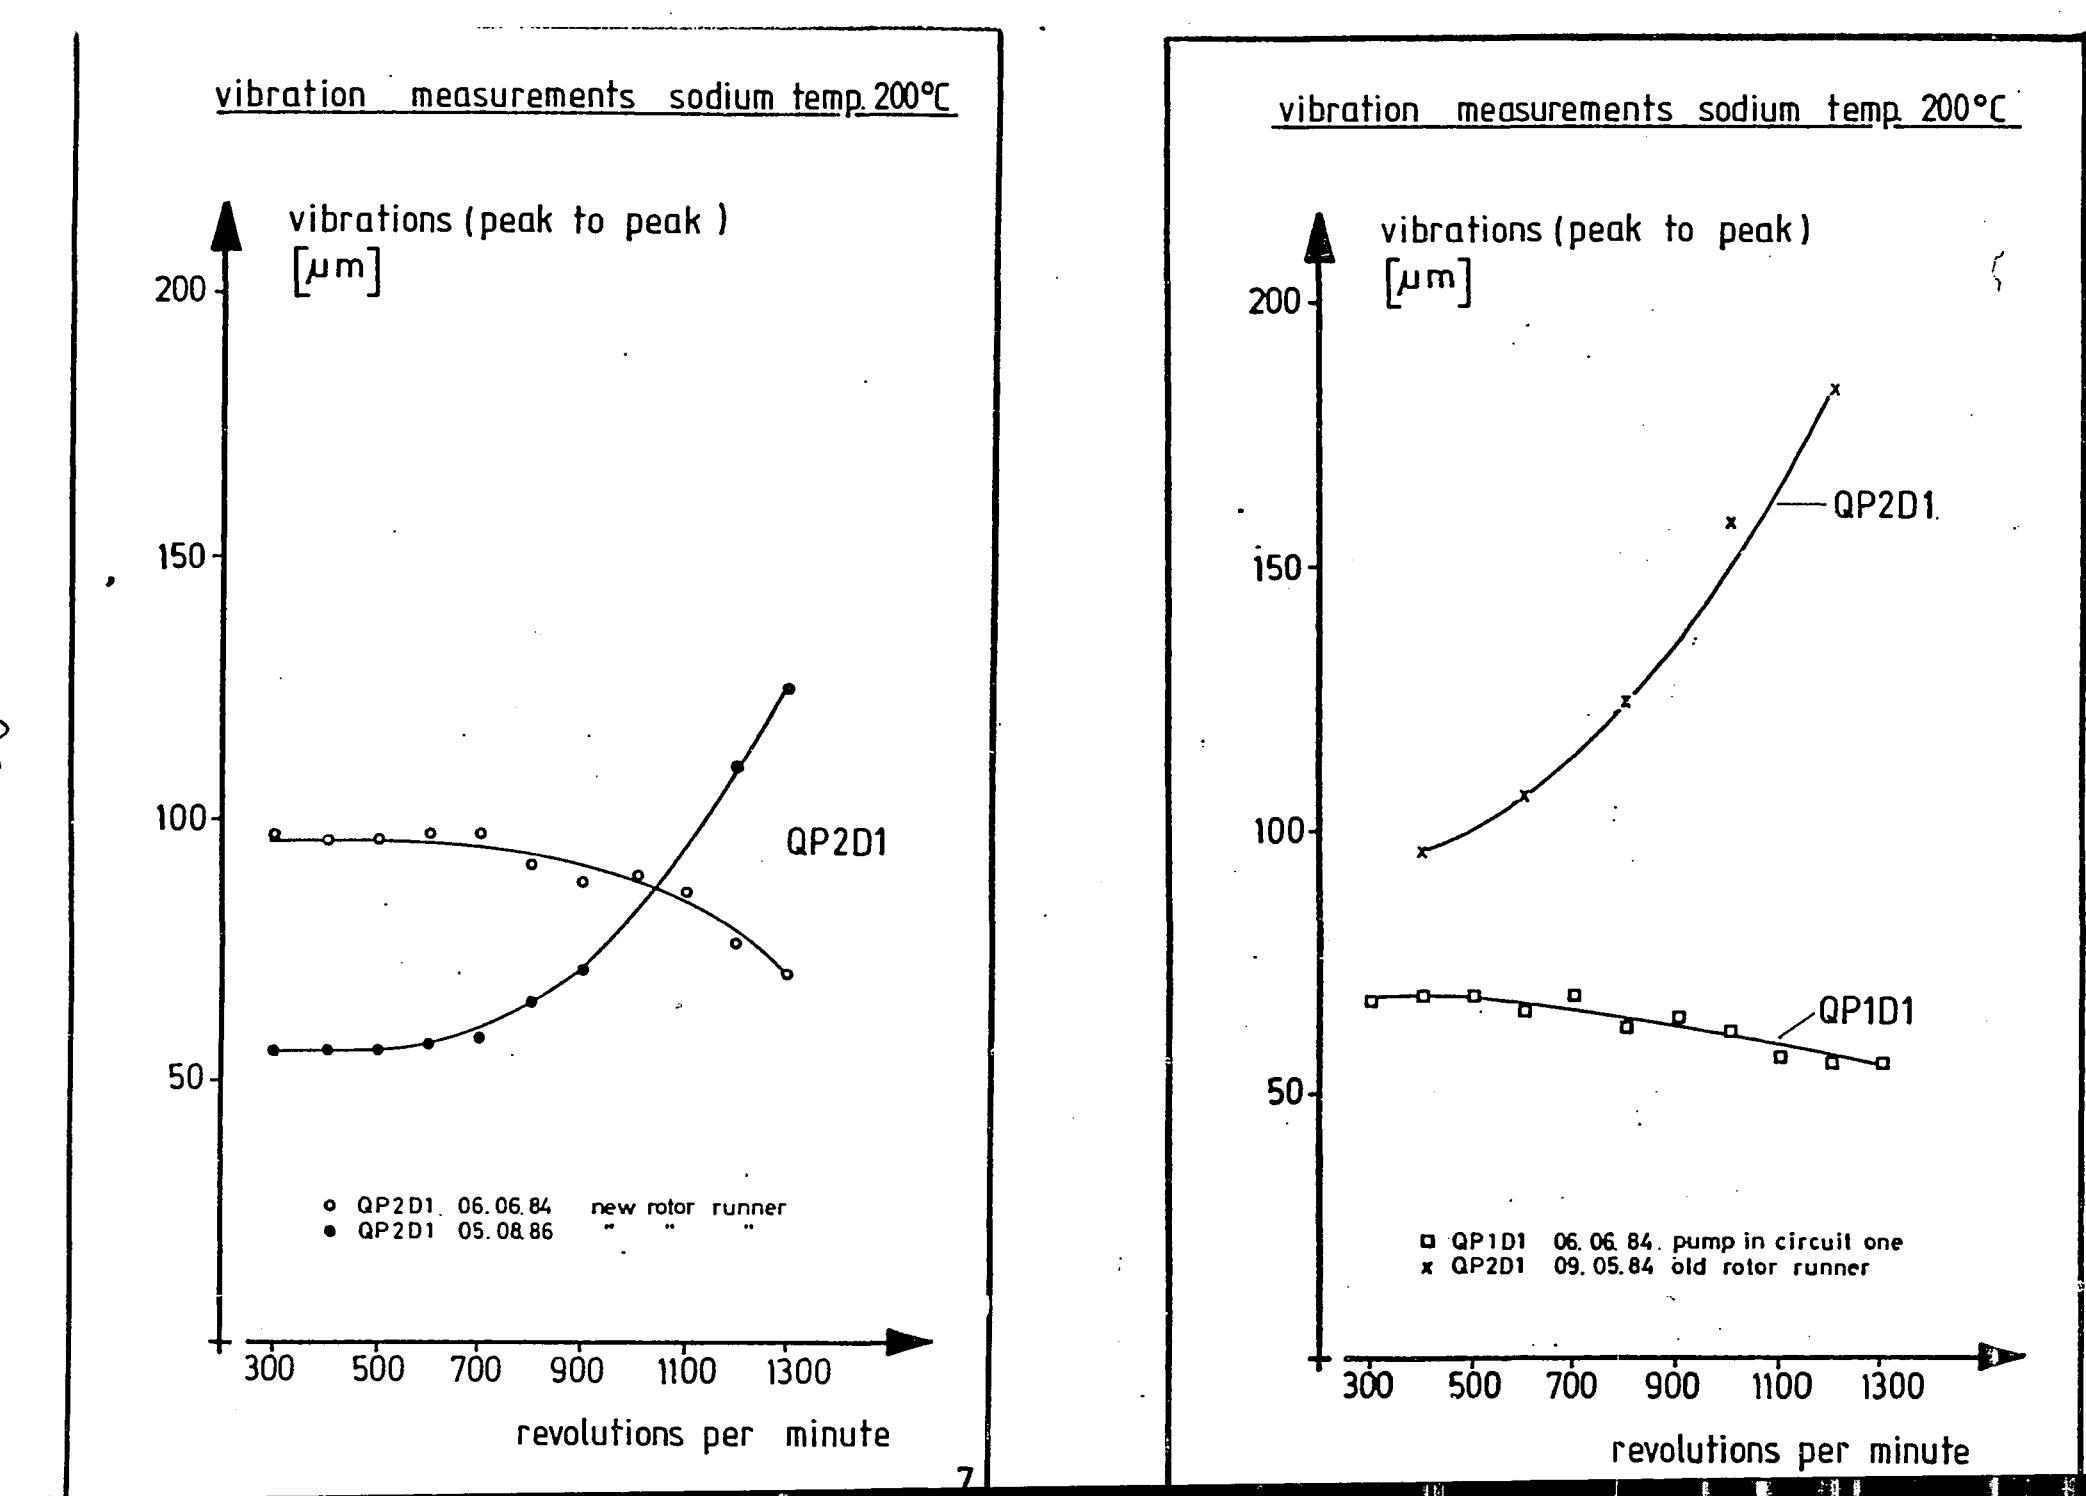
In June 1984 we have made base measurings at the new installed rotor runner at a sodium temperature of 200° C and various revolutions (pict. 7).

A controlling measurement in 1986 has shown the same symptoms as received from the old rotor runner in May 1984. (pict. 7). Compare the curve of the old rotor runner recorded in May 1984 (pict. 8). The vibration values recorded during full power operation and 520°C sodium temperature are directly comparable with the values of the old rotor runner during the same operating conditions (pict. 9). Compare (pict. 9) with (pict.4). The other curves in (pict. 9) have been recorded at a sodium temperature of 200 °C by hand measuring device at the measuring points 1, 11 and 13. (pict. 10). All these different measuring methods at different temperatures and measuring points confirm the above described tendency.
