Microbial analysis and surface characterization of SABIC carbon steel corrosion in soils of different moisture levels

Awatif Al-Judaibi¹, Aisha Al-Moubaraki²

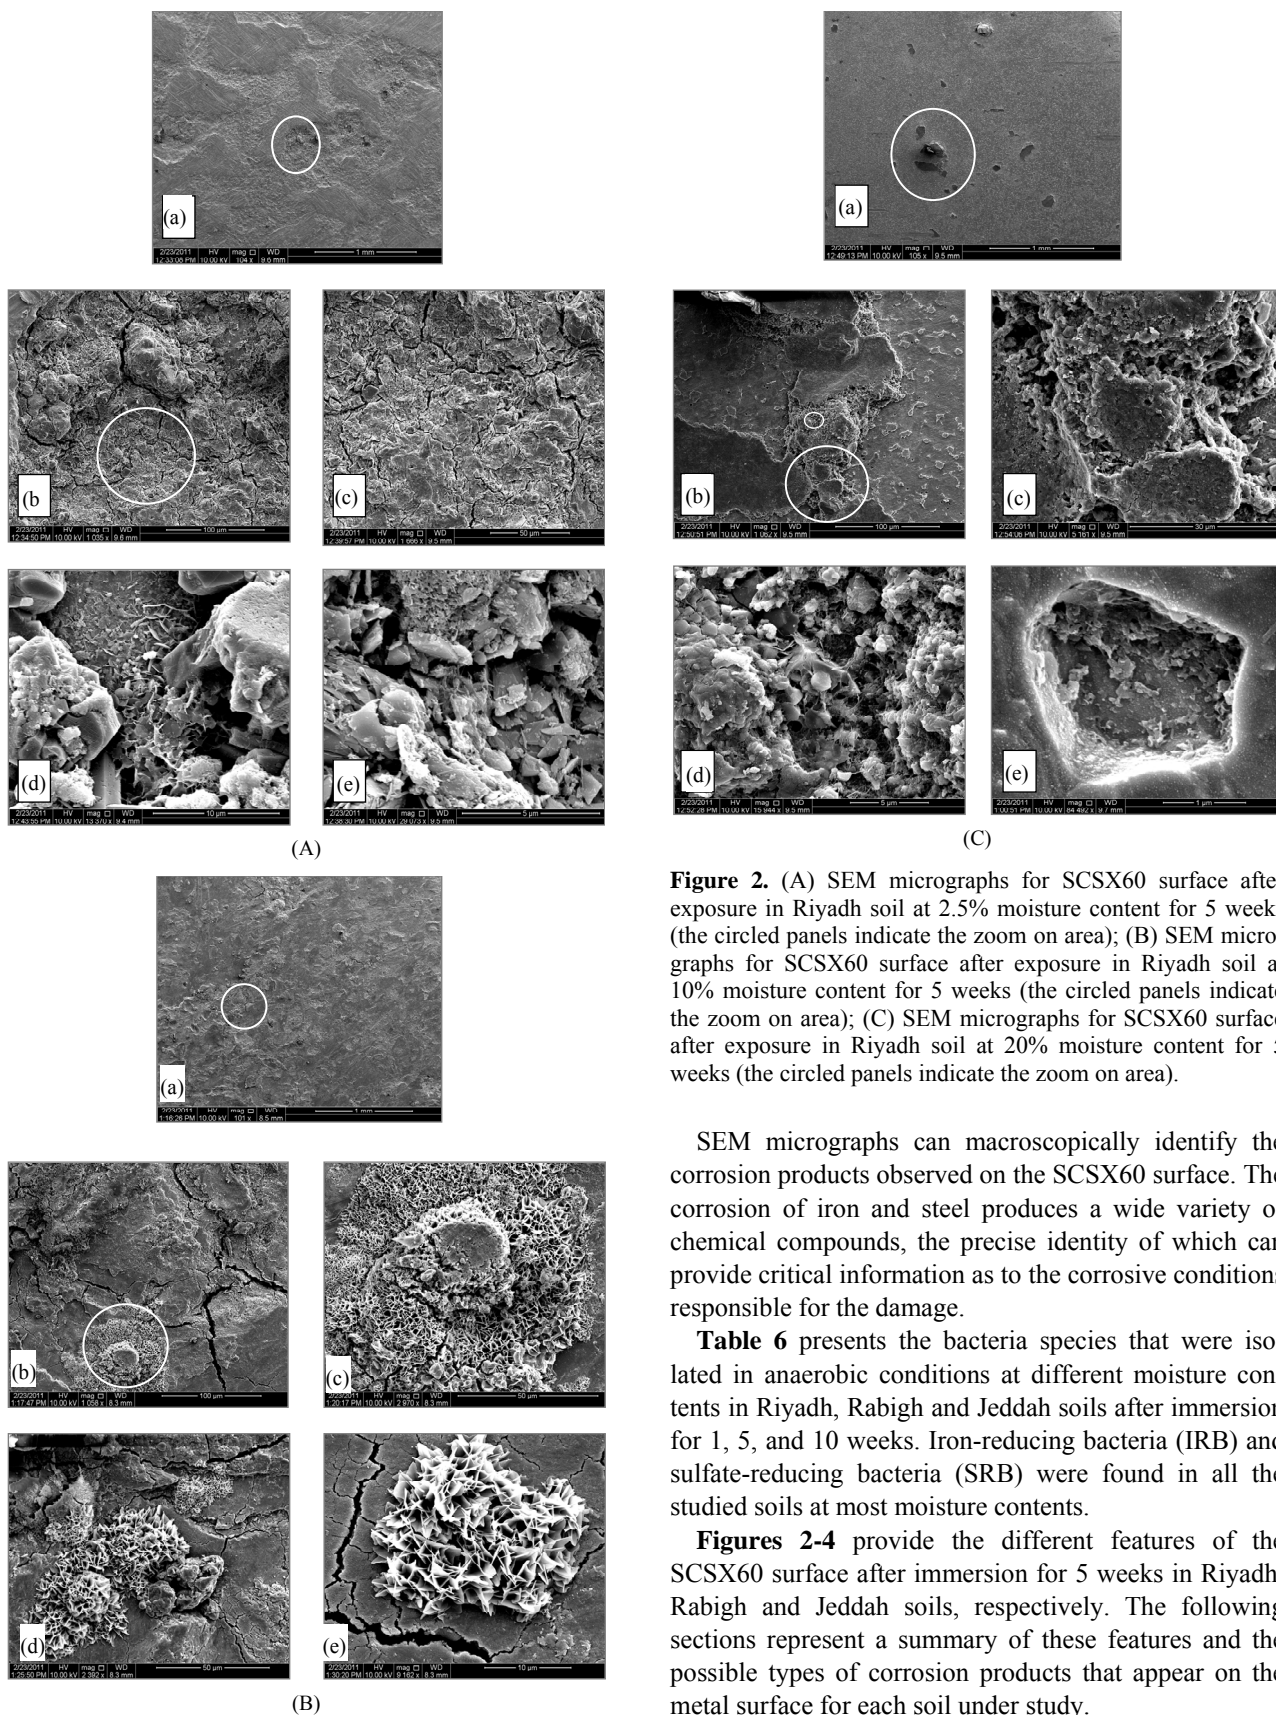
Figure 2. (A) SEM micrographs for SCSX60 surface after exposure in Riyadh soil at 2.5% moisture content for 5 weeks (the circled panels indicate the zoom on area); (B) SEM micrographs for SCSX60 surface after exposure in Riyadh soil at 10% moisture content for 5 weeks (the circled panels indicate the zoom on area); (C) SEM micrographs for SCSX60 surface after exposure in Riyadh soil at 20% moisture content for 5 weeks (the circled panels indicate the zoom on area).

Figure 2(A)-(C) show SEM micrographs for SCSX60 specimens after immersion for 5 weeks in Riyadh soil at three different moisture contents: 2.5%, 10% and 20%. As observed, the morphology and composition of the corrosion products formed on SCSX60 specimens vary according to the studied moisture contents. In 2.5% moisture content, small cracks are visible in the layer of corrosion products (**Figures 2(Ab)** and **2(Ac)**). If the film growth continues beyond this critical thickness, cracking occurs. With a high power zoom (**Figures 2(Ad)** and **2(Ae)**), substances such as jelly glue can be observed among “stone like” corrosion products. **Figure 2(Ad)**, shows a “cornflake-like” In addition, the cracks are also observed in the film on SCSX60 specimens formed by the corrosion products after immersion in Riyadh soil with 10% moisture content (**Figure 2(B)**).

A thin plate of overlapping crystals that looks like a “flowery” structure, can be seen in **Figures 2(Bb)-2(Be)**.

In 20% moisture content, a low density of corrosion products can be seen (**Figure 2(Ca)**). By comparing between the structural features of SCSX60 after immersion for 5 weeks in Riyadh soil of 2.5%, 10%, and 20% moisture contents (**Figures 2(Aa)-2(Ca)**), Riyadh soil of 20% moisture showed the lowest density of corrosion products, which is in agreement with the corrosion rate measured at various moisture contents.

According to Hausler *et al.* [36], the corrosion product forms a film that grows until a critical thickness. The products showed in **Figure 2** are extracellular polymer substances resulting from the metabolic activity of microorganisms. The formation can be observed clearly through the extracellular polymer substances. In the microscopically studied [10], the interaction between corrosion-causing bacterium and the corroding mild steel coupon. The authors found that surface of mild steel coupon changed from loss or deposition of corrosion products and from the attachment of the bacteria and its exopolysaccharide fibers to the coupon surface.

In **Figure 2** Similar structures were previously observed on X65 carbon steel samples during its corrosion in H_2S/CO_2 environments for various periods of time [37]. The crystals that appear in **Figure 2(B)** are a form of iron sulfide FeS. The formation of FeS may be generated by a microbial reduction of SO_4^{2-} to S^{2-} [3,38, 39]. Zhao *et al.* [40] reported that in an environment containing SRB, the original corrosion products are mainly iron (oxyhydr)oxide. In the presence of SO_4^{2-} , (oxyhydr)oxide transforms to sulfide with the reaction of biogenic hydrogen sulfide, extracellular polymer substances, and organic acid. The authors of a previous study studied the transformation by SRB of iron to iron sulfide through iron oxyhydro (oxide) in a marine environment [19,22,37,41].

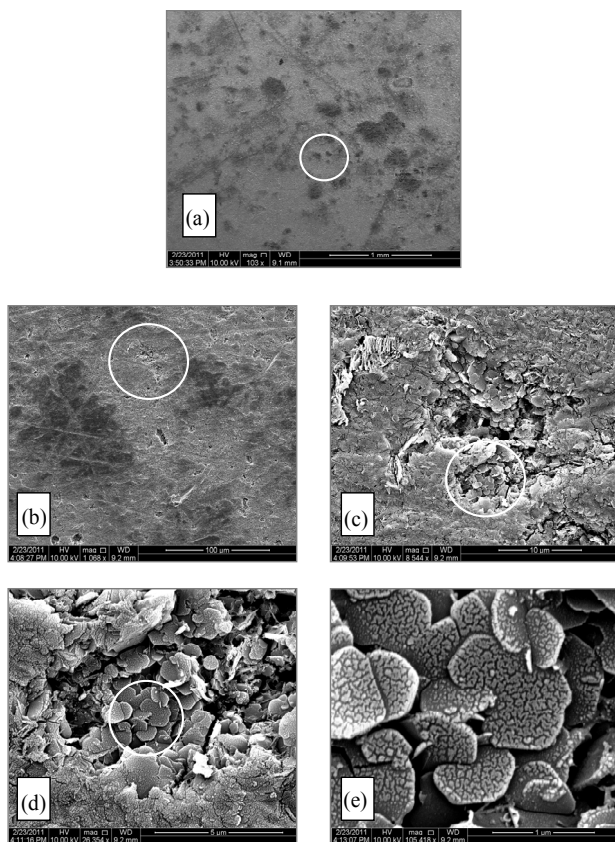
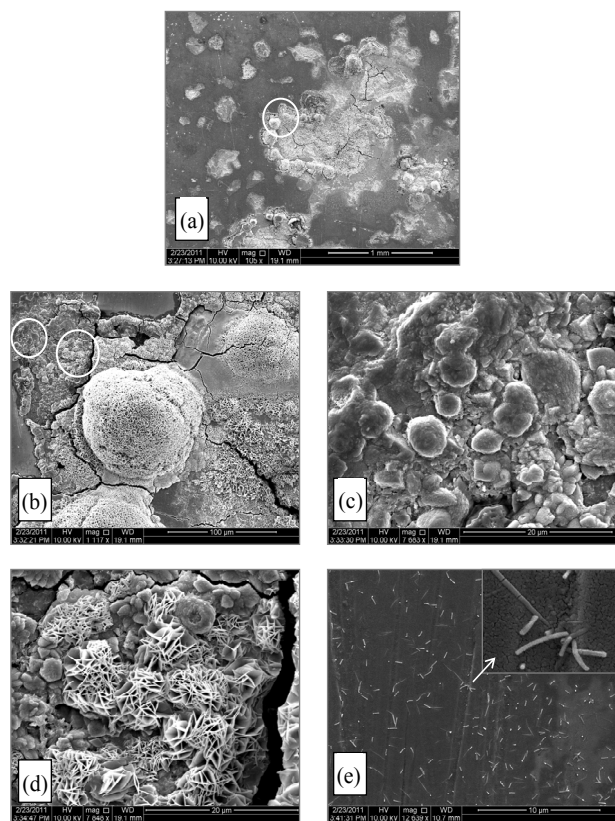
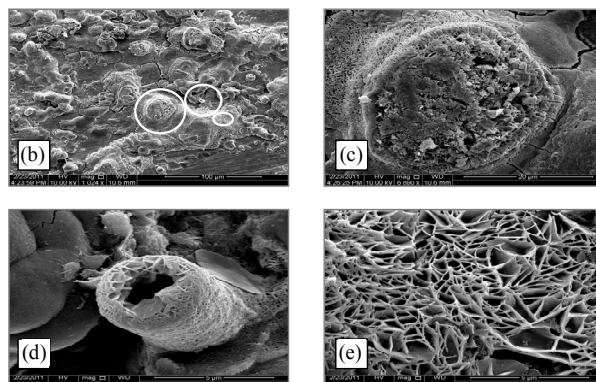
Figure 3. (A) SEM micrographs for SCSX60 surface after exposure in Rabigh soil at 2.5% moisture content for 5 weeks. (the circled panels indicate the zoom on area); (B) SEM micrographs for SCSX60 surface after exposure in Rabigh soil at 10% moisture content for 5 weeks (the circled panels indicate the zoom on area); (C) SEM micrograph for SCSX60 surface after exposure in Rabigh soil at 20% moisture content for 5 weeks (the circled panels indicate the zoom on area).

Figures 3(A)-(C) show a representative SEM micrograph for SCSX60 specimens after immersion for 5 weeks in Rabigh soil at three different moisture contents: 2.5%, 10%, and 20%. In 2.5% moisture small pits with a distinct shape were visible as shown on the electron micrographs (**Figure 3(Ab)**). These pits were filled with corrosion products. A closer view of one pit (**Figures 3(Ac)-3(Ae)**) reveals hexagonal plates with several shapes.

Interestingly, in the case of the 10% moisture content, cracks observed in a layer of corrosion products that have a “cotton ball-like” structure (**Figure 3(Ba)**). In a high power zoom view (**Figure 3(Bb)**), the cotton ball structures were found to consist of FeS crystals joined to one another. A high magnification of the circle panels in **Figure 3(Bb)** shows FeS as amorphous round shape formations (**Figure 3(Bc)**) and as crystals (**Figure 3(Bd)**). Rod and spherical-shaped microbes (SRB) on the corrosion products film can be clearly observed (**Figure 3(Be)**).

A micrograph of the SCSX60 specimen exposed to 20% moisture is presented in **Figure 3(C)**. The corrosion products are randomly distributed on the surface of the specimen (**Figure 3(Ca)**), and “cotton ball-like” structures of FeS could be observed in a high power zoom (**Figures 3(Cb)** and **3(Cc)**).

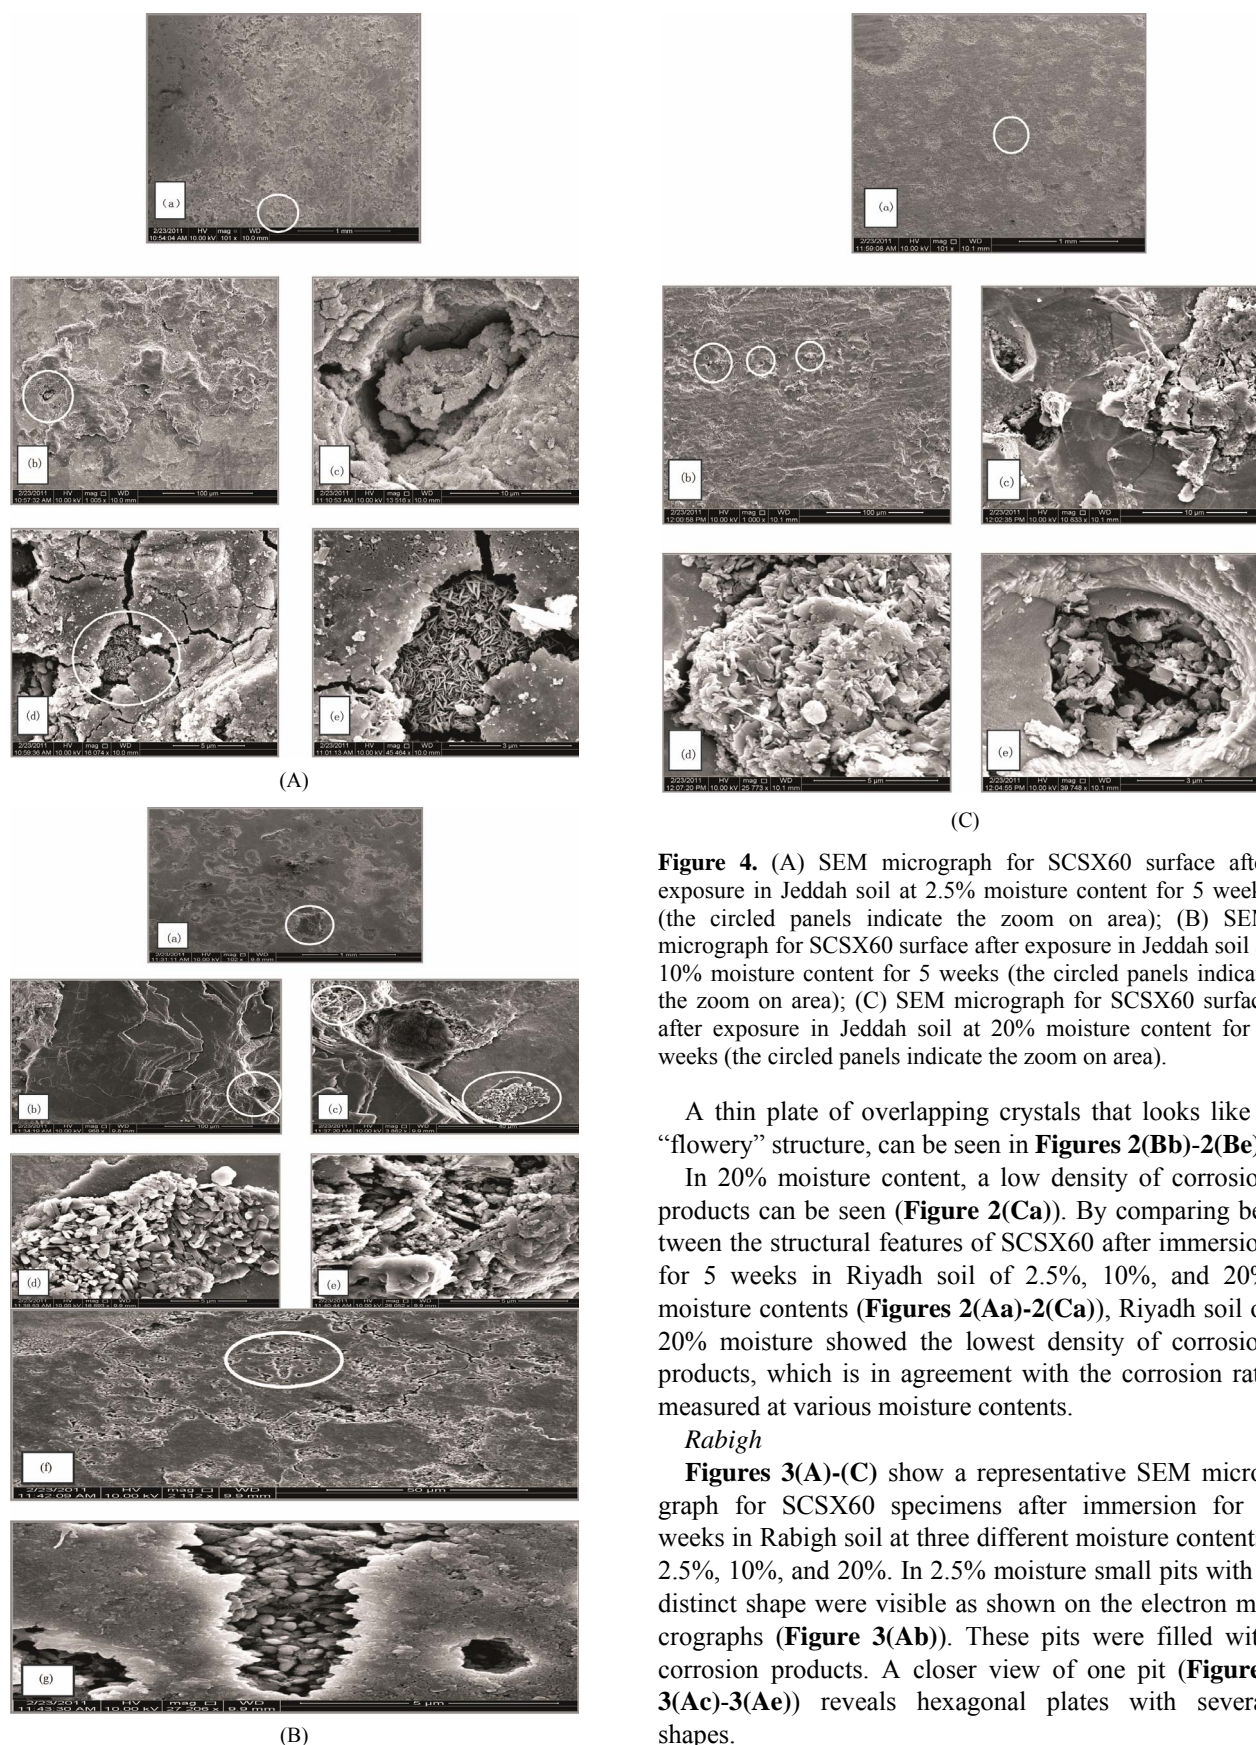
Figure 4. (A) SEM micrograph for SCSX60 surface after exposure in Jeddah soil at 2.5% moisture content for 5 weeks (the circled panels indicate the zoom on area); (B) SEM micrograph for SCSX60 surface after exposure in Jeddah soil at 10% moisture content for 5 weeks (the circled panels indicate the zoom on area); (C) SEM micrograph for SCSX60 surface after exposure in Jeddah soil at 20% moisture content for 5 weeks (the circled panels indicate the zoom on area).

Figures 4(A)-(c) present the SEM micrograph for the SCSX60 specimens after immersion for 5 weeks in Jeddah soil at three different moisture contents: 2.5%, 10%, and 20%. The film of corrosion products that formed on the SCSX60 specimen in 2.5% moisture is inhomogeneous, and several pits can be observed (**Figure 4(Ab)**). When a high power zoom was taken (**Figure 4(Ac)**), the pits are deep, irregular and filled with corrosion products, such as with crystals of FeS (**Figures 4(Ad)** and **4(Ae)**). Several cracks can be observed in the corrosion film.

The environmental effect of these microorganisms is very clear in the case of 10% moisture content (**Figure 4(Ba)**). When high power zoom was taken (**Figure 4(Bb)**), layers of corrosion products observed. Moreover, the high power zoom (**Figure 4(Bd)**) showed rhombohedral structures associated with hexagonal plates of pyrrhotite and exopolymer substances. Jelly glue-like extracellular polymer substances are also observed among the corrosion products in this study (**Figure 4(Be)**). In another location on the specimen (**Figure 4(Bf)**), cracks and irregular deep pits are observed. **Figure 4(Bg)** shows a high magnification view of one pit filled with corrosion products.

In the case of 20% moisture content, characteristics of the substances observed in 2.5% and 10% moisture content disappeared. Small pits and cracks can be observed in the corrosion film (**Figure 4(Cb)**). When a high power zoom was taken (**Figures 4(Cc)** and **(Ce)**), the pits are filled with corrosion products. Some hexagonal plates with scales structures as corrosion products can also be observed (**Figure 4(Cd)**).

The rhombohedral showed in **Figure 4** structures may be smythite, a naturally occurring rhombohedral sulfide. Smythite is formed by the sulfidation of siderite (ferrous carbonate $FeCO_3$). McNeil *et al.* [41] used mineralogical data determined by X-ray crystallography, thermodynamic stability diagrams (Pourbaix diagrams), and the simplicity principle for precipitation reactions to evaluate corrosion product mineralogy. The authors concluded that many sulfides under near-surface natural environmental conditions could only be produced by microbiological action on metals.
