# Analysis of Strain Clamp Failure on 500 kV Transmission Line

<sup>1</sup>State Grid Liaoning Electric Power Research Institute, Shenyang, China

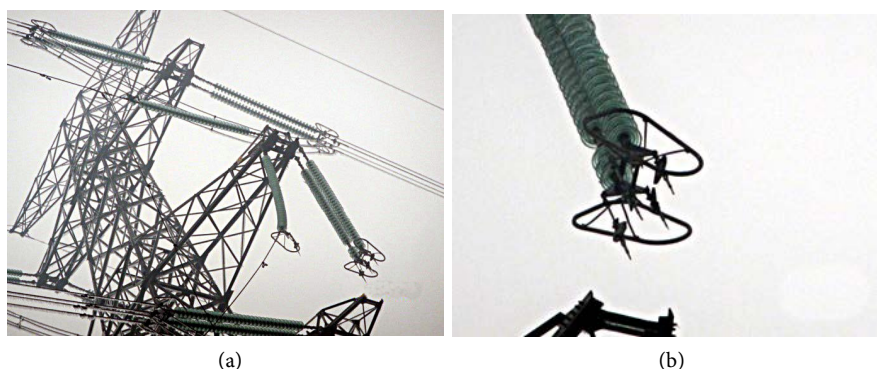
On November 7, 2015, the rare ice disaster weather in northeastern China caused the disconnection of 500 kV transmission lines. The fractured strain clamps and conductors of 500 kV transmission line are shown in **Figure 1**. The strain clamp for large side middle phase (A phase) on No. 16 strain tower of 500 kV transmission lines (double circuit in the direction of the right loop) was disconnected, with all the 4 root wires disconnected and landed. The strain clamp for small side middle phase (A phase) on the same tower also disconnected, with 3 root wires disconnected and 1 root wire not landed. The failure of strain clamps on No. 16 tower led to the breakage and landing of 3 root wires on the adjacent No. 14 and No. 15 tower middle phase (A phase). But all the towers were intact.

The initial failure point of the ice disaster was the No. 16 strain tower. 7 strain clamps on the No. 16 strain tower were damaged and out of work. The steel strands broke at the exit of the strain clamp, and the steel anchors were pulled out of the aluminum tube which brought about the injury of aluminum tube.

**Figure 1.** The fractured strain clamps and conductors of 500 kV transmission line (a) the fractured conductors (b) the steel anchors out of the strain clamps.

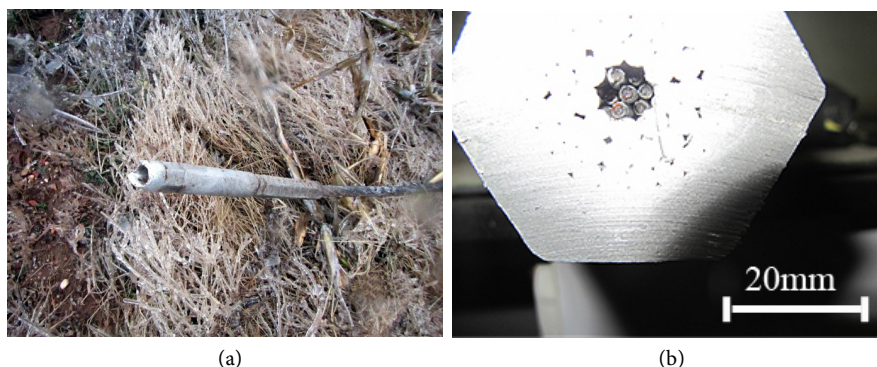
One of the landed strain clamp on site was shown in **Figure 2(a)**. One of the 7 fractured strain clamps was selected for dissection and verification, since the location and performance of the damaged sections were basically the same. The dimple plastic fracture morphology of the internal core steels of the strain clamp was shown in **Figure 2(b)**.

**Figure 2.** One of the landed strain clamp of 500 kV transmission line (a) fractured strain clamp on site (b) the fracture morphology of the core steels.

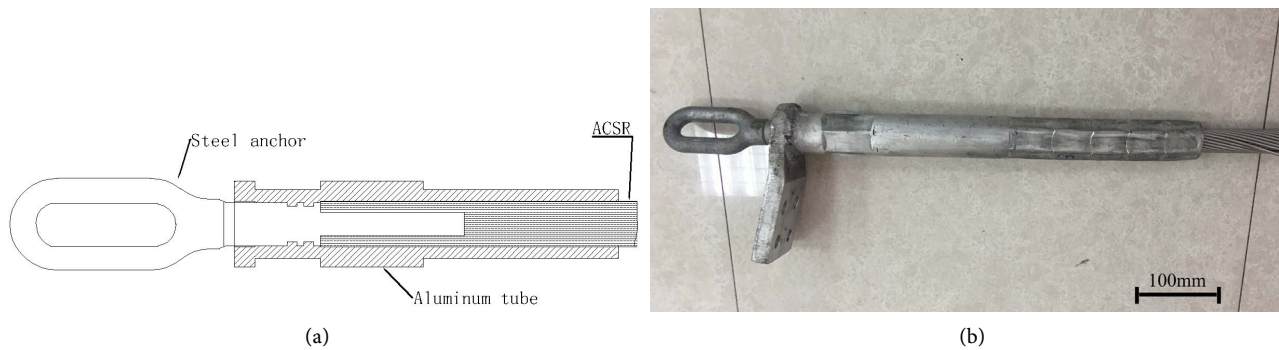
**Figure 3** shows the structure of the strain clamp. The strain clamp consists of aluminum tube and steel anchor. The steel tube in front of the steel anchor holds the steel strands. The aluminum tube at one end holds the ACSR, and the other end holds the steel anchor. The aluminum tube acts as a bridge: one end connected to the aluminum strands and the other connected to the steel anchor [9].

The aluminum stranded wires of conductor near the crimping area of steel anchor have been stripped. The force of aluminum strands has been replaced by aluminum tube, indicating that they afford 67% of rated breaking force on the conductor. This part of the force can be divided into the friction force and shear force on the hydraulic connection between the aluminum tube and the steel anchor. The friction force on the aluminum tube and the steel anchor is proportional to the crimping length of the aluminum tube on the steel anchor, while the shear force on the aluminum tube and the steel anchor is proportional to the number of grooves and the length of the grooves [10].

**Figure 3.** Structure of strain clamp.

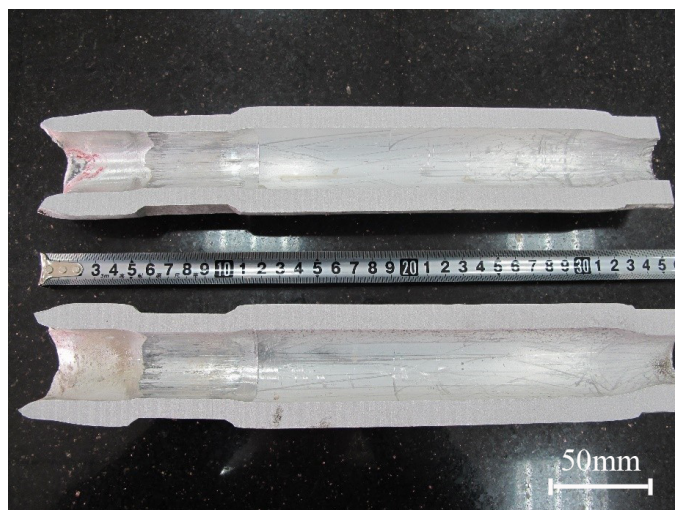
The aluminum tube broken on site is shown in **Figure 4**. The steel anchor pulled out from the aluminum tube has a smooth surface without obvious trace of slippage. Judged from the damage of strain clamps, the crimping position may be the main reason for the breakage of strain clamp. To further confirm this, the dissection of the aluminum tube is carried out and the position of the steel anchor in the aluminum tube is analyzed. The crimping region of aluminum tube is smooth and there is no crimping mark on steel anchor grooves, which indicates that the aluminum tube is not crimped on the grooves of steel anchor.

**Figure 4.** The dissection of the strain clamp.

Since the aluminum tube is crimped on the polished rod not on the grooves of the steel anchor, there is only friction force between the aluminum tube and the steel anchor without shear force. The breaking force of the strain clamp is greatly decreased. Therefore, the damage strain clamp arose.

The main reasons for the breakage of 500 kV transmission line is the disconnection between the aluminum tube and the steel anchor of strain clamp due to the improper crimping of the aluminum tube with thick ice. When the aluminum tube is crimped on the grooves of steel anchor, which is proper crimping process, the tensile strength will meet the standards for strain clamp in DL/T 5285-2013 “hydraulic crimping process specification for overhead conductor and ground wire of transmission and transformation project construction”. And when the aluminum tube is crimped on polished rod of the steel anchor, which is improper crimping process, the tensile strength will not meet the standard requirements of strain clamp. The aluminum tube of the fractured strain clamp is crimped on the polished rod of the steel anchor, which indicates the hydraulic crimping process does not meet the requirements. When improper crimping emerges, there will be only friction force between the aluminum tube and the steel anchor without shear force, and the tension of the conductor will be mainly supported by the steel strands which should be supported by both the aluminum tube and steel stands. The breaking force of the strain clamp will be greatly decreased. Therefore, larger loads, such as thick ice, will lead to the breakage of the steel strands, the slip of steel anchors, and the drop of conductors. More attention should be paid to the hydraulic process of strain clamp in the future. The hydraulic crimping process should be strictly carried out according to the standards and regulations so as to avoid the improper crimping.

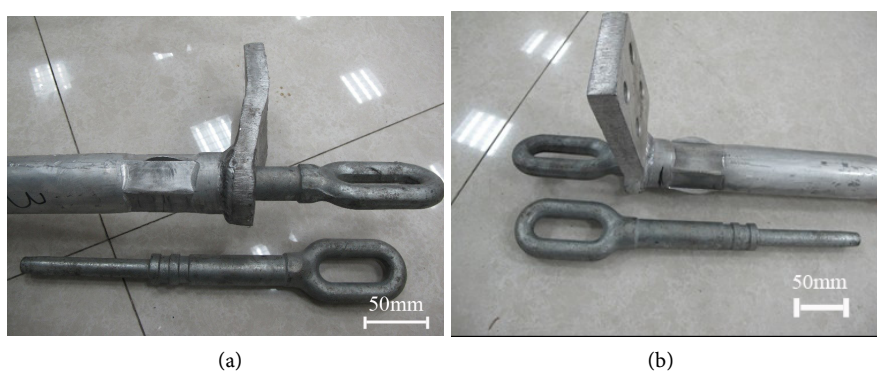
The crimping of aluminum tube on the grooves of the steel anchor is shown in **Figure 5(a)**. The two aluminum tubes at both ends of the conductor are completely crimped on the grooves of the steel anchor. After the test of mechanical properties, the conductor breaks at the exit of the strain clamp, and the position of the aluminum tube and the steel anchor does not change.

The hydraulic crimping of aluminum tube on the steel anchor polished rod is improper. As shown in **Figure 5(b)**, the two aluminum tubes at both ends of the conductor are crimped on the polished rod of the steel anchor. After the mechanical test, the steel anchor is pulled out 50 mm of the aluminum tube leaving aluminum scratches on the steel anchor. The mechanical testing machine will automatically unload and stop test after reaching the peak value. If the tension load is constant, the steel anchor will be completely removed from the aluminum tube. This is consistent with the pull-out of steel anchor from the aluminum tube under ice conditions on site.

**Figure 5.** (a) The aluminum tube crimping into different locations of the steel anchor (a) on the grooves (b) on the polished rod.

As shown in **Table 3**, the tensile strength is 152,770 N when the aluminum tube is crimped on the grooves of steel anchor properly. This value is obviously higher than the standard required value of strain clamp 135,781 N. And the tensile strength is 119,010 N when the aluminum tube is crimped on the polished

rod of steel anchor improperly. This value is lower than the boundary value and only reach 88% of the required value, so the safety coefficient of conductor is not able to meet the requirements. Under extreme conditions such as the thick ice conditions, the ice thickness tolerance of the conductor will also decrease.

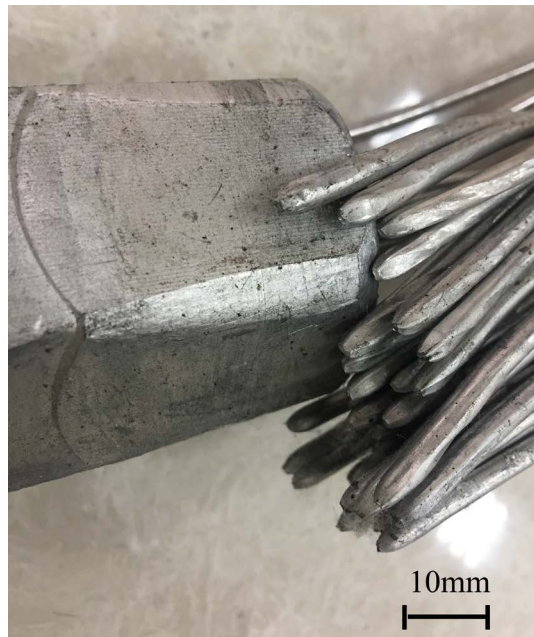
When the aluminum tube was crimped on the grooves of steel anchor, the ACSR broke at the exit of the strain clamp. The fracture surface morphologies of the fractured aluminum strands after mechanical test were shown in **Figure 6**. The fracture surface morphologies of the aluminum strands were plastic necking fracture. When the aluminum tube was crimped on the polished rod of steel

**Figure 6.** The fracture surface morphologies of the fractured aluminum strands after mechanical test.
