# Catastrophic Debrisflow in Dariali (Georgia) in the Year 2014

**George Gaprindashvili, Merab Gaprindashvili**

Department of Geology, National Environmental Agency, Ministry of Environment and Natural Resources Protection, Tbilisi, Georgia

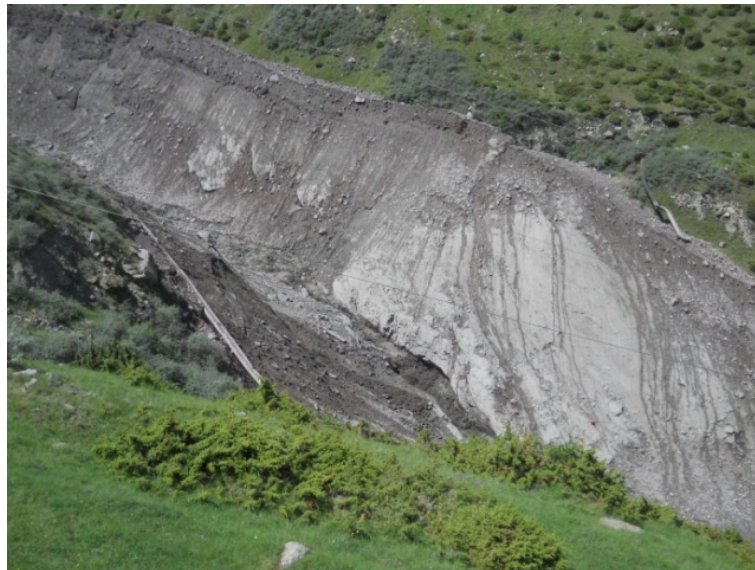
**Figure 2.** Destroyed gas pipeline.

On May 17, 2014 a catastrophic debrisflow process occurred in the area of junction of rivers Tergi and Devdoraki-Amali, which completely paralyzed functioning of infrastructure objects having strategic meaning for the country. Debrisflows have damaged Georgian military road, “North-South” connecting 700 and 1200 mm gas pipelines, knocked down transmission line, means of transportation, isolated base of border guards, customs point, residence of Georgian Patriarchate, and caused serious problems to employees (**Figure 2** and **Figure 3**) and also caused 8 victims (including foreign citizens) [5].

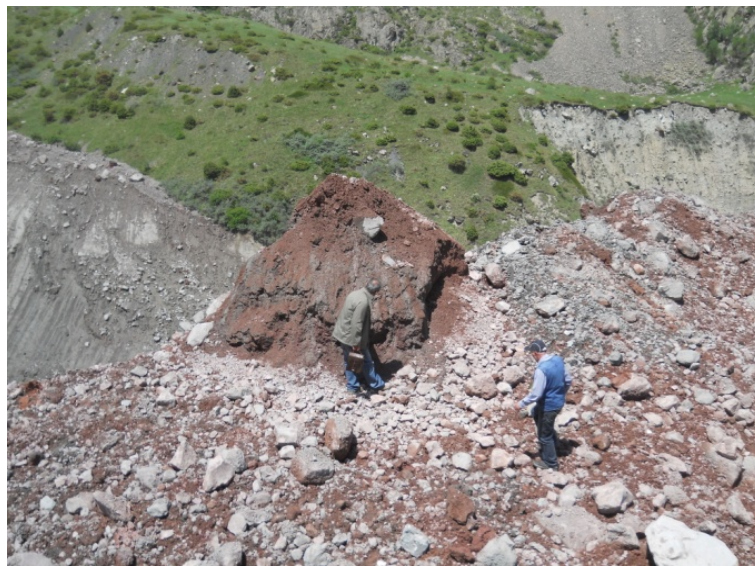
**Figure 6.** Debris material.

Alluvial fan (with approximate volume of about  $1.5 \text{ m}^3$ ) formed by accumulation of solid growth material transported by debrisflow, which blocked the Dariali gorge. The total amount of debrisflow mass taken from the wall of abruption to the junction of the river Tergi makes up  $5 \text{ m}^3$ , the most part of which is accumulated in the area of circus of abruption, on Glacier devdoraki tongue and Transit zones of Valley (Figure 8). Granulometric composition of material is: 50% - 55% is more than 200 mm material, from 10 mm to 200 mm 25% - 30% and <10 mm (gravel-sand-clay mass) 15% - 20%. Size of separate boulders varies in the range of 5 - 6 m. The so-called pellets of moraine genesis have the same sizes and they began to thaw and decompose.

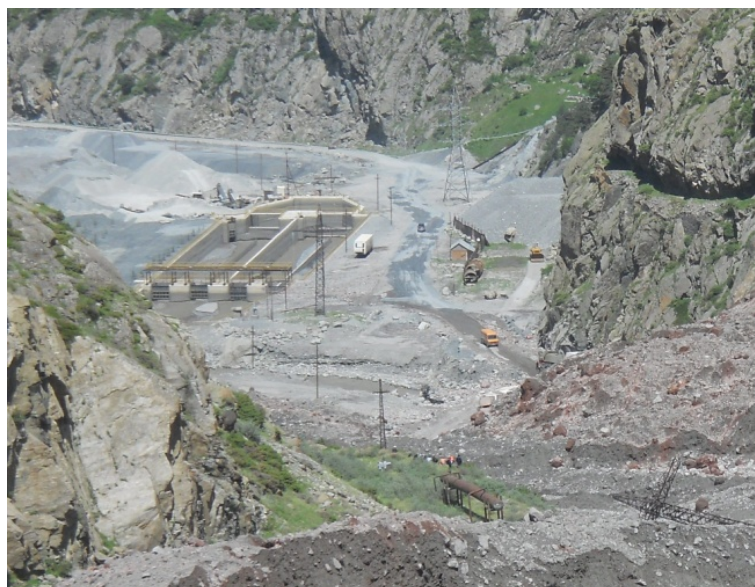
Figure 7. Larsi HPP station.

reached deposits formed by granitoid and solid growth was deposited at its bottom, at the same time the flow continued its movement in Northern direction and stopped in about 50 - 60 meters of the hydro-technical building of "Larsi HPP" (sluice and sedimentation basin) (Figure 7).

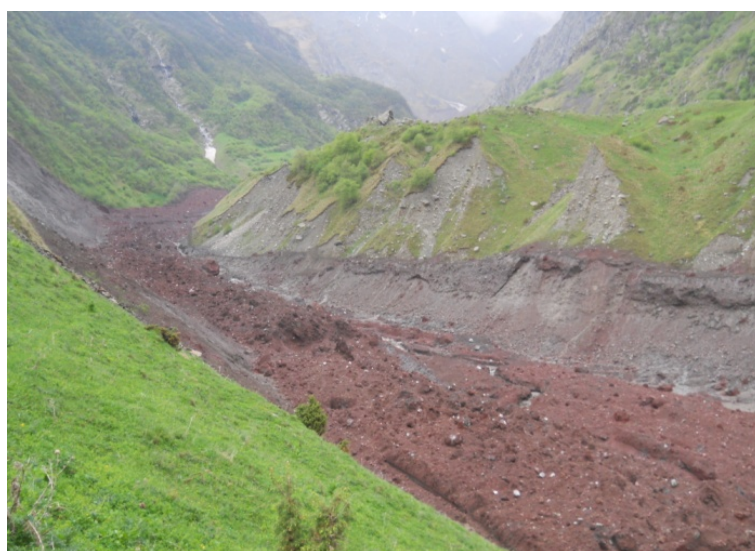
Figure 8. Accumulated debris material in Devdoraki Valley.

On average debrisflows containing of stones and mud are characterized with high durability (density). Without high durability (density) and corresponding rheological nature, it would be impossible to move such large boulders to the base level. Moreover, debrisflow is characterized with such high durability, that even after their

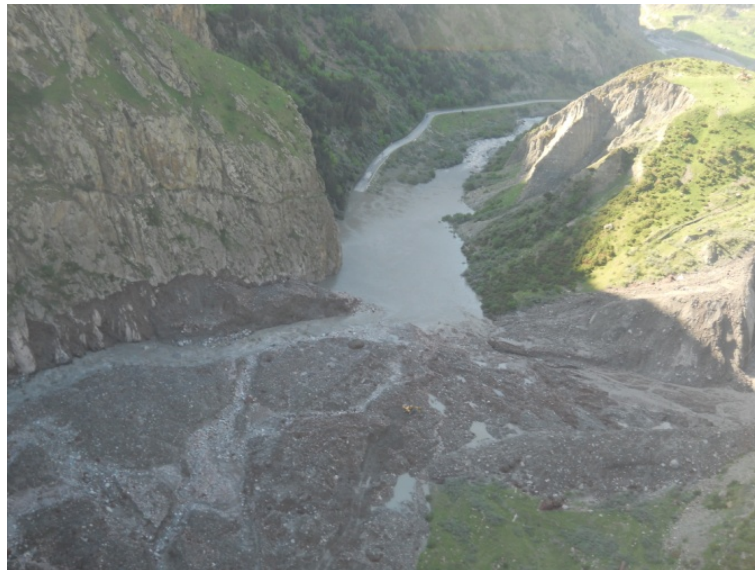
Figure 10. Blocked Tergi river and created reservoir.

Petrographically debrisflow material is mainly represented: red-pink andesite-dacite, basalt, diabase, quartzite, flaky schist, pumice stone etc. In the first days intensive movement of stone-mud flows was observed in the bed of the river, gravitational processes take place on both sides of the river nowadays. Debrisflows have blocked the river Tergi, the water was dammed and amount of water in the created reservoir made up 150,000 m<sup>3</sup> (Figure 10). Average depth of reservoir was 10 - 15 meters.

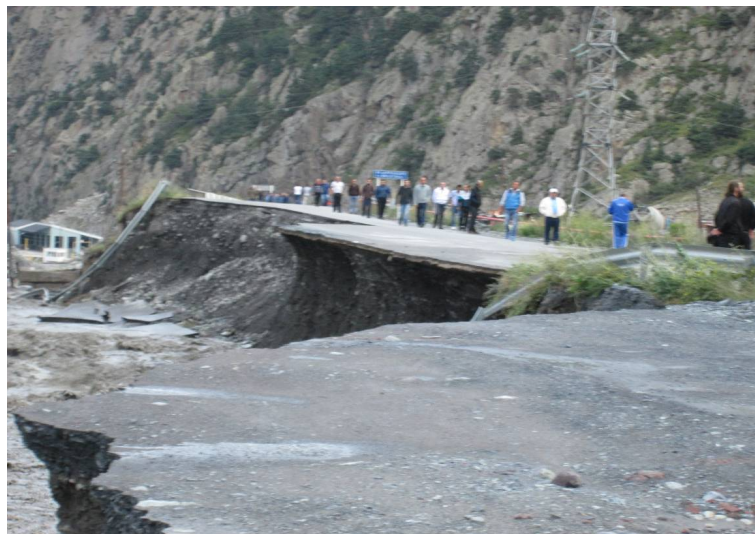
**Figure 11.** Destroyed highway.

- “North-South” 1200 mm diameter gas-main pipeline was damaged;
- 2.0 km of highway was washed off (**Figure 11**);
- Current Larsi HPP was over sanded;
- Customs checkpoint building was over sanded and deformed (**Figure 12**).

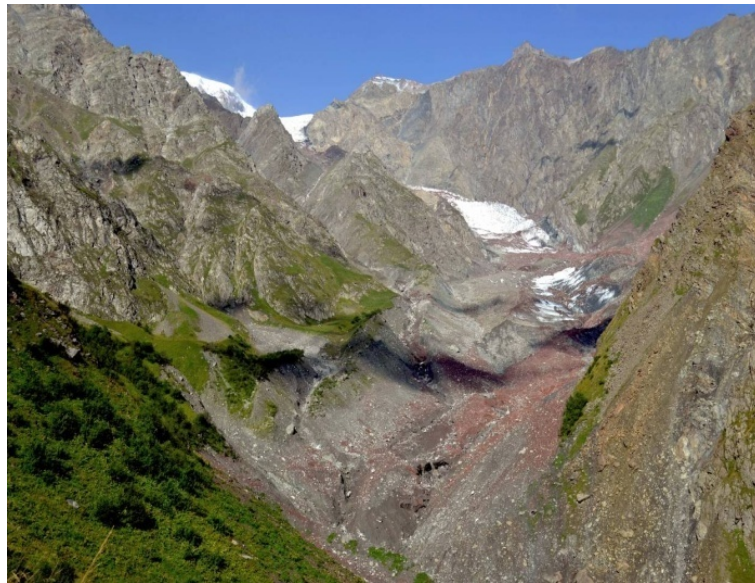
Figure 13. Glacier Devdoraki.

In the center of forming of the catastrophic debrisflow of May 17, 2014, which was characterized with avalanche of rocky-avalanche type rock and glacial mass, which was followed by interaction of the given mass and ice stream and its transfer into the gorge of the river Tergi, new deformations and abruptions are not observed if not take into account crevice in the glacier. However, it should be noted, that the ice stream of the glacier Devdoraki was insignificantly deformed during the debrisflow on August 20 (**Figure 13**).

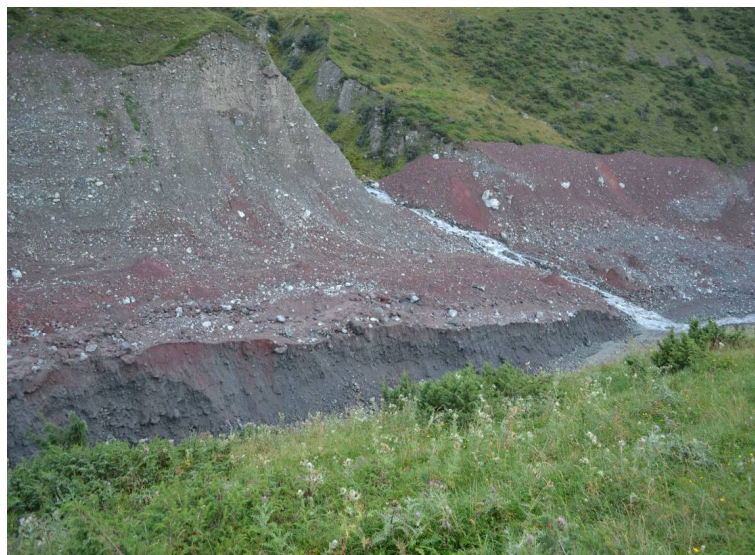
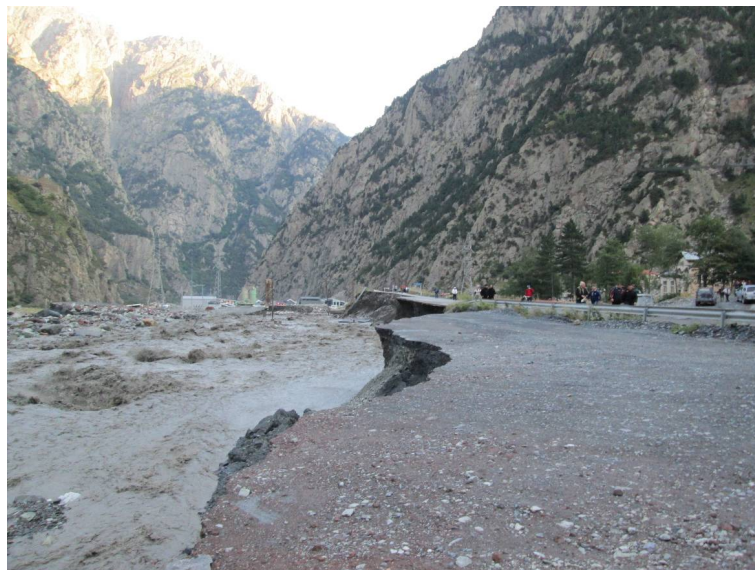
zone) on May 17, 2014. It should be noted that rheological nature of debrisflows, which occurred on May 17, was of high durability, fluctuation and viscosity, which was mainly accumulated in base of the gorge of the river Tergi. Flows, which occurred on August 20 were characterized with low durability and amount of water and were followed by deep and lateral erosive washouts and transit movement in the lower course of the base of the river Tergi (Figure 14 and Figure 15).
