CORROSION OF STEAM GENERATOR TUBING IN OPERATING
PRESSURIZED WATER REACTORS
JOHN R. WEEKS
MATERIALS ENGINEERING BRANCH
DIRECTORATE OF LICENSING *
USAEC, WASHINGTON, D. C. 20545

ABSTRACT

Corrosion of steam generator tubing has been observed in all but three PWR's that have been in operation for more than one year. The history of this experience with both stainless steel and Inconel-600 tubing is reviewed. Both intergranular stress corrosion cracking and localized, transgranular wastage have been observed with Inconel-600 tubing. The wastage can be attributed to a localized concentration, or "hideout" of phosphates in limited flow areas. A model is proposed for this wastage phenomenon which is consistent with operating experience.

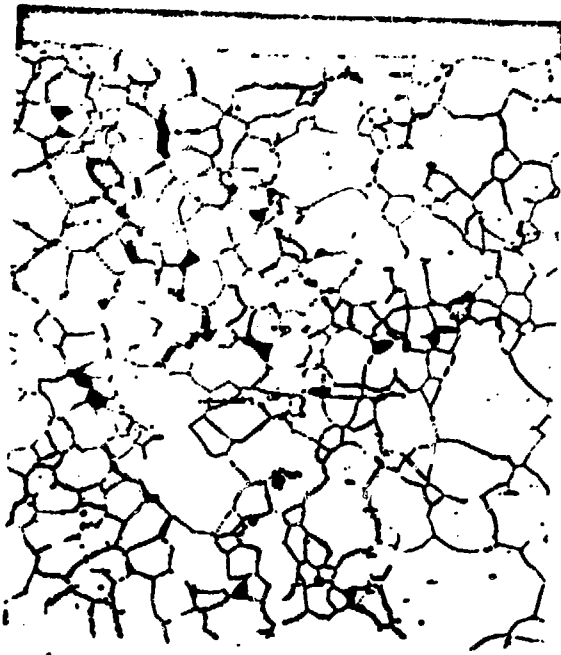
**Figure 12 Micrographs from Battelle-Columbus Labs,
Courtesy of Consumers Power Co.**

**Intergranular Corrosion that Developed at
Palisades During Shutdown 125X**

Corrosion Pit that Developed at Palisades During Shutdown

A similar phenomenon has been observed in one plant after an extended period of "dry layup," during which the coolant had been drained, and the steam generators filled with air, without the sludge deposits having been dried (18). In this case the pits were observed both in areas in which wastage had occurred during operation of the plant, and in new areas, unrelated to "normal" areas of sludge deposition, in the upper half of the steam generator tubing. This attack is shown in Figure 12. A local intergranular attack was found in the same general area, a micrograph of which is also shown in Figure 12.

so that more noble metals, such as copper ions from condenser corrosion, may precipitate on the Inconel surface in these areas, and give rise to local galvanic cells that can become active when the steam generator is exposed to air during layup periods, and cause pitting of the type observed at Palisades, shown in Figure 12.
