TRANSGRANULAR CRACKING IN COLD WORKED IRRADIATED 304L STAINLESS STEEL

Z. Livne, H. Mathias, E. Rabinovitz and A. Bar-Or

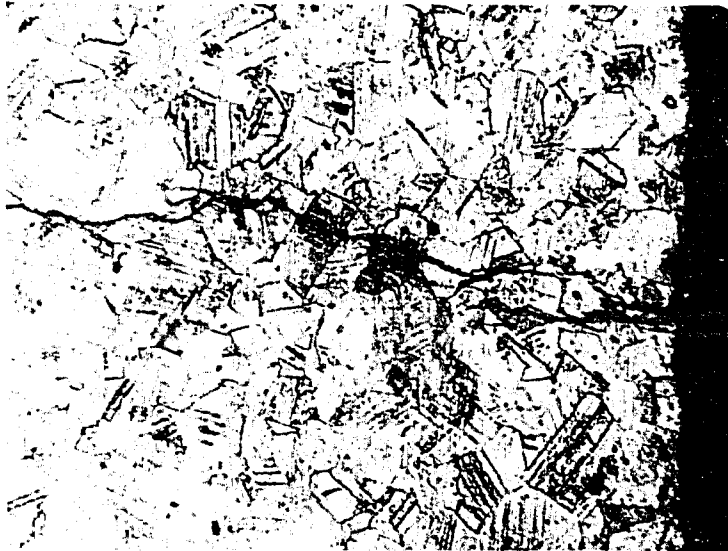
Hot cell optical microscopy revealed the following: (1) Cracks originating on the outer surface, with some penetrating the entire tube wall. (2) Cracking with well-defined branching (Fig. 14), mainly transgranular. (3) Groups of parallel line markings (Fig. 15 and 16) and many microcracks parallel with these markings.

Fig. 15  
Transgranular cracking  
of irradiated stainless  
steel tube.  
Etched, Mag: 400 X

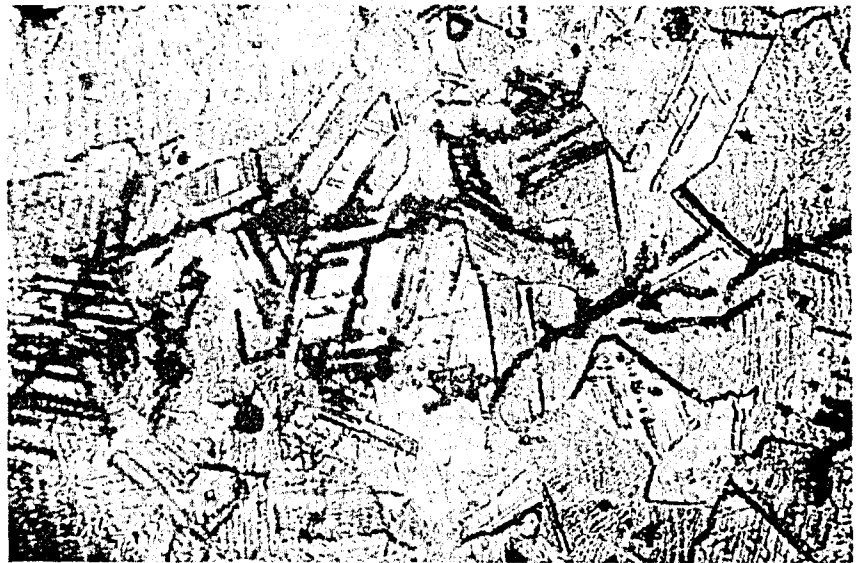
Fig. 16  
Microcracks parallel to  
line markings in  
irradiated stain-  
less steel tube.  
Etched, Mag: 400 X
