Anode-Initiated Surface Flashover\*

R. A. Anderson

Sandia Laboratories

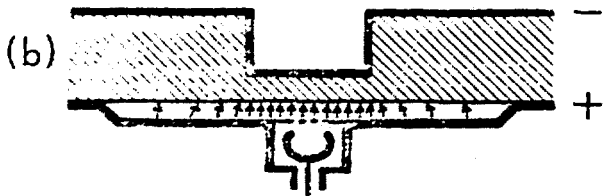
- FIG. 1 Experimental arrangements favoring anode-initiated flashover (shown in cross section). Arrows indicate the electric field in the vacuum.  
 (a) Insulator-angle insulator ( $\theta = 45^\circ$ ), (b) arrangement free of previous emission, (c) holes in the anode electrode.
- FIG. 2 Sketch of the surface charge on polymeric dielectric, showing anode-initiated branch tip.

In each of the three different experimental arrangements shown in Figure 1, dendritic patterns of damage characteristic of anode-initiated flashover were

produced on the insulator surface by the application of alternating electric field. Figure 1(a) is the case of a  $SiO_2$  insulator between parallel electrodes, where flashover resulted in an abrupt change of the insulator impedance on a narrow band like noise. In (b) and (c), however, interelectrode breakdown could not occur. As mentioned in the introduction of this report, the present study is on electrically stressed insulators, discussed in the next section. Leakage patterns were confined to the anode-cathode surface of the insulator within the electric field central section. Figure 1(c) might be taken to mean "leakage" into the bulk of the insulator. Surprisingly, visible streaks were found only on the surface of the insulator facing the hole in the anode electrode, and they branched toward the center of each hole from the high field region at the edge.

The patterns of leakage profiles under these three different circumstances were nearly identical, both in their appearance to the unaided eye and in the microstructure observable with a scanning electron microscope. Furthermore, as indicated in Figure 1, the electric field in each case was directed steeply into the surface of the insulator. It is therefore reasonable to assume that the flashover phenomena occurring in all three cases were the same. Accordingly, this type of surface flashover may account for the electron emission from the dielectric observed when electron beam cathodes contain dielectric inlays (1).

The preceding discussion does not consider how the plasma is generated at the point of initiation. In the experimental arrangements of Figure 1(a) and (c), localized electric fields at points of contact between the insulator and the anode electrode may exceed the dielectric strength of the insulator. The source of the initial plasma in the geometry of Figure 1(b) is unclear, although the conditioning effect mentioned earlier points to the involvement of either gaseous or particulate contaminants on the insulator surface.
