KFKI-1982-89

EXFOLIATION ON STAINLESS STEEL
AND INCONEL PRODUCED BY 0.8 - 4 MeV
HELIUM ION BOMBARDMENT

**CENTRAL
RESEARCH
INSTITUTE FOR
PHYSICS**

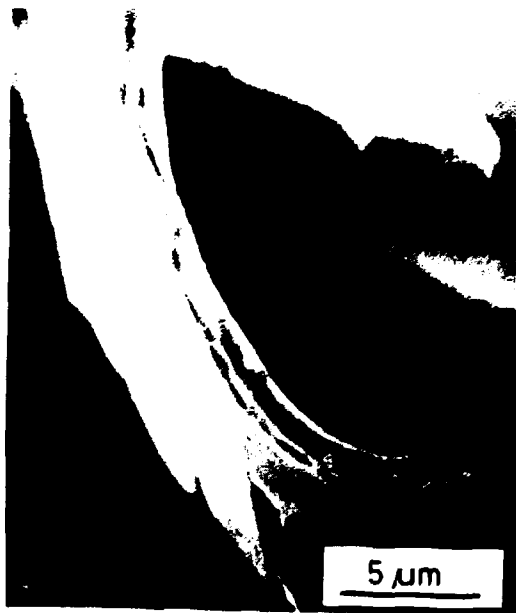
Fig. 3

1 MeV implanted EP-754. After after of the flaked skin with table layer structure

No spontaneous rupture was observed among the present experimental conditions except for EP-753 at 1 MeV where upon reaching the critical dose flaking took place instantly (*Fig. 1*). On the flaked skin several holes could be observed and the missing material was found to be stuck to the bulk of the material (*Fig. 2*). Besides the skin exhibited a two-layer structure as it had been observed on gold [5] (*Fig. 3*). However, in contrast to gold, both the skin and the bottom were relatively smooth and no structure has been observed.

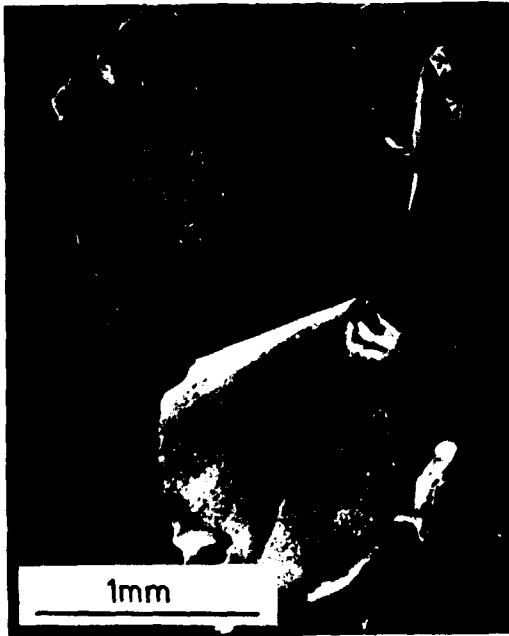
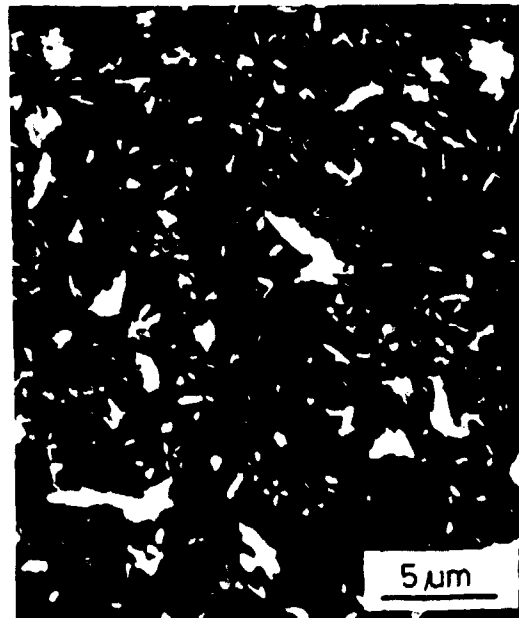
Fig. 8a

The inner structure of exfoliation on 4 MeV bombarded INCO-825. An overall picture of meshlike opened formation /a/. Spiltted off lamellae on the outer /b/ and central region /c/ of the bottom

Inside, both on the inner side of the skin and on the bottom a rough structure consisting of lamellae of different size could be observed. This might be the reason why we cannot see bottom zones observed on gold (*Fig. 8*).

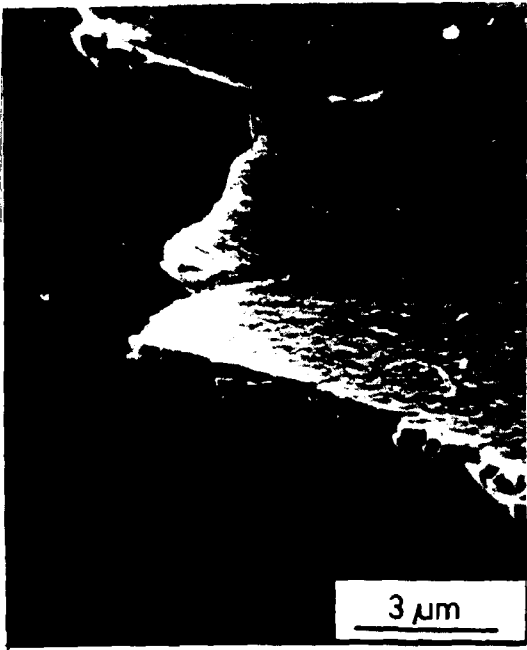
Fig. 11

0.9 MeV implanted OKH16N15M3B the
inside layer structure of the skin

The structure inside of the lower energy formations showed a different morphology from inconels. First of all on the inner side of the skin many secondary ruptured blisters of size 1-4 μm were found (*Fig. 10*). This observation is similar to those on gold. Besides, just like for any other materials the skin consisted of two layers (*Fig. 11*) and has no uniform thickness. Some of the micrographs markedly show that at many spots a part of the skin stuck to the bottom (e.g. *Fig. 12*).

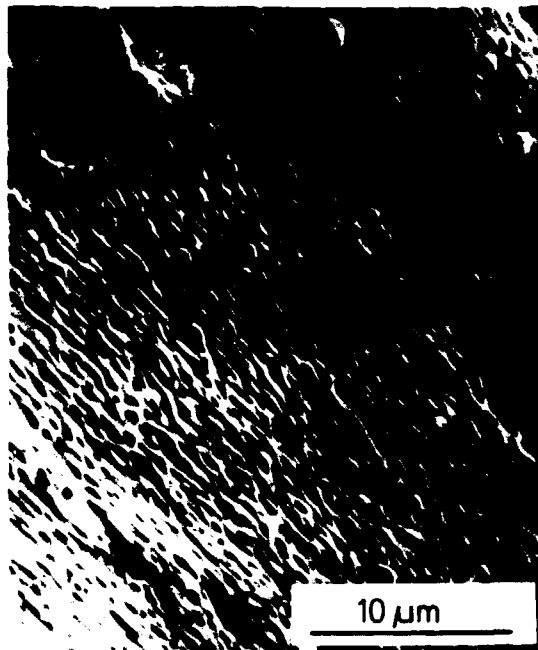
Fig. 15a

*4 MeV implanted OKH16N15M3B. Sponge-
-like structure on the central region
of the inner side of exfoliated skin
/a/ rounded by a region of secondary
blisters /b/*

Fig. 13 shows the exfoliation which was obtained after 4 MeV bombardment. According to the micrograph its shape and size are quite a similar to that observed on INCO 625 at this particular energy. On the central part the grains became recognizable (*Fig. 14*), presumably in correlation with the higher skin temperature induced by the beam. The bottom region inside was smooth but on the inner side of the cover at the central region a sponge-like structure has been clearly observed (*Fig. 15a*). Going outward on the skin this structure turns into blisters of 0.5-2 μm size (*Fig. 15b*).
