SAND79-2291 • TTC-306 • Unlimited Release • UC-71

## A Study and Full-Scale Test of a High-Velocity Grade-Crossing Simulated Accident of a Locomotive and a Nuclear-Spent-Fuel Shipping Cask

Michael Huerta, H. Richard Yoshimura

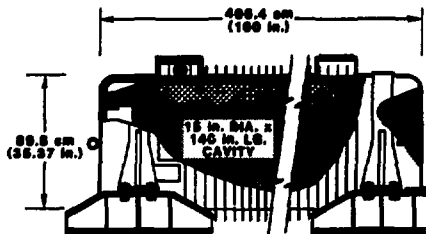
Figure 2. Schematic of the Shipping Cask

Figure 2 illustrates the cask's construction. The design utilized lead shielding and 304 stainless-steel materials. The outer shell was 2.54 cm (1 in.) thick; the inside shell was 1.9 cm (0.75 in.) thick. A 21.3-cm (8.37-in.) layer of lead shielding was used between the shells; the head and bottom had a slightly thinner layer. The head was held in place with eight 2.54-cm (1-in.) bolts. The cask was tied down to the trailer structure with heavy steel bands and four 3.2-cm (1.25-in.) bolts at each connection.

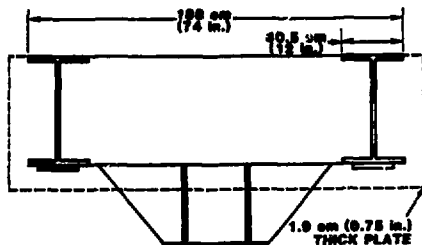
Figure 3. Schematic of the Locomotive Underframe

For a better understanding of the assumptions, we will review the construction of the front part of the underframe in more detail. As discussed previously, the underframe consists of two large I-beams covered with a 1.9-cm (0.75-in.)-steel plate on the front end. The I-beams also have stiffening plates under the bottom flange. These features can readily be seen in Figure 3, a schematic of the underframe front-end view. The width of the underframe measured from the outside edges of the I-beam flanges is 188 cm (74 in.). The area under the I-beams, called the coupler housing, is not significant to the problem except that in this analysis it is used as vertical support for the upper portion of the underframe. In the actual locomotive, the top of the I-beams is covered with steel plating 0.5 cm (0.187 in.) thick and skip welded to the structure. The underframe, with a width of 188 cm (74 in.),

impacts only the central portion of the cask, which has an overall length of 406 cm (160 in.).

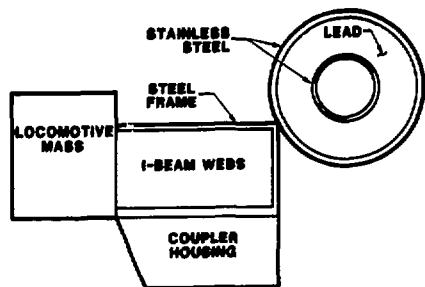
Figure 4. Geometry of the Finite-Element Model

Figure 4 schematically illustrates the 2D plane strain model constructed to analyze this problem. (Appendix A is a detailed description of the model). Because the model is 2D, the I-beam flanges are assumed solid through the width of the locomotive frame as indicated in this figure, resulting in some conservatism. The model was constructed on the basis of the width of the underframe; therefore, to give the cask the proper inertia, the lead material was made artificially heavy. The calculated lead density to achieve this was  $2.88 \times 104 \text{ kg/m}^3$  ( $1.04 \text{ lb/in.}^3$ ). The total weight of the locomotive was taken as 113.6 metric tons (250,000 lb). Because the plane strain calculation is done on the basis of a unit thickness, the density used for the locomotive mass was based on the width of the under frame and the area allotted to the locomotive mass in the model (Figure 4). The material density calculated for the locomotive mass was  $1.245 \times 105 \text{ kg/m}^3$  ( $4.5 \text{ lb/in.}^3$ ). A very high stiffness was also assigned to this material. The I-beam web material properties were calculated by determining that frontal area of the webs represented 1.35% of the area. Based on this, the yield strength of the material was set at 0.0135 times the yield strength of the mild steel. The modulus for the web area was calculated by using this same ratio. This material was

also given a very low Poisson's ratio to simulate a buckling or crushing behavior, which would be the failure mode for a relatively thin web. The rationale for spreading the web loading across the entire width of the underframe was that the 1.9 cm (0.75 in.)-thick plate at the front would serve as a load spreader.

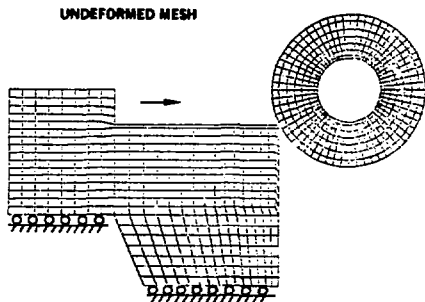
Figure 5. The Finite-Element Mesh

Figure 5 illustrates the finite-element mesh for the model generated with the program QMESH.<sup>1</sup> The locomotive portion was given an initial velocity of 129 km/h (80 mph) in the direction of the stationary cask. The underframe was supported in the vertical direction as shown in Figure 5. This is conservative, because the underframe will deflect downward less than is possible in the real structure. This boundary condition was imposed because the bending stiffness of the underframe could not be modeled very accurately, and a choice was therefore made to use this conservative assumption. The area representing the coupler housing was given the same material properties as the I-beam web material.

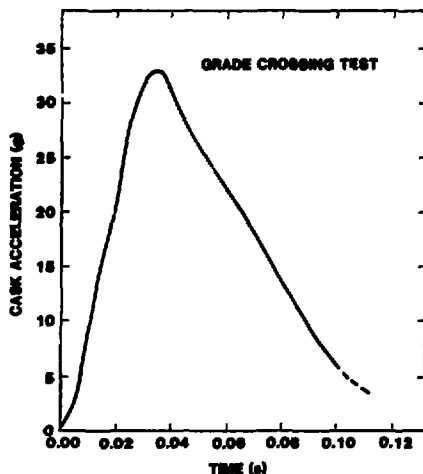
Figure 24. Acceleration-Time History for the Cask From Film Data

"rigid body" motion of the cask. This was done by following the central mark on the left end of the cask. This produced the g-time plot of Figure 24, which indicates a peak level of about 33 g's for the rigid body motion of the cask. Obtaining acceleration data from displacement film data is not an accurate procedure because successive differentiation is involved; however, the data of Figure 24 are presented as a rough approximation of the rigid-body acceleration of the cask. A check has been made by integrating this curve to see if the velocity change indicated by Figure D-4 is obtained for the time interval up to 0.10 s. The agreement was within 1%, and while this is not a positive check, it is a good indication that the data of Figure 24 are reasonable.

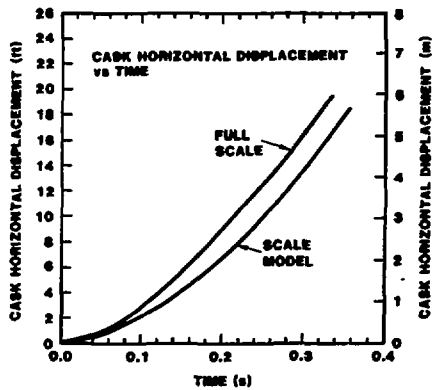
Figure 30. Cask-Horizontal Displacement vs Time for Model and Full-Scale System

Figure 30 is a plot of horizontal cask displacement vs time both for the full-scale cask and the model. (To obtain a direct comparison for plotting against the prototype, we multiplied the model times and displacements by the scale factor of 8.) This plot indicates that the model predicted less cask displacement than was observed in the full-scale test, although again the agreement in early times (less than 0.06 s) is quite good. Figure 31 is a plot of the horizontal velocity of the cask as a function of time. This plot also shows good agreement in early time with the full-scale cask accelerating much quicker, but eventually leveling off in velocity.

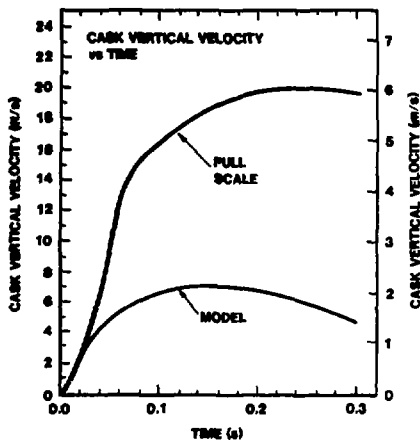
Figure 33. Cask Vertical Velocity vs Time for the Model and Full-Scale System

velocity was off by an even greater amount (Figure 33) at this same time in the impact.
