# Imaging Data Analyses for Hazardous Waste Applications

## Final Report

Dr. Nancy David  
Dr. I.W. Ginsberg

December 1995

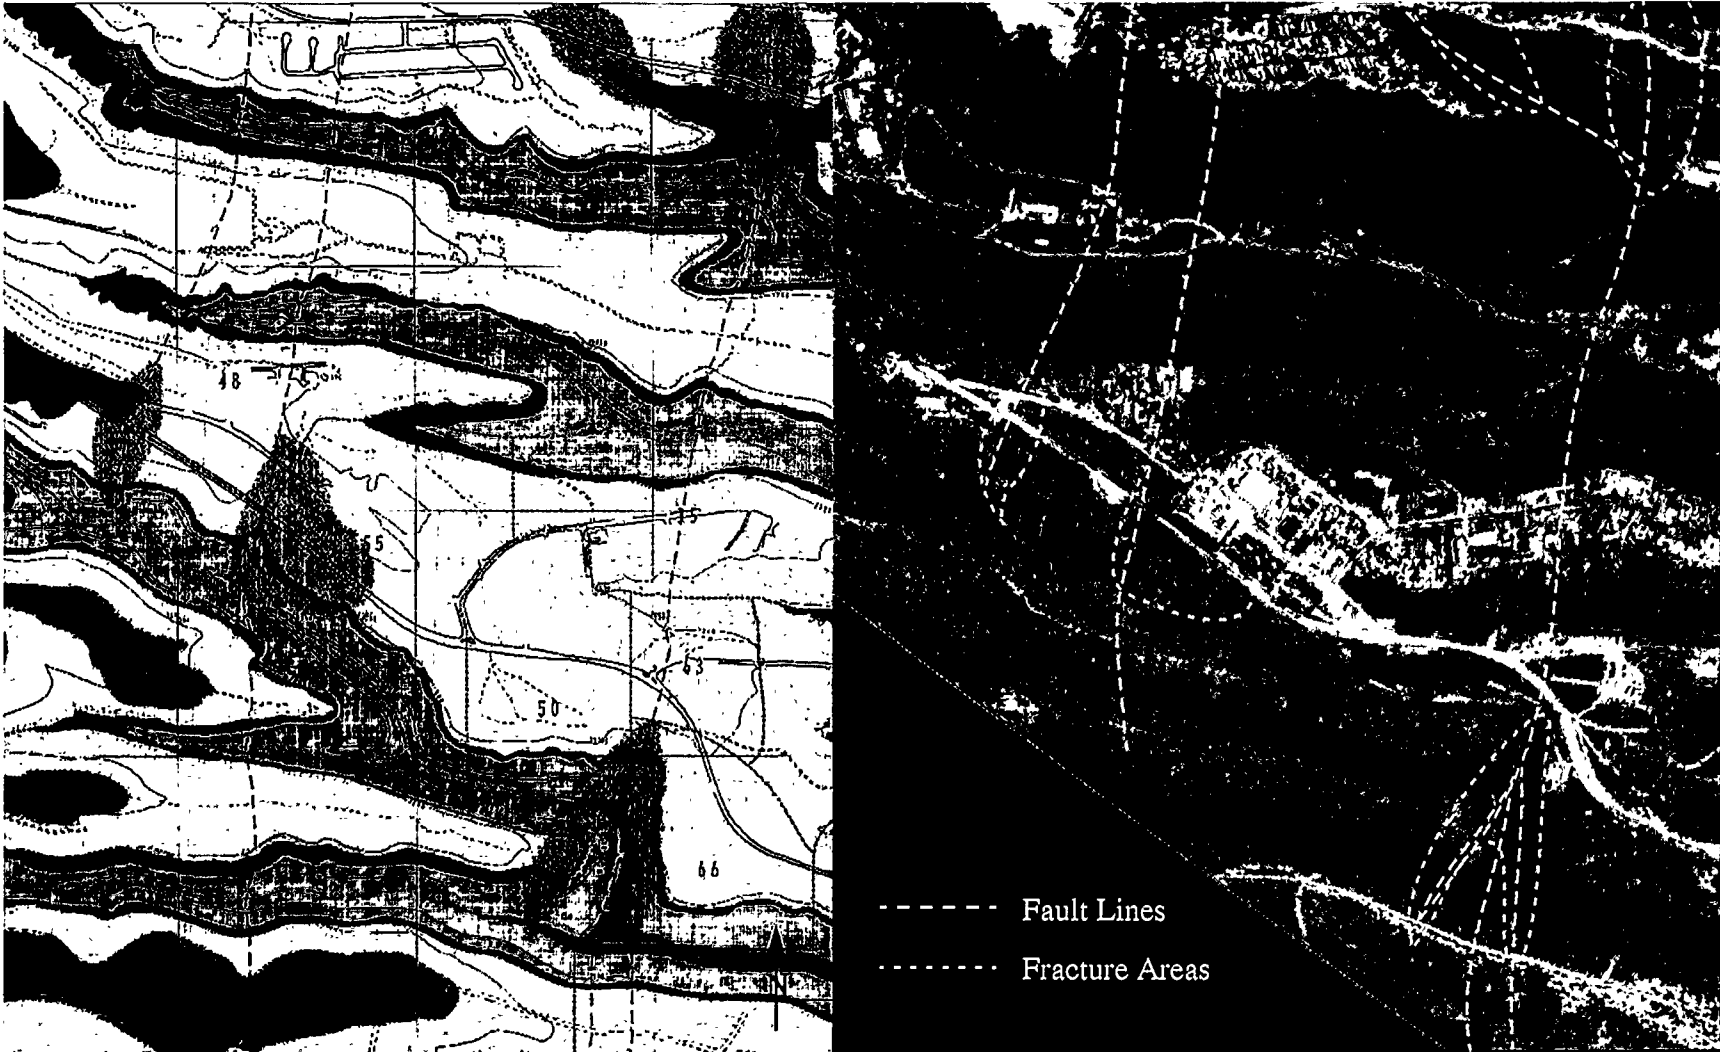
Figure 10  
25

**DESCRIPTION OF IMAGERY** The geologic map is shown on the left of Figure 10 with faults shown as black dotted lines and fractures as brown areas. To its right is a Daedalus False Color Composite of the area between TA-48 and TA-50. After analyzing signatures of the faults and fractures using several band combinations, revised estimates from the geologic map were made. These are shown on the False Color Composite in white (fault times) and yellow (fracture areas).

**INFERENCE** The fault and fracture lines shown on the geologic map were mostly verified on the imagery. There were a few minor corrections that can be seen by comparing the graphics, left-to-right.

# Comparison of Daedalus Imagery to Geologic Map of Mortandad Canyon (Koch Site, TA-48)
