# INVESTIGATION OF DELAYED HYDRIDE CRACKING MECHANISM IN THE CANDU PRESSURE TUBE

The paper presents the testing methodology on the CANDU pressure tube specimens (Zr-2.5% Nb alloy) to determinate the fracture mechanics parameters. The crack initiation and subsequent DHC propagation tests were performed on compact-tension (CT) specimens prepared from pressure tube off-cuts. Previously, the CT specimens were subjected to the specific method to increase the hydrogen concentration up to 50 ppm. This process consists of two stages: the first one is the electrolytic disposal of a uniform zirconium hydride layer and, the second one is to apply a homogenization thermal treatment causing the diffusion of hydrogen into the zirconium matrix from the hydride surface layer. The testing temperature was around 280oC, which is the temperature of interest for the pressure tubes operating in CANDU 6 reactor.

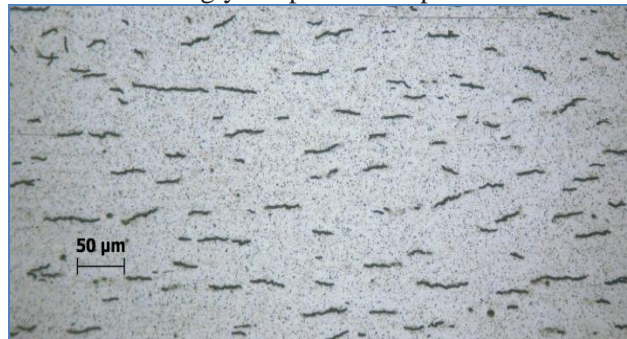
**Fig 1.** Micrograph showing hydrides in Zr-2.5%Nb pressure tube

Delayed Hydride Cracking (DHC) involved the accumulation of hydrides to some critical size at a region of elevated tensile stress, the fracture of this hydrided region up to its leading edge and the repetition of this process. In pressure tube material, DHC is largely limited to the radial-axial plane of the tube. Optical micrographs of arrested DHC cracks show that hydrided regions formed at a crack can be idealized as plate shaped, extending in the crack growth directions with thickness much smaller than their in-plane lengths. The hydrides platelets have an irregular aspect, darker in contrast with zirconium matrix (Fig. 1). Lying on the pressure tube's radial-axial plane these plate shaped (often tapered) hydrided regions are also referred to as radial hydrides. Observations of fracture surfaces at low magnifications often showed periodic rows of ridges (striations) extending in rows parallel to the crack front. The fracture surfaces between these striations were of brittle appearance, being flat with cleavage-like river patterns. The lengths between these striations were strongly temperature dependent.

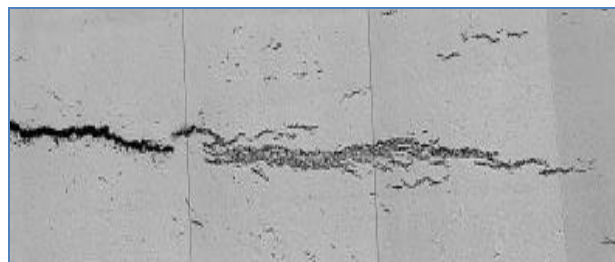
The interpretation of the experimental observations is that the hydrided region grows to some critical length from the crack tip, fracturing along its length up to its leading edge (Fig. 2). The fracture of the hydrided region causes an abrupt increase in length of the macroscopic crack, which is arrested at the leading edge of the hydrided region by the ductile matrix. The striations are the physical evidence of this arrest and the distance between each row of striations, called the striation spacing, represents the critical fracture length of the hydrided region while the striation length itself is associated with the plastic zone of the macrocrack at its point of arrest.

**Fig. 2.** Crack growth by DHC mechanism in Zr-2.5%Nb

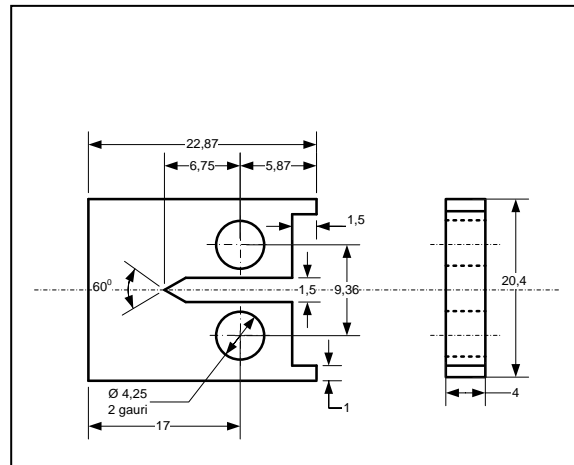
**Sample preparation.** The fracture mechanics tests were performed on CT (Compact Tension) samples cut from Zr-2.5% Nb pressure tubes. The geometry of the samples used in fracture mechanics tests, carried out to determine the parameter  $K_{IH}$ , must meet specific standards for fracture mechanics tests : ASTM E 399, ASTM E 647 , ASTM E 1820. The samples are obtained from the axial direction of the pressure tube. The sketch of the CT sample is shown in Figure 2.

**Fig. 2** The CT specimen for DHC test

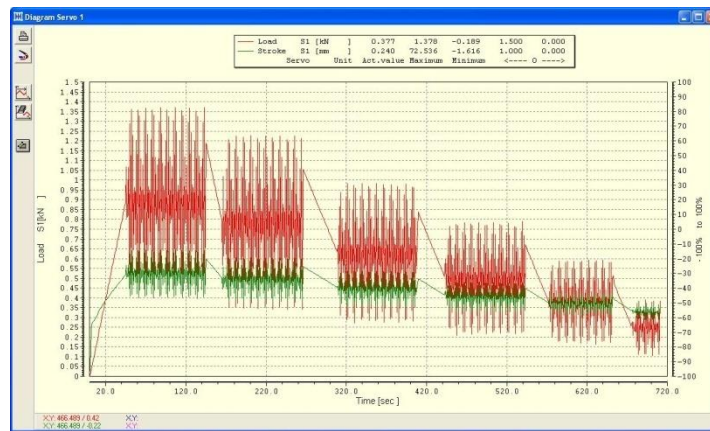
The pre-cracking process consists of cycling test on which the load has been gradually reduced while maintaining the stress ration is kept constant,  $R \cong 0.28$ . The fatigue pre-cracking process should be done carefully to diminish the probability of development plasticity at the crack tip.

**Fig. 3** Stress versus time during pre-cracking fatigue process

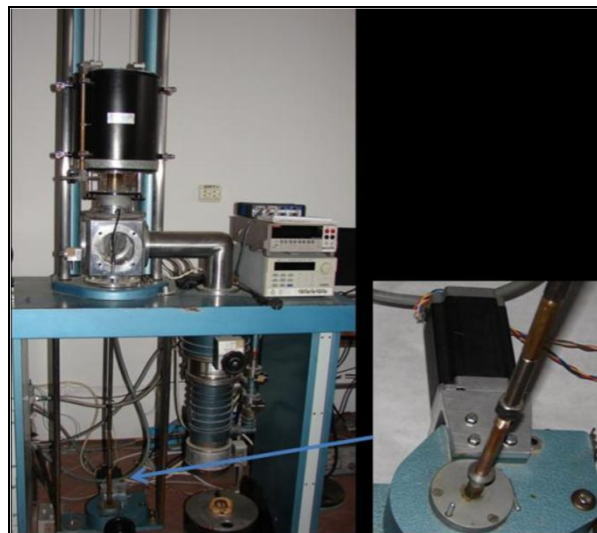
**The testing and analyses facilities.** Figure 4 shows a photo with tensile creep machine where the experimental fracture tests were performed, in order to obtain the values of threshold stress intensity factor,  $K_{IH}$ , which characterize the initiation of DHC.

**Fig. 4** DHC testing facility

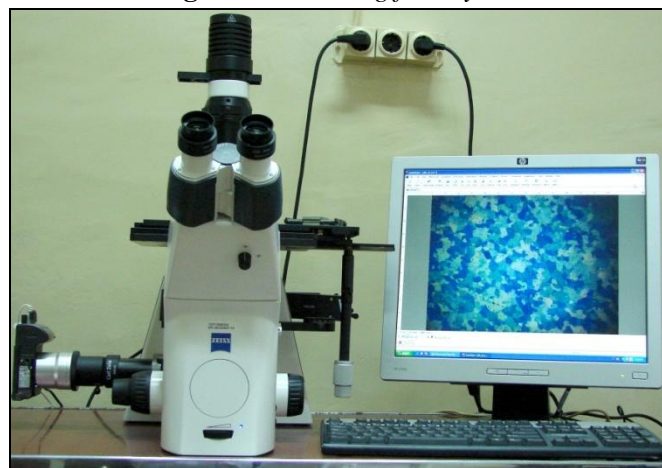
**Fig. 5** Optical microscope

The fracture surface and crack propagation measurements were performed by using metallographic examination with the optical microscopy (Fig. 5).

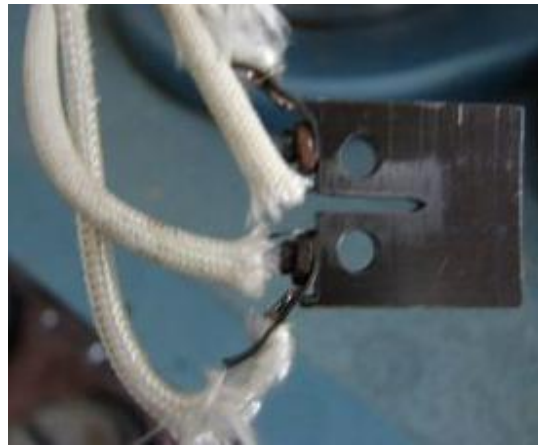
The initial applied load, before test starting, is to develop a stress intensity value of  $K_I=18.5 \text{ MPa}\sqrt{\text{m}}$ . At each step of  $50 \mu\text{m}$  crack advance, the software automatically decrease the load with 3% from previous load. This process is repeated during 24 hours, until the cracking is stopped. In this last stage, the test is stopped and the specimen is removed from the furnace in order to perform its examination. During the test the crack propagation is monitored by the potential drop (PD) method. A specimen ready for test is shown in Figure 6.

**Fig.6** The CT specimen wired for PD method

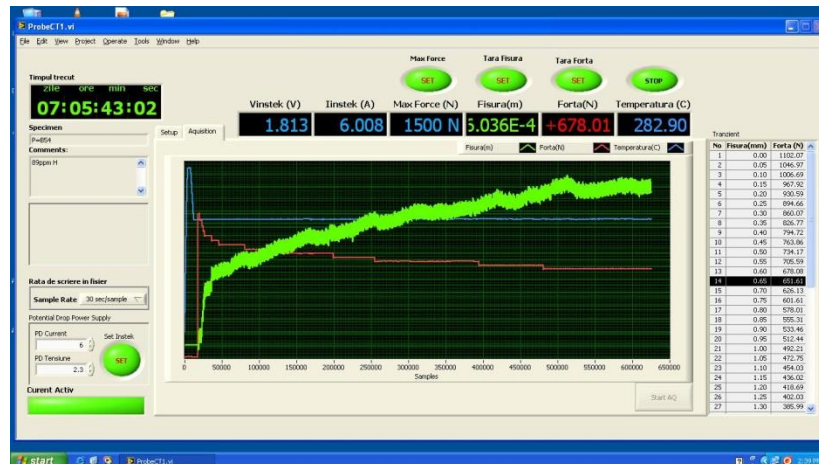
A window with parameters monitored during the test are displayed in Figure 7.

**Fig. 7** Windows with evolution of main parameters  $K_{IH}$  test

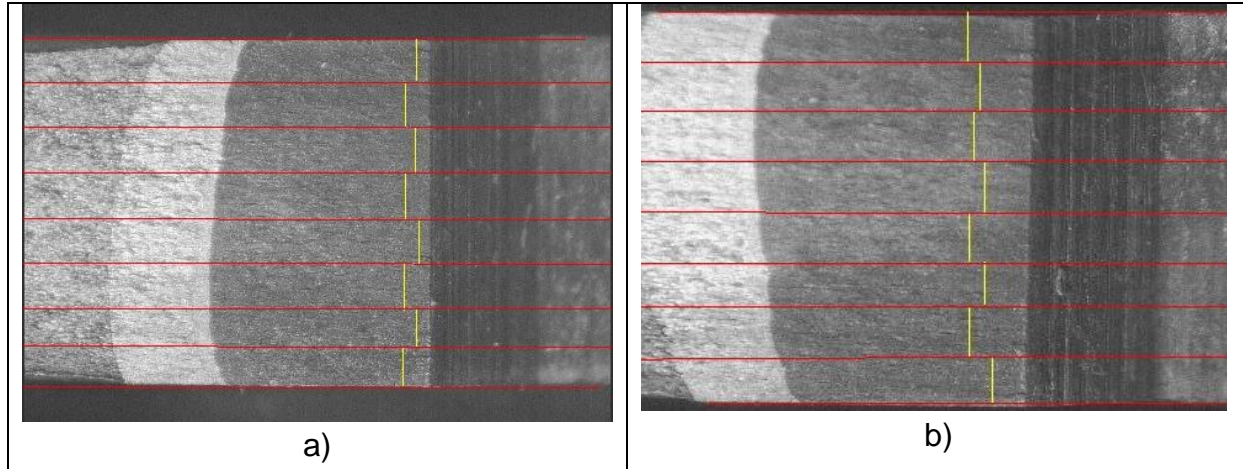
To infer the  $K_{IH}$  value, the last load step is considered, which the step is when the crack does not propagate for 24 hours. On the metallographic capture (Fig. 8) the crack length has been evaluated by means of the “nine segments method”. This allows obtaining the  $K_{IH}$  value according the E-399 ASTM.

**Fig. 8** Măsurarea propagării fisurii prin metoda „celor 9 segmente” pe proba B55: a) fața A a probei, b) fața B a probei

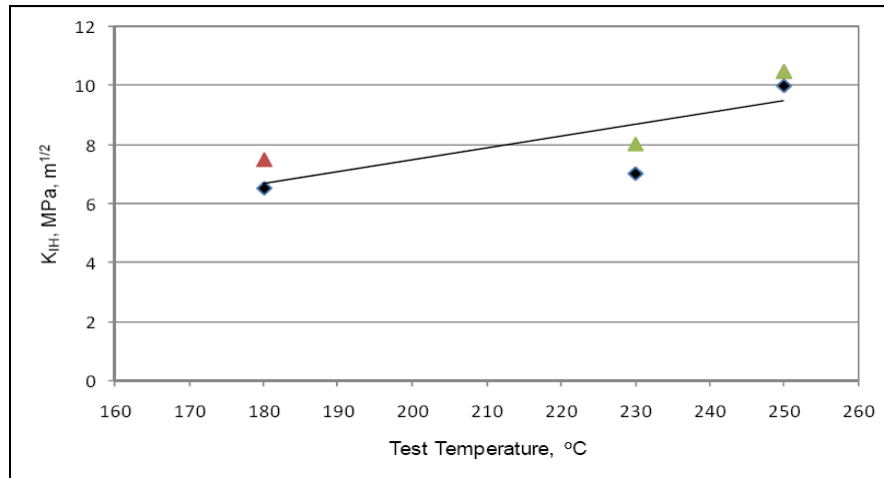
By using the above equations in present work two values of threshold stress intensity factor  $K_{IH}$  were obtained at 280 °C:  $K_{IH}=13.1 \text{ MPa}\cdot\sqrt{\text{m}}$  and  $K_{IH}=19.6 \text{ MPa}\cdot\sqrt{\text{m}}$ . For a temperature range between 180-250 °C, the reference [2] declared values displayed in Figure 9.

**Fig. 9** Values of  $K_{IH}$  versus temperature Zr-2,5%Nb [2]

One can see that the results from the present paper are in a rather good agreement with those mentioned in cited reference.
