# REPARATION OF AN EXCAVATOR BUCKET

**SUPERCOMBINATA<sup>®</sup>  
BASIC**

The Supercombinata BASIC is Elsa's new answer for the earthmoving sector. In this case study the boring machine was used on-site to repair the bucket of a JCB back excavator.

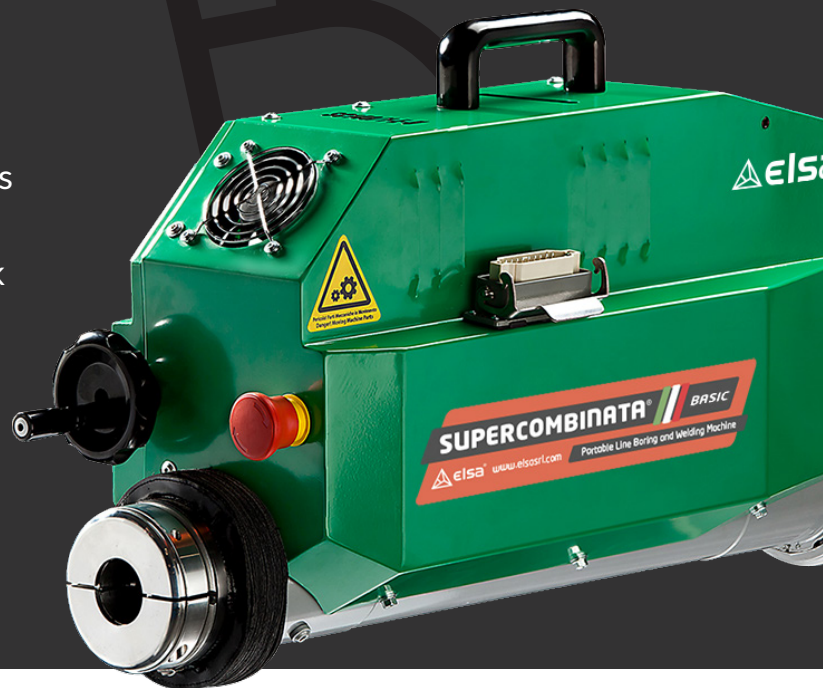
Thanks to its small size and extreme versatility and precision, SP Centro Edile Srl has been able to carry out the processing directly on-site reducing time and costs compared to a conventional repair.

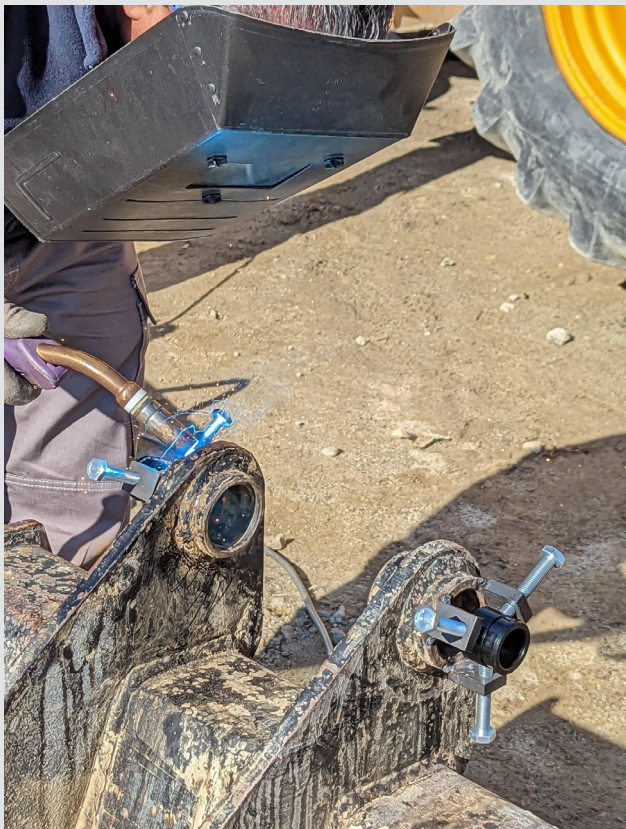
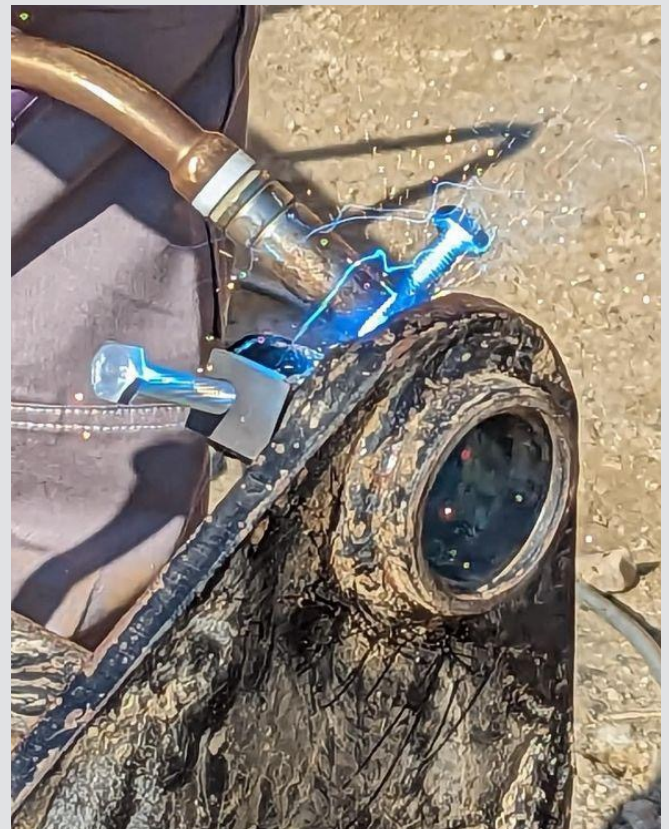
# 1

## CENTERING OF THE BORING BAR

Before starting the welding work, the surface was cleaned. The centering was done in traditional way, by welding the corresponding ELSA centering kit.

It should be emphasized that the welding mode was preferred over other centering types, as working with this centering kit ensures higher precision for further processing.

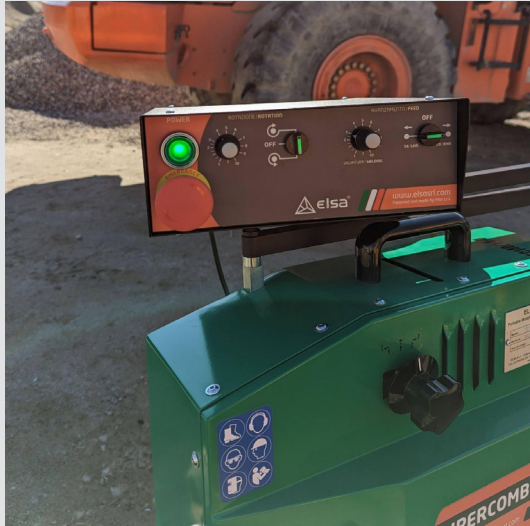
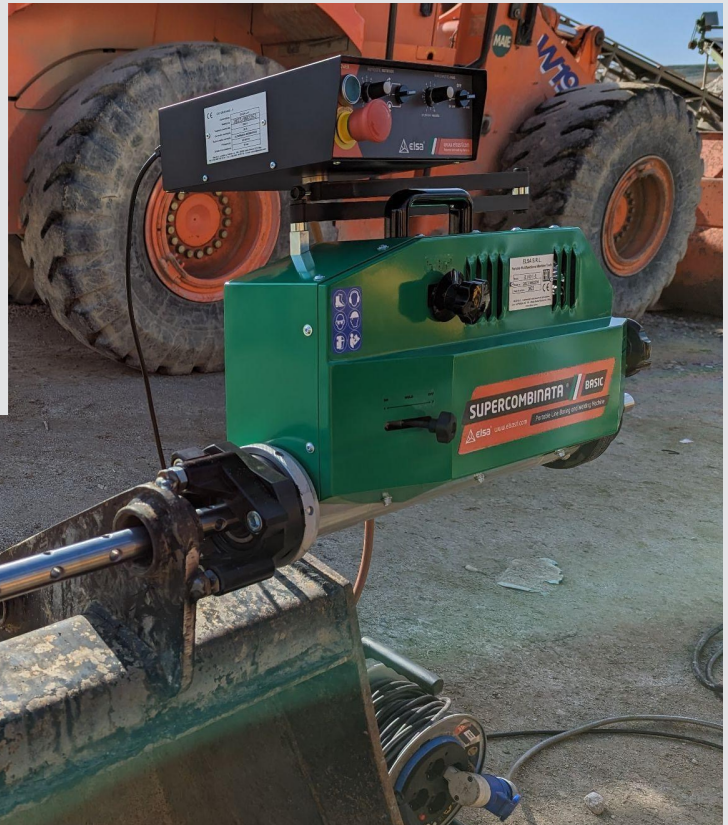
# 3

Once the machine was attached to the machine holder, the control unit was installed on the corresponding holder.

After connecting the cable between the machine and the control unit, the machine and the control unit could be connected to the power supply.

## MACHINE GROUP READY FOR OPERATION

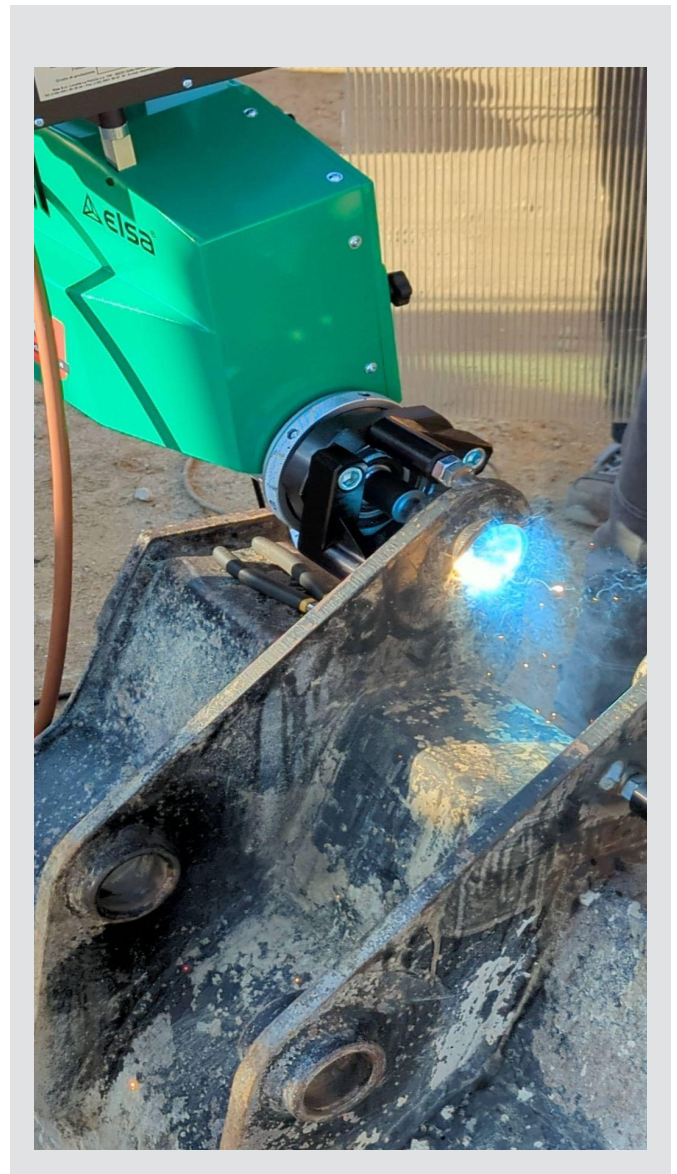
# 5 OVERLAY WELDING

The portable line boring machine BASIC was equipped with the optional kit BASIC 250.

After setting the correct parameters, the welding application phase was triggered by actuation of the welding lever, which sets the automatic synchronization of the rotation with the feed movement.

During the overlay welding process in which the welding lance applies material on the machined surface, the previously set parameters could be subsequently changed by the potentiometer provided for this purpose.

The welding operation was accompanied by an even noise, which confirms correct processing. The result was a uniformed weld bead without overlaps and interruptions.

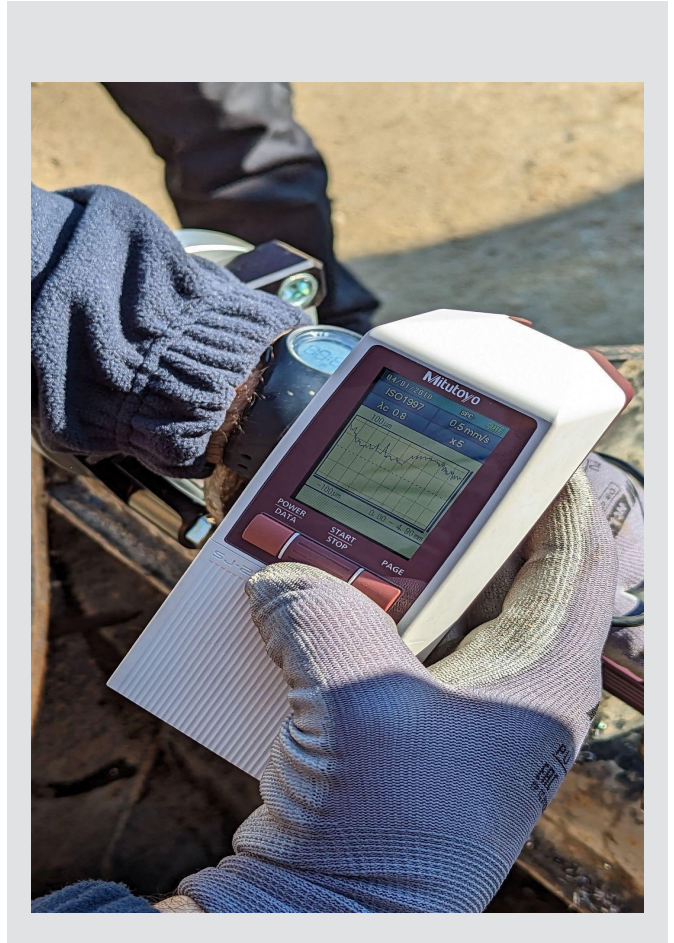
## ACHIEVED RESULTS

At the end of machining, after having completed the repair of the holes, the diameters of the holes and the roughness were measured.

The total time for machining four bushings was approx. 236 minutes (less than 4 hours) and allowed the JCB rear excavator to be repaired in short time. Obviously, the processing time is indicative as it may differ depending on the user's experience.

The final measurements showed a value of 45 mm with H7 tolerance, while the roughness was 3.2  $\mu\text{m}$ .
