## Monitoring Corrosion Process of Reinforced Concrete Structure using FBG Strain Sensor

Almubaied, O, Chai, HK, Rajibul Islam, M, Sing Lim, K & Ghuan Tan, C 2017, 'Monitoring Corrosion Process of Reinforced Concrete Structure using FBG Strain Sensor', *IEEE Transactions on Instrumentation and Measurement*. <https://doi.org/10.1109/TIM.2017.2676218>

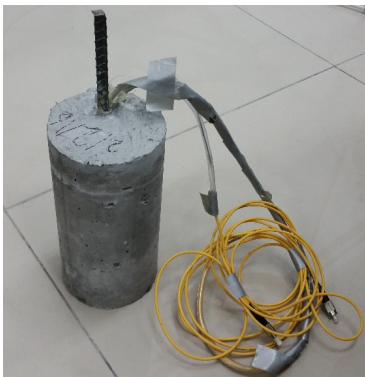
Fig. 5. Specimen after curing.

Two 200 x 100 mm concrete cylindrical specimens were prepared for the study, as shown in Fig. 5. Ordinary Portland cement was used as the binder. The concrete mix was designed by referring to a previous work [22] with binder to water ratio of 0.55. The proportional ratio for binder, coarse aggregate and fine aggregate was 1:1.65:3, with maximum coarse aggregate size of 10 mm. A structural grade deformed steel bar of 10 mm in diameter was placed at the center of specimen. After casting, the specimens were demolded after 24 hours and cured inside a water tank for 16 days. Among the two specimens, one was used to assess capability of the FBG strain sensor in detection and evaluation of steel corrosion, while the other one was intended for investigating the feasibility of FBG strain sensor in assessing concrete cracking. The top and bottom faces of the second specimen were coated with epoxy resin to prevent concrete from directly in contact with NaCl solution during accelerated corrosion process, considered as an attempt to mimic the actual exposure condition of a typical RC element to corrosion, in which moisture and chloride ions are penetrating from concrete cover and in a direction perpendicular to steel reinforcement.

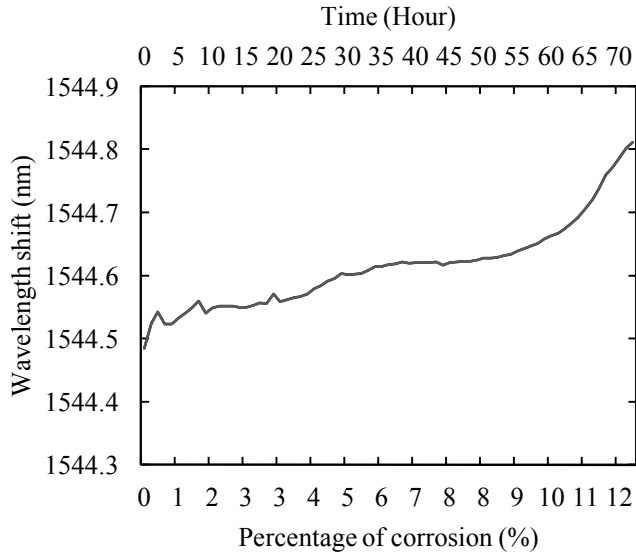
Fig. 7. Wavelength shift of specimen 1 versus time versus percentage of corrosion.

Following the end of accelerated corrosion process for the first specimen, FBG measurement was stopped and the specimen was break opened to examine the conditions of steel bar and the FBG strain sensor. Fig. 12 shows the condition of steel bar found in the first and second specimen at the end of accelerated corrosion process. As given by the time history plot in Fig. 7 suggested the occurrence of accumulated corrosion activities that have introduced stresses cause gradual change in the FBG wavelength over time. Also Fig. 7 relates the change of FBG wavelength with the level of corrosion, expressed in terms of mass loss of steel by percentage, in other words it is the weight loss of steel bar (Faraday's law) by the original weight of the bar before start of corrosion process. Fig. 8 shows the development of FBG wavelength measurement for the second specimen against time and steel corrosion percentage.

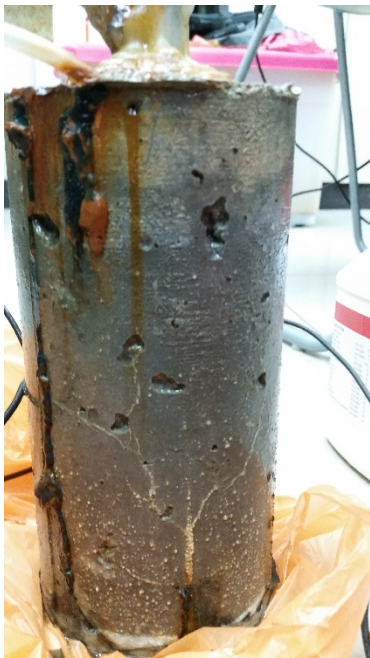
Fig. 11. Rust stain emerged from concrete cracks.

The FBG strain sensor has proven its capability to detect the three stages of corrosion process out of four stages of corrosion process [22]. The first stage is associated with chloride penetration and corrosion initiation. First stage takes years in actual corrosion process and in the current study, it can be considered as the initial two hours after corrosion has started. The second stage was defined as the time during which free expansion of corrosion products, namely rust occurred, which was during the 101 hours of the corrosion process. In this stage, the voids surrounding the steel bar were occupied by rust. The third stage is regarded as the stress initiation where the rust has induced stresses on the concrete, resulting in cracking events. In this study, the third stage of steel corrosion could not be clearly identified by the FBG strain sensing because of the isolation of the sensors from concrete material by the polystyrene foam cover, the last stage was evident, with which the FBG wavelength shift has registered a drop after 103 hours of corrosion, a result of intensified cracking that gave change to concrete stress transfer over the polystyrene foam cover. After the release of the stresses on the polystyrene foam cover the inner volume of the polystyrene foam cover has been increased to allow the corrosion products to flow and reduce the cumulative corrosion products under the sensor fig. 9. The stages are illustrated in Fig. 10. Fig. 11 shows the cracks on the second specimen.

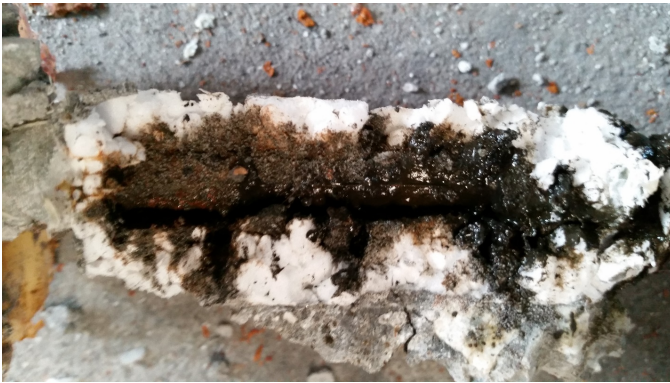
Fig. 12. Condition of FBG strain sensors in specimen 1 and 2 after corrosion test. (a) specimen 1. (b) specimen 2.

Fig. 12a shows that the responses attained from the sensors are due to the volume of the corrosion products layer. However, the FBG wavelength reading was found to be almost constant for Specimen 2 during a period of 97 hours to 103 hours after corrosion has started. This inferred that in this period, the continuing corrosion activity did not induce significant stress to the FBG strain sensor. In other words, the corrosion products at this stage act as fluid which passes around the fiber without changing the wavelength shift. After that stage, which is at the beginning of the fifth day, cracks were observed to have propagated from the bottom of the specimen at 7.54 % of corrosion. Nevertheless, the first specimen has reached over 12% of corrosion level without any indication of crack, and the reason behind that is the non-uniformity of the reinforcement corrosion. Table I shows the current's Ampere and voltage, where the ampere has changed for the second specimen to keep the voltage constant for safety reasons. Due to the low Ampere at the beginning of the second specimen the reinforcement corrosion was more uniform. However, the first specimen started with high ampere value which lead to less corrosion uniformity. Fig. 12 shows the actual corrosion at the location of the sensors. In other words, the reinforcement part that had most corroded was not on the sensor area. After 103 hours into the corrosion process for specimen 2, there was a decline in the wavelength shift which signified the change in corrosion products arrangement. As the polystyrene foam was in contact with concrete, cracks that formed in concrete have created a release stress on the polystyrene foam. Therefore, the polystyrene foam inner volume was increased to allow for the corrosion products to fill the side boundaries of the polystyrene foam. A marked jump in the wavelength shift as noted between 96 hours to 97 hours after the corrosion process initiated. The jump was corresponded to the increase in electric current, where the increment occurs to allow the current voltage to be constant throughout the experiment, the fifth column in Table II shows the corrosion increment which is the corrosion percent of the current hour minus the corrosion percent of the previous hour ( $6.291 - 6.223 = 0.068 \%$ ).

At the end of experiment, both specimens were crack opened to examine the conditions of FBG strain sensors. Fig. 12 shows the conditions of FBG sensors in specimen 1 and 2 after corrosion process. It is obvious that specimen 2 has developed a more severe corrosion than Specimen 1, which is confirmed by our theoretical calculations. Fig. 12a shows the corrosion layer formed on the steel bar that induced stress on the FBG sensor, this layer was formed from two types of corrosion products namely, adherent and non-adherent products in which the adherent layer is deposited over the bar surface. On the other hand, the non-adherent layer was loosely bounded to the metal surface and it may dissolve into the solution during the corrosion process [26]. Therefore, at high corrosion level the non-adherent corrosion products with the presence of solution may act as fluid as shown in Fig. 12b. Upon detailed examination, the FBG sensors in both specimens were found intact and their bonds with steel reinforcement remained sound. In other words, the sensors were found to be in good working condition and could be recycled for other use by detaching them through from the steel bars through heating of the bonding epoxy resin. This finding is important in validating the feasibility of the mounting procedure for FBG strain sensor developed for monitoring and evaluating steel reinforcement corrosion in concrete.
