Agricultural Damage Assessment in the Gaza Strip from October 7th 2023 to September 1st 2024

This document compiles damage assessments conducted by FAO and UNOSAT across various indicators in the Gaza Strip from October 7th 2023 to September 1st 2024, utilizing very high-resolution and high-resolution satellite imagery and data from FAO Palestine, Agriculture Census² and UNOSAT for comprehensive evaluations of agricultural and infrastructure impacts.

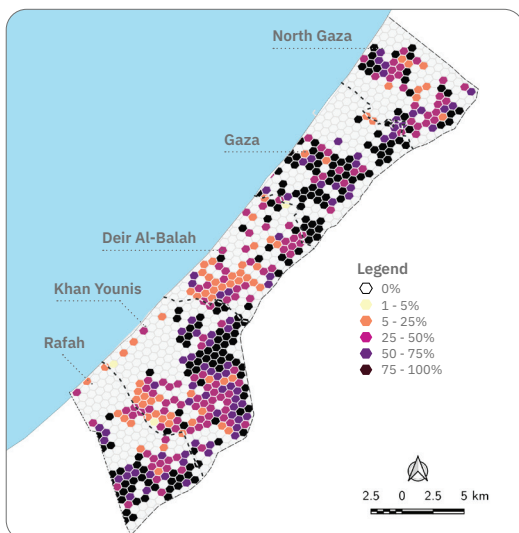
Damage to Agricultural Infrastructures

Agricultural infrastructure locations from 2021 were used as baseline data due to limited availability for data collection in the area of interest. The damage assessment utilized Sentinel-1 SAR data, identifying infrastructures within 15 meters of damaged sites and mapping damage severity in localized areas. Damage was estimated through the Coherence Change Detection (CCD) algorithm, using two pre-event and one post-event image sets. Coherence layers were analyzed to detect changes, with the resulting damage proxy map (DPM) highlighting alterations in built-up areas.

1. Based on the latest assessment, home barns (606), broiler farms (538) and sheep farms (427) are the most damaged agricultural infrastructures.
2. The governorate of Khan Younis has the largest number of damaged agricultural infrastructures (1 496 damaged).

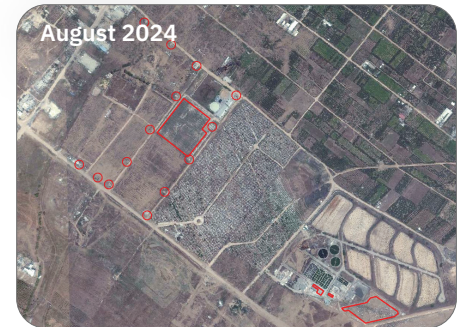
Damage to Water Treatment Plant in the Northeast of Gaza

Very high-resolution imagery (WorldView-3)⁸ was employed to assess the damage to the Wastewater Treatment Plant located in the Northeast of Gaza. This facility was specifically assessed due to its relevance and FAO's support towards the sustainable and inclusive utilization of this critical infrastructure. Although there are other facilities in the Strip, the focus on this one stems from its importance. A comparison of imagery from August 2023 and August 2024 revealed significant destruction. 42 500 square meters of solar panels were destroyed. Of the 14 recovery wells, 12 were destroyed, while two were partially damaged, and at least two of the plant buildings were destroyed.

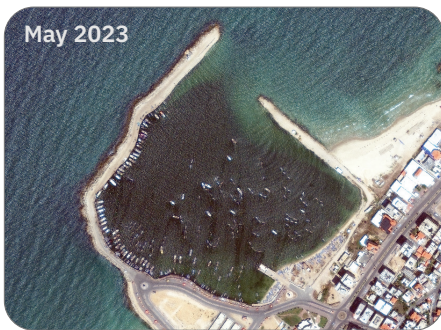
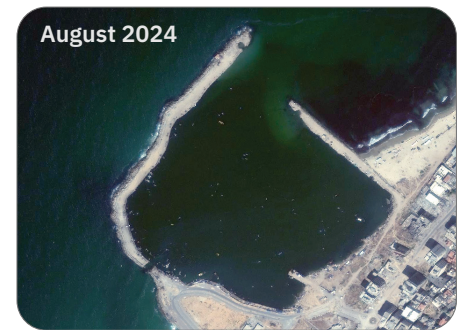
Damage to Port of Gaza City

Similarly, very high-resolution satellite imagery (WorldView-2) was used for a specific assessment of strategic infrastructure in the Gaza Strip, for example, the port of Gaza City, which was a vital hub for economic activity. Most of the port infrastructure and vessels were destroyed at the beginning of the conflict (October and November 2023) and remain non-functional, severely impacting local trade and livelihoods. A comparison of imagery from before (May 2023) and after (May 2024) shows the extent of the port's damage.
