The Fukushima Daiichi Incident

1. Plant Design
2. Accident Progression
3. Radiological releases
4. Spent fuel pools
5. Sources of Information

Matthias Braun
PEPA4-G, **AREVA–NP** GmbH
Matthias.Braun@AREVA.com

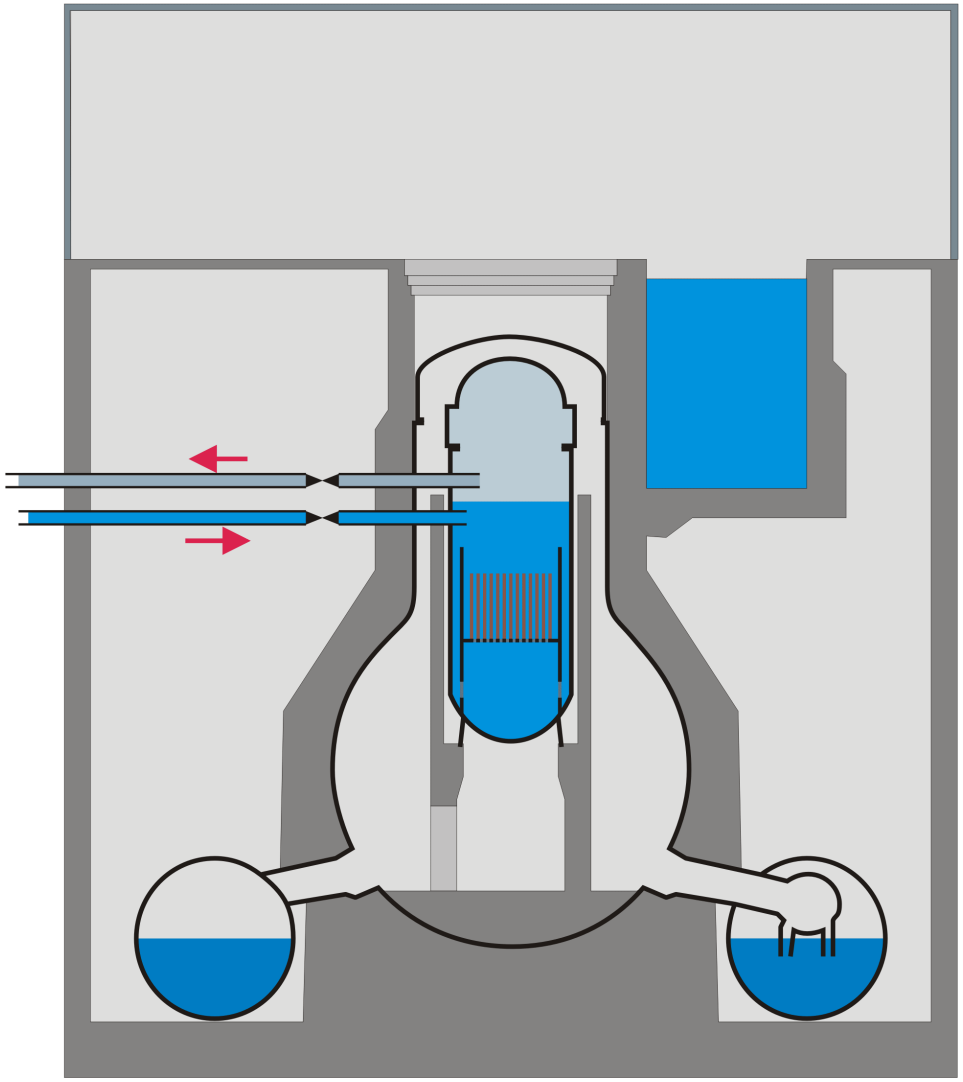
- 11.3.2011 14:46 - Earthquake
  - Magnitude 9
  - Power grid in northern Japan fails
  - Reactors itself are mainly undamaged
- SCRAM
  - Power generation due to Fission of Uranium stops
  - Heat generation due to radioactive Decay of Fission Products
    - After Scram ~6%
    - After 1 Day ~1%
    - After 5 Days ~0.5%

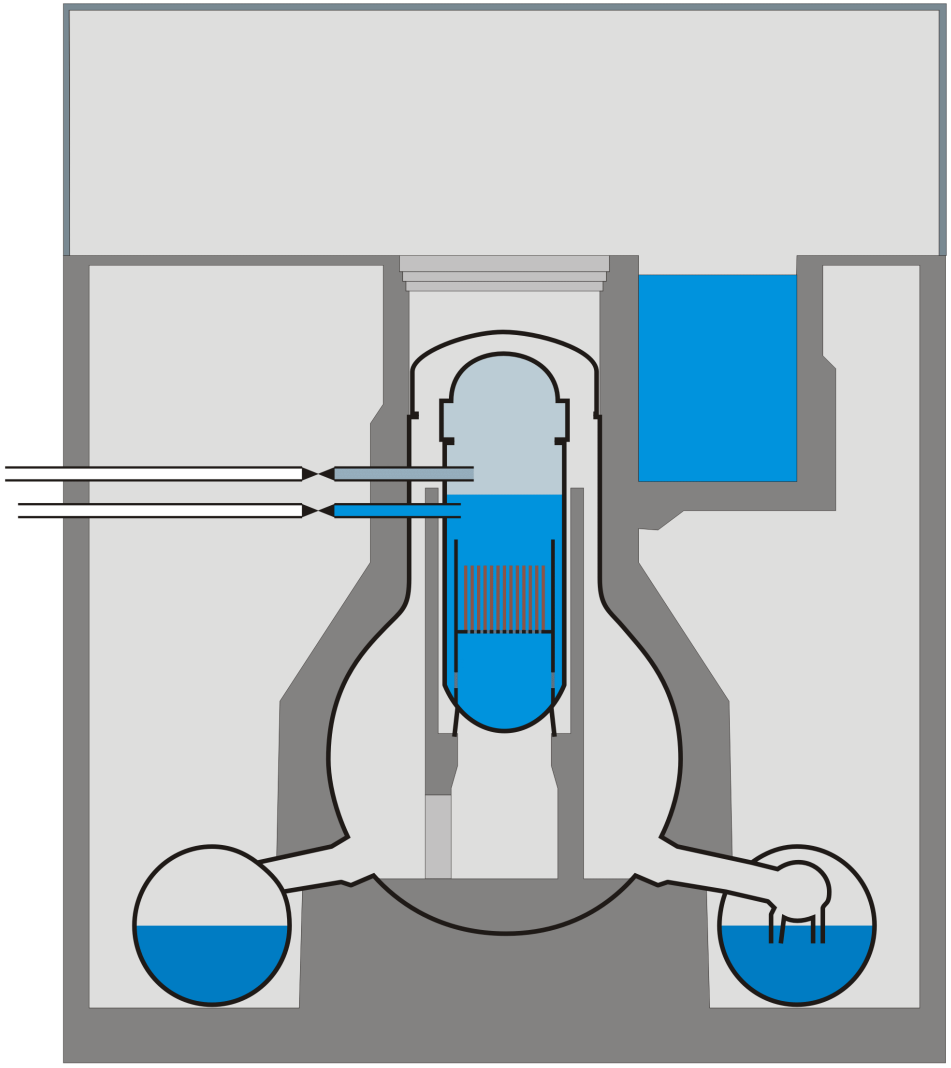
- Containment Isolation
  - Closing of all non-safety related Penetrations of the containment
  - Cuts off Machine hall
  - Due to successful containment isolation, a large early release of fission products is highly unlikely
- Diesel generators start
  - Emergency Core cooling systems are supplied
- Plant is in a stable save state

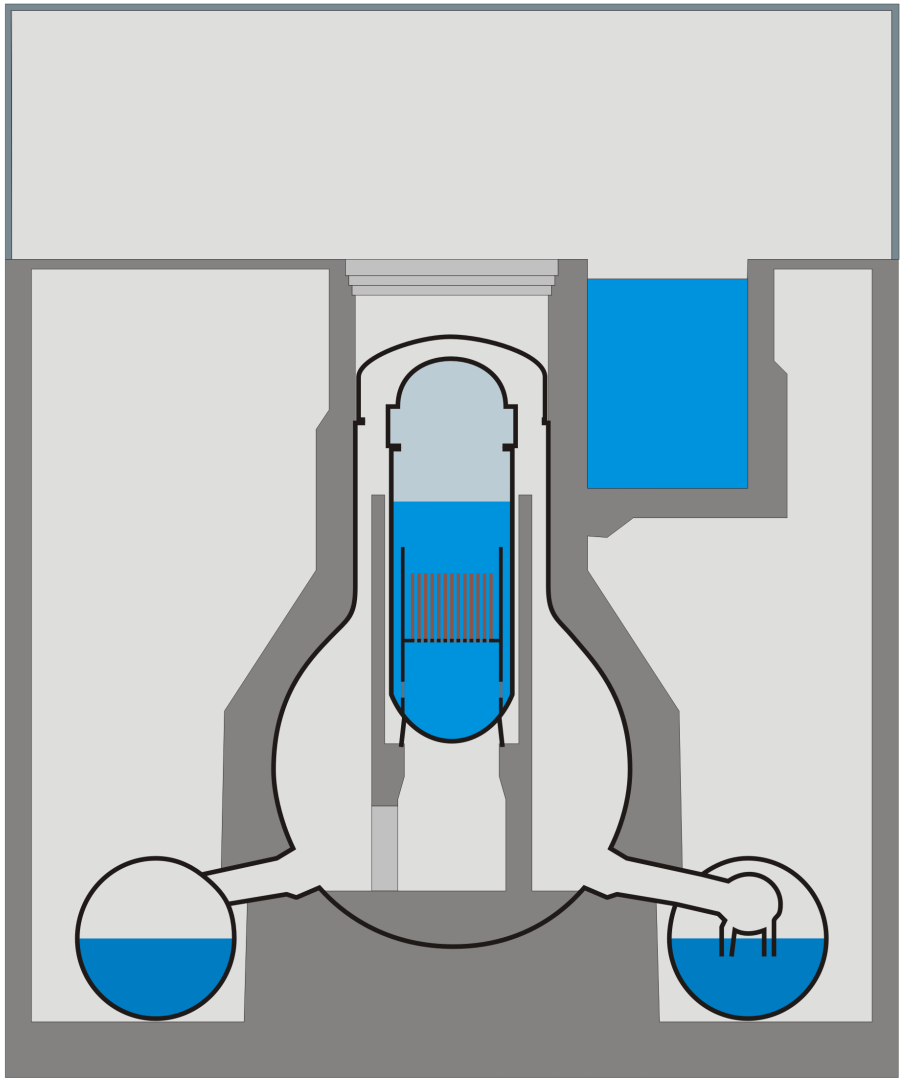
- 11.3. 15:01(?) Tsunami hits plant
  - Plant Design for Tsunami height of up to 5.7-6.5m
  - Actual Tsunami height 7-11m
  - Flooding of
    - Diesel and/or
    - Switchgear building and/or
    - Fuel Tanks and/or
    - Essential service water buildings
- 11.3. 15:41 Station Blackout
  - Common cause failure of the power supply
  - Only Batteries are still available
  - Failure of all but one Emergency core cooling system

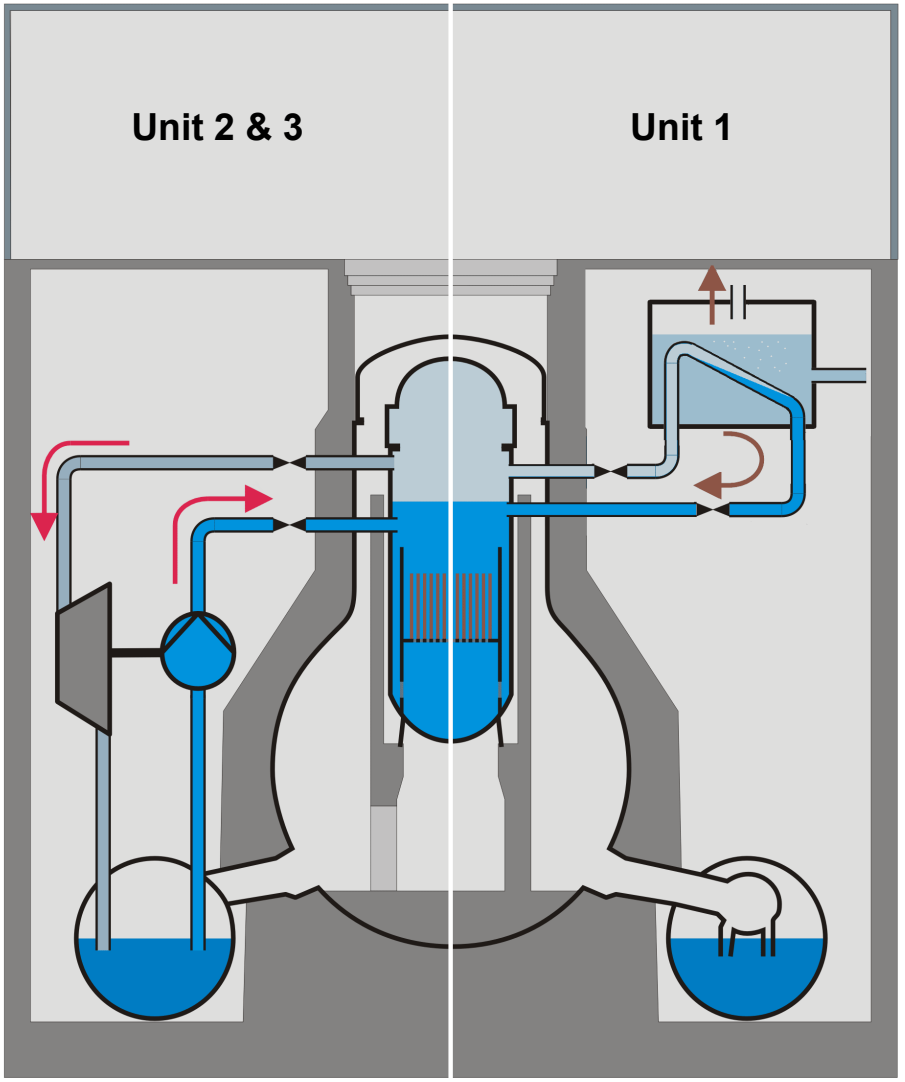
- Fukushima I -Unit 1
  - Isolation Condenser
    - Steam enters heat exchanger
    - Condensate drains back to RPV
    - Secondary steam released from plant
  - Need Pumps for Water supply
  - Can't replace water in Reactor
- Fukushima I Unit 2 & 3
  - Reactor Core Isolation Pump
    - Steam from Reactor drives Turbine
    - Steam gets condensed in Wet-Well
    - Turbine drives a Pump, pumping Water from the Wet-Well in reactor
  - Necessary:
    - Battery power
    - Wet-Well Temperature < 100°C
  - No heat removal from the buildings

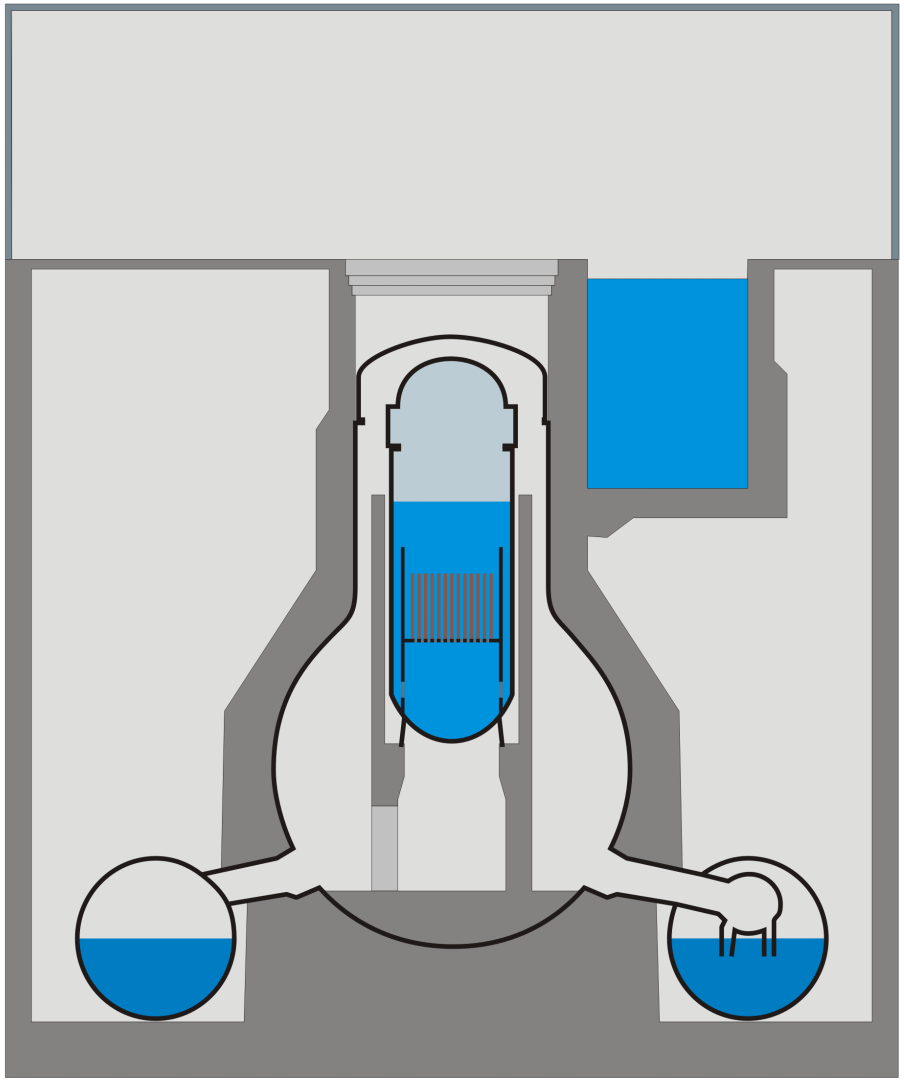
- 11.3. 16:36 in Unit 1
  - Isolation condenser stops
  - Tank empty(?)
- 13.3. 2:44 in Unit 3
  - Reactor Isolation pump stops
  - Batteries empty
- 14.3. 13:25 in Unit 2
  - Reactor Isolation pump stops
  - Pump failure
- Consecutively, all reactors are cut of from any kind of heat removal

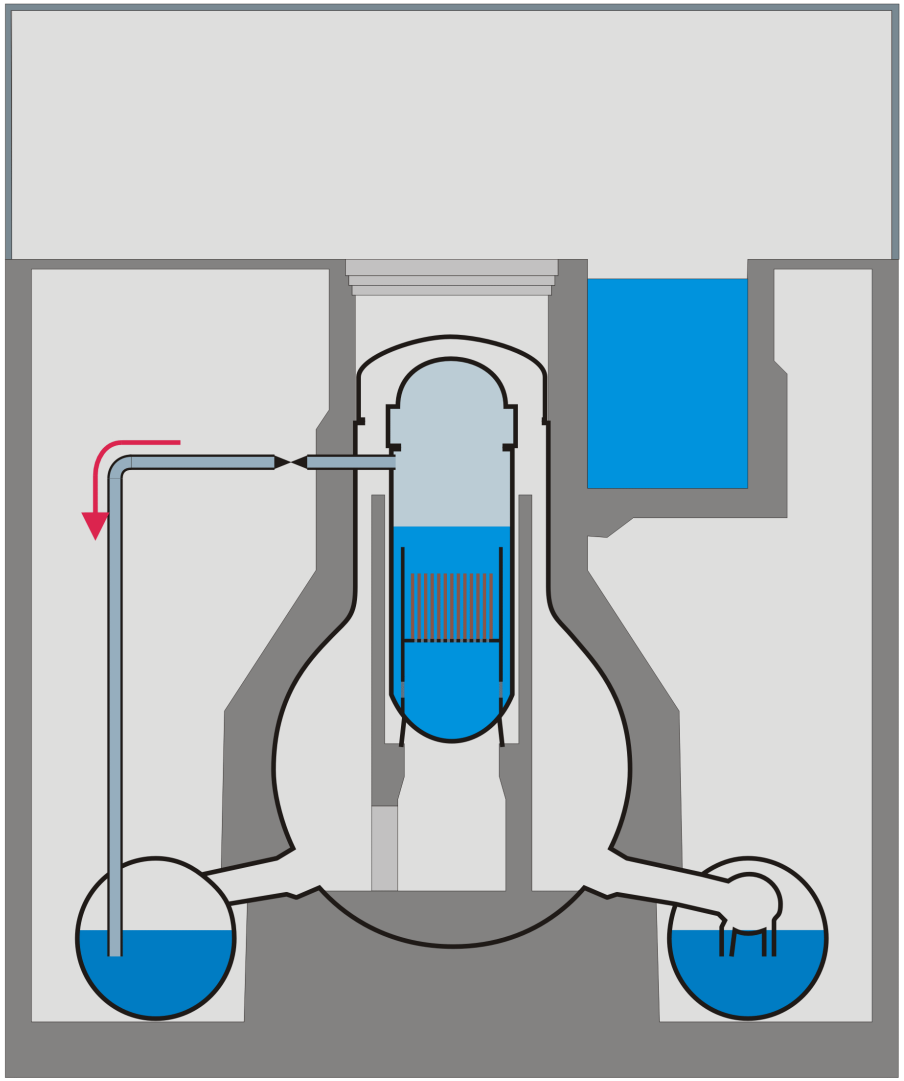
- Decay Heat produces still steam in Reactor pressure Vessel
  - Pressure rising
- Opening the steam relieve valves
  - Discharge Steam into the Wet-Well
- Descending of the Liquid Level in the Reactor pressure vessel

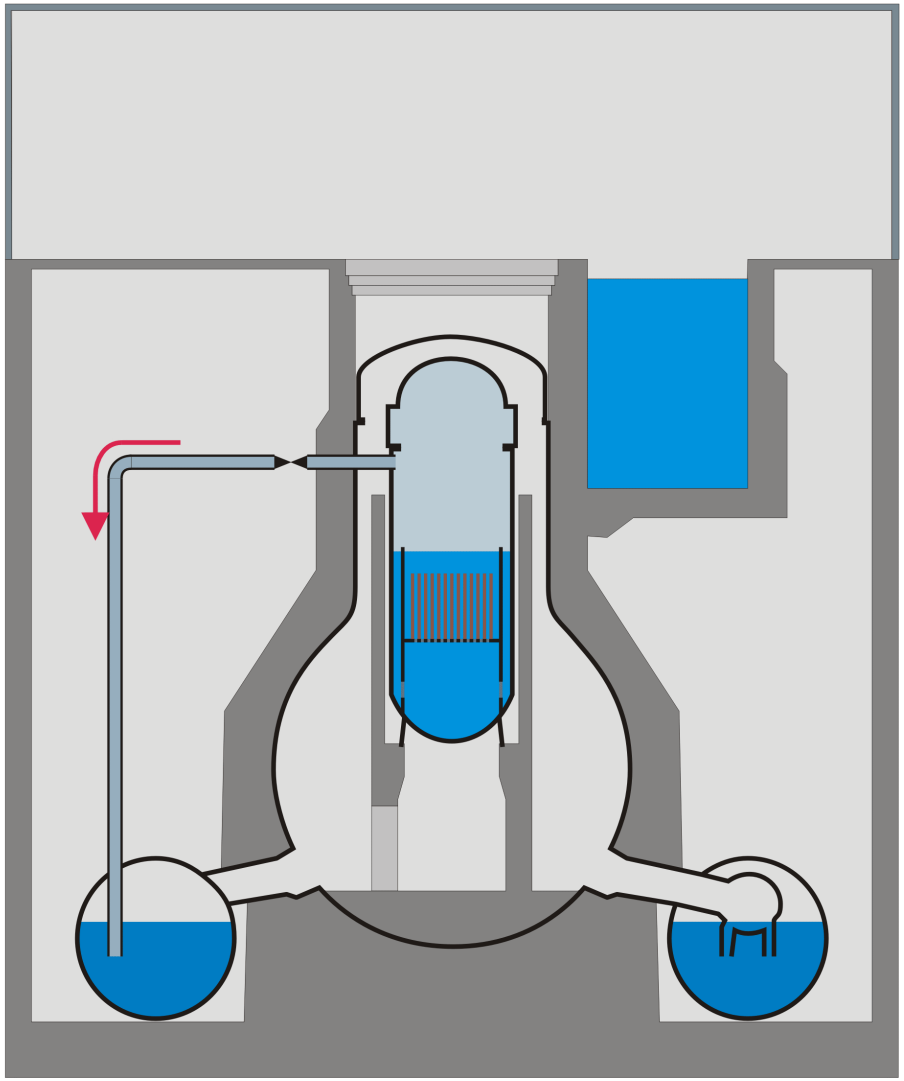
- Decay Heat produces still steam in Reactor pressure Vessel
  - Pressure rising
- Opening the steam relieve valves
  - Discharge Steam into the Wet-Well
- Descending of the Liquid Level in the Reactor pressure vessel

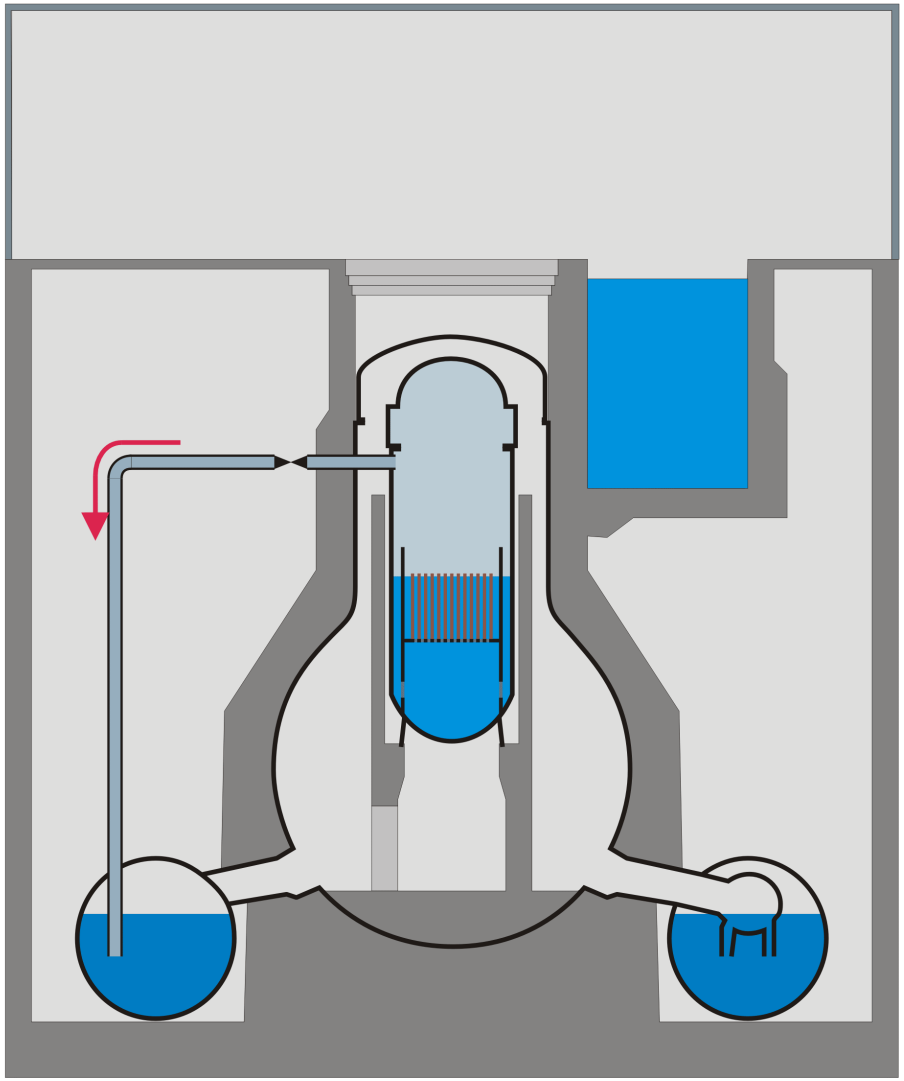
- Decay Heat produces still steam in Reactor pressure Vessel
  - Pressure rising
- Opening the steam relieve valves
  - Discharge Steam into the Wet-Well
- Descending of the Liquid Level in the Reactor pressure vessel

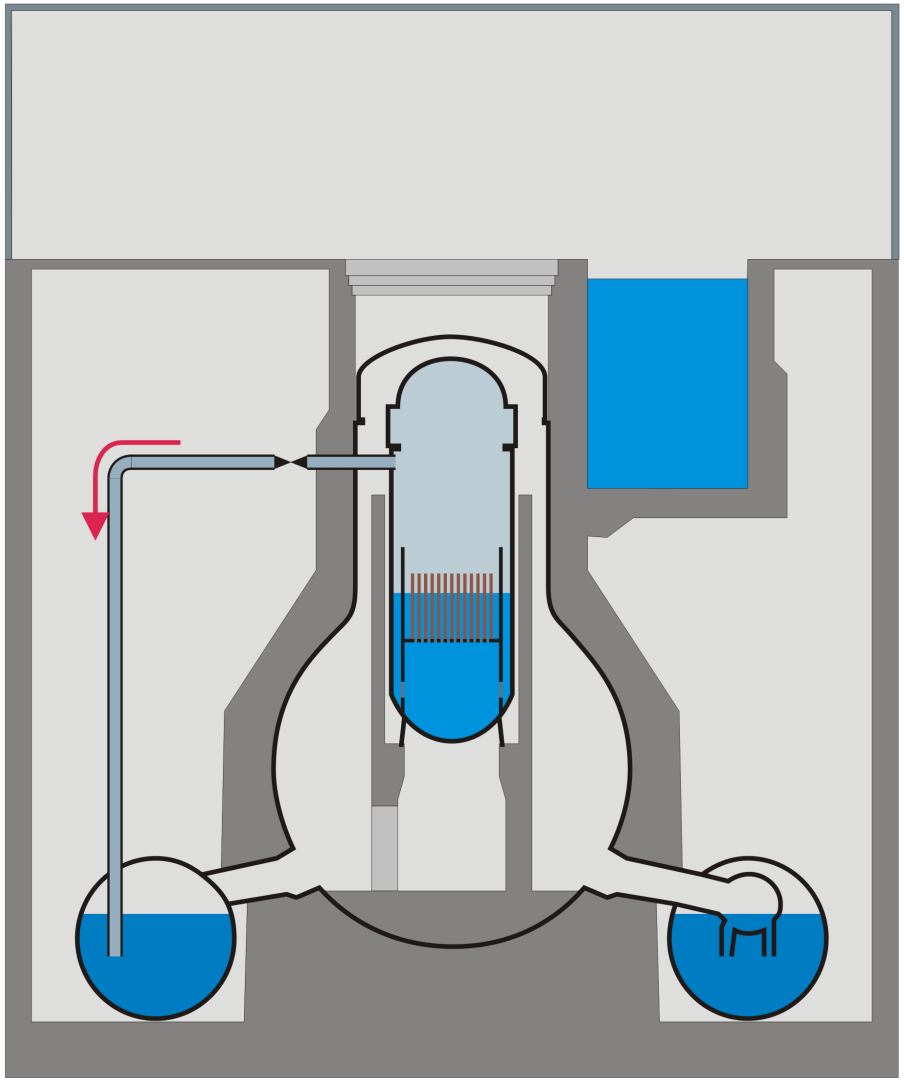
- Decay Heat produces still steam in Reactor pressure Vessel
  - Pressure rising
- Opening the steam relieve valves
  - Discharge Steam into the Wet-Well
- Descending of the Liquid Level in the Reactor pressure vessel

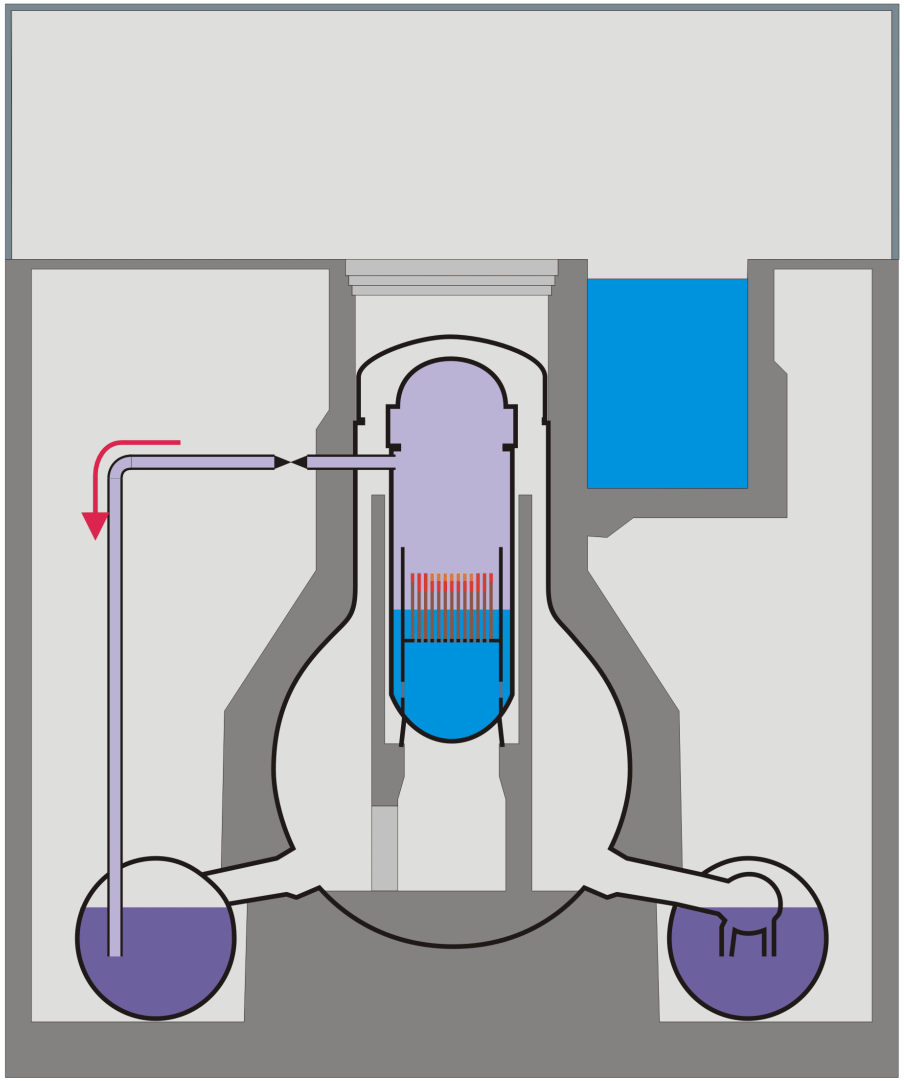
- ~50% of the core exposed
  - Cladding temperatures rise, but still no significant core damage
- ~2/3 of the core exposed
  - Cladding temperature exceeds ~900°C
  - Balooning / Breaking of the cladding
  - Release of fission products from the fuel rod gaps

(Measured levels are collapsed level. The actual liquid level lies higher due to the steam bubbles in the liquid)

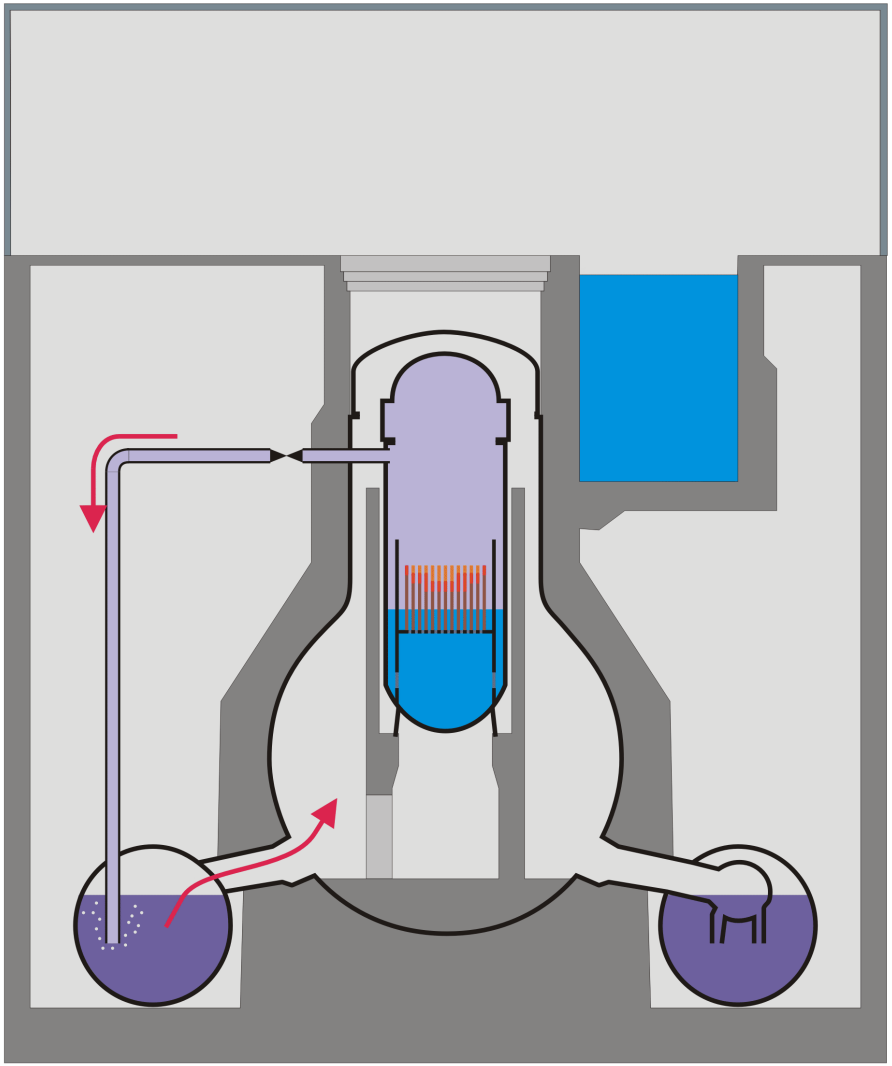
- ~3/4 of the core exposed
  - Cladding exceeds ~1200°C
  - Zirconium in the cladding starts to burn under steam atmosphere
  - **$Zr + 2H_20 \rightarrow ZrO_2 + 2H_2$**
  - Exothermal reaction further heats the core
  - Estimated masses hydrogen
    - Unit 1: 300-600kg
    - Unit 2/3: 300-1000kg
  - Hydrogen gets pushed via the wet-well and the wet-well vacuum breakers into the dry-well

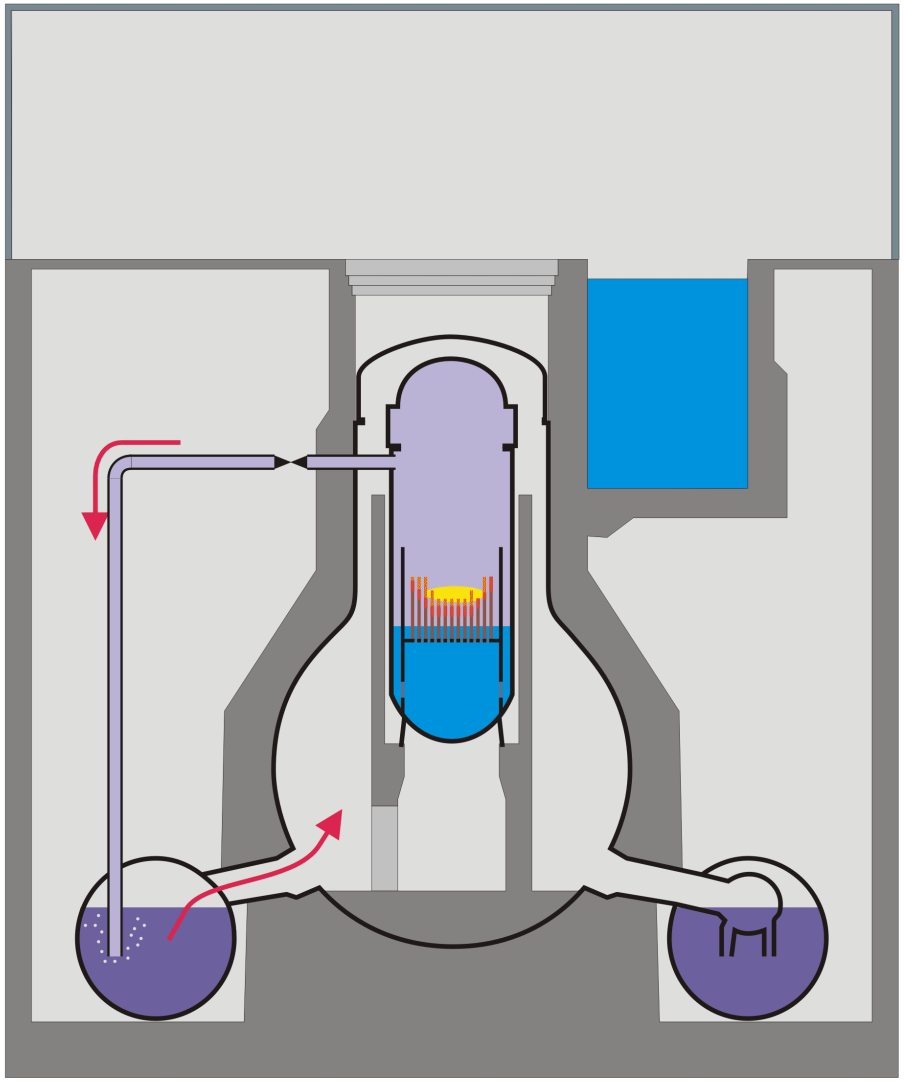
- at ~1800°C [expected Unit 1,2,3]
  - Melting of the Cladding
  - Melting of the steel structures
- at ~2500°C [expected Unit 1,2]
  - Breaking of the fuel rods
  - debris bed inside the core
- at ~2700°C [maybe Unit 1]
  - Significant melting of Uranium-Zirconium-oxides
- Restoration of the water supply stops accident in all 3 Units
  - Unit 1: 12.3. 20:20 (27h w.o. water)
  - Unit 2: 14.3. 20:33 (7h w.o. water)
  - Unit 3: 13.3. 9:38 (7h w.o. water)

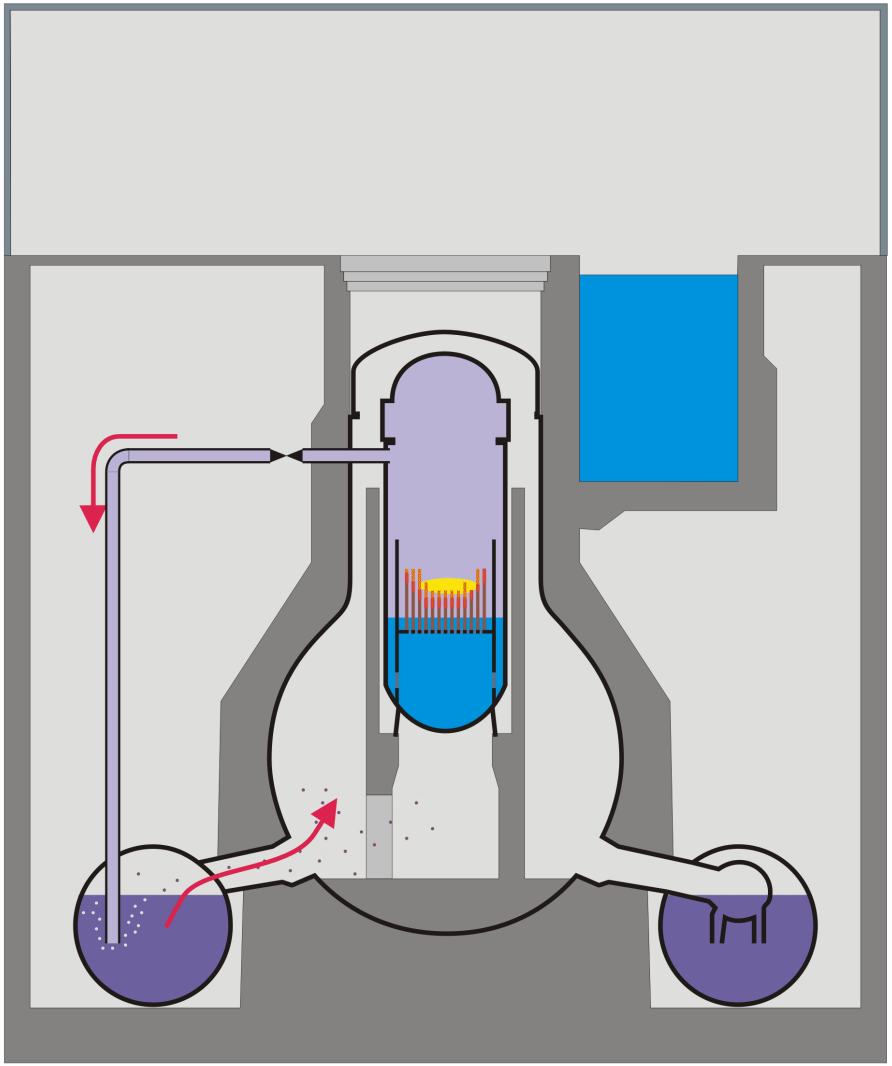
- Release of fission products during melt down
  - Xenon, Cesium, Iodine,…
  - Uranium/Plutonium remain in core
  - Fission products condensate to airborne Aerosols
- Discharge through valves into water of the condensation chamber
  - Pool scrubbing binds a fraction of Aerosols in the water
- Xenon and remaining aerosols enter the Dry-Well
  - Deposition of aerosols on surfaces further decontaminates air

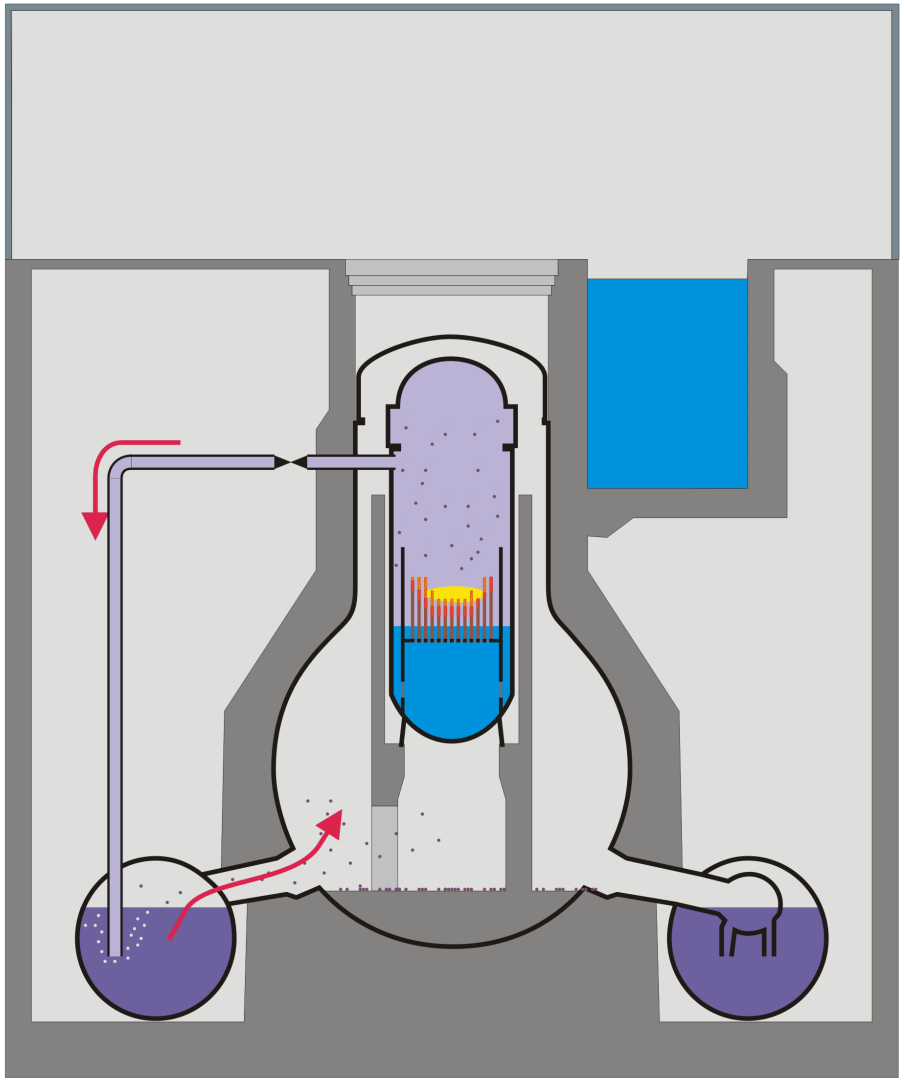
- Containment
  - Last barrier between Fission Products and Environment
  - Wall thickness ~3cm
  - Design Pressure 4-5bar
- Actual pressure up to 8 bars
  - Normal inert gas filling (Nitrogen)
  - Hydrogen from core oxidation
  - Boiling condensation chamber (like a pressure cooker)
- First depressurization of the containment
  - Unit 1: 12.3. 4:00
  - Unit 2: 13.3 00:00
  - Unit 3: 13.3. 8.41

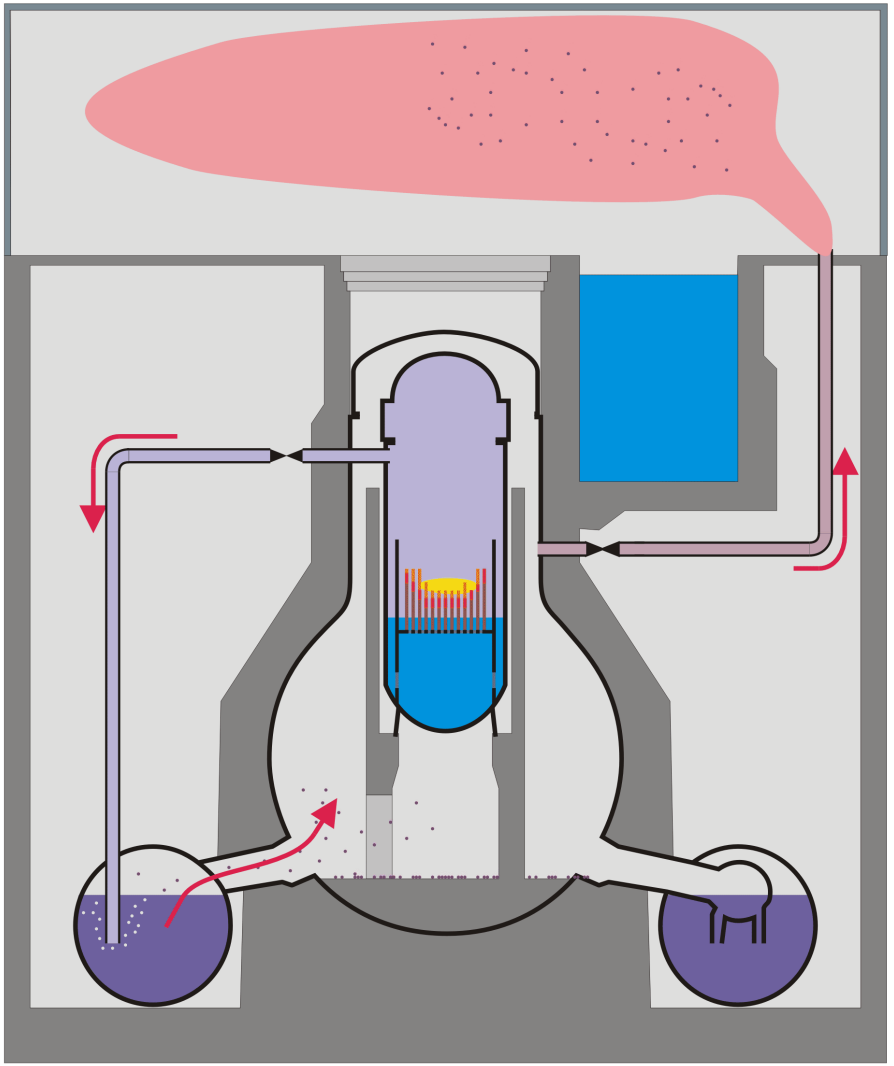
- Positive und negative Aspects of depressurizing the containment
  - Removes Energy from the Reactor building (only way left)
  - Reducing the pressure to ~4 bar
  - Release of small amounts of Aerosols (Iodine, Cesium…)
  - Release of all noble gases
  - Release of Hydrogen
- Release of unfiltered venting?
- Gas is released into the reactor service floor
  - Hydrogen is flammable

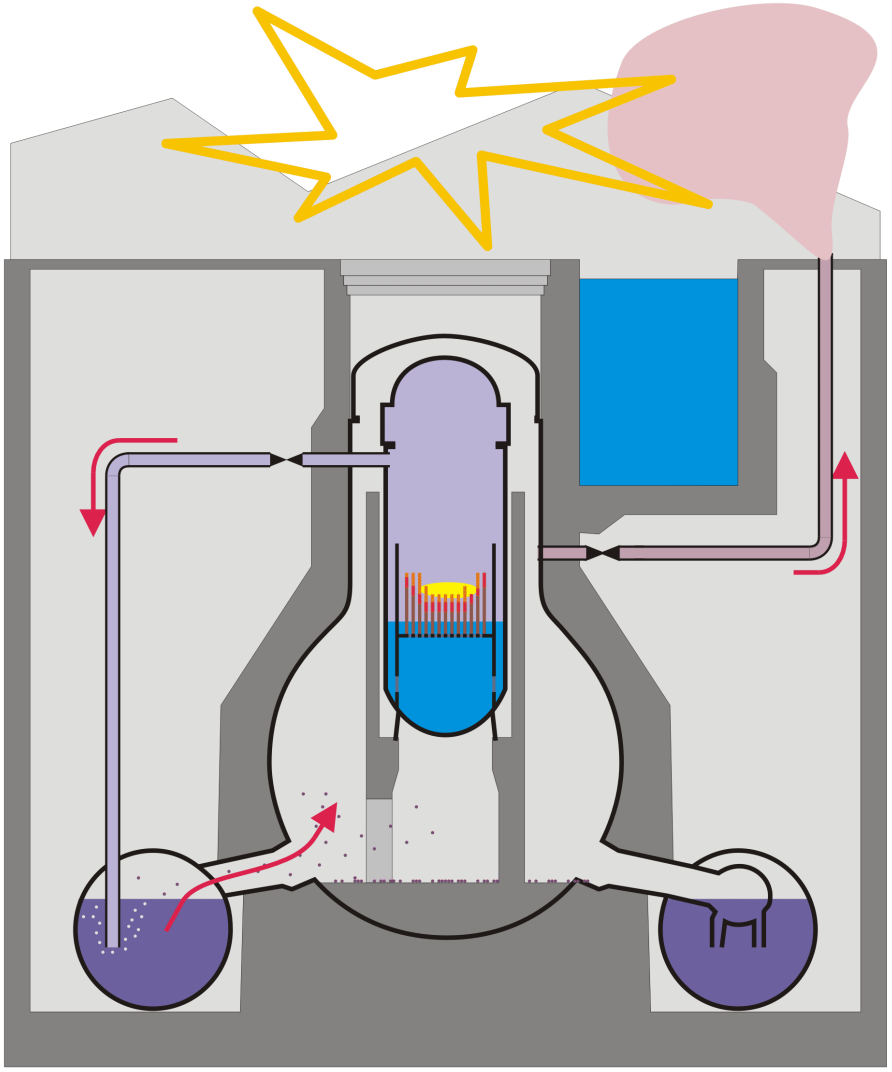
- Unit 1 and 3
  - Hydrogen burn inside the reactor service floor
  - Destruction of the steel-frame roof
  - Reinforced concrete reactor building seems undamaged
  - Spectacular but minor safety relevant

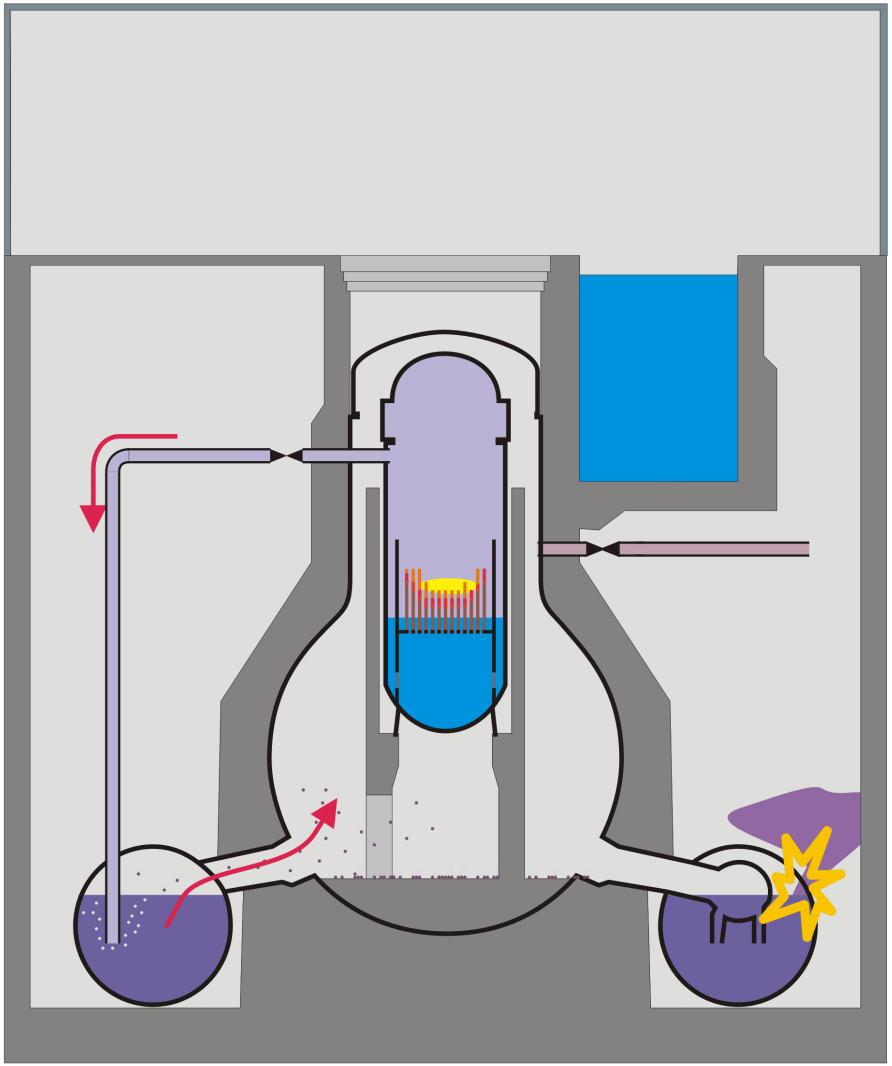
- Unit 2
  - Probably Hydrogen leakage of the condensation chamber (actual pressure exceeds design pressure)
  - Burn inside the reactor building in proximity to the wet-well
  - Damage to the condensation chamber
  - Uncontrolled release of
    - Gas
    - highly contaminated water
    - Aerosols of fission products
  - Temporal evacuation of the plant
  - High local dose rates on the plant site due to wreckage hinder further recovery work

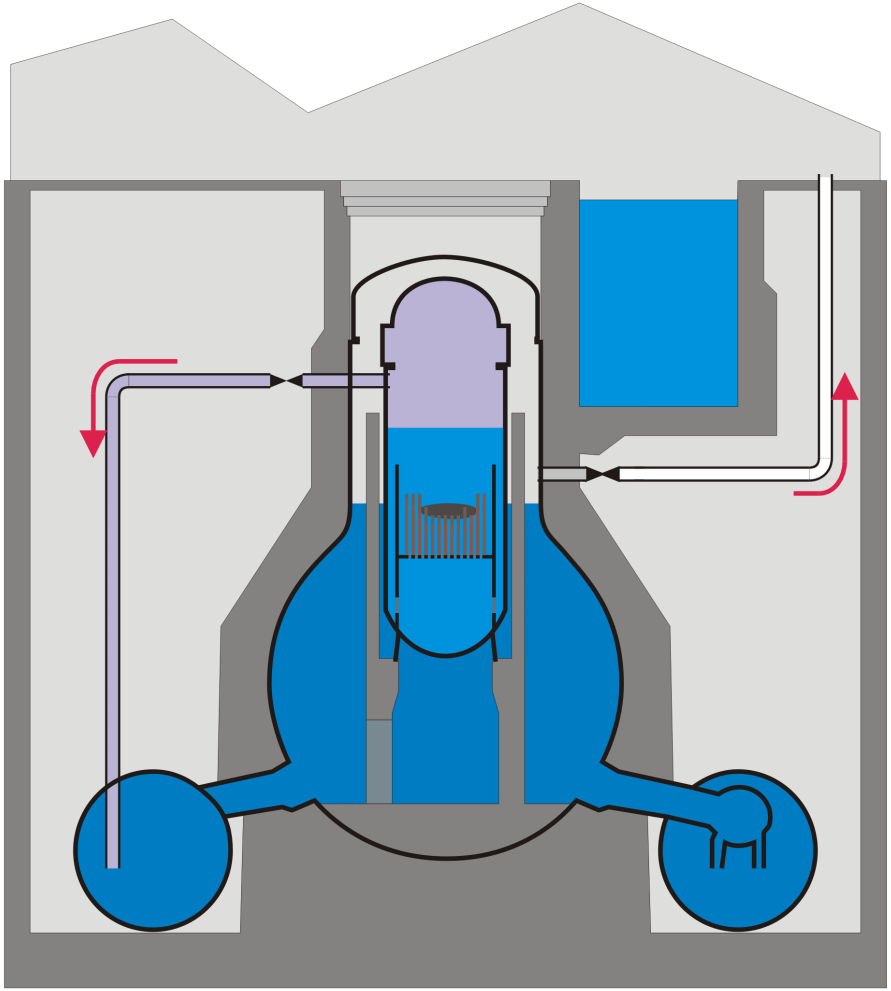
- Current status of the Reactors
  - Core Damage in Unit 1,2, 3
  - Building damage due to various burns Unit 1-4
  - Reactor pressure vessels flooded in all Units with mobile pumps
  - At least containment in Unit 1 flooded
- Further cooling of the Reactors
  - Unit 1: by Isolation Condensers
  - Unit 2&3: by releasing steam
- Only small further releases of fission products can be expected from Unit 2 and 3
