The Fukushima Daiichi Incident

1. Plant Design
2. Accident Progression
3. Radiological releases
4. Spent fuel pools
5. Sources of Information

Matthias Braun
PEPA4-G, **AREVA–NP** GmbH
Matthias.Braun@AREVA.com

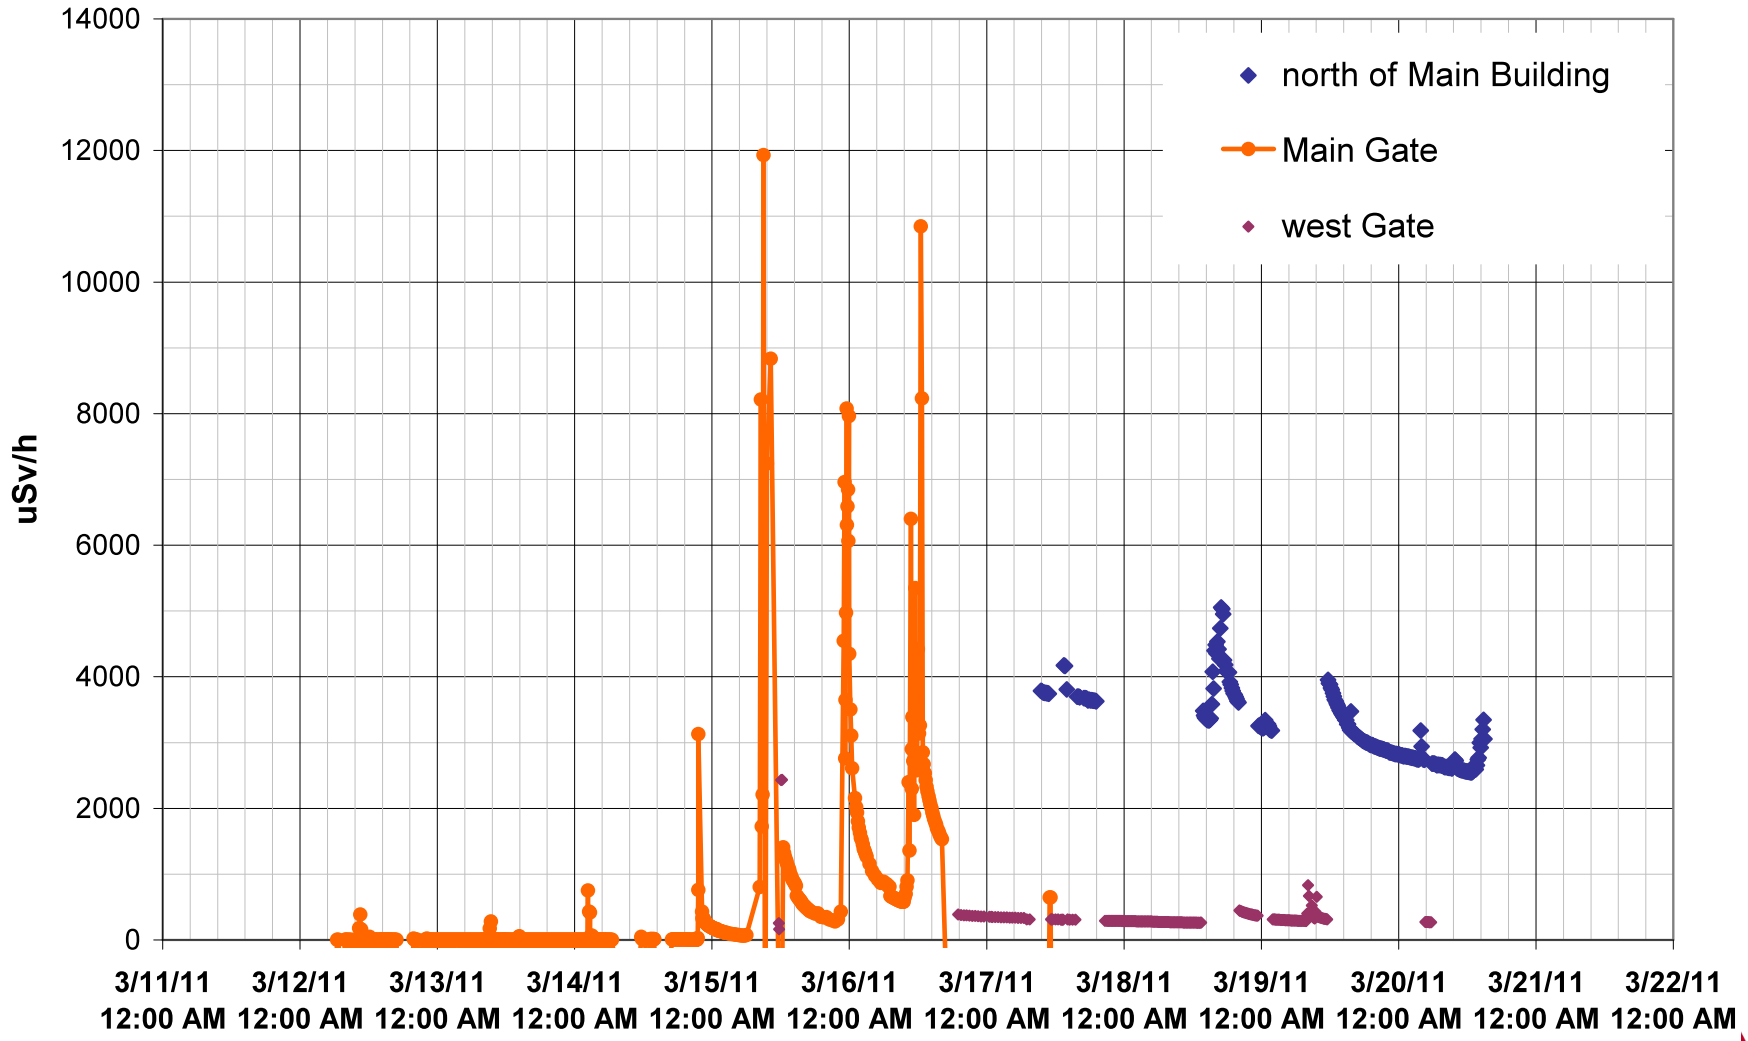
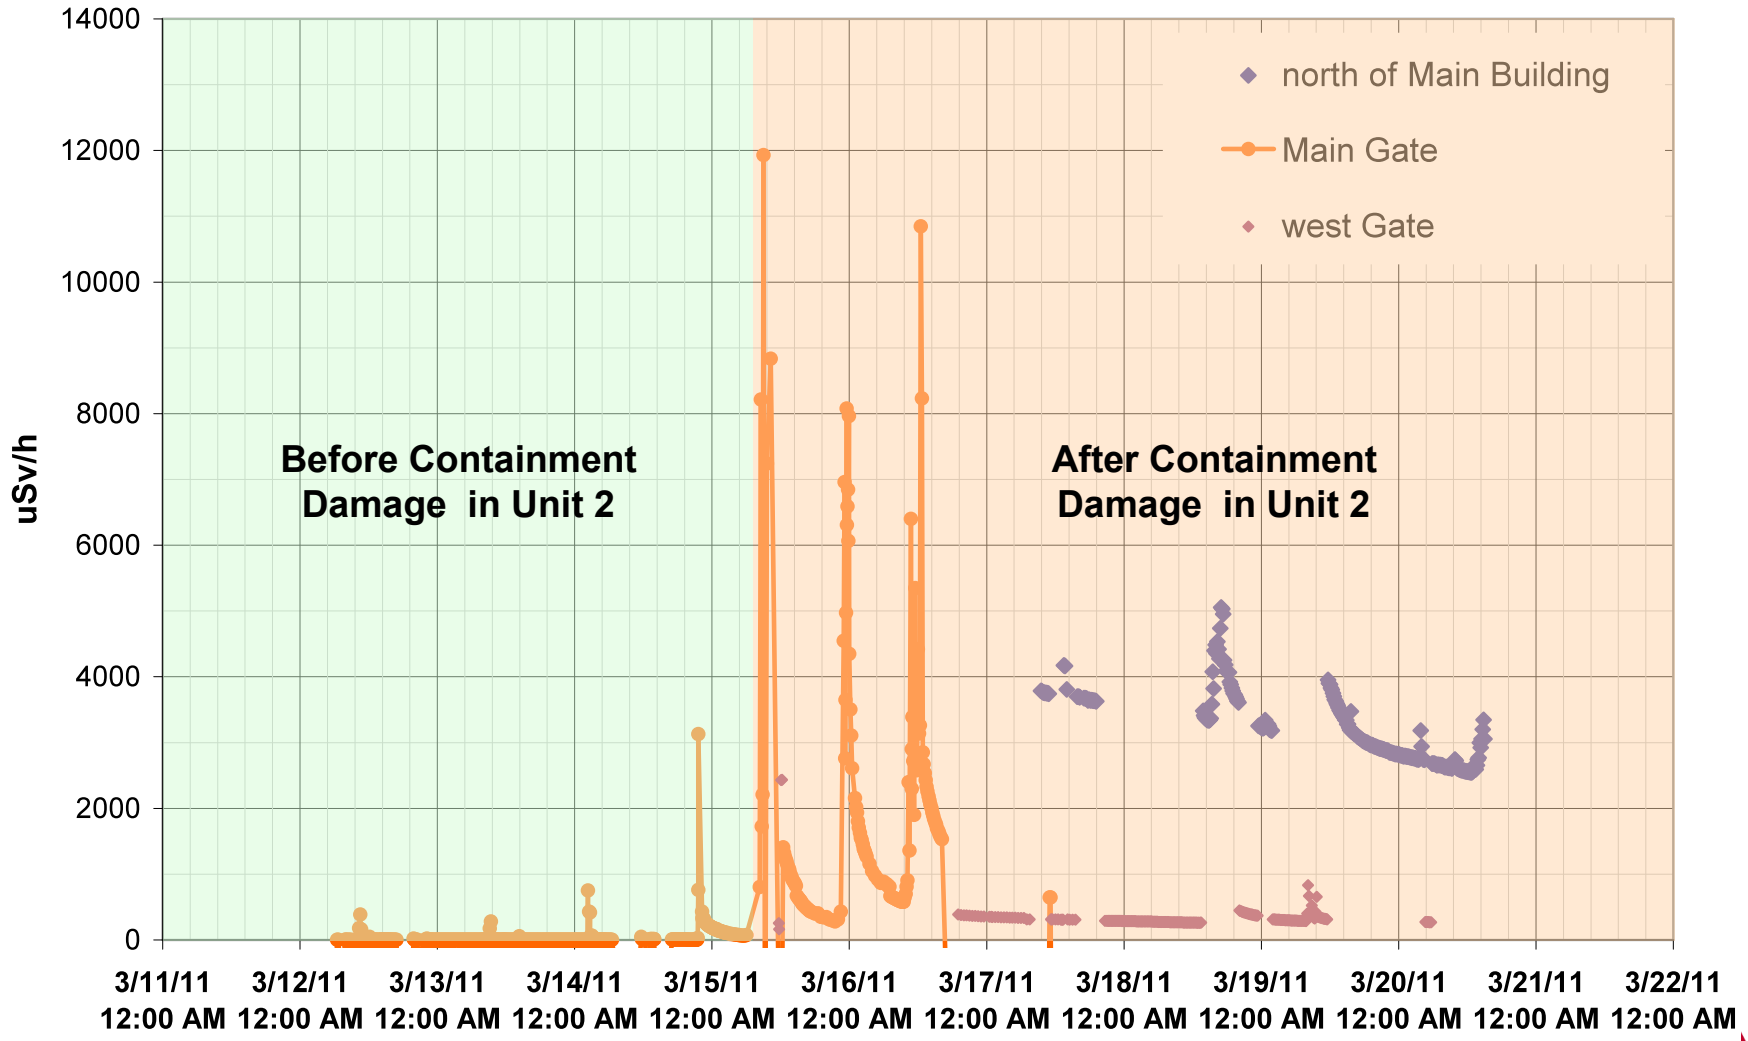
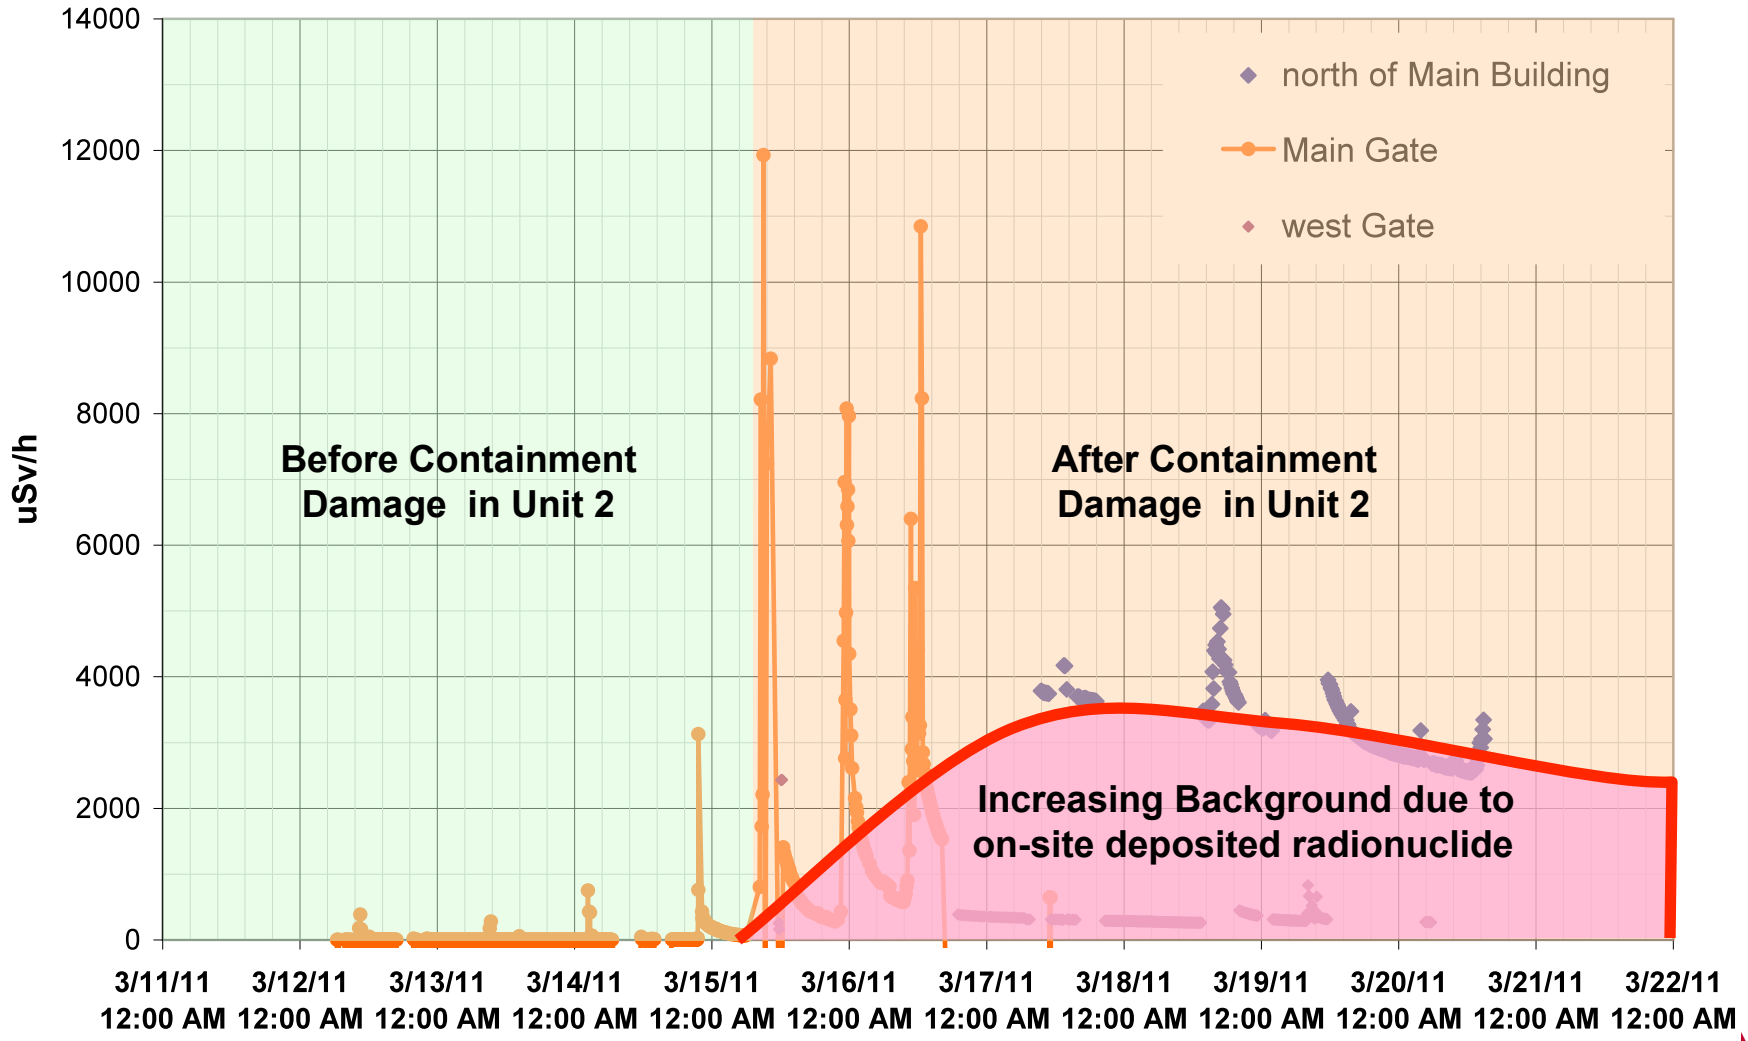
The Fukushima Daiichi Incident
3. Radiological releases

- Its not Chernobyl-like
- Directly on the plant site
  - Before Explosion in Unit 2
    - Below 2mSv / h
    - Mainly due to released radioactive noble gases
    - Measuring posts on west side. Maybe too small values measured due to wind
  - After Explosion in Unit 2 (Damage of the Containment)
    - Temporal peak values 12mSv / h (Origins not entirely clear)
    - Local peak values on site up to 400mSv /h (wreckage / Wet-Well inventory)
    - Currently stable dose on site at 5mSv /h
    - Inside the buildings a lot more
  - Limiting time of exposure of the workers necessary

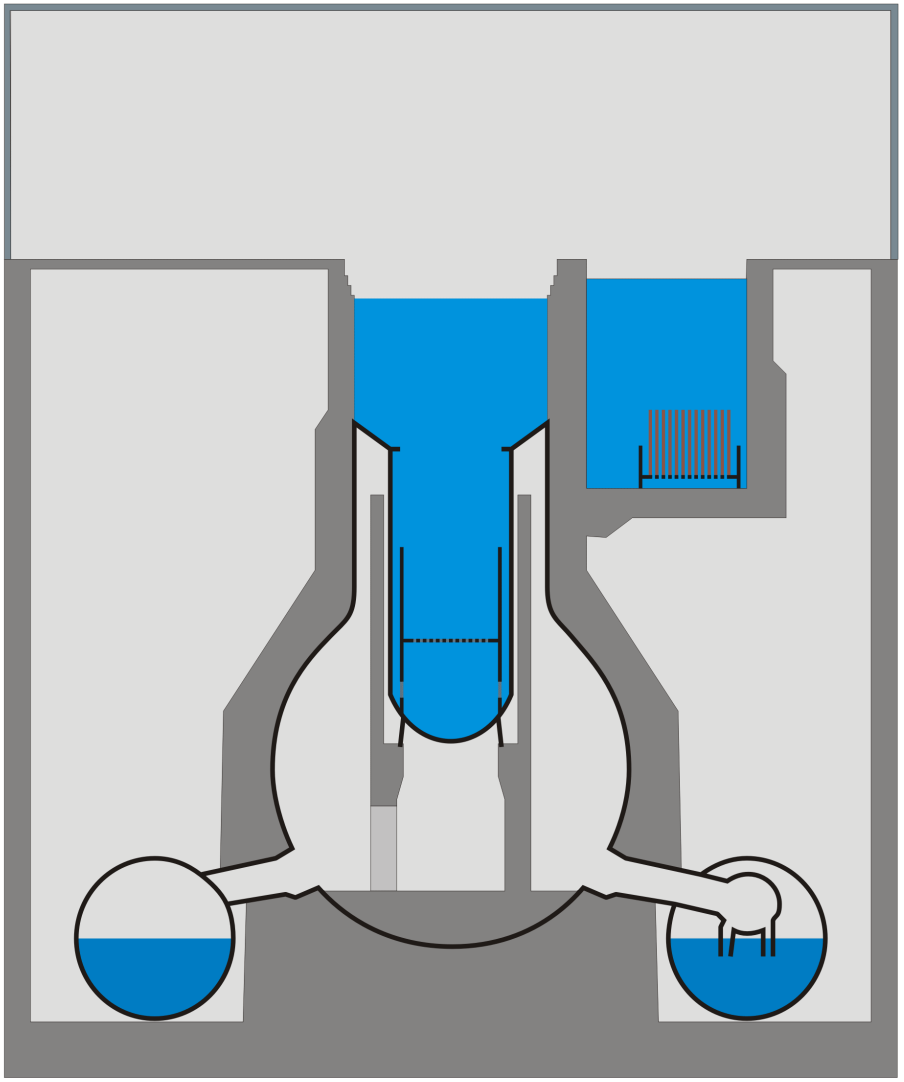
- Spend fuel stored in Pool on Reactor service floor
  - Due to maintenance in Unit 4 entire core stored in Fuel pool
  - Dry-out of the pools
    - Unit 4: in 10 days
    - Unit 1-3,5,6 in few weeks
  - **Leakage of the pools due to Earthquake?**
- Consequences
  - Core melt „on fresh air “
  - Nearly no retention of fission products
  - Large release

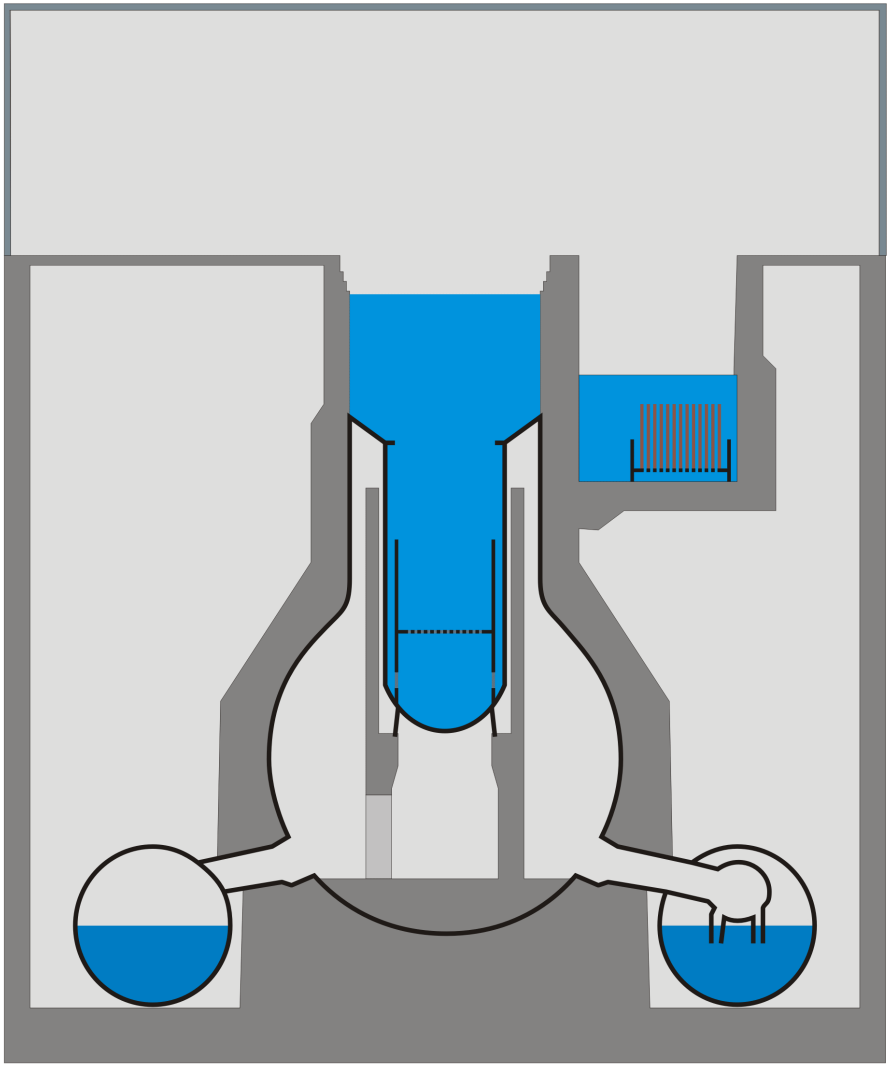
- Spend fuel stored in Pool on Reactor service floor
  - Due to maintenance in Unit 4 entire core stored in Fuel pool
  - Dry-out of the pools
    - Unit 4: in 10 days
    - Unit 1-3,5,6 in few weeks
  - **Leakage of the pools due to Earthquake?**
- Consequences
  - Core melt „on fresh air “
  - Nearly no retention of fission products
  - Large release

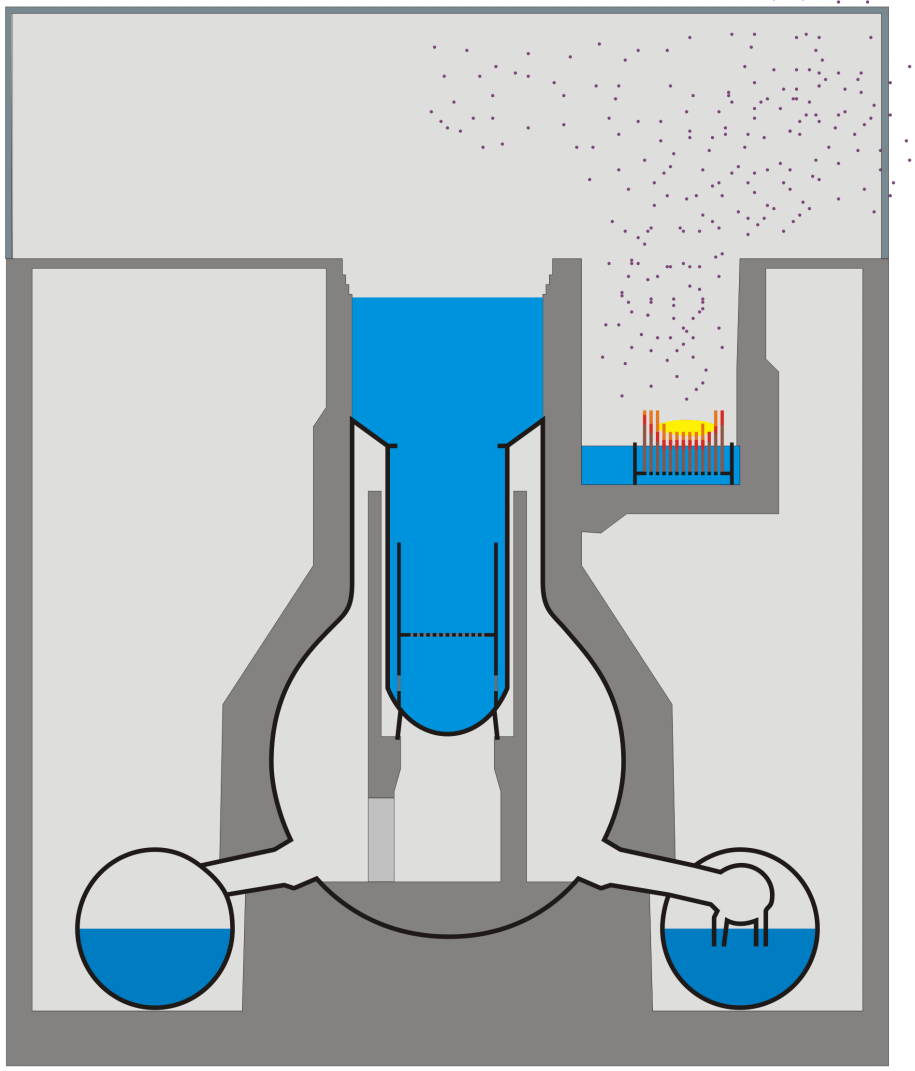
- Spend fuel stored in Pool on Reactor service floor
  - Due to maintenance in Unit 4 entire core stored in Fuel pool
  - Dry-out of the pools
    - Unit 4: in 10 days
    - Unit 1-3,5,6 in few weeks
  - **Leakage of the pools due to Earthquake?**
- Consequences
  - Core melt „on fresh air “
  - Nearly no retention of fission products
  - Large release
- **It is currently unclear if release from fuel pool already happened**
