Evaluation of Water Delivery Performance of Nkhafi Irrigation Scheme in Dowa District, Malawi, Africa

Abstract

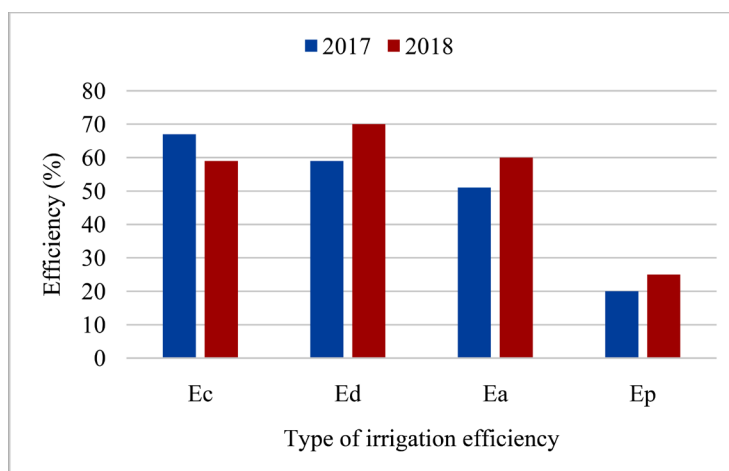
Figure 2. Irrigation efficiencies at the scheme.

range in 2017 season and improved to 60% in 2018 season. According to the study conducted by [16], the distribution efficiency should be ≥60%. The results from this study revealed that the distribution efficiency was below 60% in 2017 season and improved to 70% in 2018 season. According to [17], the acceptable conveyance efficiency is 90% and 70% for lined and unlined canals respectively. In reference to **Figure 2**, the conveyance efficiencies at the scheme were below the acceptable limit in both seasons. This clearly shows that there is laxity in managing water in the conveyance system.

In a surface irrigation scheme, overall irrigation efficiency of 50% - 60% is considered to be good; 40% is considered to be reasonable, while overall irrigation efficiency of less 40% is poor [18]. Though there was an improvement in distribution and application efficiency from 2017 season to 2018 season, the overall irrigation efficiency was poor in both seasons. In reference to **Figure 2**, the results show that the scheme overall irrigation efficiency was 20% and 25% for 2017 and 2018 growing seasons respectively. This revealed that more water was wasted in the scheme due to poor water management practices. It was also noted that water was being delivered to field blocks without knowing the quantity of water to apply and the exact time of water application. Therefore, to improve water management, irrigation scheduling would help in matching the right quantity of water to apply based crop water requirement. Proper field leveling is also required at the scheme. Desilting and effective lining need to be intensified in the distribution network in order to minimize the seepage losses. Trainings in water management should also be targeted to all farmers participating in scheme activities. The study has also revealed the need for high level technical knowledge as indicated in **Table 3**. Absence of supportive training on best irrigation practices to guide sustainable water management and irrigation scheduling further result into low performance of water delivery in an irrigation scheme.
