Lease Road to English #1 Well

Report on the Investigation of the Natural Gas Invasion of Aquifers in Bainbridge Township of Geauga County, Ohio

September 1, 2008
Ohio Department of Natural Resources
Division of Mineral Resources Management

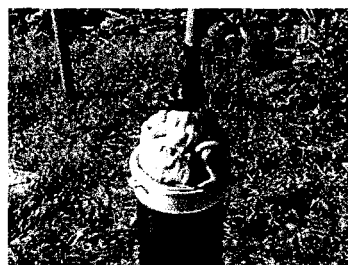
Swab around brush

Step Four: Re-development

Once the physical cleaning is complete, all of the material removed from the casing and borehole walls must be removed from the well. The well must then be re-developed.
