Final Report

The effect of power-line explosion on the performance of E-glass/Vinyl Ester Composite Panels Manufactured by Armorcast Products Co. for the Voltek System

This report is submitted as part of cooperative agreement No. F-14-3575-1.0 between The University Corporation at California State University Northridge and The Voltek Division of Armorcast Products Company.

The effect of power-line explosion on the performance of E-Glass/Vinyl Ester Composite manufactured by Armorcast Products Co. for the Voltek System

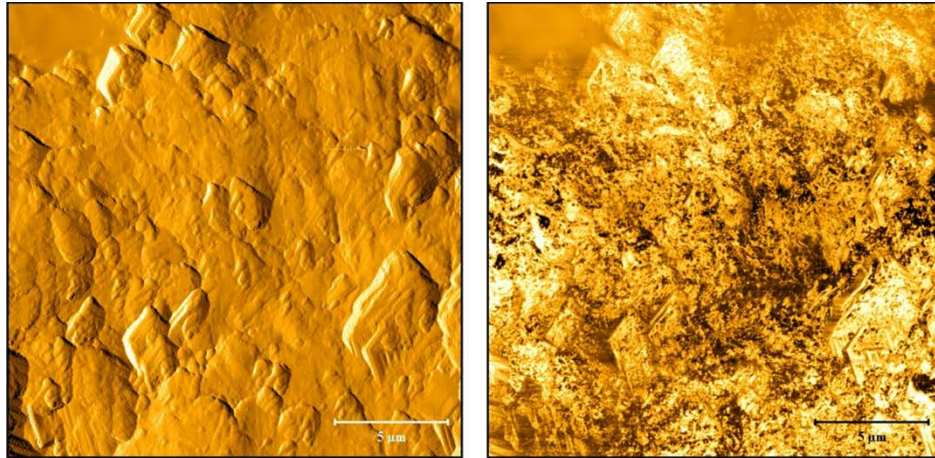
Figures 10 and 11 show topography and phase of the surface from two different specimens that were cut from the new panel, while Figures 12 and 13 are the scans of specimens from field-deployed sample blocks. Generally, there is no significant change in the surface roughness, when comparing topographical images of new and field-deployed specimens. The aspect ratio of the surface roughness to the panel lateral dimension is very small. Therefore, it has a negligible effect on the overall mechanical performance of the composite panels in the field. Nonetheless, the contrast of the phase images from the new panels appears to be slightly darker than that from field-deployed samples. This represents change in the stiffness of the surface layer after the composite panels were exposed to harsh in-service conditions, e.g., surface contamination and power-line explosion. It is important to note here that the increase in the stiffness is only limited to the surface layer since optical images did not show any penetration of the burn marks into the thickness.

Figure 10: AFM topography (left) and phase (right) of specimen from new panel with scan size of 20µm X 20µm.

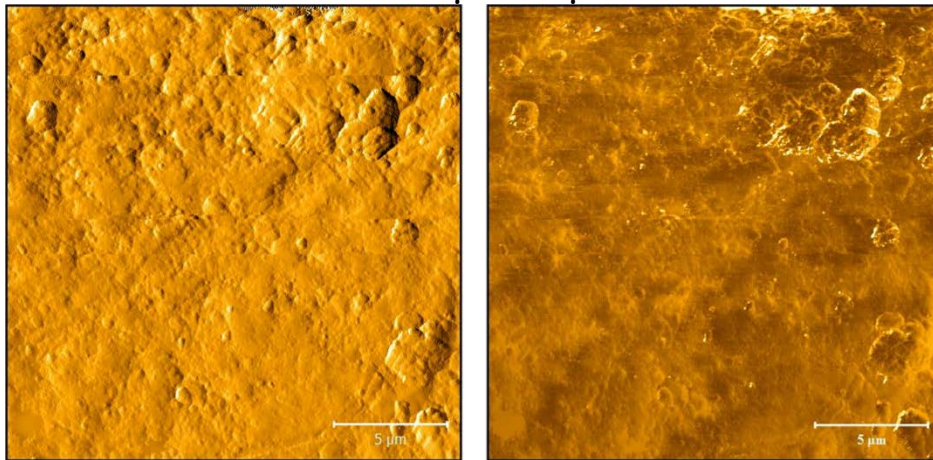
Figure 11: AFM topography (left) and phase (right) of specimen from new panel with scan size of 20µm X 20µm.

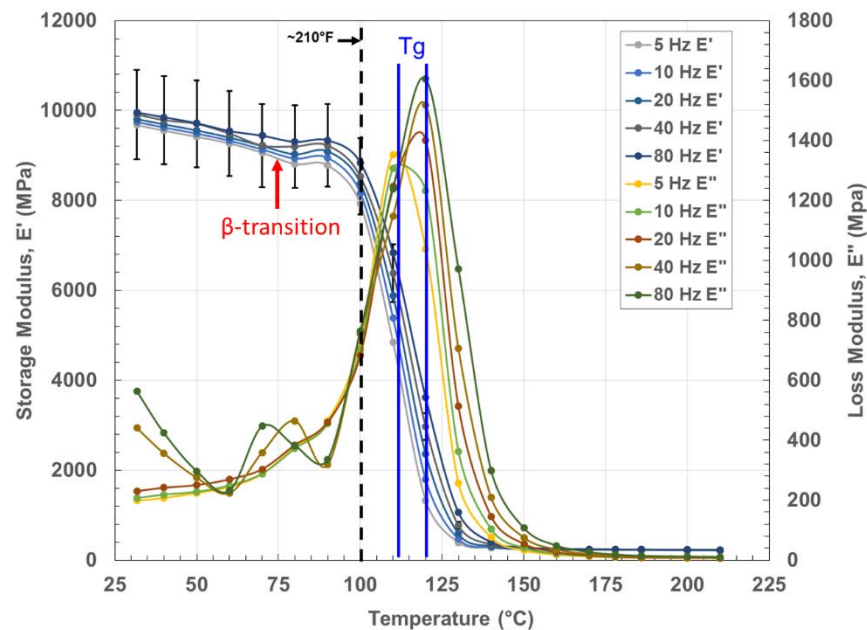
Figure 14 displays the average thermo-mechanical performance of four specimens from new panel. Below 100°C (~210°F), the laminate has flexural storage modulus of 9277 ± 470 MPa and relatively low loss modulus, which is to say the laminate behaves as a quasi-isotropic and homogenous solid. The figure also shows two transition points, at which there is a noticeable drop in the storage modulus values. The first transition occurs at ~75°C, which is usually referred to as the beta transition (T_β) and related to change in toughness. T_β marks the transition between the matrix chains bending and stretching motion mechanism (below T_β) and sliding of chains (above T_β). The change in the molecular relaxation mechanisms results in increase in the area under the stress-strain curve; hence change in toughness. The T_β change is also observable as an increase in the loss modulus, which indicates an increase in the energy dissipation ability of the laminate. The second transition is the glass transition temperature (T_g), previously discussed before. Figure 14 also shows the dependency of T_g on the frequency, which varies from ~112°C at low frequency to ~120°C at high frequency.

Figure 14: thermo-mechanical spectra of new specimen at different frequencies.

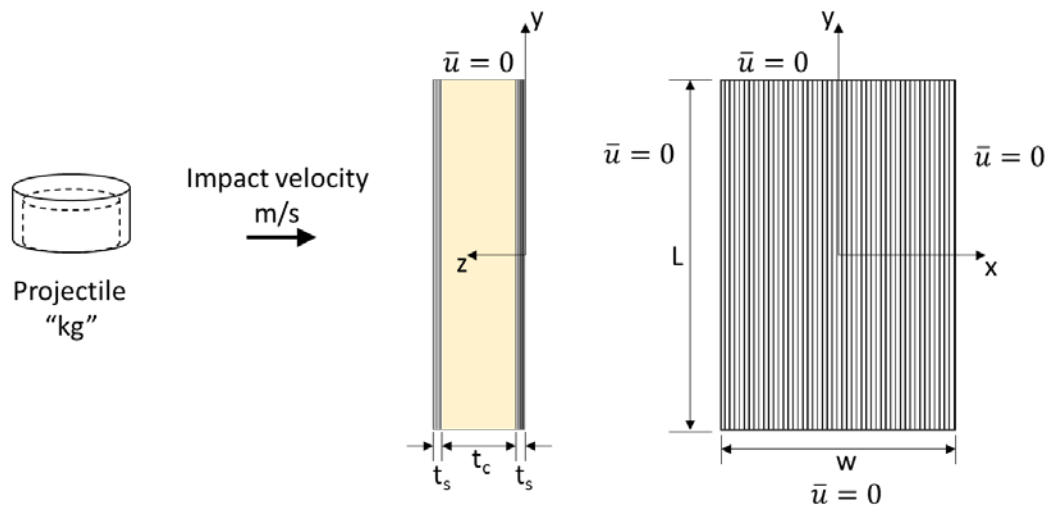
Figure 16: Geometry and boundary conditions of numerical simulation impact study.

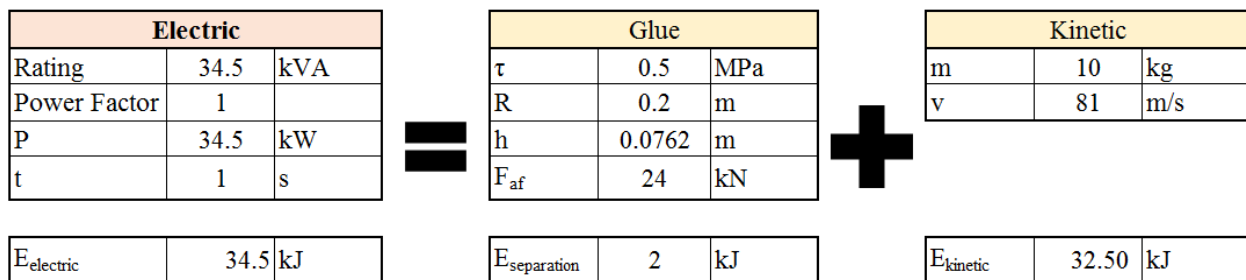
The preceding discussion was used to calculate a projectile velocity of ~80 m/s. The impact velocity in the simulation was increased by a factor of 10 since the temperature effect was not taken into account. It is important to note that the calculation of the projectile velocity is based on the absolute worst-case scenario; actual scenarios may vary based on the details of the energy balance. For example in the aforementioned calculation, the energy lost as heat was neglected as well as the potential energy of the cover projectile. Figure 18 shows a screenshot of the velocity calculator, which was designed and included as part of the deliverables package. This calculator can be used to determine the impact velocity, which can be used as an input to the finite element simulation to predict the ply-failure characteristics.

Figure 18: Screenshot of Impact projectile velocity calculator.
