Installation of a Riparian Forest by Means of Soil Bio Engineering Techniques—Monitoring Results from a River Restoration Work in Southern Brazil

Hans Peter Rauch¹, Fabricio Sutili², Stephan Hörbinger¹

Soil bioengineering has been applied more and more in different regions of Brazil in recent years. The study in hand presents the installation of “new” riparian forest based on soil bioengineering techniques. This riverbank restoration work was implemented in the year 2010 and two onsite vegetation surveys, one shortly after the construction, and one in 2013. Besides that, the structures of reinforcement work, and its effectiveness were evaluated. By means of the vegetation survey, the applied species were examined for their ability to establish the riverbank in an environmentally sustainable way. Most notably, the species *Calliandra brevipes* Benth. (Fabaceae, Mimosoideae), *Phyllanthus sellowianus* Müller Arg. (Euphorbiaceae), *Salix humboldtiana* Willd. (Salicaceae), *Bauhinia forficata* Link (Leguminosae), *Inga marginata* Willd. (Mimosoideae) and *Ateleia glazioviana* Baill. (Leguminosae, Papilionoideae) showed a good growth development. The proportion of spontaneous vegetati

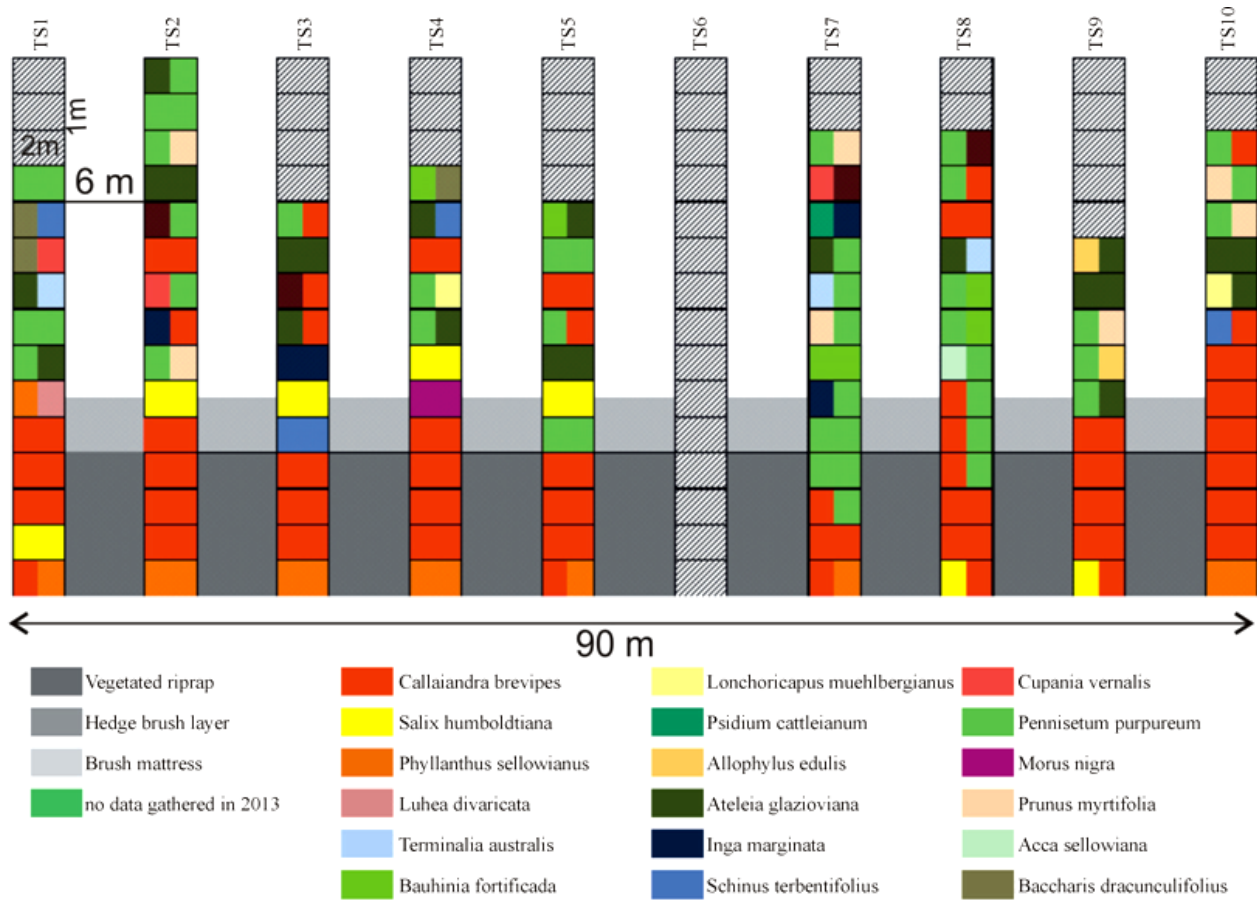
Figure 4. Sectional view, illustrating the interventions taken at the embankment.

The vegetation surveys were conducted in 2010 and 2013 as described in the methodology chapter. **Figure 4** shows an overview of all sections.

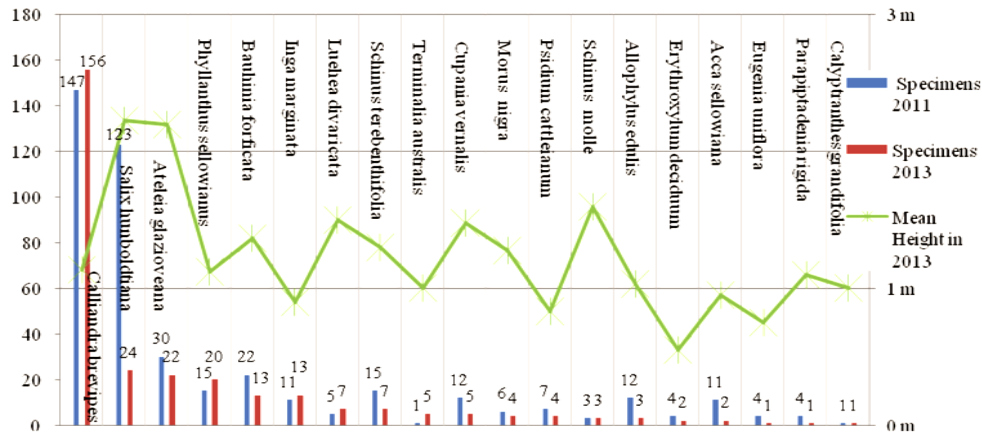
Figure 5.
Growth development of the species after 3 years of intervention.

In [Table 2](#), the species, which were found in the plant survey in 2011 but disappeared until 2013, are listed. Particularly strong losses were seen with the species *Machaerium paraguayense* Hassl., *Eugenia myrcianthes* Nied. and *Myrcianthes pungens* Berg. Legr. In [Figure 5](#), the species, which were found in both vegetation surveys plus their mean plant height are shown. The species which developed best are *Calliandra brevipes*, *Phyllanthus sellowianus*, *Ateleia glazioveana*, *Salix humboldtiana*, *Bauhinia forficata* Link and *Inga marginata* Willd. In [Figure 6](#), the growth development of these species is illustrated. *Salix humboldtiana*, showed great losses in the number of individuals. However, it grew very strong and highest of all species in the plant stand. The second highest grown species is *Ateleia glazioveana*. Its mean vitality was classified as 1 and only a few losses of plant individuals occurred. During the period of the monitoring, the plant individuals of *Phyllanthus sellowianus* increased and showed significantly the best growth along the mean water level. The plant individuals of *Bauhinia forficata* showed a good development. The same applies to *Inga marginata*, which could even increase the number of plant individuals. As well, *Luehea divaricata* Mart. and *Inga marginata* showed to be able to emerge on river embankments, as its number of individuals increased. *Pouteria salicifolia*, which was used in the hedge brush layer completely disappeared. Further species of the hedge brush layer are *Morus nigra* and *Terminalia australis*.

They were observed in the second survey but only in small number. *Calliandra brevipes* had the most significant increase of all applied species. The habitus is a small grown shrub, which produces many shoots. It can be assessed as a very dominating species, with the ability to grow on extreme conditions. Species which showed a good development but occurred only in a small number of individuals are *Schinus terebentifolia*, *Schinus molle*, *Cupania vernalis* Cambess. and *Psidium cattleianum* Sabine.
