# FONTENELLE DAM, RIRIE DAM, AND TETON DAM – AN EXAMINATION OF THE INFLUENCE OF ORGANIZATIONAL CULTURE ON DECISION-MAKING

*Fontenelle Dam, near Fontenelle, Wyoming, built by the Bureau of Reclamation between 1960 and 1964, had a serious incident in 1965 that nearly caused a breach of the structure that could have released more than 300,000 acre-feet of water. Teton Dam, near Rexburg, Idaho, built by the Bureau of Reclamation between 1972 and 1976, failed in 1976 releasing more than 250,000 acre-feet of water and causing 11 fatalities. Ririe Dam, also near Rexburg Idaho, was built in geologic conditions similar to Teton by the Walla Walla District of the Corps of Engineers between 1970 and 1976 – was subsequently transferred to Reclamation – and has performed well over its life. The dams are all located within 150 miles of each other. The story of why Teton Dam failed is more complex than the technical details surrounding its construction and destruction. The Teton disaster is a story of engineering judgment, communication, decision-making, economics, organization, culture, and individual and organizational hubris. To tell this story, one needs to examine the organizational culture

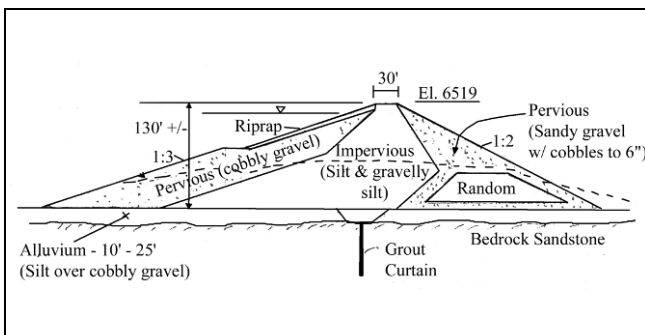
**Figure 3A.** Maximum cross-section, Fontenelle Dam.

Despite the intensity and width of the fractures in the right abutment, the planned designs relied entirely on 'special compaction' and the grout curtain to reduce the erosive forces at the contact between the cutoff trench and the grout cap. It appears that the designers did not fully appreciate the hydraulic gradient that would occur across the bottom of the cutoff and the relatively narrow grout curtain.

The design documents list the Zone 2 drain material just downstream of the core as suitable for drainage; however there were no specified gradations or size limitations on the finer material. The Zone 2 was attributable to three borrow areas that were thought to contain more pervious material based on test pits in those locations. The ability for the Zone 2 to function as an actual drain is questionable, but even if it was able to do so, it did not extend below the original ground surface and would not protect the narrow cutoff trench. This same condition led to many of Teton Dam's design problems.

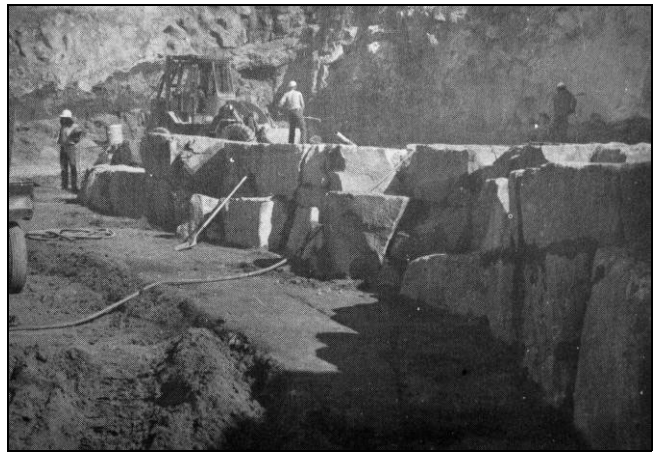
**Figure 10B.** Construction photo of Ririe right abutment.

The basalt layers contain both open and silt- and clay-filled joints and fractures resulting from gentle folding and arching. The open and filled joints range from minute fractures to one-foot openings. Most of the joints and fractures have been predominantly filled with silty clay materials. Figures 10A and 10B illustrate the nature of the foundation at Ririe.

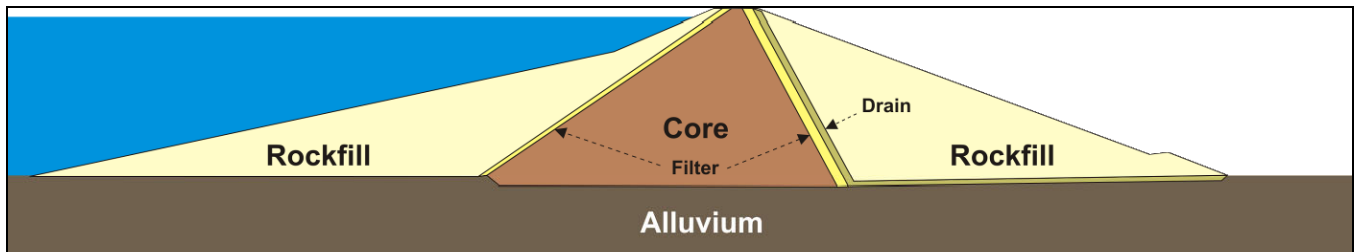
**Figure 11.** Ririe Dam Cross Section 1966

Before designs were envisioned, the Corps was concerned about the competence of the foundation of Ririe Dam. The first published design which was planned in the early 1960's and included in the design report in 1966 is shown in Figure 11. Interestingly, the design included a 10' wide chimney filter and 10' wide chimney and blanket drain. It had a wide core, but did not include a cutoff trench. Following substantial exploration at the dam site and review comments from headquarters, the design was changed in 1971 as shown in Figure 12. This design change added a cutoff to competent rock and reduced the size of the core.

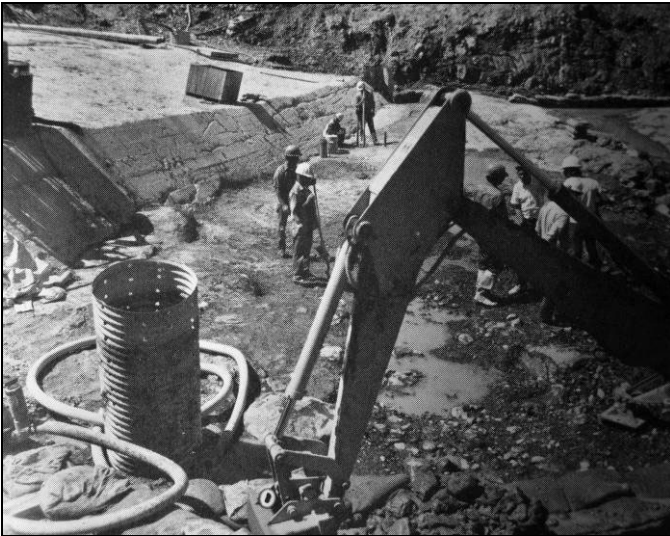
A number of foundation preparation and surface treatment provisions were employed to deal with the many foundation defects encountered during construction. The Corps extensively documented methods and locations, and numerous construction photos exist (Figures 14A and 14B). Zones of concern were protected by a shotcrete cover layer or mass dental concrete. The Corps began applying the lessons learned from Ken Lane's trip report about the Fontenelle Dam incident by specifying conservative treatment of contact surfaces between dams and their foundations and the contact surfaces of adjacent zones of different materials. At about the same time that the Corps was using shotcrete to protect the foundation, a few miles away, Reclamation was rejecting the use of shotcrete for a key trench in very similar material.

**Figure 14A.** Construction photo from Ririe showing dental concrete and foundation cleanup.

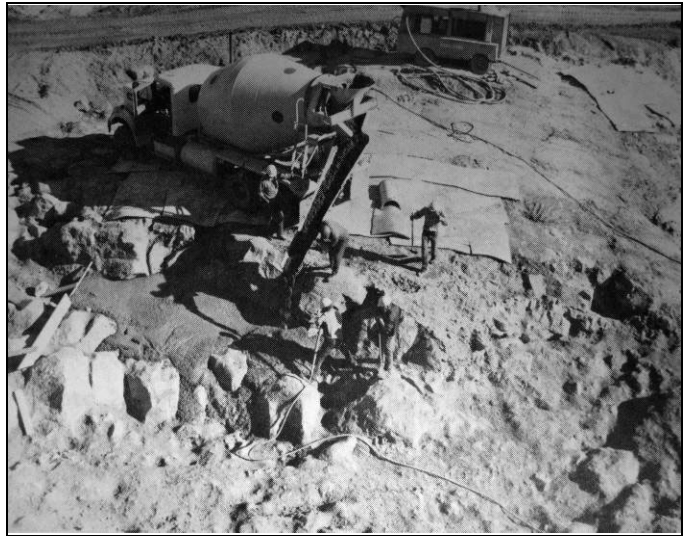
**Figure 14B.** Construction photo from Ririe showing the placement of dental concrete.

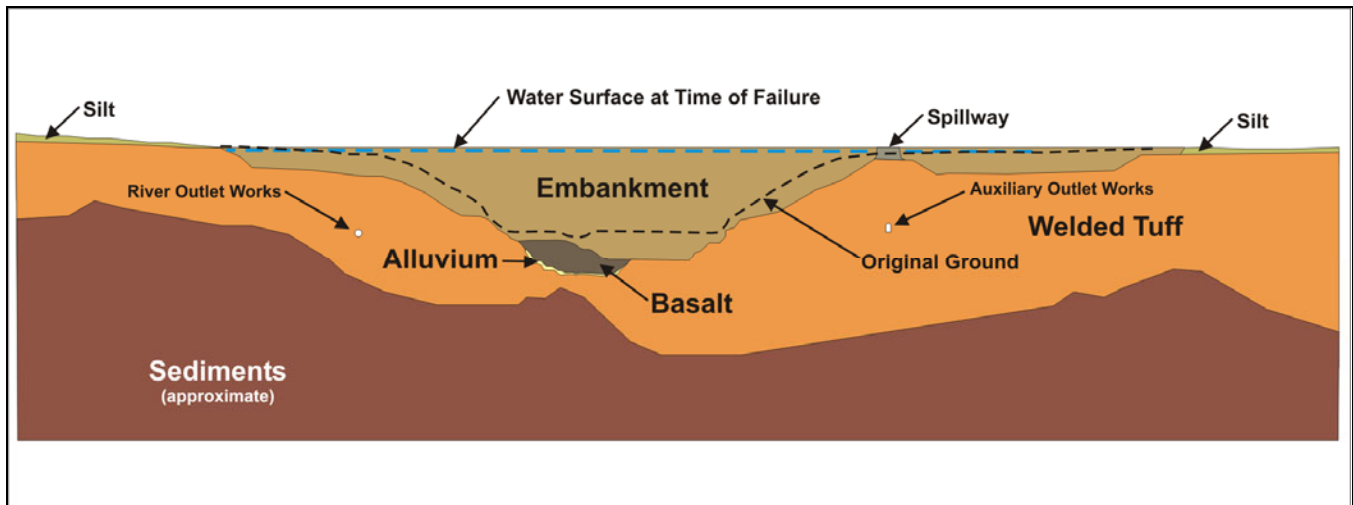
**Figure 18.** A profile of the Teton embankment and foundation looking downstream.

Basalt is present in the bottom of the Teton River Canyon and is a remnant of a lava flow that filled the canyon to about El. 5005 (see geologic section, Figure 18). In the dam foundation, the basalt is restricted to the left side of the river channel section, where it has a maximum thickness of about 124 feet. It is separated from the underlying welded tuff by a deposit of alluvial material consisting of silt, sand, and gravel from 4 to 22 feet thick. The basalt is dense to moderately vesicular and contains closely spaced, randomly oriented joints and other fractures. In spite of its fractured nature, it is an adequate foundation rock for the dam. Water pressure tests showed the basalt to be tight and the thin alluvial fill between the basalt and the welded tuff to be permeable.

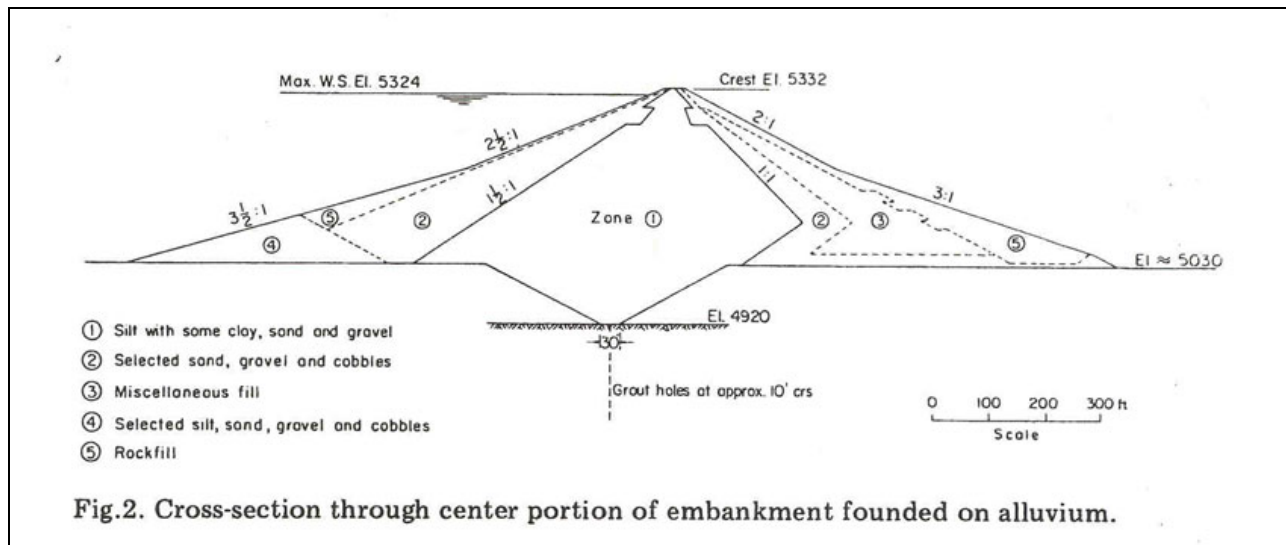
**Figure 19A.** Teton Dam maximum section<sup>4</sup>.

The design for Teton followed standard practices with an impervious core and progressively coarser materials used as the zoning progressed downstream. In the maximum section, a relatively shallow-sloped cutoff leads to a narrow 30-foot-wide contact with a competent foundation. The intent of the design was to rely on the grout curtain and the cutoff to create an impermeable barrier to protect the main core of the dam. As shown in Figure 19A and 19B, there are no additional defensive measures provided in either the main embankment or the abutment sections. On each abutment, the side wall of the cutoff trench steepens to 0.5H:1V. However, owing to the steepness of the abutment looking parallel to the axis, the actual sidewalls approach vertical on both abutments, which can easily be seen in Figure 20.
