PANEL ON "EXPERIENCE AND TECHNIQUES IN THE REPAIR OF REACTOR COMPONENTS" -
VIENNA - NOVEMBER 1972

PAPER NO **PL-504 - 1.**

EXPERIENCE AND TECHNIQUES IN MAINTENANCE AND REPAIR OF REACTOR COMPONENTS ON
THE DOUNREAY FAST REACTOR

J KIRK

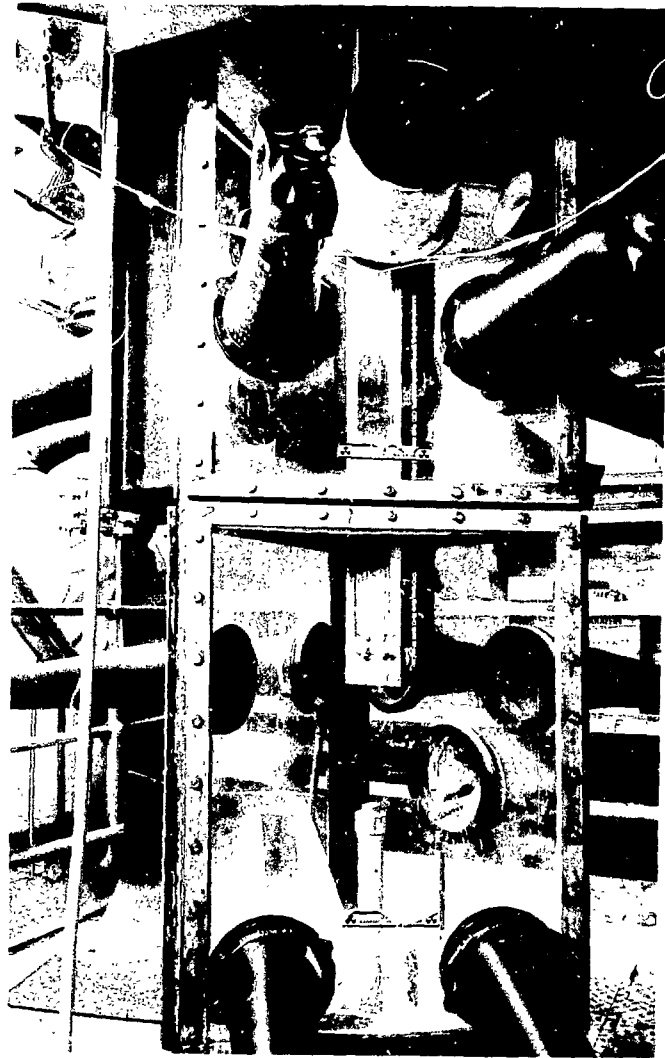
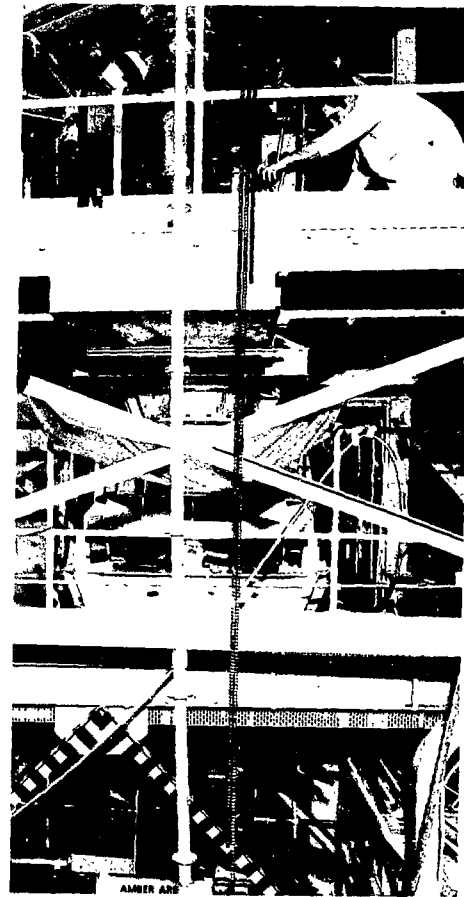
FIGURE 7 - Charge machine maintenance - glove box

28. The problem was overcome by a modified operating procedure, ie by pressurising the liner tube so that the NaK level inside it was lowered. The relatively smooth surfaced grab of the charge machine then became the only directly contaminated component of charge/discharge equipment. The lower portion of the charge machine test station which is situated inside the containment building was converted into a simple unshielded glove box so that running maintenance, eg cleaning, adjustment and changing of grabs during discharge operations could be accomplished quickly without losing the machine's inert atmosphere (fig 7). As fission product activity levels built up in the coolant, the glove box began to serve the additional purpose of preventing the spread of radioactive contamination. The box is usually cleaned out after each complete discharge operation and it has never been necessary to add shielding since the accumulated contamination inside the box after a normal discharge operation rarely exceeds a few mr/h.
