The Degradation of Steam-Generator Tubing and Components  
by Operation of Pressurized-Water Reactors\*

John R. Weeks and Carl J. Czajkowski

Corrosion Science Group  
Department of Nuclear Energy  
Brookhaven National Laboratory  
Upton, New York 11973

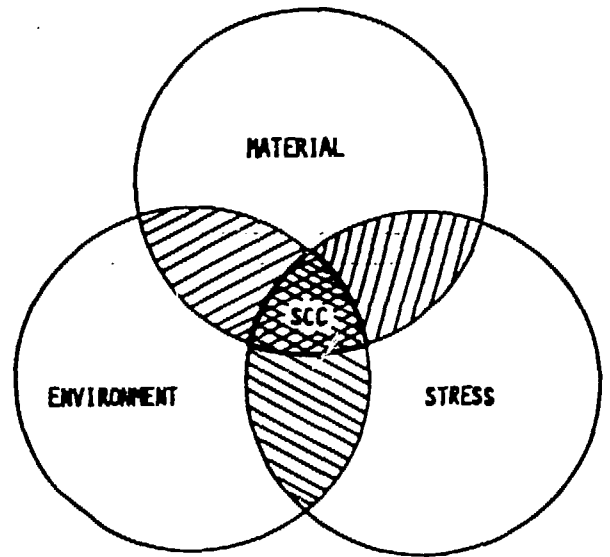
Figure 3 is an often repeated sketch (7) showing the synergistic interplay of environment, material composition, and stress that underly all SCC phenomena. An NRC sponsored research program is underway at BNL (8), the purpose of which is to develop a sufficient understanding of the degradation mechanisms and causative factors to permit an estimation of the lifetime of a steam generator tube. Results to date have been encouraging that these goals can be met, the principal observations are summarized in Table 4. It is anticipated that by the end of 1983, the program will be completed to a point where predictions of the life time of tubing under a variety of operating conditions can be made, including the situations where active deformation of the metal continues, where deformation has occurred but has been arrested, and where abnormal water chemistry might be encountered with or without active deformation.

FIGURE 3: SKETCH OF THE INTERPLAY OF STRESS, MATERIAL, AND ENVIRONMENTAL FACTORS THAT CAUSE SCC

With regard to solutions to the problem, returning again to Figure 3, the environment, at least on the primary side of a PWR steam generator, probably cannot be changed at the present time. The material can be changed only in new plants; for all SG's manufactured after approximately 1980, the Inconel 600 tubing has been given a heat treatment to improve its resistance to primary side SCC. On an existing generator, the only variable that can conceivably be modified is the stress pattern, and research is underway at the present time, under the auspices of the Electric Power Research Institute Steam Generators Owners Group (EPRI-SGOG), to develop techniques for in situ stress relief, particularly in those areas where the tube is expanded into the tube sheet.
