# The Axial Location of Cladding Failure During a Slow Transient Overpower TREAT Test

R. J. Page, W. F. Murphy and J. W. Holland

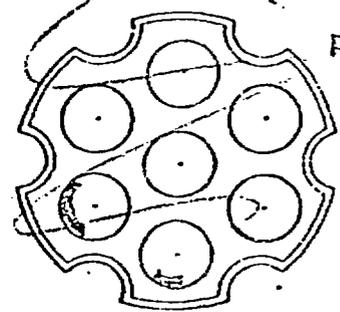
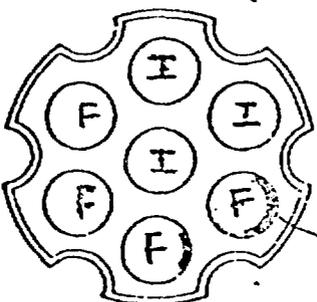
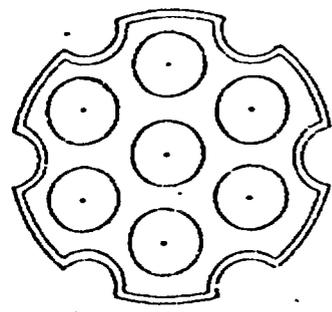
Fig 1

The fuel pins at 2, 4 and 6 o'clock failed. The failures started at the tops of the fuel columns and extended upward along the insulator pellets for a total length of about 20 mm. Cladding failures tended to be toward the outside of the cluster with a bias toward an adjacent pin. The fuel expelled from one pin may have contributed toward failure of an adjacent element. The fuel expelled from the three failed elements was not enough to make a significant blockage to coolant flow.

The axial and circumferential locations of cladding failure are showed schematically in Fig. 1. Also shown are the locations of fuel pellets and insulator pellets, indicating the extent of fuel expansion. Fig. 2 is a cross-section of the fuel pin bundle about 10 mm above the top of the original active fuel column.

Cladding failure locations for the J1 test.
