**EVALUATION OF BONDING IN KAMINI PLATE TYPE FUEL ELEMENTS
USING ULTRASONIC IMMERSION TESTING AND METALLOGRAPHY**

B.A.R.C. - 1472

BHABHA ATOMIC RESEARCH CENTRE
BOMBAY, INDIA

1989

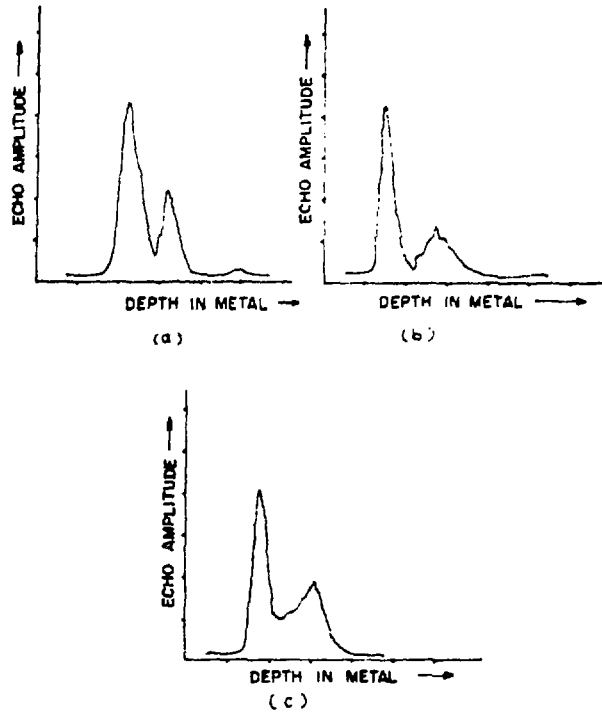
With the appropriate setting of the ultrasonic flaw detector the signals received from the simulated non-bond regions in the reference standard are presented in Fig. 4a,b & c. The actual fuel plates were then tested and lack of bond signals intercepted were compared to those recorded from the simulated non-bonds for classification. Typical non-bond signals from a fuel plate are presented in Fig. 5 a&b.

Fig.4. Lack of bond indication from reference standard
(a) 10mm ϕ flaw (b) 5mm ϕ flaw (c) 2mm ϕ flaw.
