CORROSION PROBLEM IN THE C.R.E.N.K.
TRIGA MARK II RESEARCH REACTOR.

Professor MALU WA KALENGA *

* Centre Régional D'Etudes Nucléaires de Kinshasa
(C.R.E.N.K.); B.P. 184; Kinshasa XI; Zaïre.

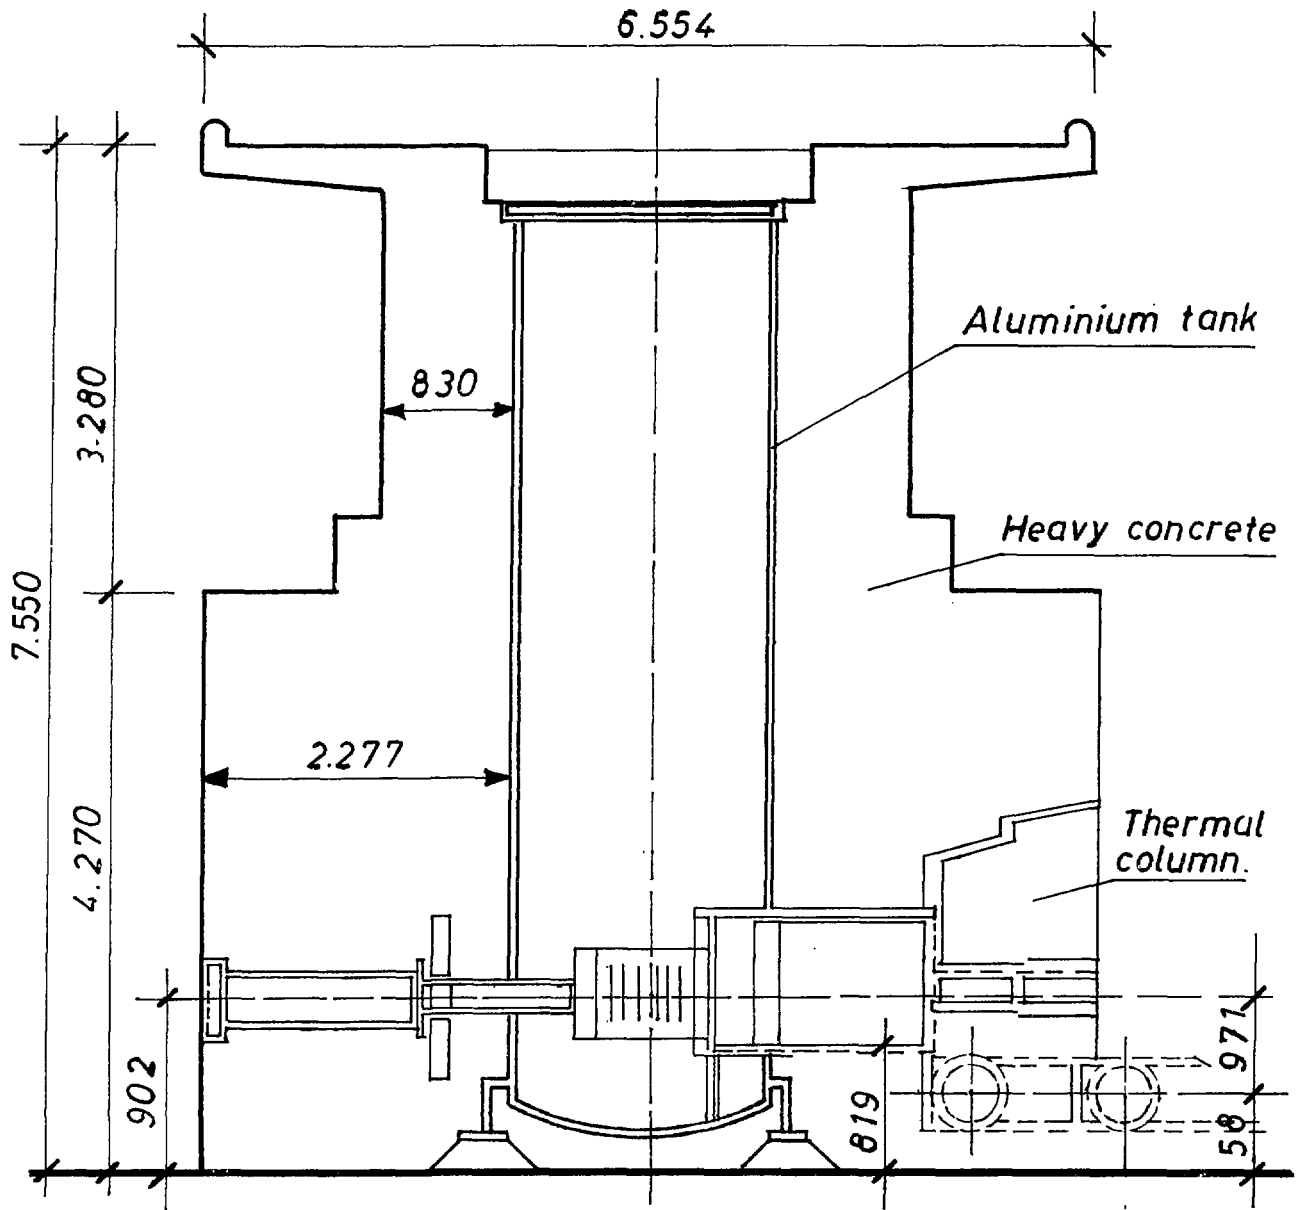
If the reactor has been in service since 1972, the tank housing the core was in fact manufactured in 1965 in Austria using 6061-T67 aluminum. The tank was coated on the outside with a layer of pitch followed by a layers of tar paper. It was then embeded in an above ground high density concrete structure, 7,7 m height. It contains about 22 cubic meter of demineralised water, [1]. Figure 1 gives the CRENK Triga Mark II reactor cross section.

Fig.1 Vertical cross section of the C. R. E. N.-K. Reactor.
(Figure in mm)
