## **PROBLEMS EXPERIENCED DURING OPERATION OF THE PROTOTYPE FAST REACTOR, DOUNREAY, 1974–1994**

A. CRUICKSHANK, A.M. JUDD  
British Nuclear Fuels Ltd,  
Risley, Warrington, United Kingdom

### **Abstract**

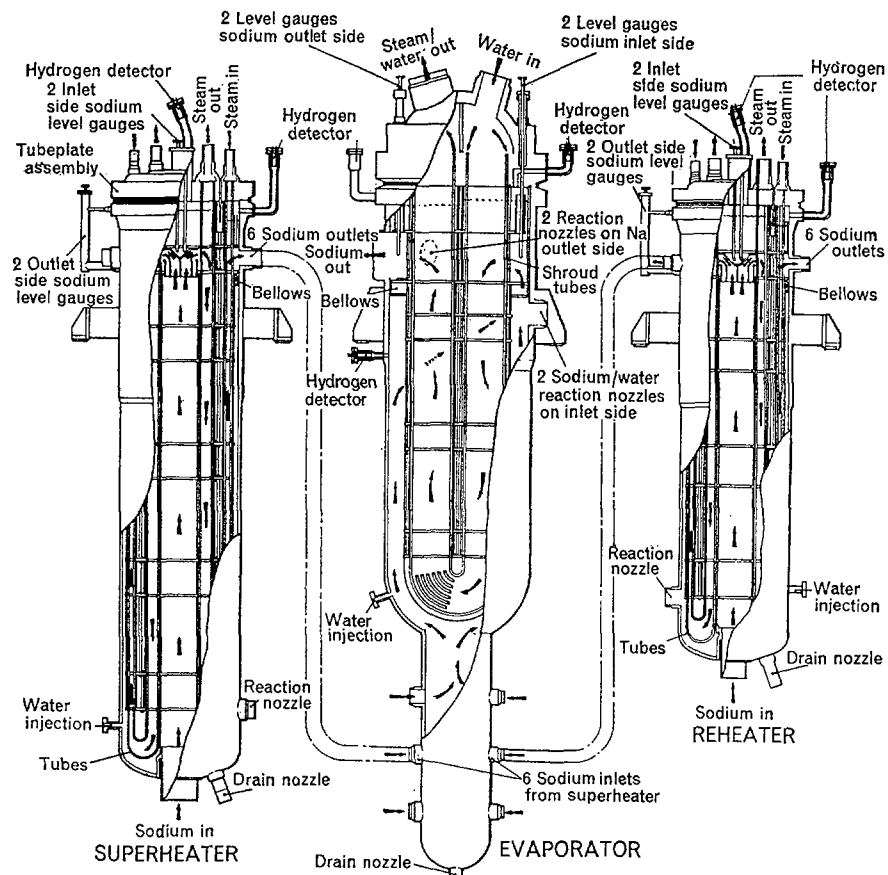
Figure 1.1. PFR Steam Generators

PFR had three secondary circuits, each of which had an evaporator, a superheater and a reheater. Figure 1.1 shows the general arrangement, and Figure 1.2 shows an evaporator in more detail. A total of 37 gas-space leaks was experienced in PFR steam generator units in the period 1974 to 1984 with 33 of these occurring in evaporators, 3 in superheaters and 1 in a reheater. All of the gas-space leaks originated at the welds between the tubes and the tubeplates. The effect of these leaks on PFR availability was considerable, so that the highest annual load factor prior to 1984 was only 12%.

PFR went critical for the first time in March 1974 and commissioning of the steam generators followed. Up to 1976 there were failures in gas-space leaks in one evaporator, two superheaters and one reheater. These early failures are believed to have been due to manufacturing faults.

In the case of the austenitic superheaters and reheaters the leaks gave rise to considerable concerns about the design. Although both the damaged superheaters continued in use up to 1986, having had the leaking tubes plugged, one of the superheaters and the reheater had suffered from caustic stress corrosion cracking of the tube plate caused by the products of the sodium-water reaction. The superheater was salvaged by grinding out the cracks and thoroughly washing the tube plate with hot sodium to remove the reaction products. Damage to the reheater tube plate was so extensive that the tube bundle was

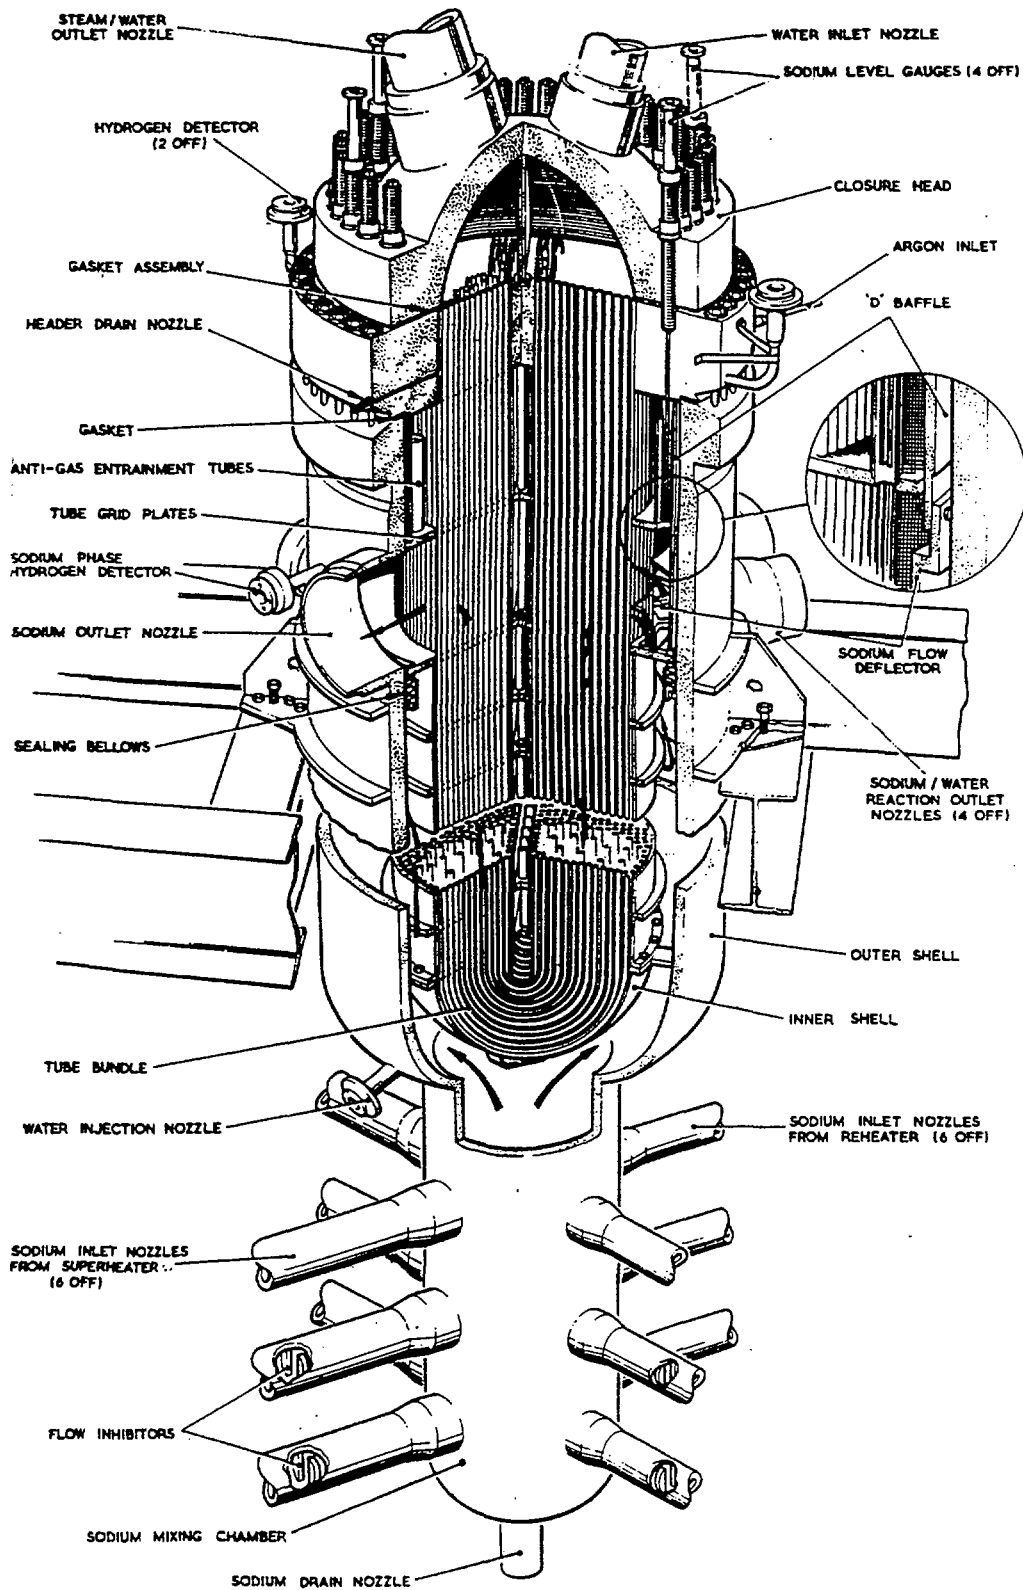
Figure 1.2. A PFR Evaporator

The 33 leaks experienced in the ferritic steel evaporator units (Figure 1.2) were relatively benign as ferritic steel is not so subject to caustic stress corrosion, but the effect on availability while leaking tubes were being repaired was considerable.

The evaporator gas space leaks were all associated with cracking of the tube-to-tubeplate welds. These were hard and had high residual stresses because there was no post-weld heat treatment. None of the evaporator leaks gave evidence of wastage damage to the neighbouring tubes, probably because they were detected early by the installed gas-space hydrogen detection system. This was based on katharometers and was very sensitive, being capable of detecting leaks as small as 0.1 mg/s. The leaks were repaired by plugging the affected steam tubes.

Nevertheless it appeared that one leak would, after a few days or weeks of further operation, cause others. It was concluded that residual caustic reaction products in the gas space above the sodium caused further cracking of welds and initiated more leaks after an incubation period. Sodium flooding of the tubeplate at a temperature in excess of 400 °C for periods in excess of 24 hours had some success in removing reaction products. It was also required to wash out sodium hydrides which could lead to false hydrogen detection signals when they dissociated at high operating temperatures.

This did not cure the problem completely, however, and eventually it was concluded that washing with hot sodium did not remove caustic material from the roots of pre-existing fine cracks in the welds, so that in the presence of the residual stresses corrosion continued and the cracks grew to give rise to further leaks.

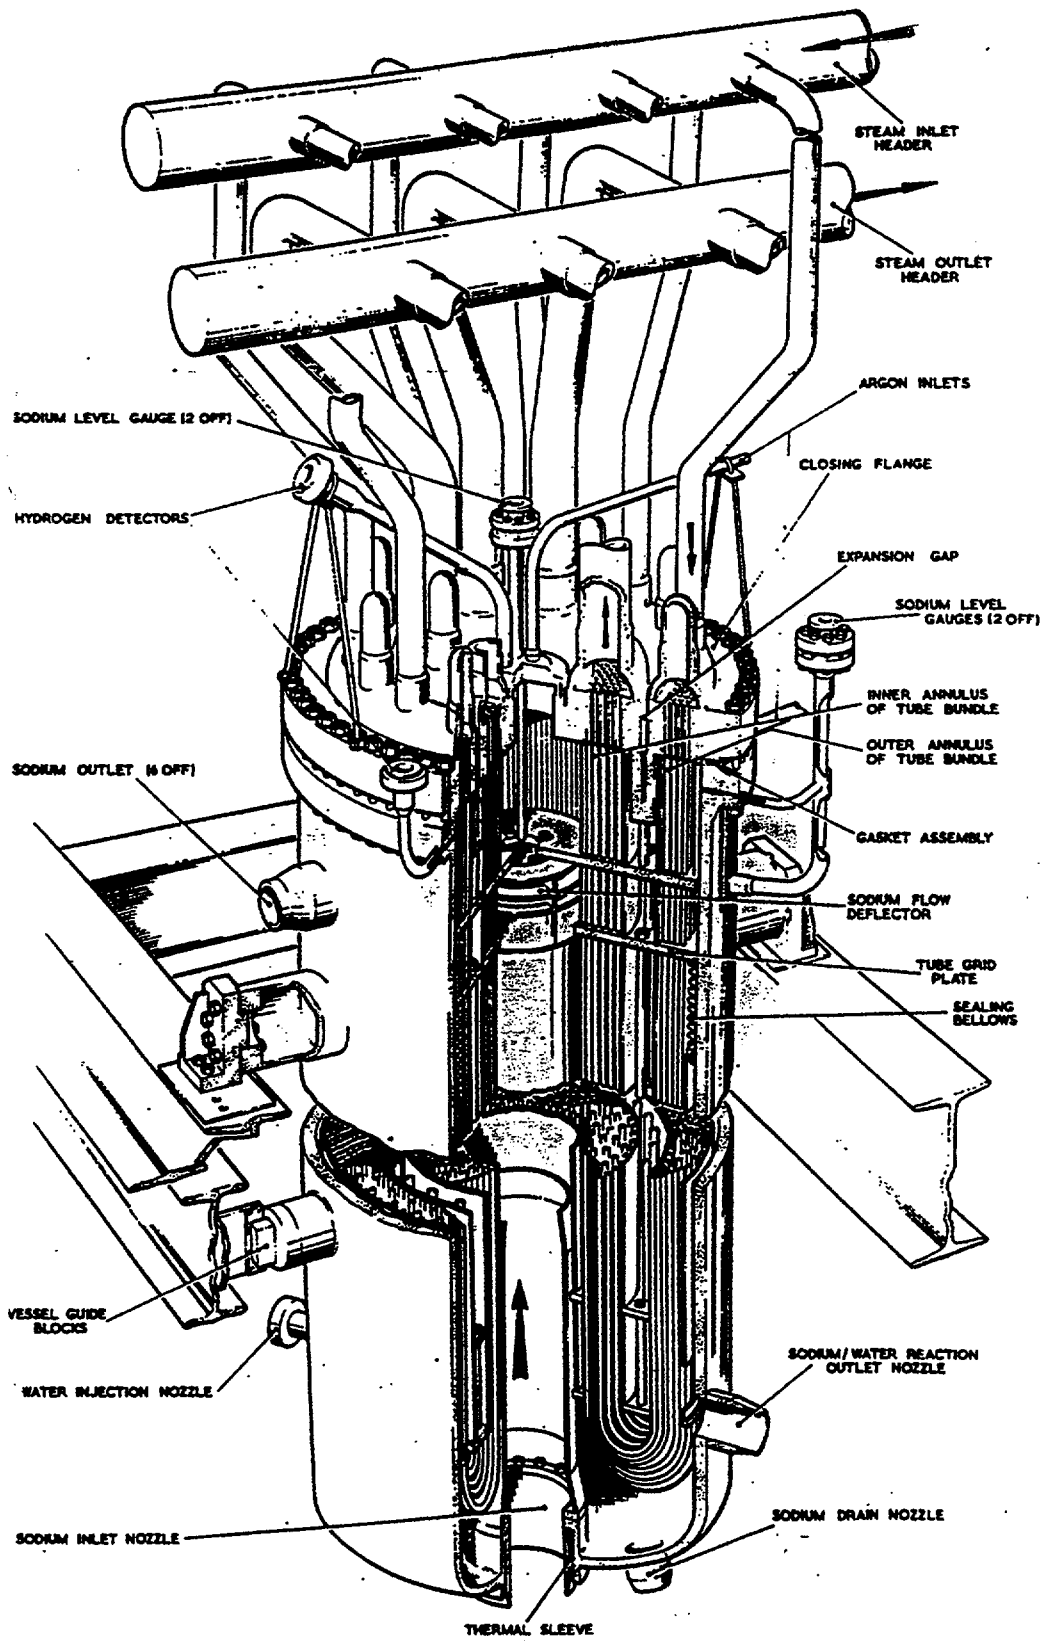
Figure 2.1 An Original PFR Superheater

It was confirmed shortly after the incident that a large under-sodium leak had occurred in superheater 2. Figure 2.1 shows one of the original PFR superheaters. After the sodium circuit had been cleaned to remove reaction products the superheater tube bundle was removed from its vessel in a nitrogen-filled bag and examined. This revealed that between two tube support grids one of the six baffle plates forming the central sodium inlet duct had become detached, and the remaining 5 plates in this region were deformed. Considerable distortion of steam tubes could be seen through the aperture left by the missing baffle plate.

The entire tube bundle was then dismantled and forty steam tubes were found to have ruptured, with longitudinal gapes of such a size as to be effectively equivalent to double-ended guillotine breaks. The locations of the failed tubes are shown in Figure 2.2. Sixteen of the failures were in the row adjacent to the central sodium duct and faced towards the duct. Four of the failed tubes had wear flats facing the central baffle and on one of these (tube 16) a circumferential crack at right angles to the main fracture was apparent. This was opposite a small wastage pit in the baffle, and it is concluded that this was the initiating leak.

Evidence of fretting on a further 13 tubes adjacent to the baffle was found, all close to the seams between the six plates forming the baffle. It was concluded that sodium leakage through the seams, shown in Figure 2.3, caused flow-induced vibration of the tubes resulting in contact with the duct and giving rise to wear and the eventual failure of tube 6.

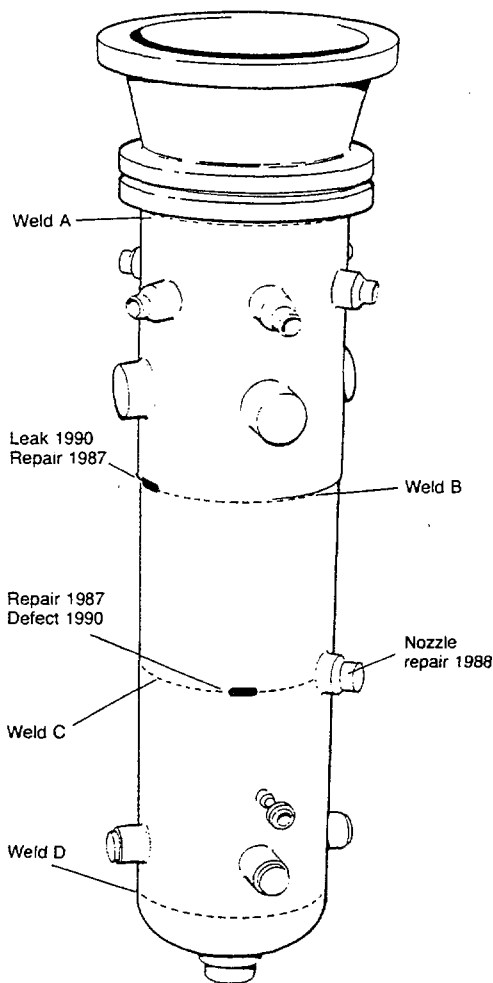
Figure 3.1. PFR Reheater 1 Vessel

Figure 3.1 shows a typical steam generator vessel. The vessels were manufactured from cold rolled annealed type 321 (18Cr 10Ni 1Ti) austenitic steel plate. Three cylindrical courses, together with a flanged upper end and a domed lower end, were welded using type 347 (19Cr 9Ni 1Nb) weld metal. Manual metallic arc weld root runs with submerged arc weld fill were used. During manufacture the welds were inspected and in some cases inclusions and other defects were found. These were ground out and made good with additional rectification welds. None of the welds was stress-relieved. The vessels were considerably overdesigned to withstand a continuous pressure of 34.5 bar, although the operating pressure was only 2 bar.

In 1987 the first steam generator vessel leak occurred in seam B of the reheater 2 vessel. Following this cracks were found on vessels during every inspection except 1989. All the cracks occurred in the B, C and D welds with none in A. Seam A is in the gas space, above the sodium level, and therefore at much lower temperatures than the other seams. (Following the fitting of the new tube bundles in 1987 weld A also operated under sodium.) At the final inspection in 1993 cracking was found for the first time in the welds of set-on features such as the vessel supports and nozzles.

Detailed optical and scanning electron microscopic examination of samples cut from reheaters 1 and 2 and superheater 2 were carried out in 1987. In all cases the cracks were associated with deep weld rectifications in the circumferential weld seams. The cracks either passed along the fusion line of the rectification or were on or close to the fusion line of the original rectified weld. Cracks passed through the parent steel along or closely parallel to the fusion line and through the weld material. Cracking was intergranular.

The cracking mechanism was identified as delayed-reheat or stress-relief cracking. Titanium stabilised type 321 steel is subject to this form of cracking, caused by dissolution of titanium carbide close to a weld fusion line as a result of the high temperatures attained during welding. Subsequent re-precipitation of the carbides on dislocations produced by weld shrinkage during high temperature operation locks the dislocations and hardens the matrix. Relaxation strains occurring during operation causes intergranular failure.

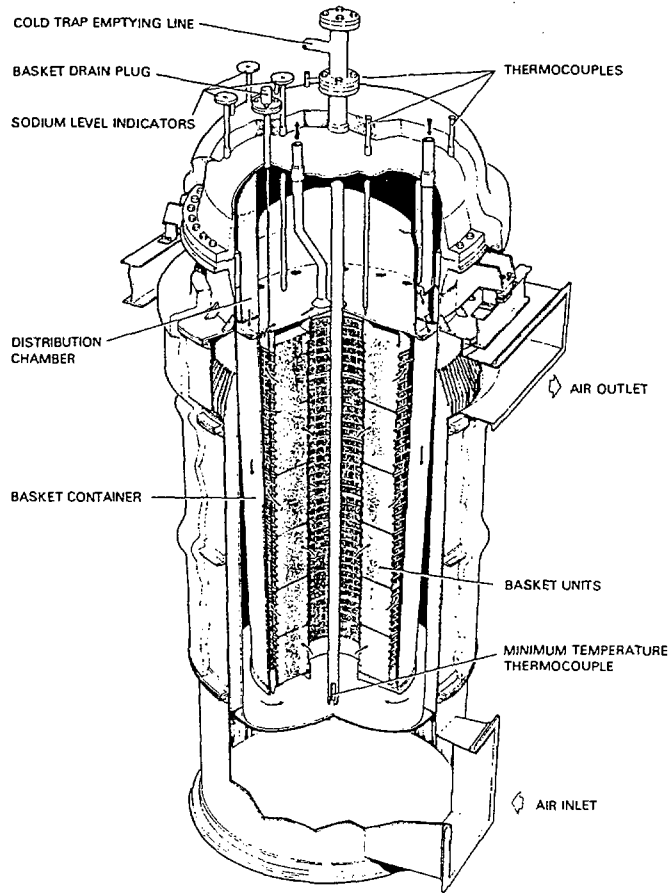
Figure 4.1. The PFR Secondary Sodium Cold Trap

The PFR secondary cold trap vessel and basket are shown in Figure 4.1. Secondary sodium, partially cooled in a regenerative heat exchanger, was delivered to an annular chamber. From there it was injected through six 22 mm diameter holes into an annular space between the vessel and a mesh basket. The vessel was air-cooled and the intent was that the sodium should be cooled to about 20 °C below its current impurity saturation temperature before flowing through six annular "doughnuts" of steel wire mesh. The mesh presented a large surface area for the deposition of sodium oxide and hydride. Cold trap baskets were regularly removed and cleaned for re-use, fitted with new set of doughnut meshes, when a gradual reduction in the sodium flow as the mesh blocked up indicated that the maximum loading had been reached. Expected loadings were in excess of 100 kg of mixed sodium hydride and oxide.

Inefficient operation of the PFR secondary cold trap led to impurity loadings below the theoretical maximum. Improved trapping techniques aimed at avoiding cooling the sodium too far below its saturation temperature, and more careful operation solved the problem after 1981.

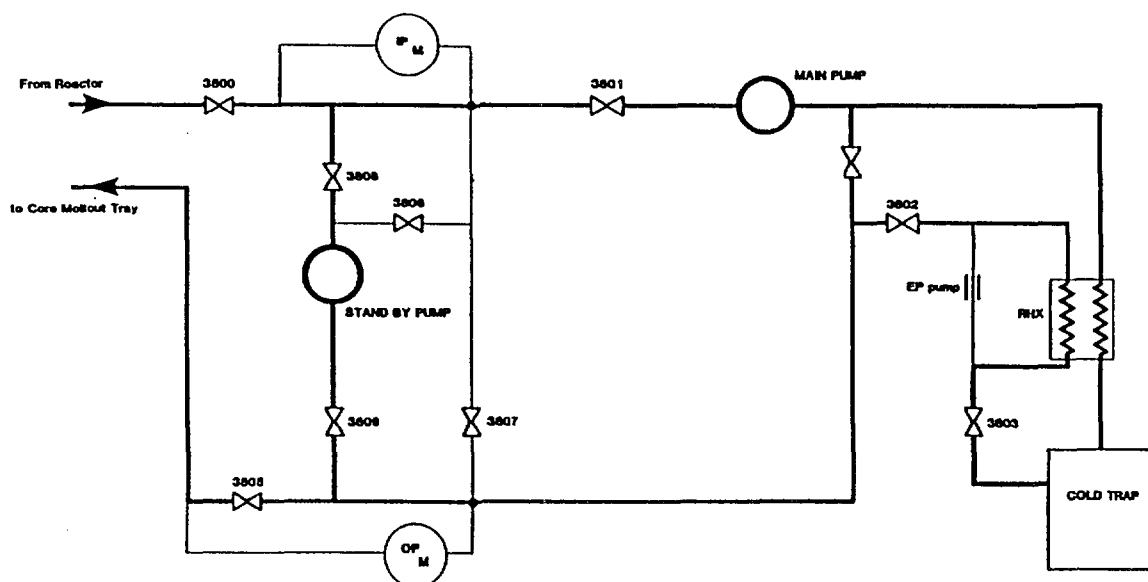
Figure 5.1. Schematic diagram of the PFR Primary Cold Trap Loop

The PFR primary cold trap loop (PCTL), shown in Figure 5.1, is an auxiliary circuit connected to the primary circuit. It purifies the active sodium by removing impurities. During PFR operation it also supplied sodium coolant to the core melt-out tray situated below the diaphragm in the reactor vessel. During the current decommissioning period it remains in use for cold trapping, if necessary, and measuring impurity levels in the primary sodium. The PCTL is situated in a shielded air-cooled concrete vault adjacent to the reactor vessel, as shown in Figure 5.2.

Each time a pump seized attempts were made to remove the sodium mechanically or melt it by use of the trace heating, but on no occasion did this succeed. Pumps had to be removed, decontaminated and stripped down in order to free the pump shaft.

During maintenance it was noted that oxide or hydride could be seen floating on the surface of the sodium in the pump tank. It was considered that such material, if raised inadvertently into the vent or feed lines, would contribute to the blocking of the gas valves. In 1988 both main and standby pumps had seized during the year, so during refurbishment a modification was carried out on the pumps to deal with the accumulation of these solid impurities. A jet of sodium was diverted from the discharge sides of the pumps to disperse the deposits and prevent valve blockages, as shown in Figure 5.3. This modification was not entirely successful in preventing further blockages and the pumps seized again in 1989 and 1990.

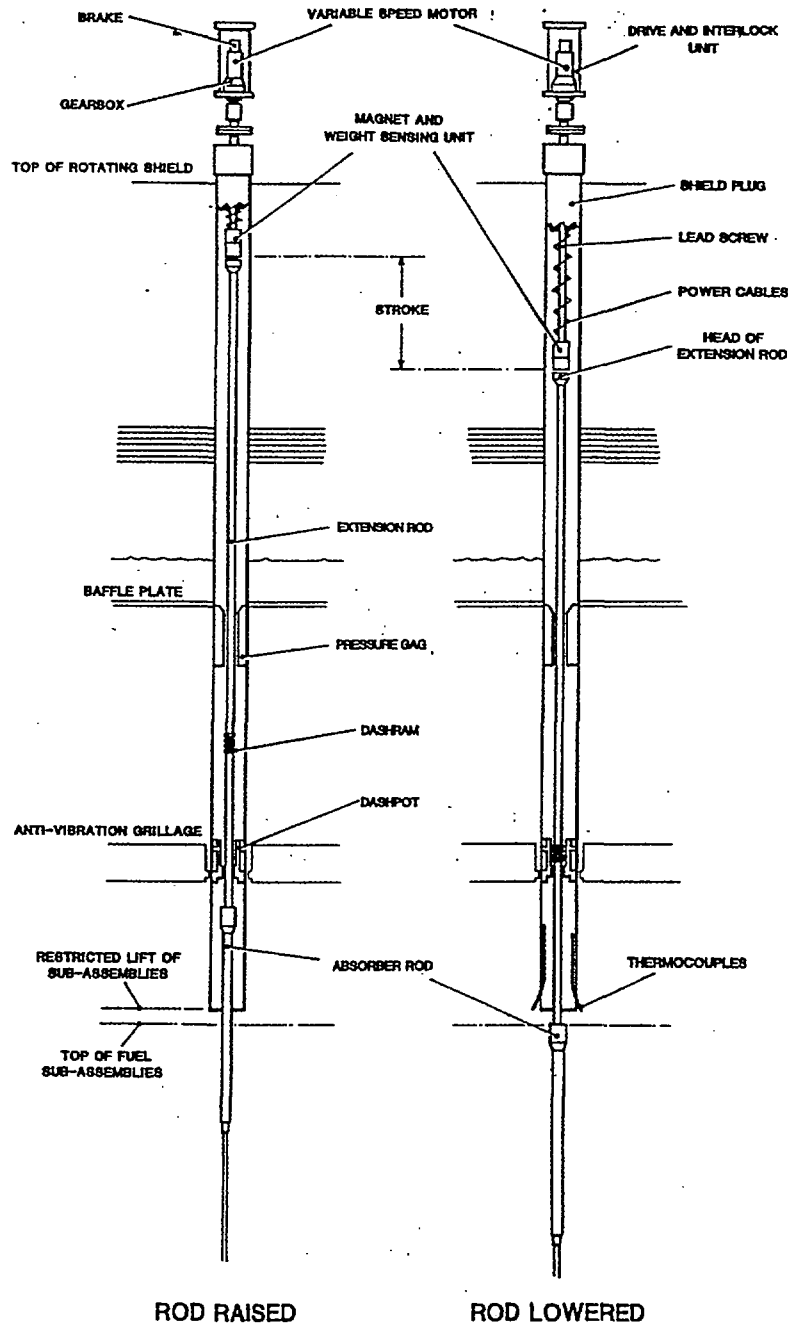
Figure 6.1. The PFR Absorber Rods

A diagram of PFR absorber rods is shown in Figure 6.1. PFR had 5 shut off rods (normally fully raised) and 5 control rods inserted to control power. The rods were essentially identical  $B_4C$  assemblies supported by electromagnets. On a trip all ten rods dropped. Magnet current, apparent rod weight, rod release time and time of flight were measured by installed instrumentation.

At the design stage it was recognised that following a trip there was potential for sodium aerosol to deposit on the parted magnet faces in the gas space. A continuous purge flow of argon gas was passed through the absorber liner tube to avoid the problem. Following trips the flow was enhanced to try to prevent aerosol building up. This however did not solve the problem fully and throughout its operational life PFR suffered from gradual reduction in the efficiency of the magnets due to the gradual buildup of sodium deposits on the faces of the magnets. This led to plant trips on a number of occasions due to absorbers dropping off their magnets during power operation.

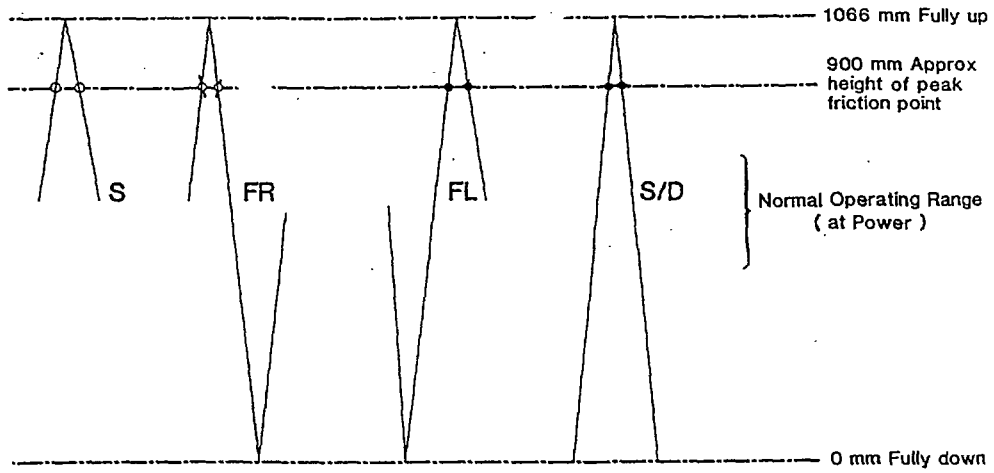
Figure 6.2. Movement of the PFR Absorber Rods during Exercising

Typical rod movements during exercising are shown in Figure 6.2. The exercising was found to have the effect of reducing friction. Peak friction occurred at about 900 mm (see Figure 6.2) but the magnitude depended on whether the rods were raised or lowered first. Lowering first reducing friction levels. Figure 6.3 shows an actual trace of friction for a control rod, which in this case started by being raised. The actual weight of absorber plus extension tube is 230 kg. The dotted line marked FINISH is an immediate partial repeat of the test showing the decrease in friction resulting from the first test.

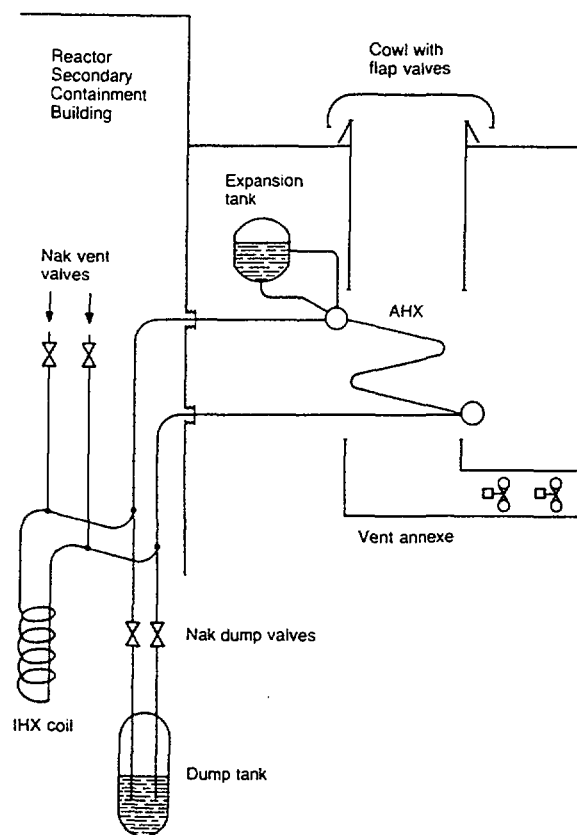
Figure 7.1. Schematic Diagram of a PFR Thermal Syphon Decay Heat Rejection Loop

PFR had three thermal syphon decay-heat rejection loops, shown in Figure 7.1. Each consisted of a NaK-filled loop connecting a heat exchanger coil positioned in the main reactor vessel adjacent to an intermediate heat exchanger to an air heat exchanger (AHX) on the roof of the reactor containment building. In the event of loss of electric power supplies each loop was capable of removing 1.5 MW of decay heat from the reactor by natural convection. Each AHX was equipped with 2 fans connected to emergency diesel power supplies, which could enhance the decay heat removal to over 4 MW per loop. When the reactor was operating normally heat removal was limited by dampers which restricted the airflow to the AHXs.

Although the thermal syphon system operated well, by 1984 it had become apparent that the AHXs suffered from a systematic fault leading to failures and leaks. Each AHX consisted of forty serpentine parallel tubes welded to pulled tees in two headers, as shown in Figure 7.2. The tubes were finned along the straight lengths but plain at the bends, which were clamped together and supported. Further rigidity was provided by cleats which were welded to the tops of the fins on adjacent tubes. Flow of NaK was from the top down. Leaks were occurred at the welds between the tubes and the pulled tees in the headers.

The measurements indicated that the problems occurred essentially because the AHX tubes were in parallel, and were horizontal with no fall to ensure good filling. When the AHXs were filled gas locks were occurring at the pipe bends. The gas-locked tubes remained cold, and as a result oxide impurities could be precipitated causing permanent blockages. Because of temperature differences between a cold blocked tube and the adjacent hot tubes to which it was clamped, large stresses were imposed. As a result the weakest point in the system, the weld between the tube and the header, was stressed, suffered cracking and eventually leaked.

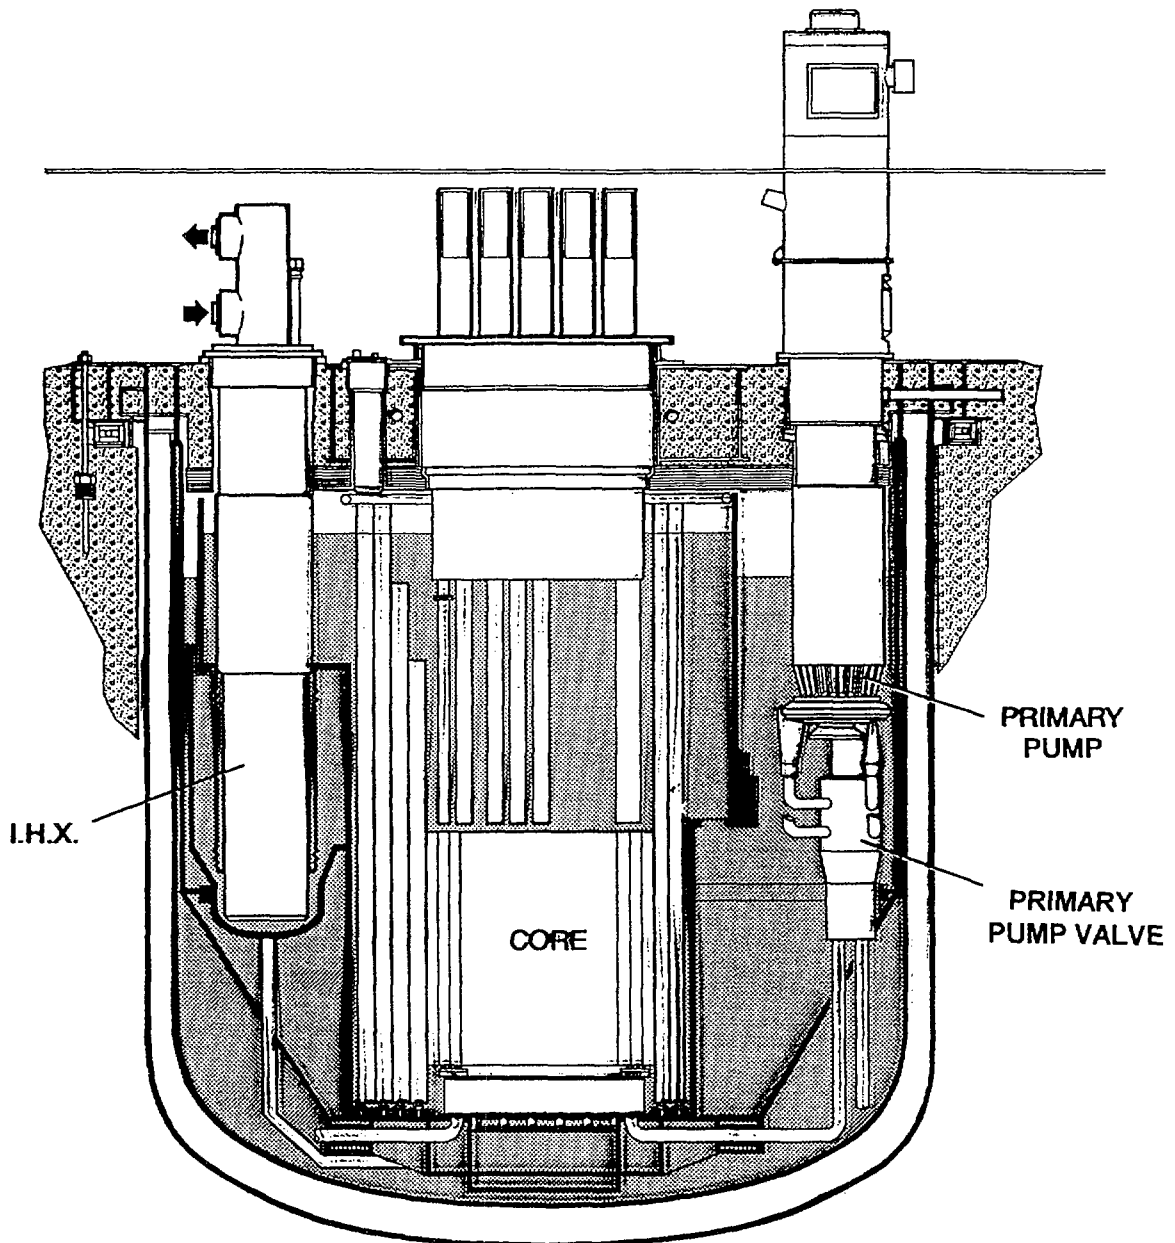
Figure 9.1. The PFR Primary Circuit

The PFR primary sodium circulation system is shown in Figures 9.1 and 9.2, and Figure 9.3 shows details of a primary sodium pump (PSP). The sodium from each PSP flows through filters and a stop valve to the diagrid, and thence to the fuel subassemblies. Each subassembly has a filter at its inlet. Figure 9.4 shows the relationship between the pump and subassembly filters.

In 1974 primary sodium pump 2 (PSP 2) was removed from the reactor for modifications to its instrumentation and was noticed to be heavily contaminated by a black sooty deposit. In the same year the charge machine was removed, revealing that its immersed surface was black with adherent tarry lumps.

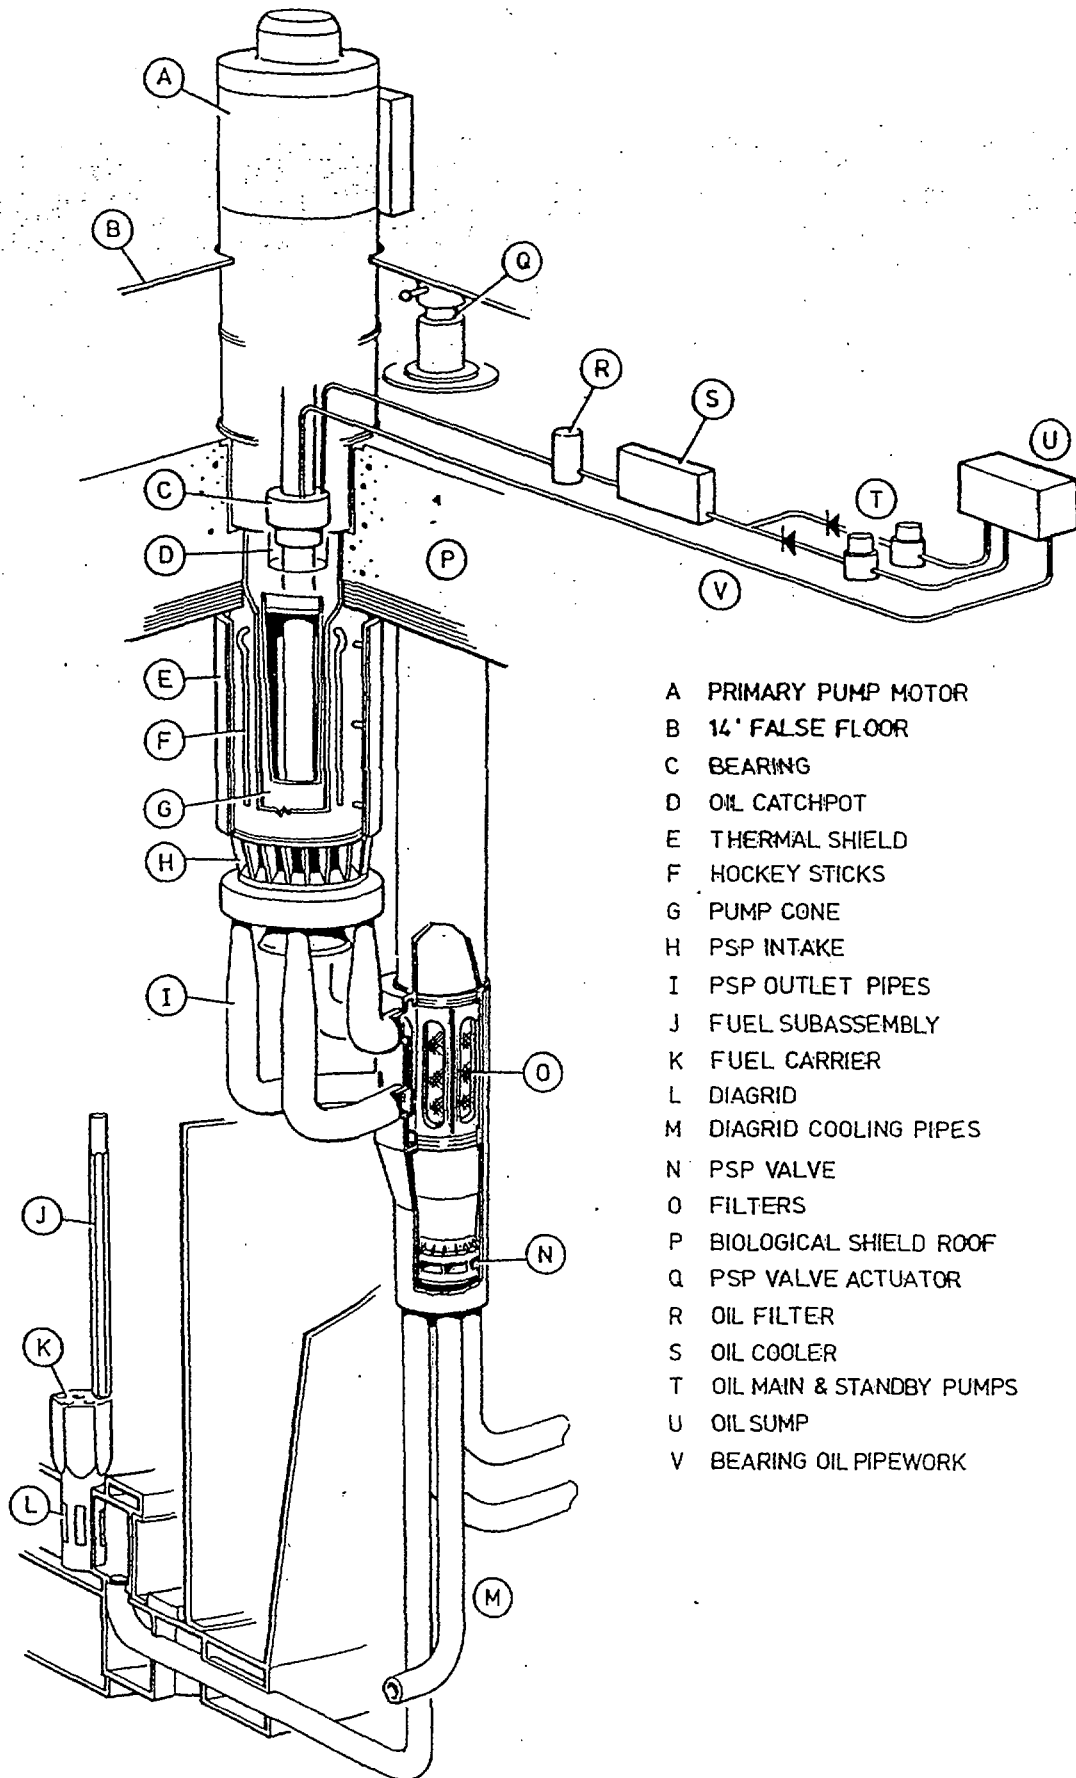
Figure 9.2. A PFR Primary Sodium Pump and its associated Valve and Filter Assembly

During this period of operation some 65 litres of oil had been lost from the pump upper seal oil systems, part of which is believed to have entered the reactor vessel. When the reactor was taken critical no effects of the oil were observed. It is suspected, however, that as a result of the spill the filter on PSP 2 valve ("O" in Figure 9.2) failed due to high differential pressure because it became blocked by oil-sodium reaction products. It is also thought that partial blockage of the pump casing overflow pipe (Figure 9.3) was to lead to the major problem in 1991.

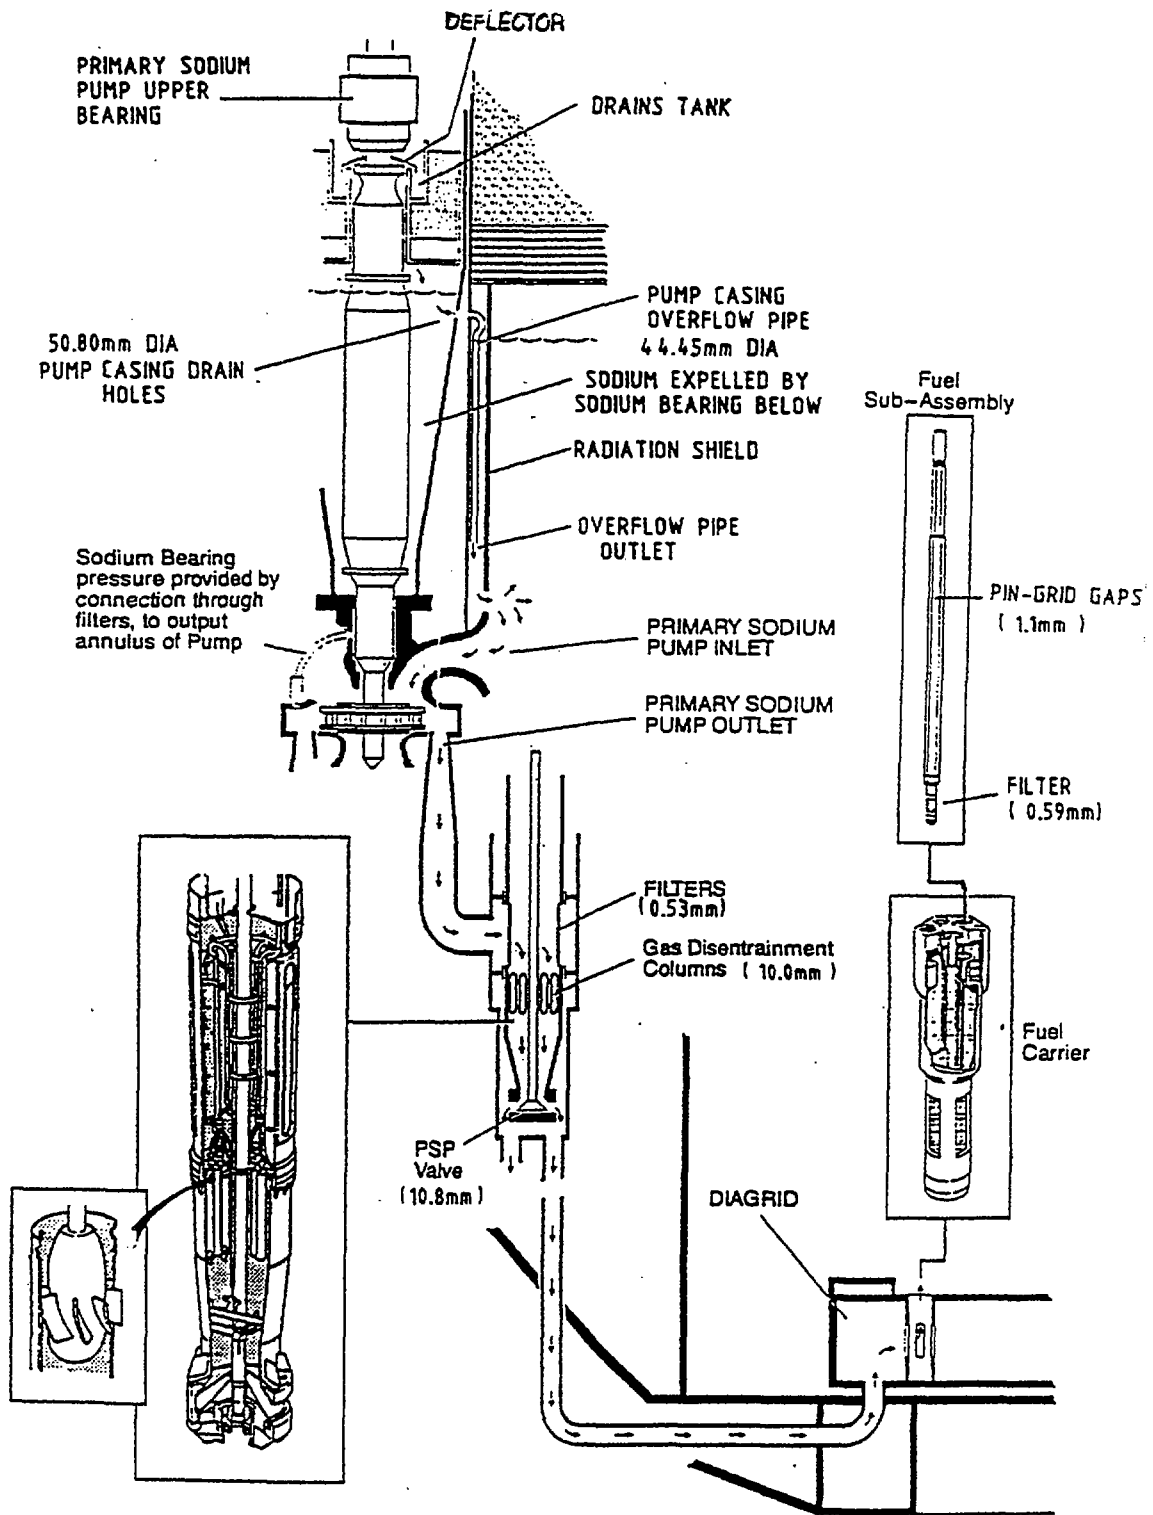
Figure 9.4. Filter Mesh Sizes in the PFR Primary Circuit

No further problems were observed until 1990 when it was noted that PSP1 drive current was slowly dropping at constant pump speed and its discharge pressure was rising. The situation was under observation when suddenly the current rose, the discharge pressure

fell and the flow of coolant through the core increased. A similar sequence of events occurred a few weeks later, when flows and current returned to normal. Although no oil spill was recorded it is now believed that oil had entered the system and blocked the filter of PSP 1, causing it to fail in stages. When it had failed completely and offered no resistance the coolant flow returned to its normal value.
