BACKFITTING OF THE FRG REACTORS

W. Krull

GKSS-FORSCHUNGSZENTRUM GEESTHACHT GMBH

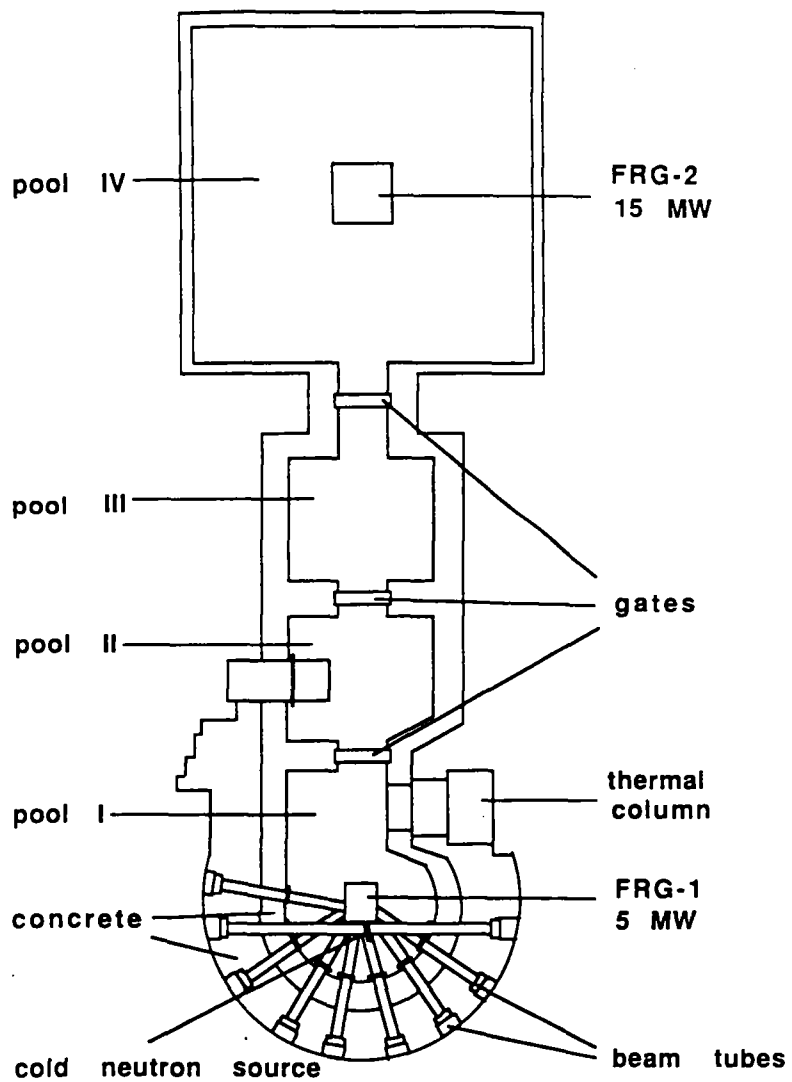
Fig. 1

The GKSS-research centre is operating two research reactors of the swimming pool type fueled with MTR-type type elements. The research reactors FRG-1 and FRG-2 having power levels of 5 MW and 15 MW are in operation since 31 a (FRG-1) and 27 a (FRG-2). They are comparable old like others, too. The reactors are operated at present at approximalety 180 d (FRG-1) and between 210 d and 250 d (FRG-2) per year. Both reactors are located in the same reactor hall in a connecting pool system (fig. 1).

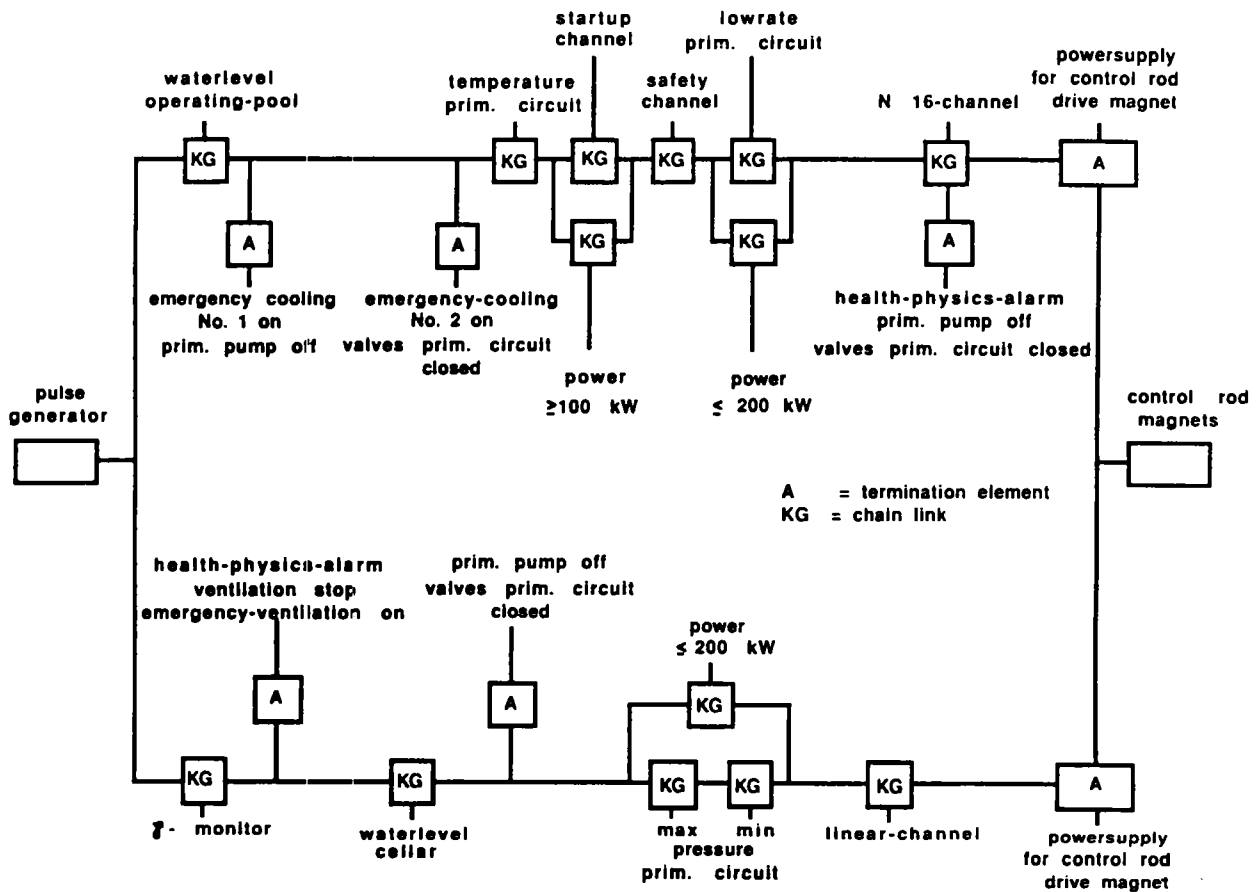
3. The main accidents had to be rediscussed like startup from low and full power, loss of coolant flow, loss of heat sink, loss of coolant and fuel plate melting.
4. We were forced to install a new reactor protection system following today demands on redundancy (2 out of 3), diversity etc. from the relevant power reactor standard. Fig. 2 gives a general overview of the design of the reactor protection system. The design principle can be seen in the table. It should be known that there are comparators between each channel of the redundant analog signals.

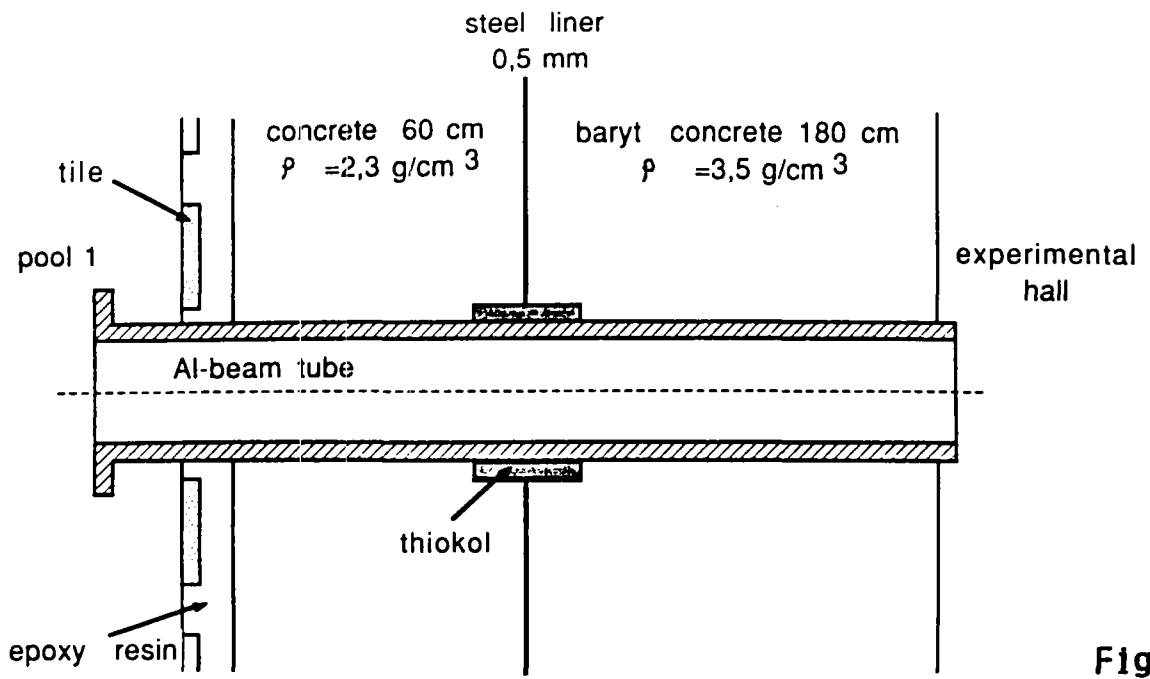
Fig. 7

To understand the considerations and the proposed repair program a brief design description of the biological shield must be taken from fig. 7. It is clear that there were raised the following questions:

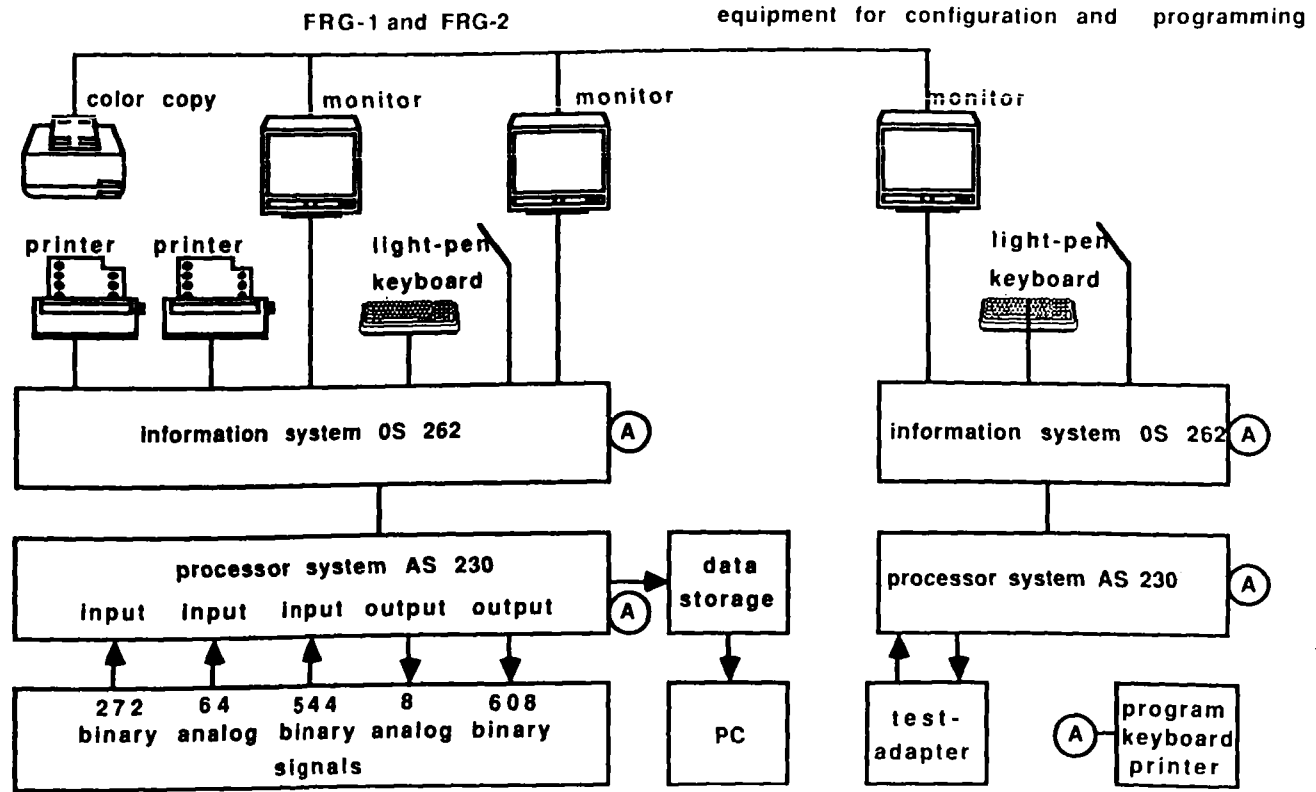
As it could be seen that there will be within the next future increasing difficulties for maintaining and repairing the process control system and for getting new spare parts it was decided to renew the instrumentation, the process control system and the alarm system. The order was placed end of 1988. Fig. 11 shows the principal design of the instrumentation and monitoring system. The system is being implemented. We are hoping to go into operation again in March 1990.

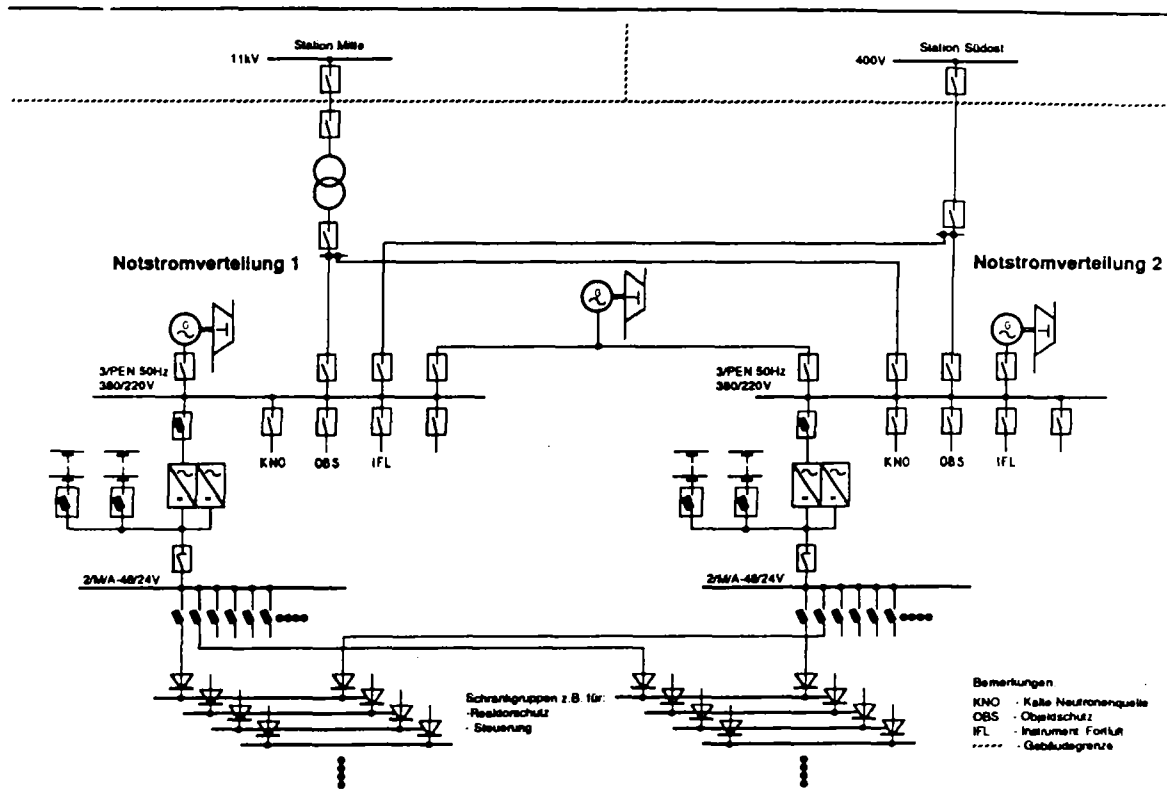
Fig. 12

only used for the needs of an emergency power supply. Probable faults can be caused by other reasons.

Considering this situation the decision was made to build a new station for (1 out of 2) diesel generators to be used only for the emergency power supply for our two reactors. The principal design work is being finished and we are going to ask for inquiries from competent suppliers. The principal design can be taken from fig. 12.
