KAPL-4763

**STRESS CORROSION CRACK TIP MICROSTRUCTURE  
IN NICKEL-BASE ALLOYS**

**Corrosion/94 Symposium  
Baltimore, MD  
February 28 - March 5, 1994**

**KNOLLS ATOMIC POWER LABORATORY  
SCHENECTADY, NEW YORK**

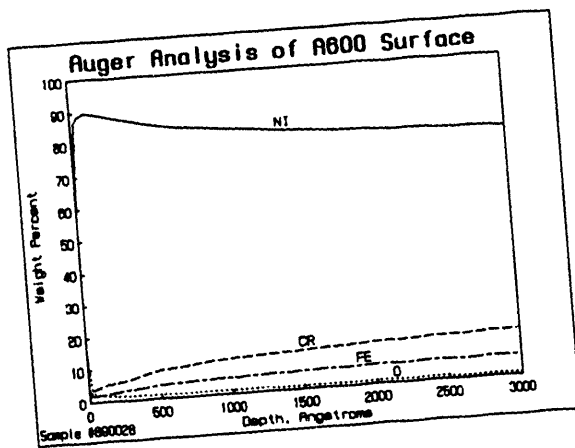
FIGURE 7 - Auger Analysis of General Surface for Alloy 600 After 500 Hours Exposure in 10% Caustic at 585°F

Fe(III) and Fe(II) based spinels or oxides were also present in small quantities. Similar Auger results were observed for Alloy 600 and Alloy 690. Figures 7 and 8 show that the general corrosion surfaces are enriched in Ni and depleted in Cr and Fe for both Alloy 600 and Alloy 690. ESCA results showed primary corrosion products as Ni(OH)<sub>2</sub>, a Cr(III) based spinel (or oxide) and a Ni(II) based spinel (or oxide).

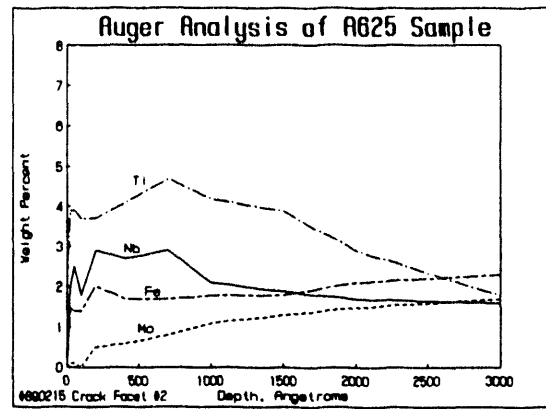
FIGURE 9 (b) - Same as 9 (a) but showing Ti, Nb, Fe and Mo Profiles

**SCC Crack Facets.** The surface film composition of the crack facets near the crack tip was evaluated using Auger analysis. Figure 9 shows the Auger results for Alloy 625. Unlike the general corrosion surface, the fracture surface near the crack tip showed enrichment in Cr and Ti. It was depleted in Mo, Ni and, to a lesser extent, Fe and Nb. The oxide layer was thicker than that on the general surface. The reason for the apparent Cr-enrichment probably comes from the Cr-rich oxides inside the crack tip which covers part of the crack facets. This is confirmed by AEM results inside the crack tip, as discussed in the next section. Figure 10 shows the Auger results of crack facets near the crack opening. It showed enrichment in Ni and depletion in Cr, Mo, Nb and Fe. This is similar to the general corrosion surface film composition. Auger results of Alloys 600 and 690 were similar to the Alloy 625 results. The crack facets near the crack tip of Alloy 600 and Alloy 690 showed enrichment in Cr and Ti, Figures 11 and 12. The crack facets near the crack opening showed enrichment in Ni, similar to the general corrosion surface.

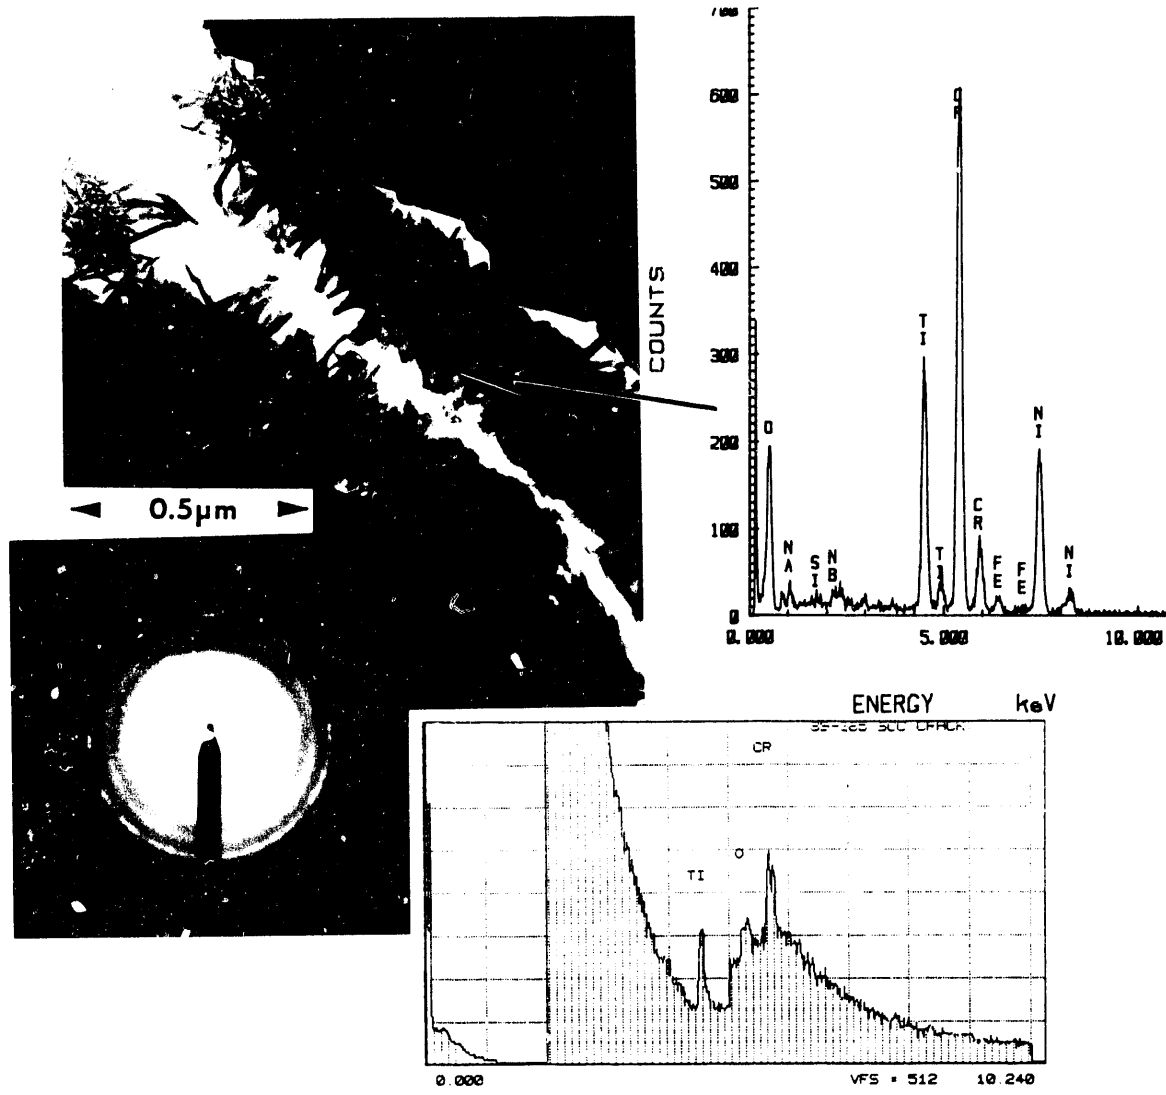
Figure 15: Oxide Appearance in the Crack Opening (Region 1)
